## Sheen Monitoring Report #17

# Mayflower Pipeline Incident Response

## Mayflower, Arkansas

**Monitoring Period:** Daily from 02/10/2014 through 02/16/2014

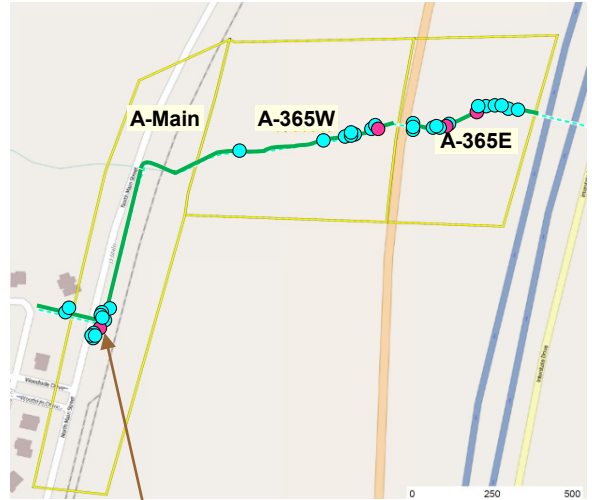
**Drainage Ways (Summary of Observations from 02/10/2014 through 02/16/2014)**

- A-Main
  - Seven covers (no particular structure) and three patches of silver gray sheens; and one cover/patch of metallic/silver gray sheens observed. Sheens broke apart when disturbed ("brittle")<sup>1</sup>.

- One patch of silver gray sheens observed. Sheens did not break when disturbed ("non-brittle")<sup>2</sup>.
- A-365W
  - One cover (no particular structure) of brittle<sup>1</sup> metallic/silver gray sheens; four covers and two patches of brittle<sup>1</sup> silver gray sheens; and one patch of brittle<sup>1</sup> rainbow/silver gray sheens observed.

- One patch of brittle<sup>1</sup> and non-brittle<sup>2</sup> silver gray sheens observed (shown as non-brittle<sup>2</sup> on figure).
- A-365E
  - Two covers (no particular structure) and one patch of brittle<sup>1</sup> metallic sheens; eight covers and one patch of brittle<sup>1</sup> silver gray sheens; and one patch of brittle<sup>1</sup> rainbow/silver gray sheens observed.

- One cover (no particular structure) of non-brittle<sup>2</sup> silver gray sheens observed.
  - One cover (no particular structure) of brittle<sup>1</sup> and non-brittle<sup>2</sup> silver gray sheens observed (shown as non-brittle<sup>2</sup> on figure).

**Mitigation:** Suspected petrogenic sheens were removed using absorbent materials.

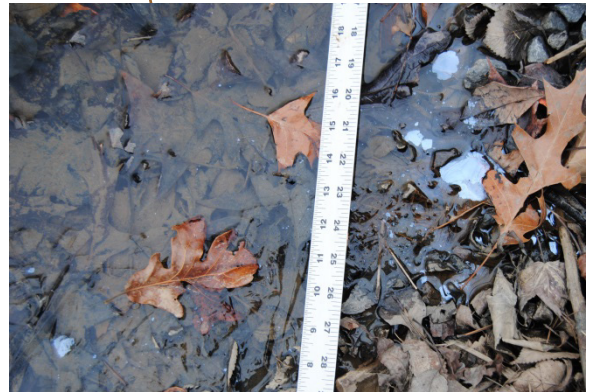
**Silver Gray Sheen Patch Observation on 02/12/2014**

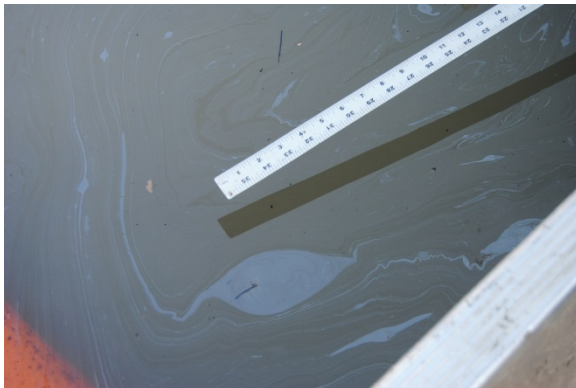
**Rainbow/Silver Gray Sheen Streamer with Oil Spots (0.1- to 1-inch Wide) Observation on 02/13/2014**

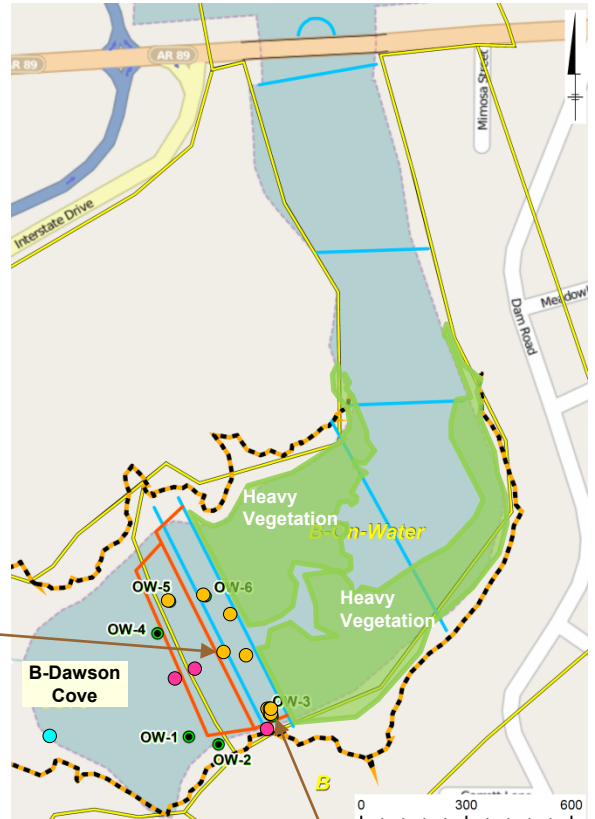
**Dawson Cove (Summary of Observations from 02/10/2014 through 02/16/2014)**

- One cover (no particular structure) of brittle<sup>1</sup> silver gray sheens observed.
- Two patches/streamers (with 0.25- to 0.5-inch wide oil spots), three streamers (with 0.1- to 1-inch wide oil spots), and one patch (with 0.5-inch wide oil spot) of non-brittle<sup>2</sup> rainbow/silver gray sheens; and two patches (with 0.05- to 0.25-inch wide oil spots), two streamers (one with 0.1- to 0.25-inch wide oil spots), three patches/streamers (two with 0.1- to 0.25-inch wide oil spots); and one cover (no particular structure) of non-brittle<sup>2</sup> silver gray sheens observed.

- Continue sheen monitoring in all areas.

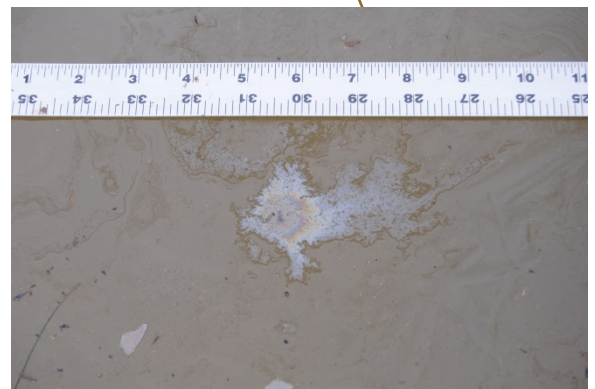
**Rainbow/Silver Gray Sheen Streamer with Oil Spots (0.25- to 1-inch Wide) Observation on 02/12/2014**
