QUALITY ASSURANCE PROJECT PLAN ASBESTOS-CONTAINING MATERIALS ABATEMENT REVISION 0

CARLISLE COMMERCIAL PROPERTY 216 & 218 WEST MAIN STREET CARLISLE, ARKANSAS 72024

EnSafe Project Number 0888840689

May 9, 2025

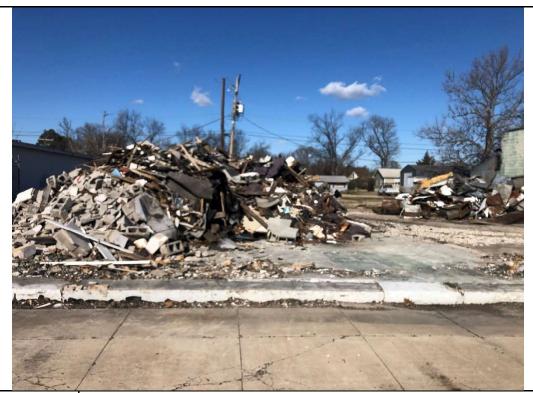
PHOTO NO. 1 DESCRIPTION:

View of demolished building - remaining debris is considered asbestos-contaminated waste requiring disposal by a licensed asbestos contractor at an approved landfill. Photo provided by Arkansas DEQ.

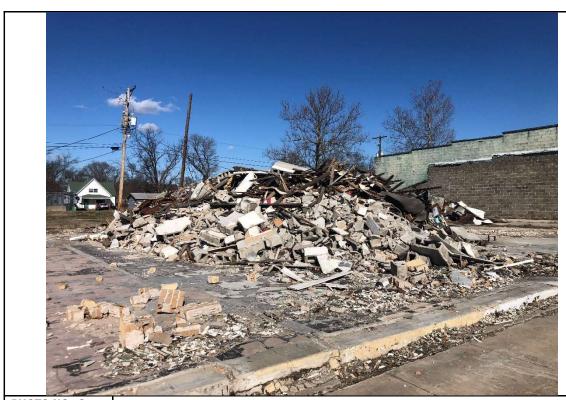
PHOTO NO. 2 DESCRIPTION:

View of demolished building. Photo provided by Arkansas DEQ.

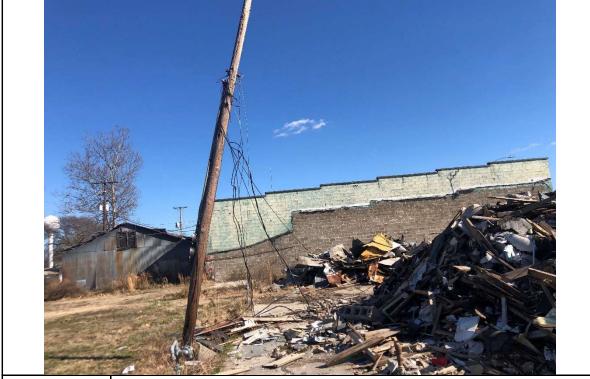
PHOTO NO. 4
DESCRIPTION:

View of demolished building. Photo provided by Arkansas DEQ.

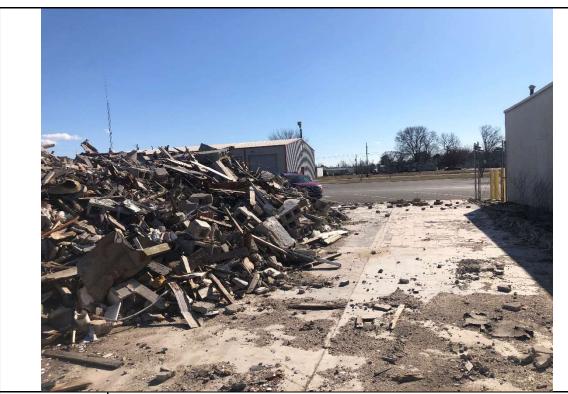
PHOTO NO. 5 DESCRIPTION:

View of demolished building. Photo provided by Arkansas DEQ.

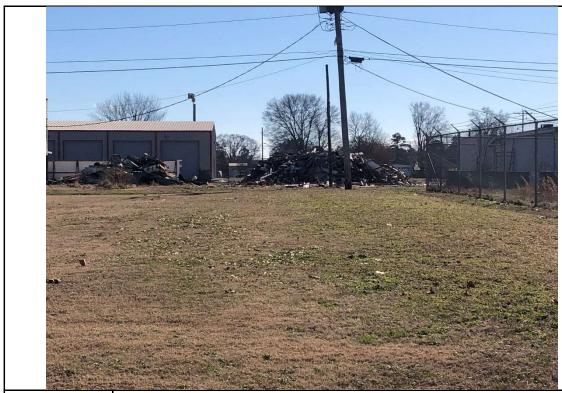
PHOTO NO. 6
DESCRIPTION:

View of demolished building. Photo provided by Arkansas DEQ.
