Hazardous Materials Survey

**De Queen MC Hospital
1306 West Collin Raye Drive
De Queen, Arkansas 71832**

October 8, 2024

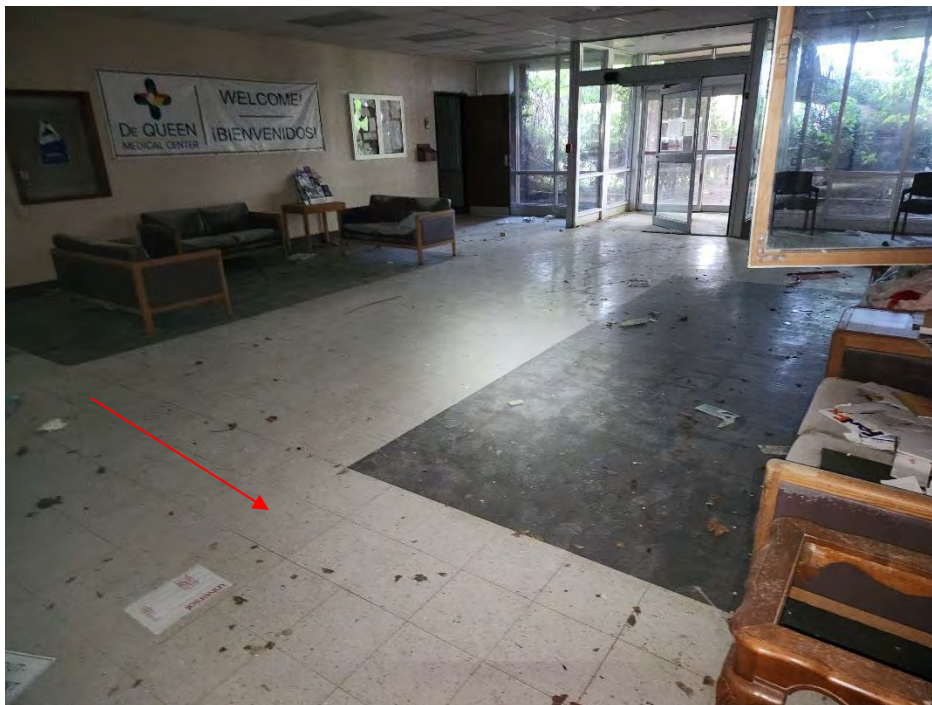
- ACM was identified within the subject property Hospital building in black mastic associated with white with green and gray streaks vinyl floor tile, gray vinyl floor tile, and tan with brown streaks vinyl floor tile (approximately 3,750 square feet [SF]) in the front entryway, main offices, and hallways off the front entryway and offices. The mastic was represented by samples HS-VFT03-001, -002, and -003; HS-VFT04-001, -002, and -003; and HS-VFT05-001, -002, and -003. Laboratory results indicated that the mastic contained 4 percent chrysotile asbestos.

Photo 4: This photograph shows the asbestos-containing material (ACM) 12- x 12-inch white with green and gray streak vinyl floor and black mastic (HS-VFT03) in the front entryway of the Hospital building (red arrow).

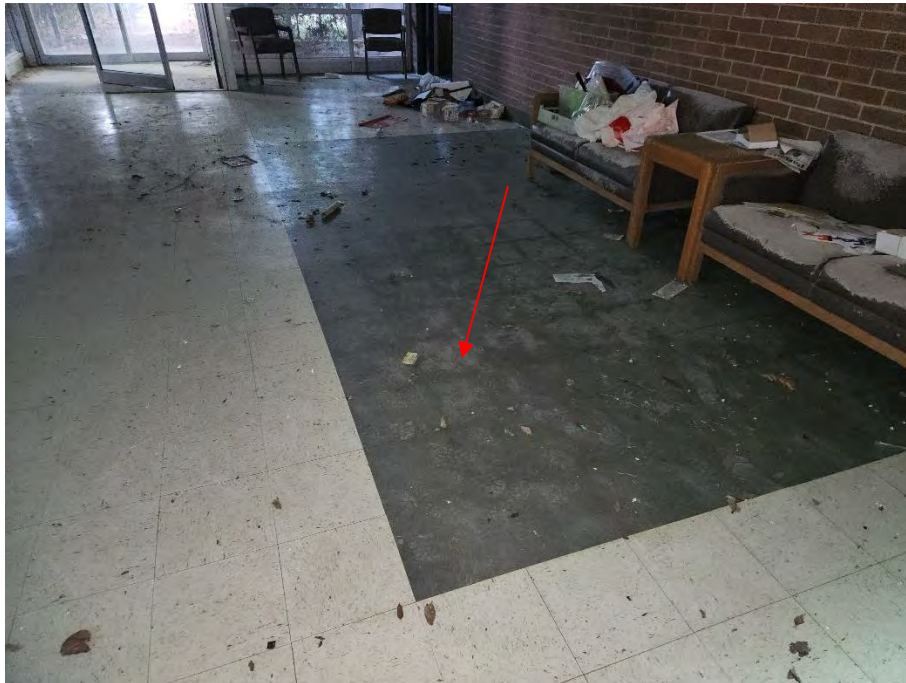
Photo 5: This photograph shows ACM 12- x 12-inch gray vinyl floor tile and black mastic (HS-VFT04) in the front entryway of the Hospital building (red arrow).

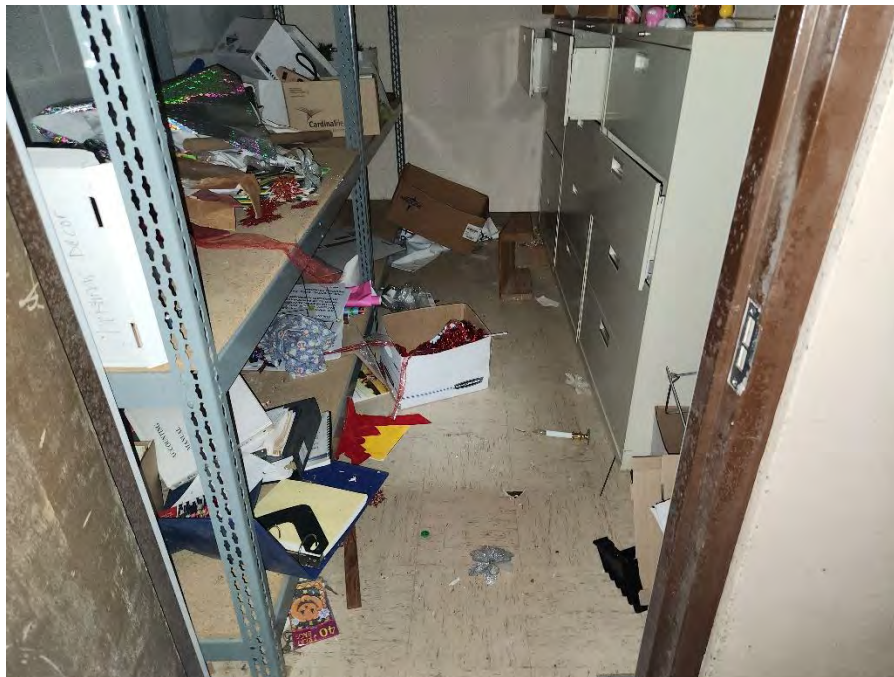
- ACM was identified within the subject property Hospital building in tan with brown streaks vinyl floor tile (approximately 1,500 SF) in the main offices and hallways off the offices near the front entryway. The floor tile was represented by samples HS-VFT05-001, -002, and -003. Laboratory results indicated that the floor tile contained 5 percent chrysotile asbestos.

Photo 6: This photograph shows ACM 12- x 12-inch tan with brown streaks vinyl floor tile and black mastic (HS-VFT05) in the offices off the front entryway of the Hospital building.

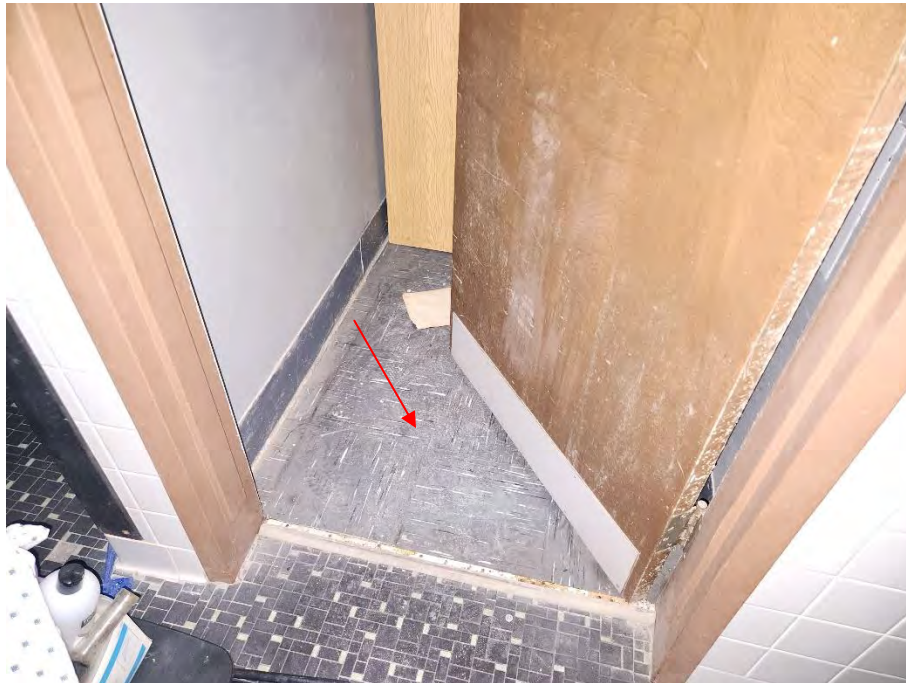
- ACM was identified within the subject property Hospital building in black mastic associated with gray with white and black streaks vinyl floor tile (approximately 300 SF) in the operating room doctor's lounge. The floor tile was represented by samples HS-VFT07-001, -002, and -003. Laboratory results indicated that the mastic contained 3 percent chrysotile asbestos.

Photo 7: This photograph shows ACM 12- by 12-inch gray with white and black streaks and black mastic (HS-VFT07) in the operating room doctor's lounge of the Hospital building (red arrow).

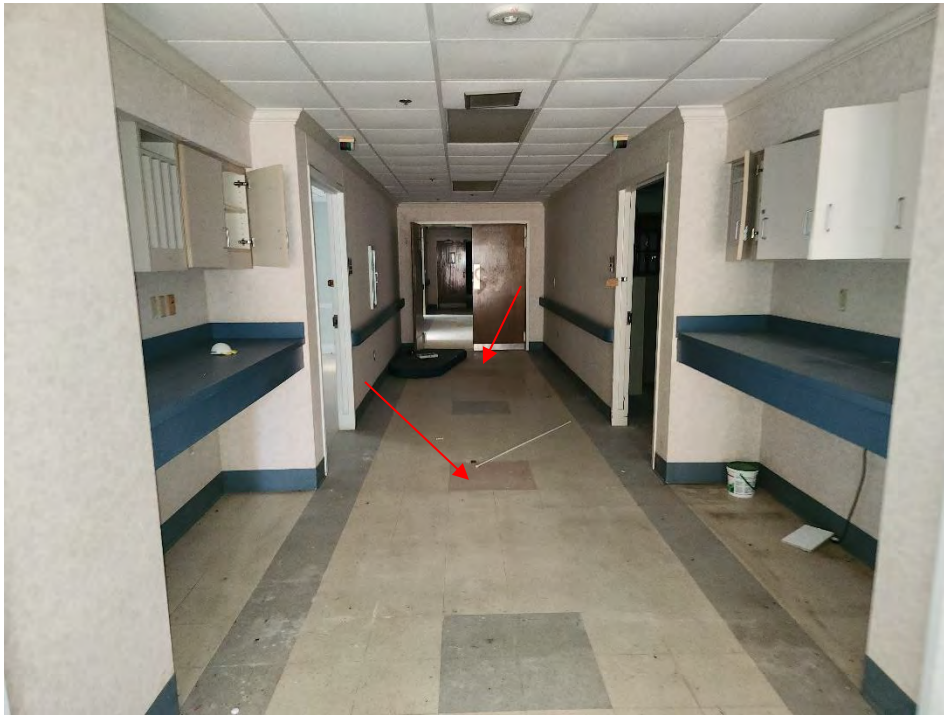
Photo 9: This photograph shows ACM 12- x 12-inch pink with white streaks vinyl floor tile and yellow mastic (HS-VFT09) in the maternity area hallway of the Hospital building (red arrows).

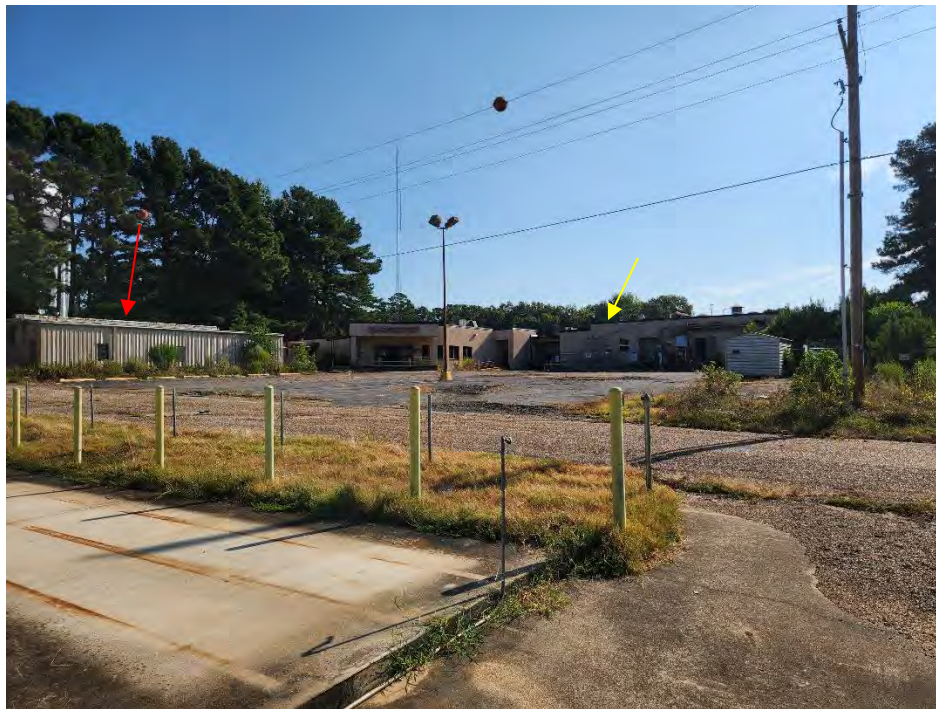
Photo 10: This photograph shows a view of assumed ACM roofing material on the Purchasing Department building (red arrow) and the Hospital Building (yellow arrow).

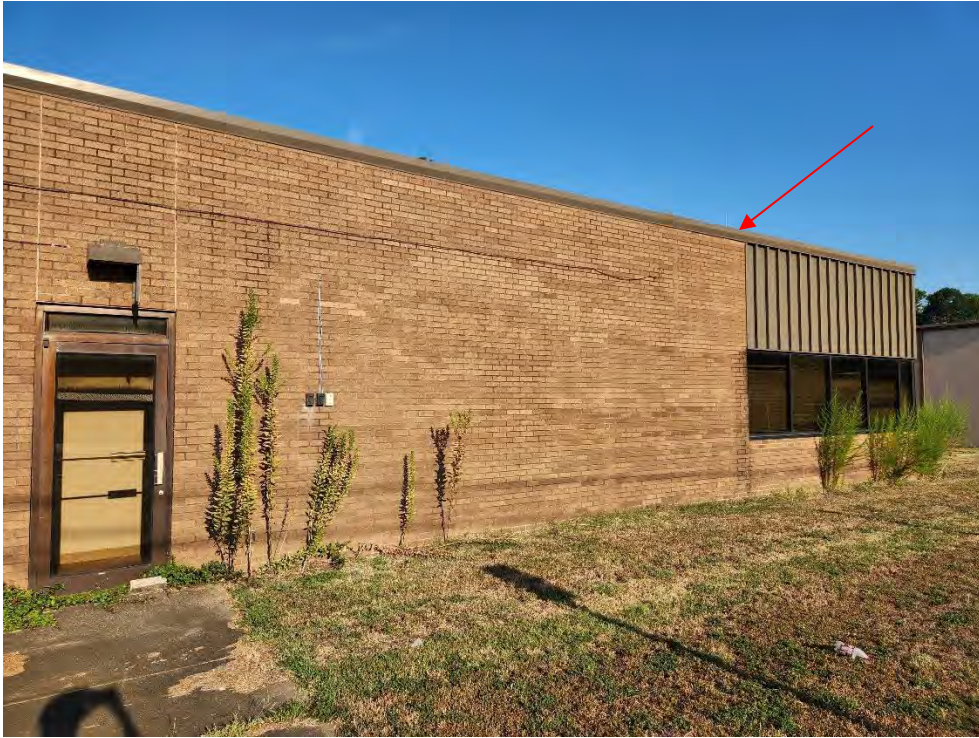
Photo 11: This photograph shows a view of assumed ACM roofing material on the Medical Plaza building (red arrow).

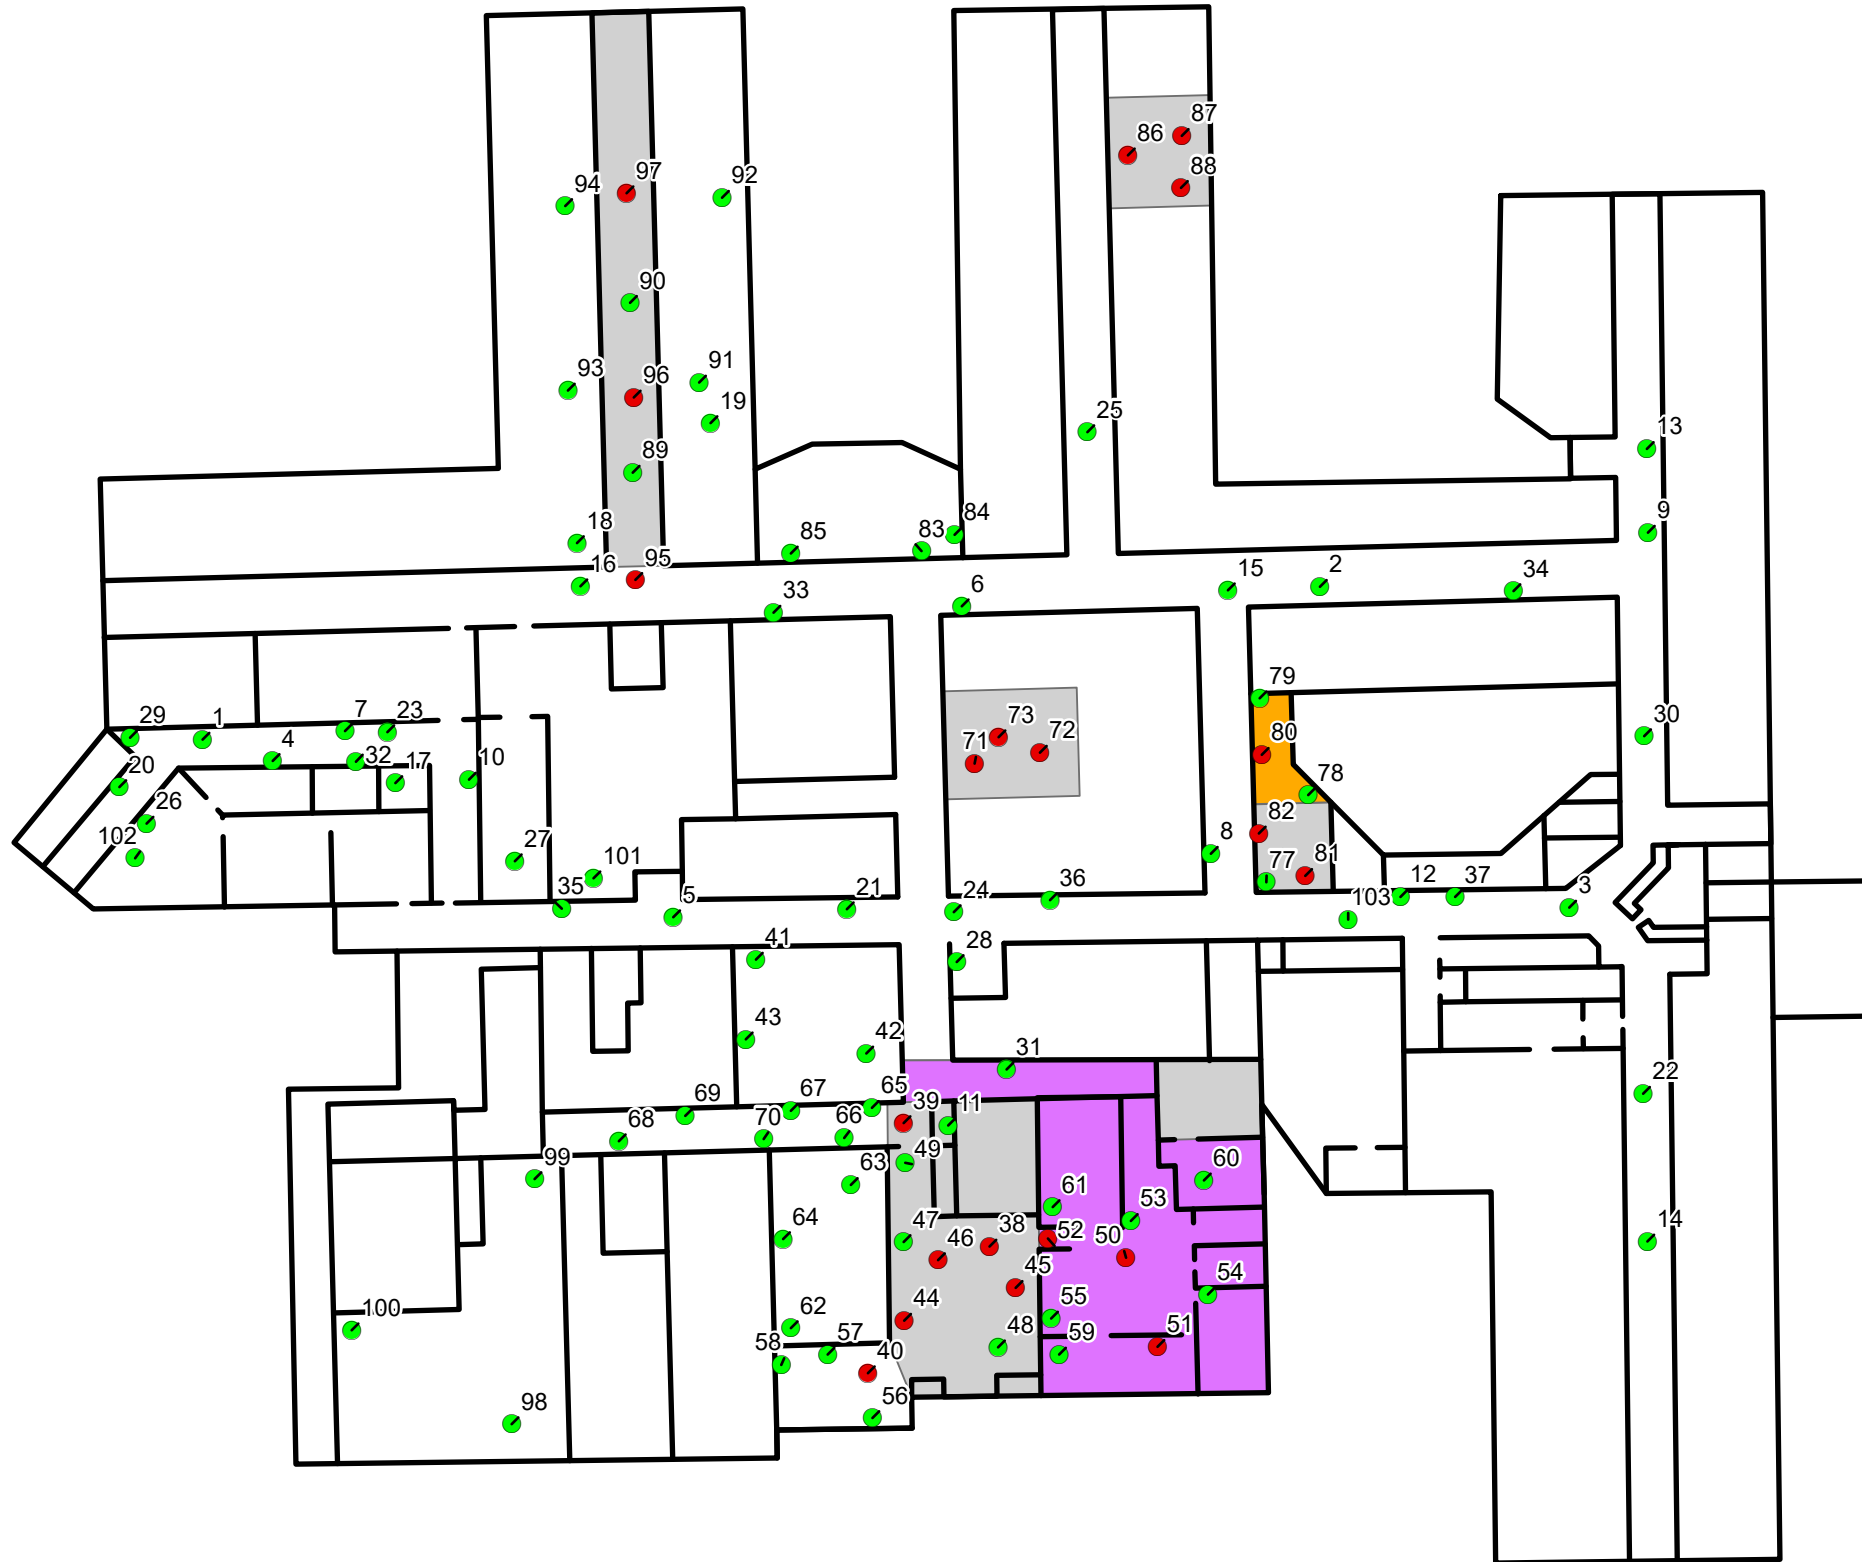
Sample Key Table

- Asbestos-Containing Material Sample Location
- Non-Asbestos-Containing Material Sample Location
- Asbestos-Containing Black Mastic
- Asbestos-Containing Orange Tile and Black Mastic
- Asbestos-Containing Tan Vinyl Floor Tile and Black Mastic

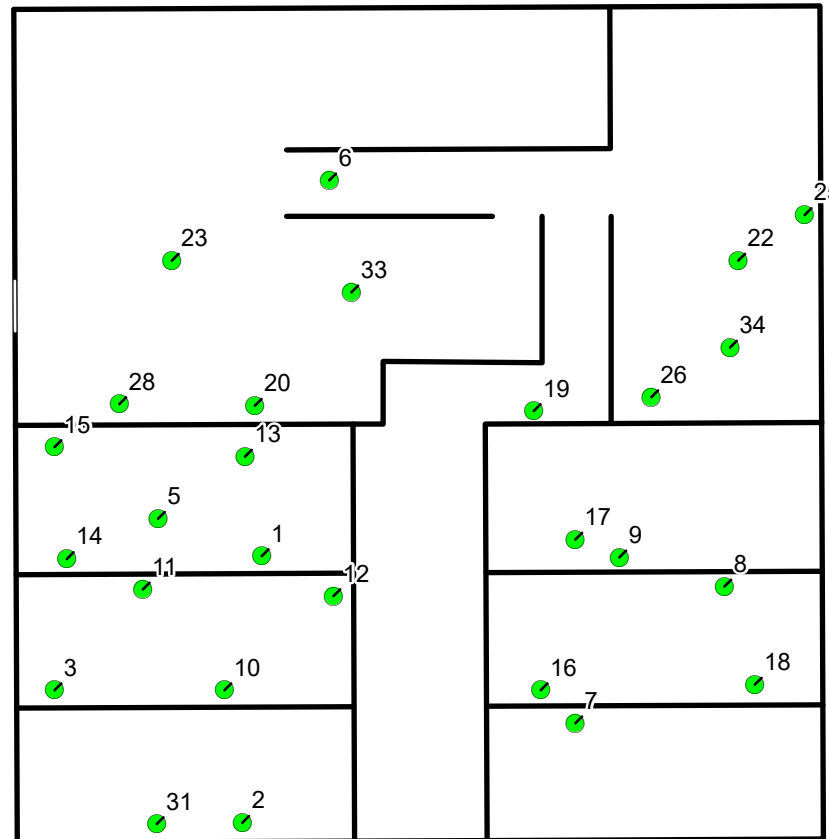
Sample Key Table

- Asbestos-Containing Material Sample Location
- Non-Asbestos-Containing Material Sample Location
