**Subject: Phase I Environmental Site Assessment
De Queen Medical Center Clinics, EMS, and Hospital
1314-1316 West Colling Raye Drive
De Queen, Sevier County, Arkansas 71832
Contract No: 4600054308**

**Phase I Environmental Site Assessment Report
De Queen Medical Center EMS, Clinics, and Hospital
1306 West Collin Raye Drive and 1007-1017 North 14th Street
De Queen, Arkansas
Tetra Tech Project No. 103S9501018.001**

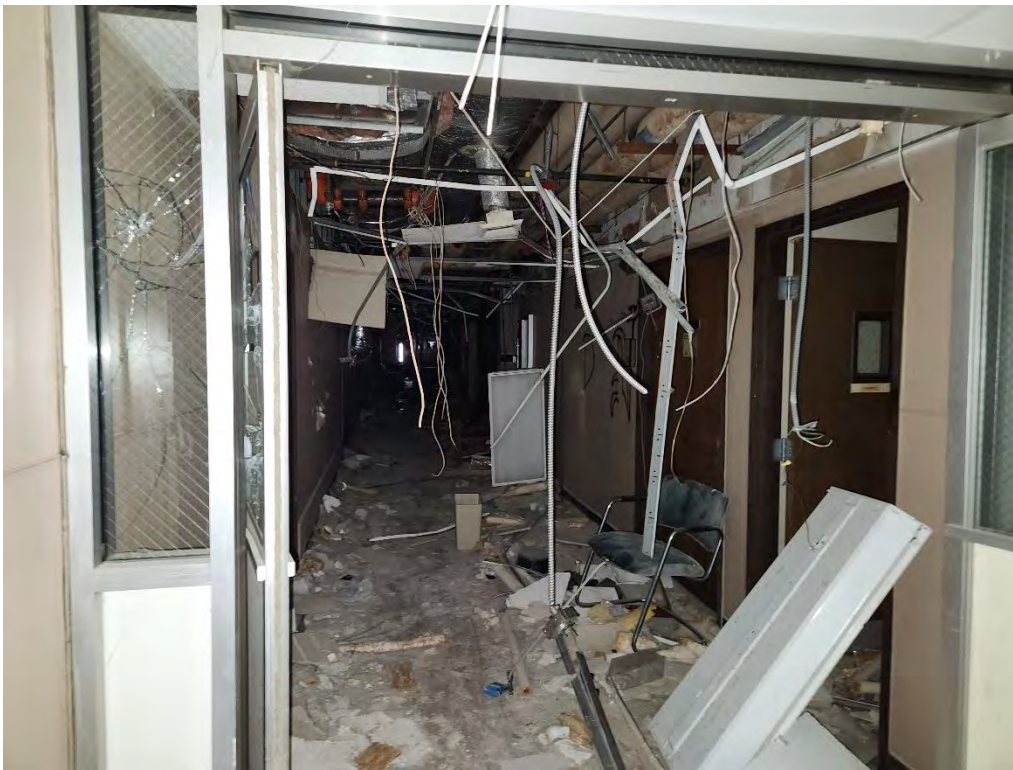
Photograph 5 (West): View of a hallway in the Hospital building, typical of the disrepair observed in most of the hallways in the Hospital building.

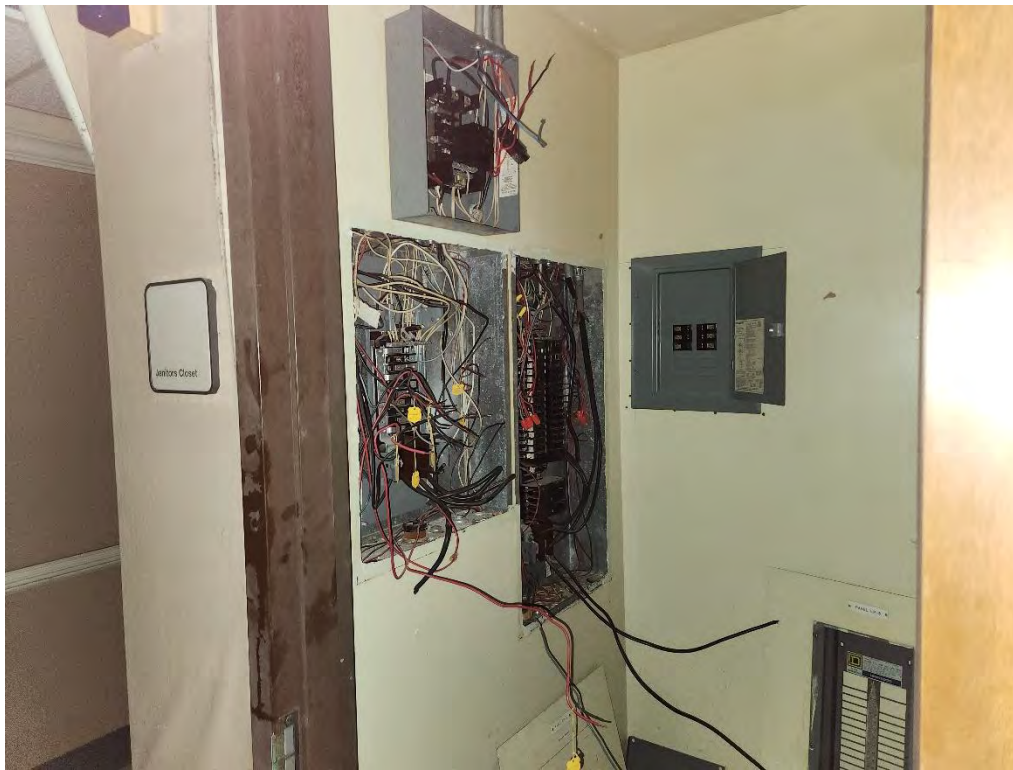
Photograph 9 (NA): View of a broken and stripped breaker box in the Hospital building, typical of the disrepair of most of the breaker boxes observed at the subject property.

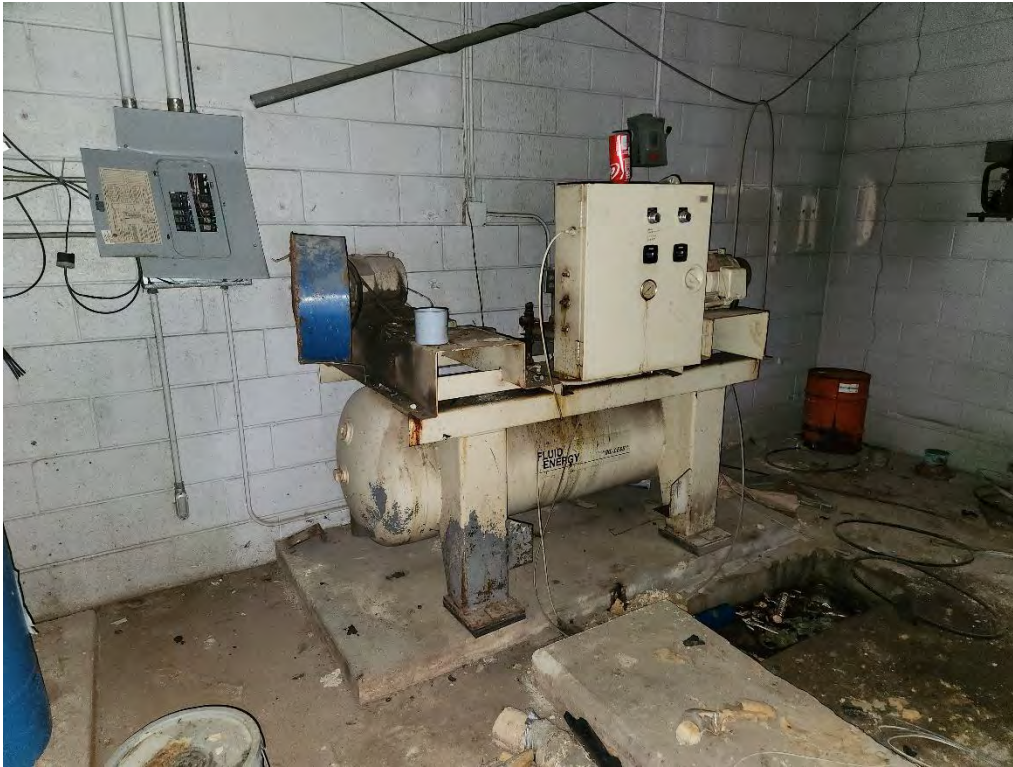
- ▶ One air compressor was found in the Hospital building boiler room with heavy staining visible surrounding the air compressor (Photograph #13). The heavy staining around the boiler room air compressor poses a REC for the subject property.
- ▶ A former dark room (used for development of photographs/x-rays) was present in the x-ray wing of the Hospital building. During a previous Phase I ESA at the Hospital in 2024, containers of developer and fixer were observed near the x-ray rooms. These containers were not observed during the 2025 site reconnaissance, perhaps as a result of the greater amount of debris generated by the building's increasing deterioration.

Photograph 13 (Southeast): View of the air compressor in the boiler room of the Hospital building, with staining on the floor.

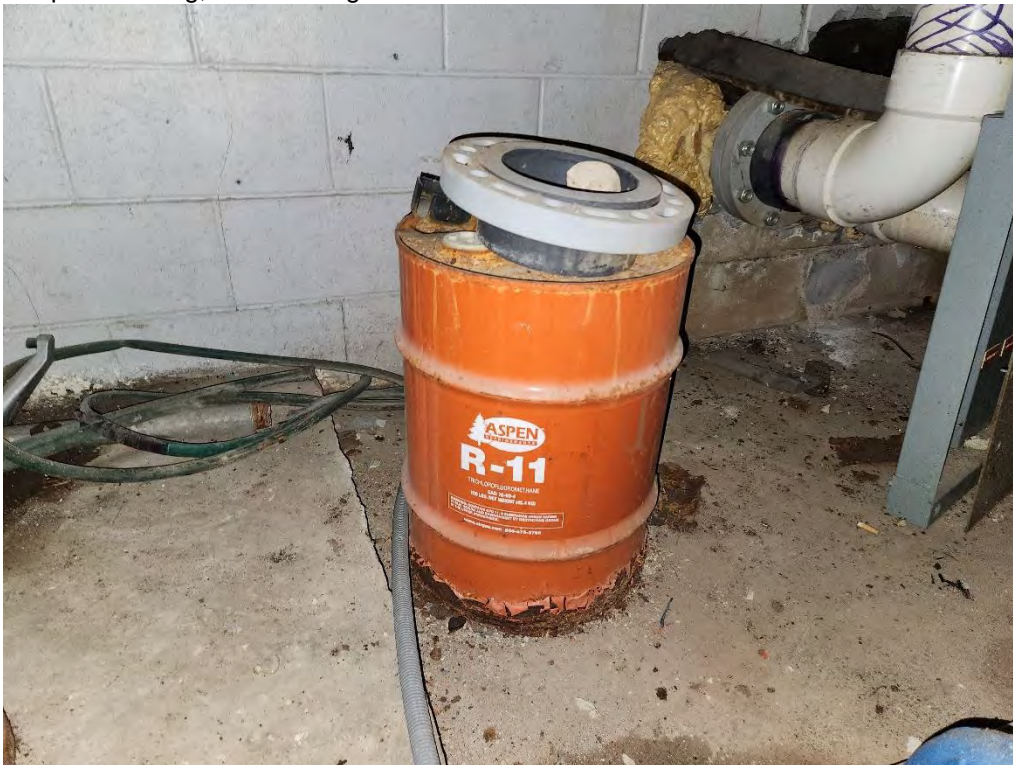
Photograph 14 (South): View of the metal drum of trichlorofluoromethane (Freon-11) in the boiler room of the Hospital building.

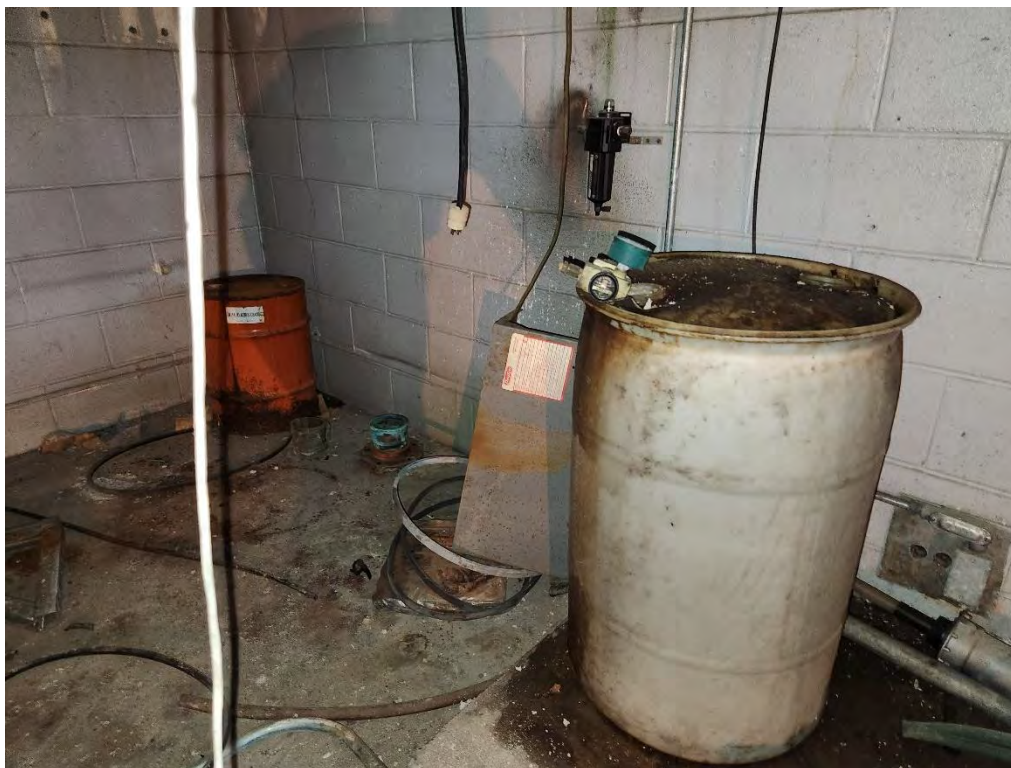
determine if staining was present. The 100-pound metal drum and 55-gallon drum in boiler room are considered a REC for the subject property.

Photograph 15 (Southeast): View of an unlabeled plastic 55-gallon drum in the boiler room of the Hospital building, which was surrounded by stained pavement, and an unlabeled 10-gallon drum.

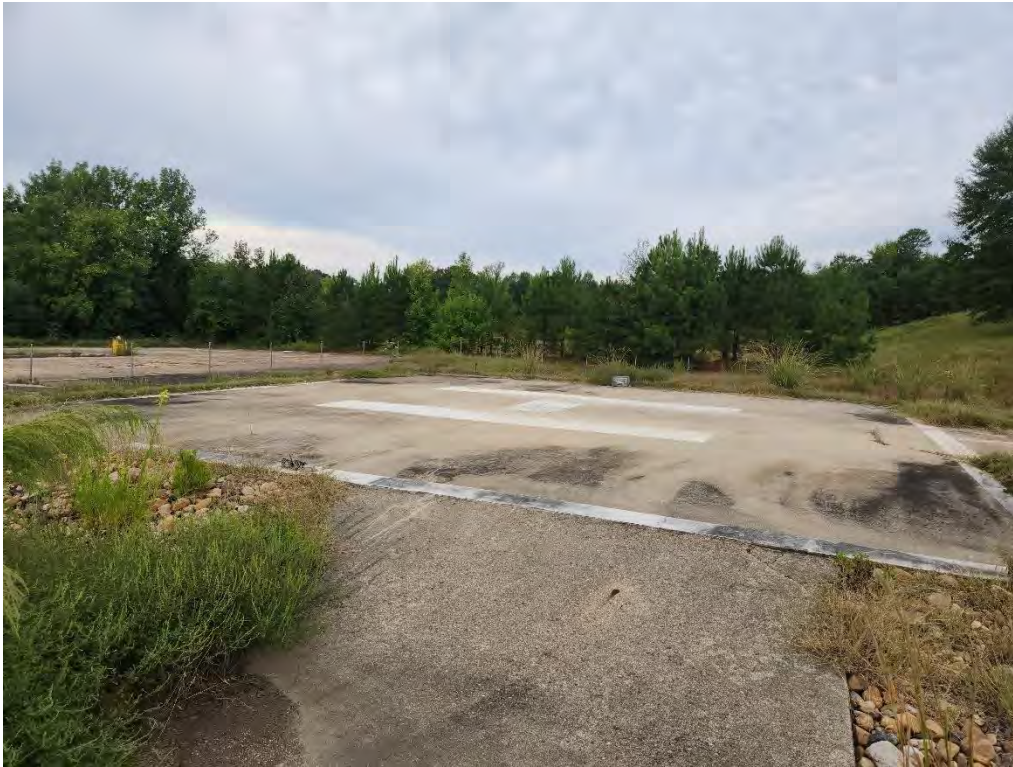
- ▶ Staining was present on the ground on the southern parking lot and on the helicopter landing pad. Because the staining does not present a threat to human health or the environment and would not be the subject of an enforcement action if brought to the attention of appropriate governmental agencies, it is considered a de minimis condition.

Photograph 29 (West): View of the helicopter landing pad, with de minimis staining.

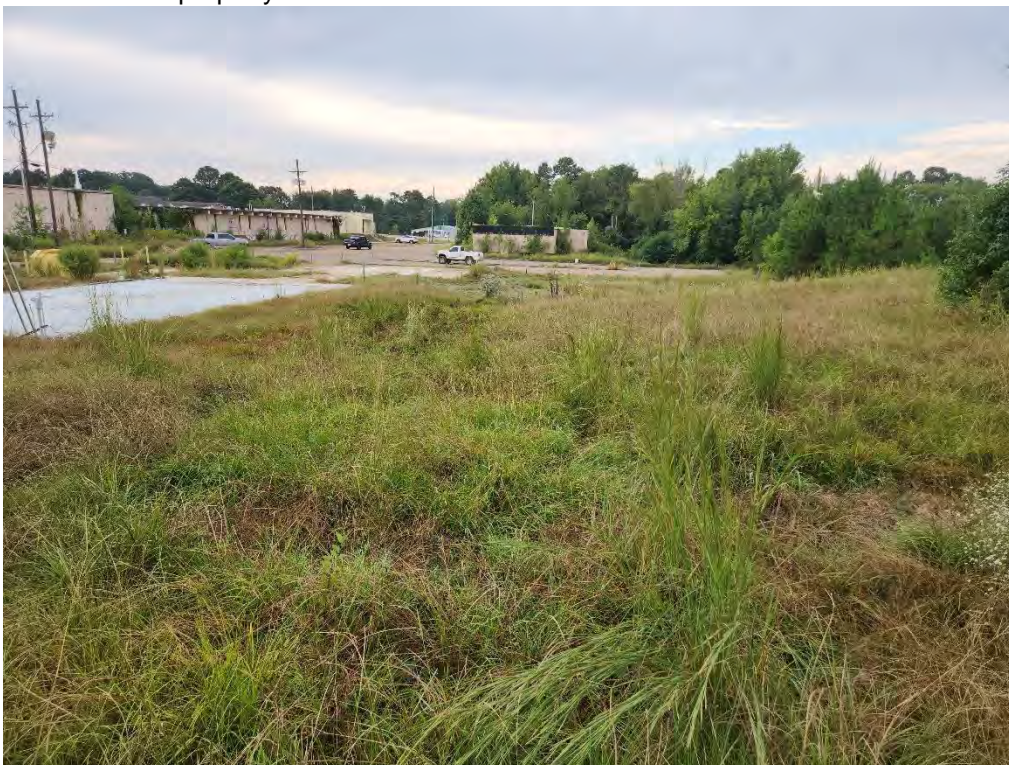
- ▶ The subject property, at the address of 1007-1017 North 14th Street, is listed in the Aboveground Storage Tank (AST), Permits, E Manifest, and Brownfields/US Brownfields databases. According to the AST database, one 4,000-gallon AST containing kerosene is listed as in use on the subject property, installed on September 1, 2007. According to the aerial photographs, this AST used to be east of the helicopter landing pad however, it is no longer present on the subject property. No violations or leaks have been reported regarding the AST, and no staining or distressed vegetation was observed in the area during the site reconnaissance. According to the regulated storage tanks (RST) data files, the steel AST contained kerosene (DEQ 2025d). The removal of a registered tank without any closure process is considered a BER for the subject property.

Photograph 32 (South): View of the former area of the 4,000-gallon kerosene AST, with no visible staining or distressed vegetation.

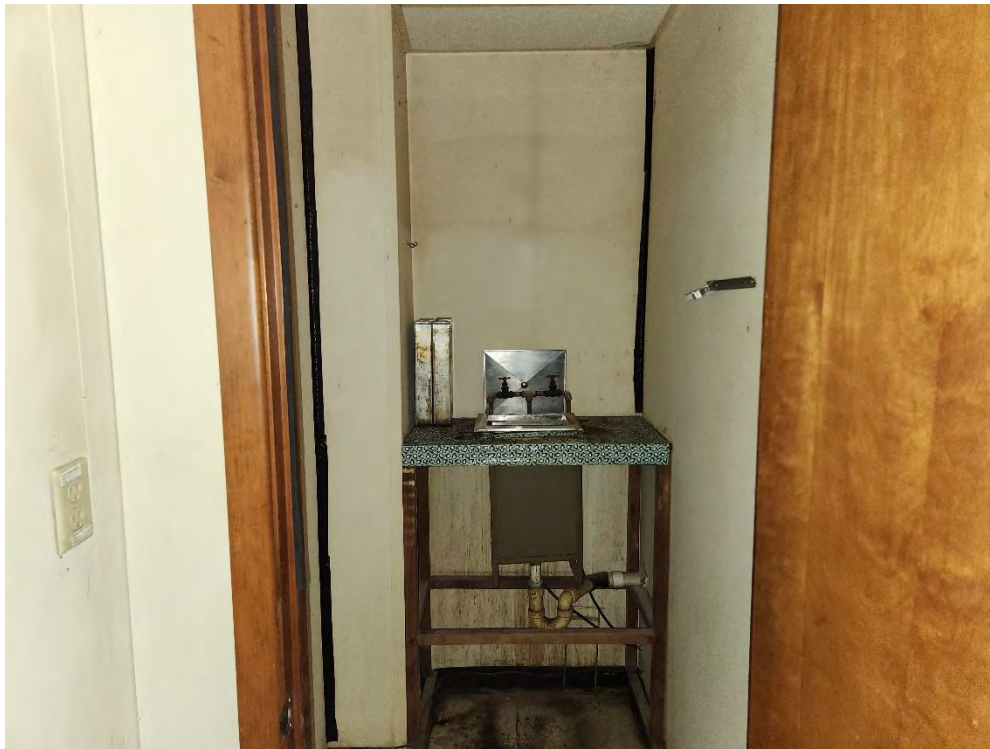
A former dark room (used for development of photographs/x-rays) was present in the back northwest portion of the Medical Arts building. A sink and picture hangers on the wall were present in the room. No photo processing chemicals were observed in the room; however, the sink appeared to be discharged to a location outside the room (possibly to the municipal sewer system), and staining was observed on the floor beneath the sink.

Because the subject property building was constructed around 1968 and operated until 2019, long-term use of hazardous materials associated with the photograph/x-ray development process poses a REC for the subject property.

Photograph 41 (North): View of the photo-processing room found in the back of the Medical Arts building, with staining on the floor.

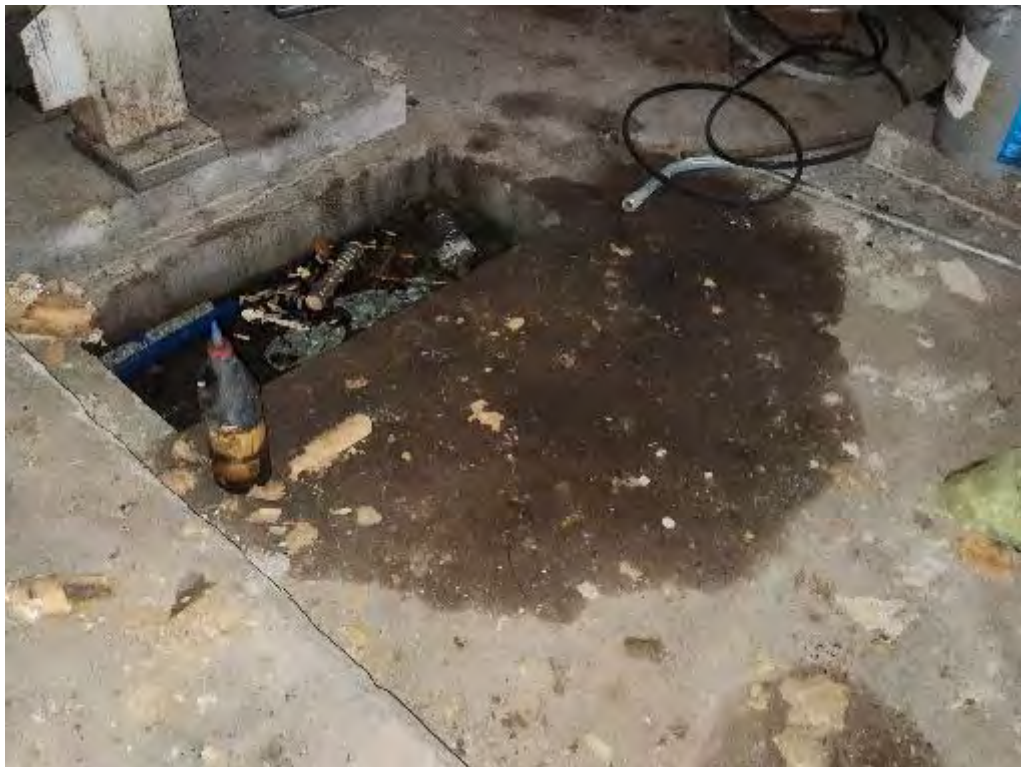
Photograph 22 (NA): View of stained concrete slab next to the air compressor in the boiler room.

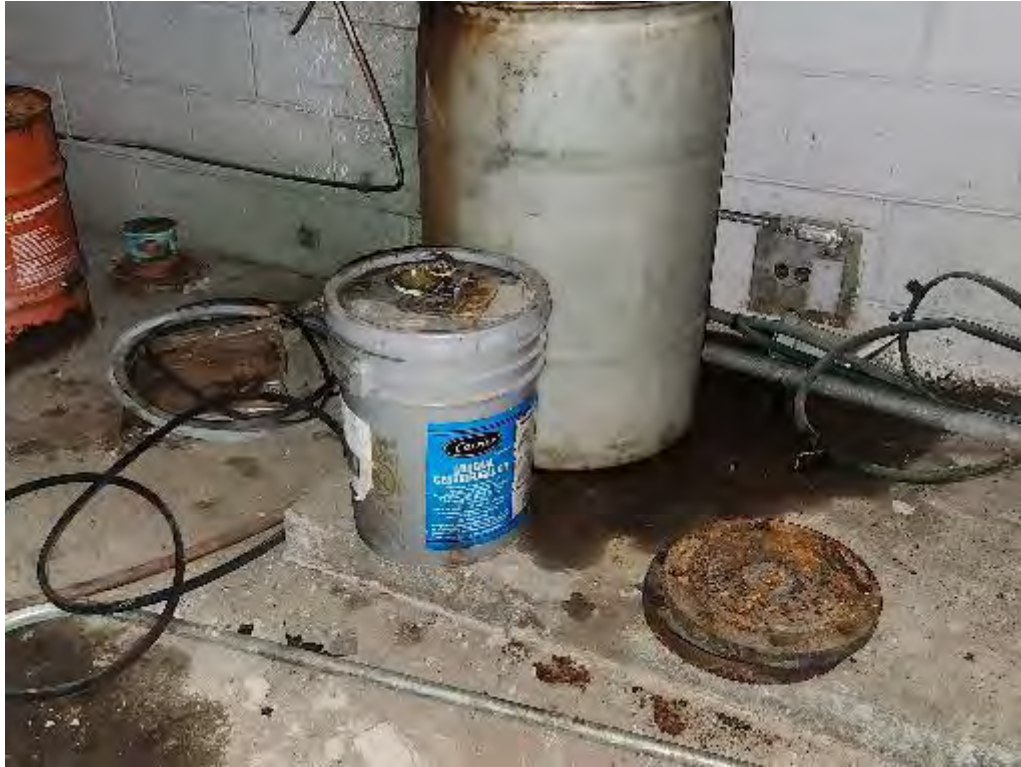
Photograph 23 (NA): View of an unlabeled 55-gallon drum and 5-gallon bucket of mineral oil with heavy staining surrounding them (in the boiler room).

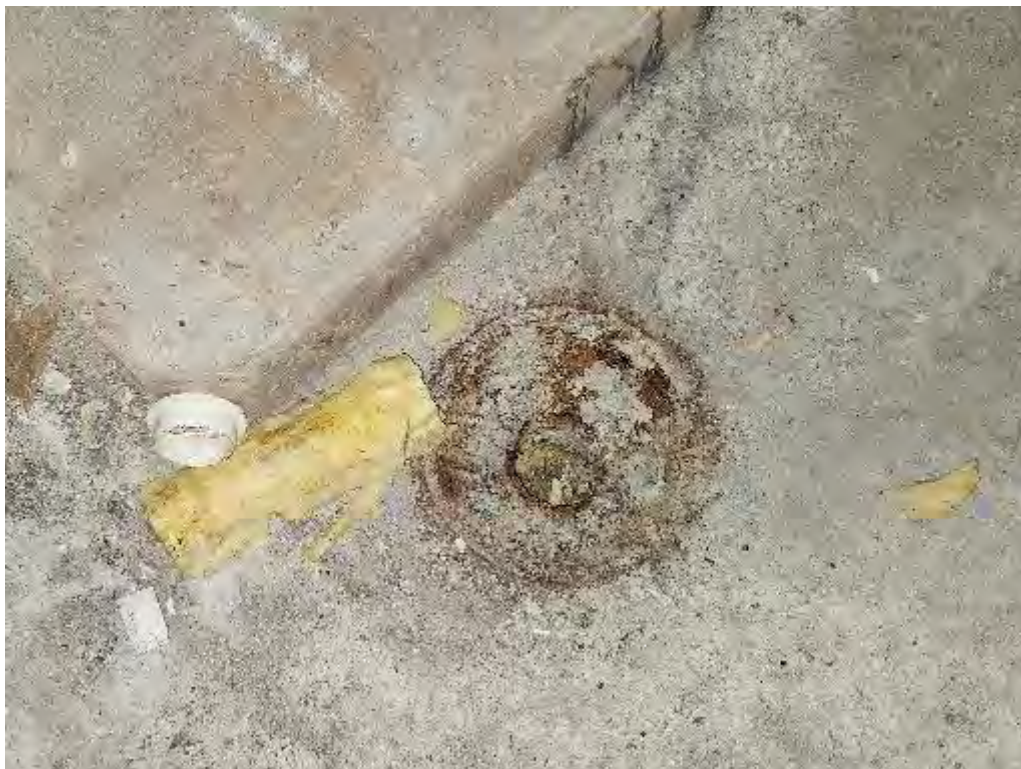
- ▶ Multiple drains or possible clean-outs were observed in the floor of the boiler room. The discharge points for potential drains are unknown. Based on the staining observed in the boiler room and unknown point of discharge, if these are drains rather clean-out points, this poses a REC for the subject property.

Photograph 26 (NA): View of drains observed throughout the floor of the boiler room in the main Hospital building.

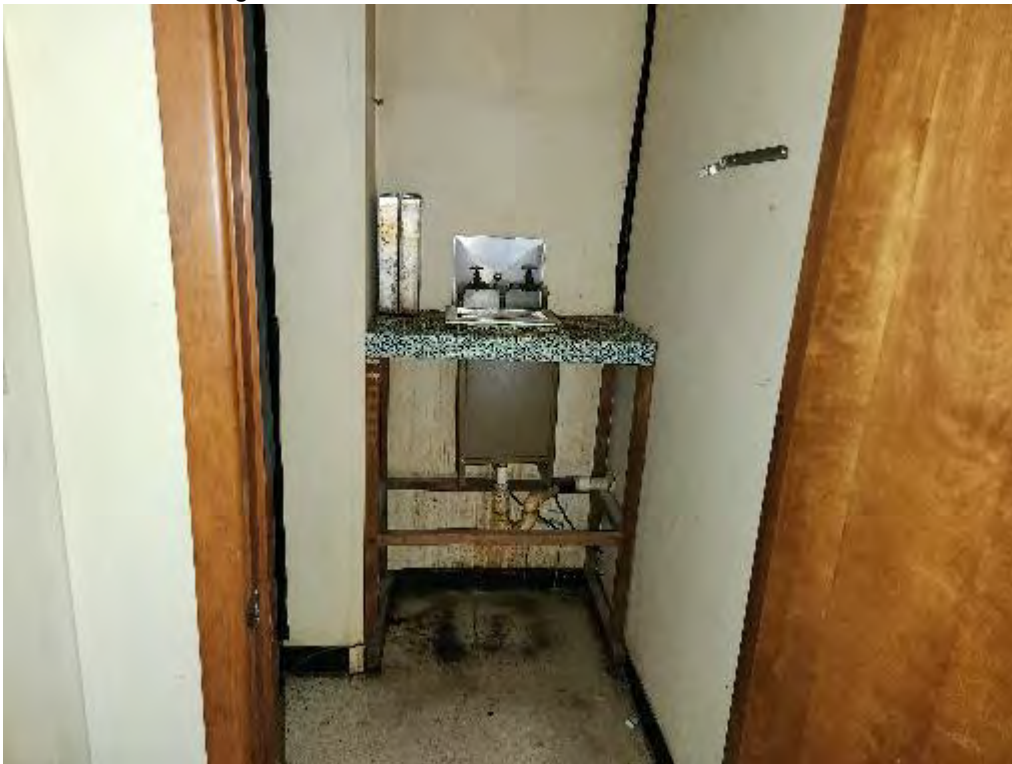
Photograph 6 (Overview): View of former dark room in the back northwest corner of the Medical Arts building. Staining was observed on the floor beneath the sink. The sink drains to the sewer system.

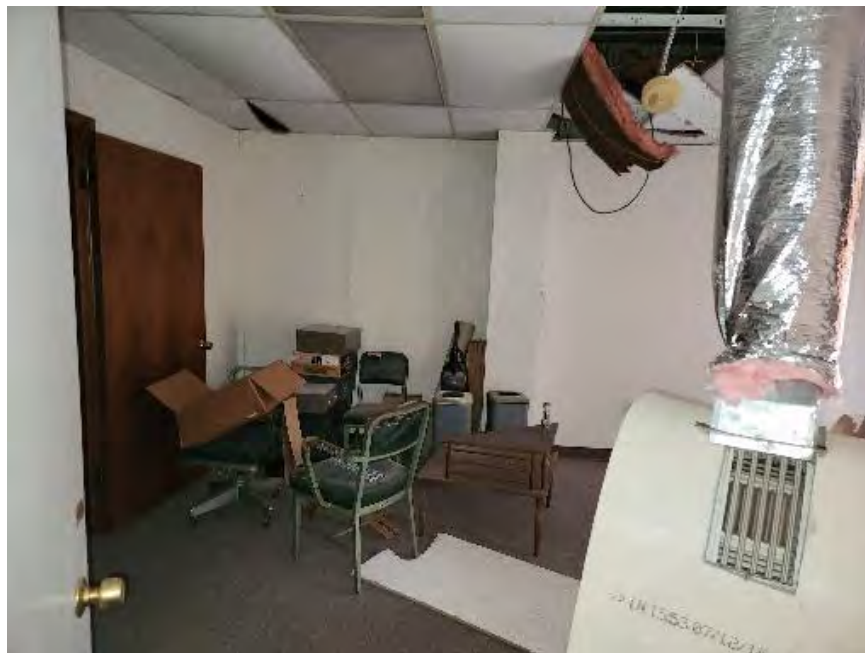
Photograph 12 (Overview): View of office space in the southwest corner of the Medical Arts building. Heating, ventilation, and air conditioning (HVAC) ducting was observed falling down from the ceiling.

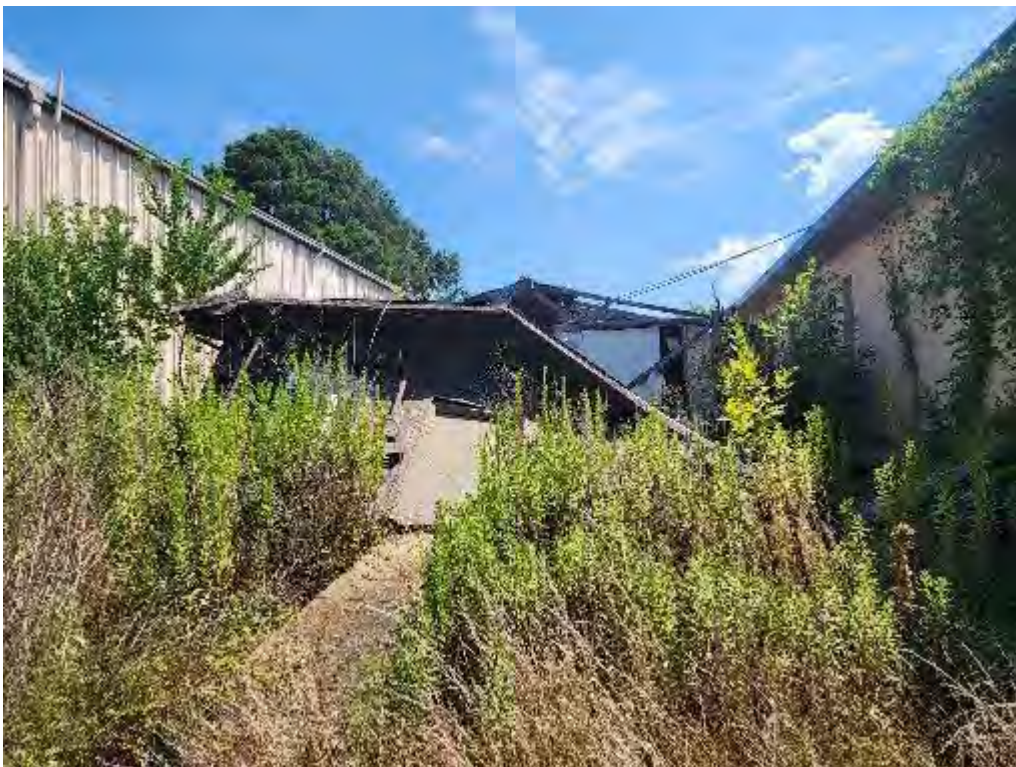
- ▶ A small wooden structure between the Medical Arts and Medical Clinics buildings had collapsed and was unsafe to enter. Therefore, no interior inspection of the wooden structure occurred. According to Angie Walker, site contact with Feed Local, Inc, the structure was used for storing hospital records. This is a significant data gap.

Photograph 16 (East): Back view of collapsed wooden structure between the two clinic buildings. The structure was unsafe for entry.

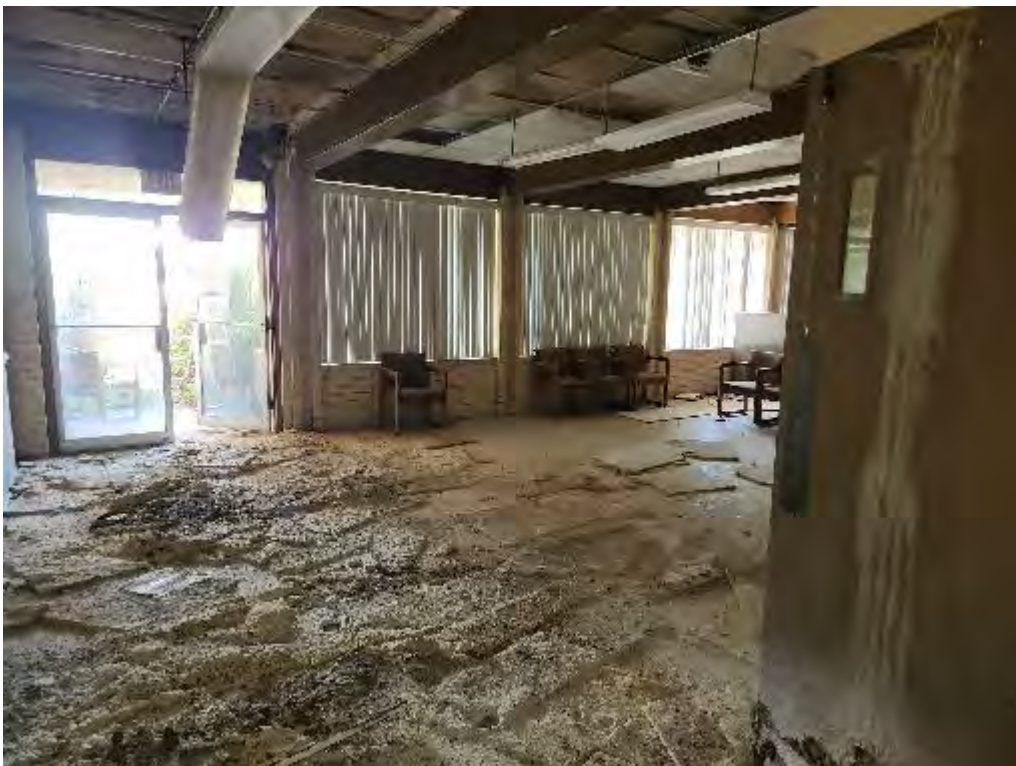
Photograph 18 (Southeast): View of front entryway in the Medical Clinics building. The majority of ceiling tiles had fallen to the floor because of roof leaks.

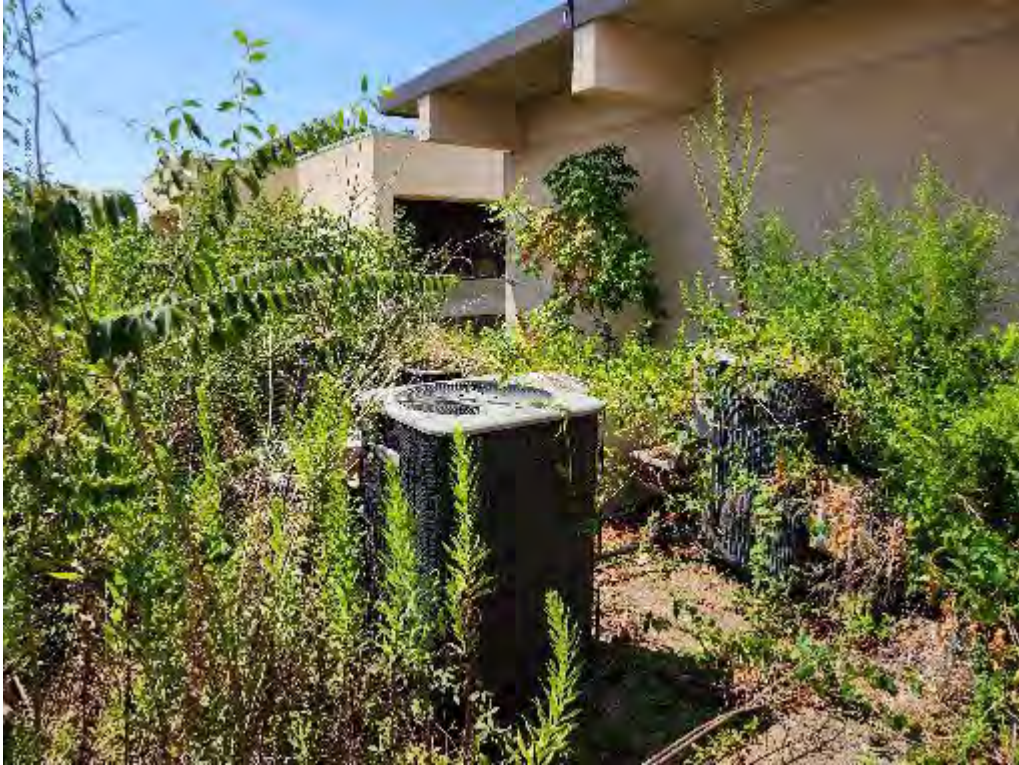
Photograph 25 (Southwest): View of air conditioning units overgrown with vegetation in front of the Medical Clinics building (east side).

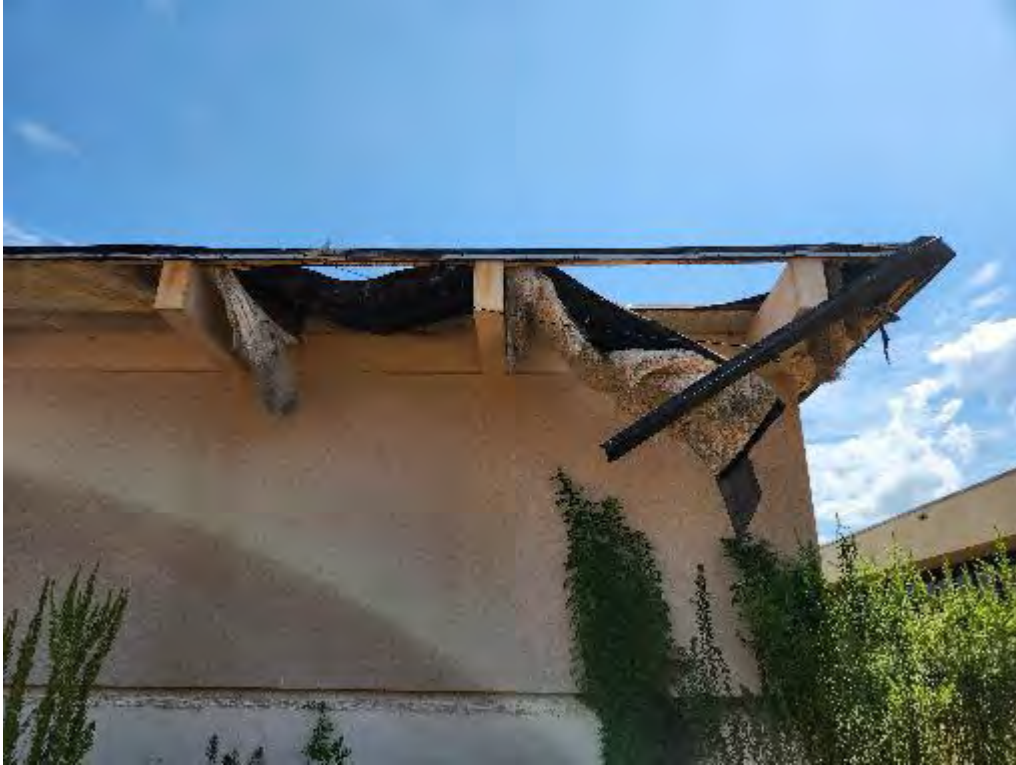
Photograph 27 (East): View of leaking roof edge along the back southwest corner of the Medical Clinics building.

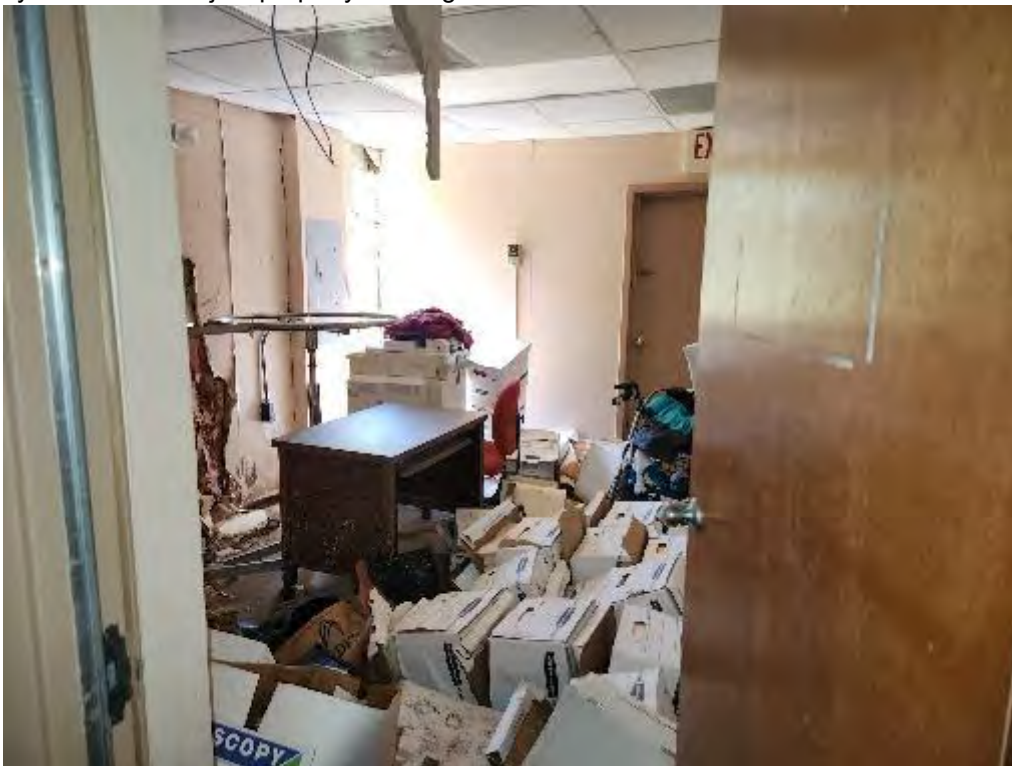
Photograph 10 (West): View of back room with files along the west side of the subject property building. A hole is along the back wall of the room and signs of water damage are evident.

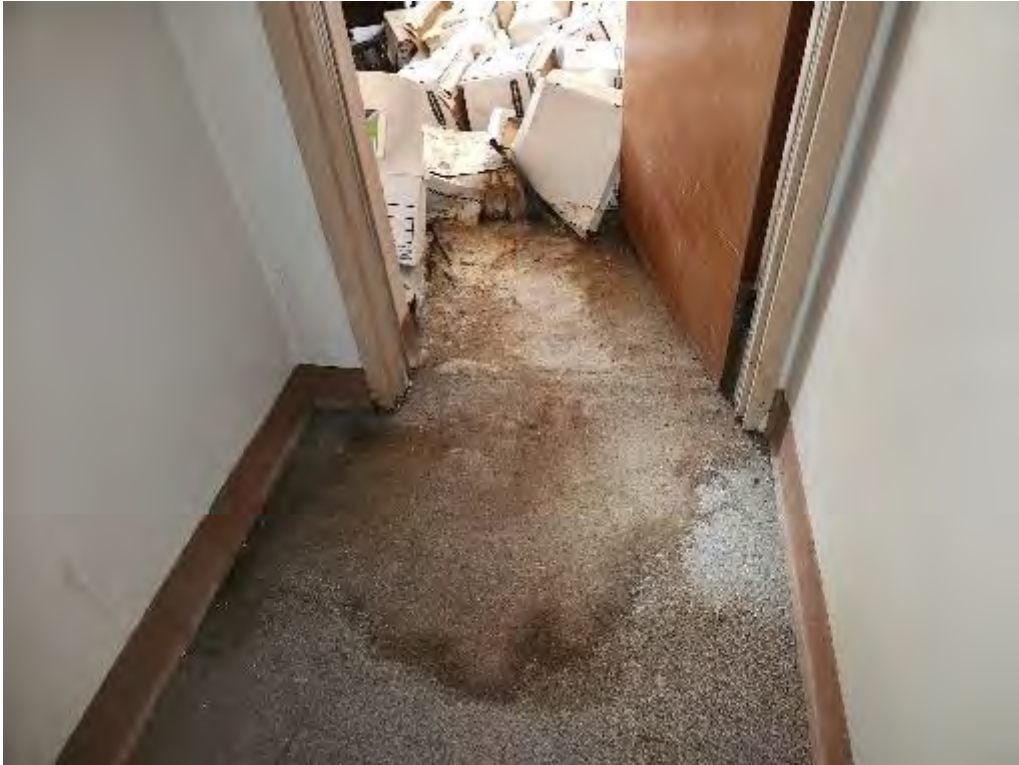
Photograph 11 (Not Applicable [NA]): Overview of water damage leading to the back room.

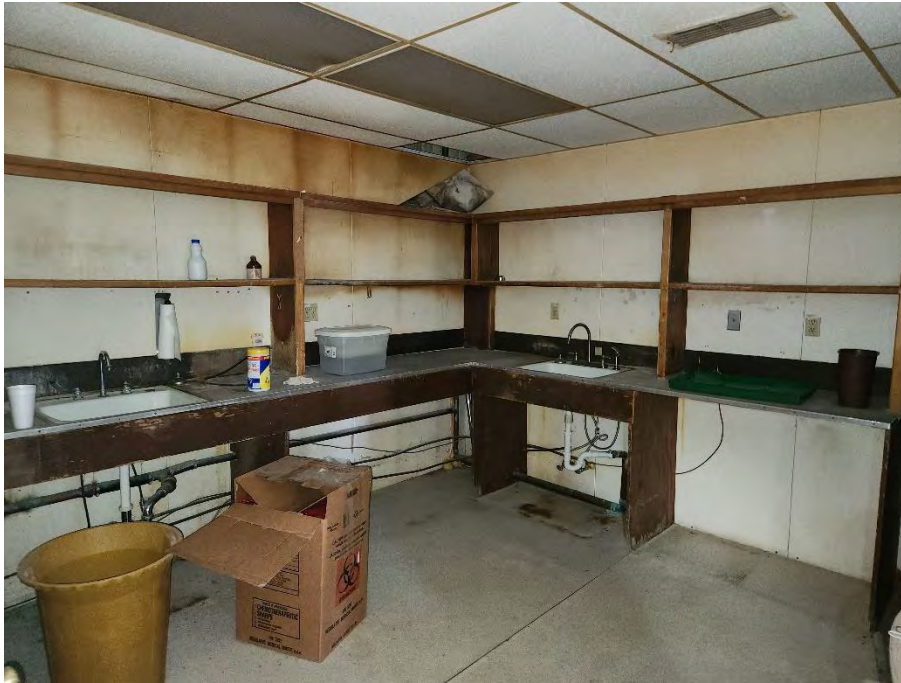
Photo 3: This photograph shows the asbestos-containing material (ACM) cream sheet vinyl flooring and black mastic (MA-SV01) found in the northern hallway and various dental exam rooms of the Medical Arts building.

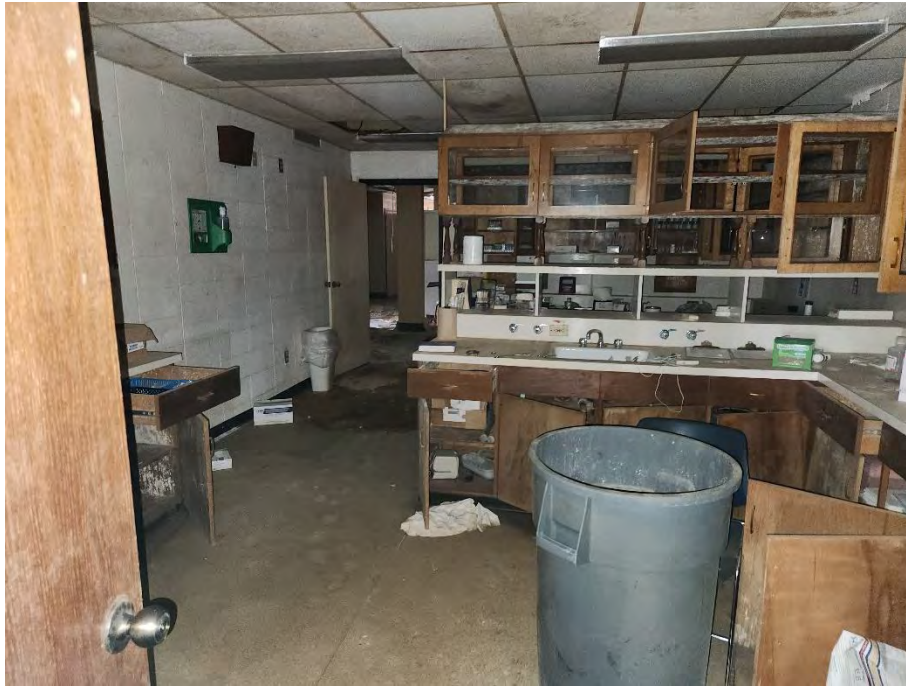
Photo 5: This photograph shows ACM cream sheet vinyl flooring and white mastic (MC-SV02) found in the laboratory room and rooms off the main hallway of the Medical Clinics building.

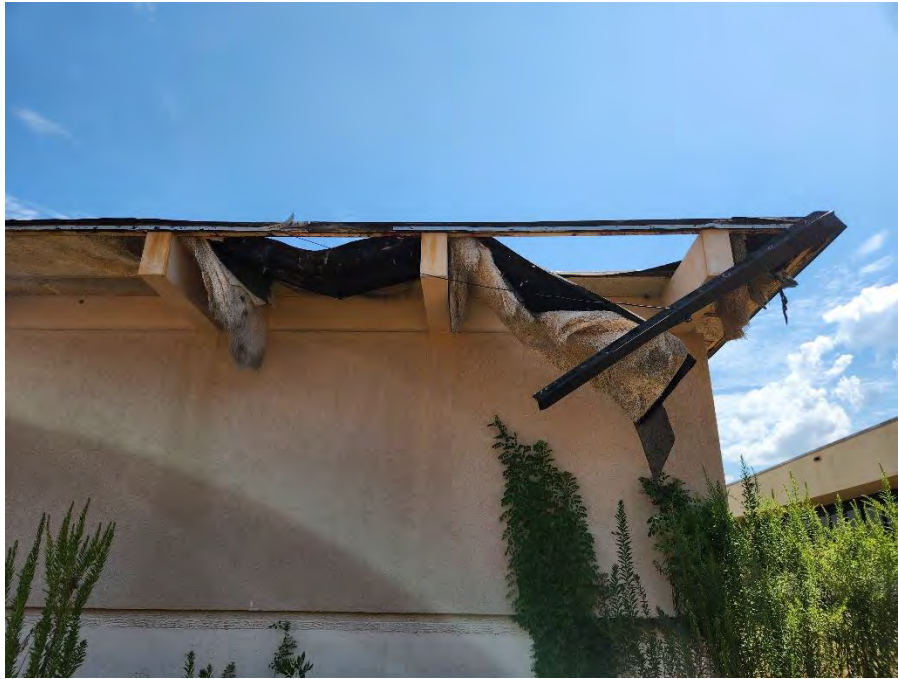
Photo 7: This photograph shows a closeup view of the assumed ACM roofing material on the Medical Clinics building and its damage.
