**Re: Preliminary Assessment Report for Lewis Lumber and Manufacturing Company
136 West Mill Street
Cove, Polk County, Arkansas
EPA SEMS ID: ARD006348353; AFIN: 57-00020**

**PRELIMINARY ASSESSMENT
FOR
LEWIS LUMBER AND MANUFACTURING COMPANY
EPA SEMS ID: ARD006348353
COVE, POLK COUNTY, ARKANSAS**

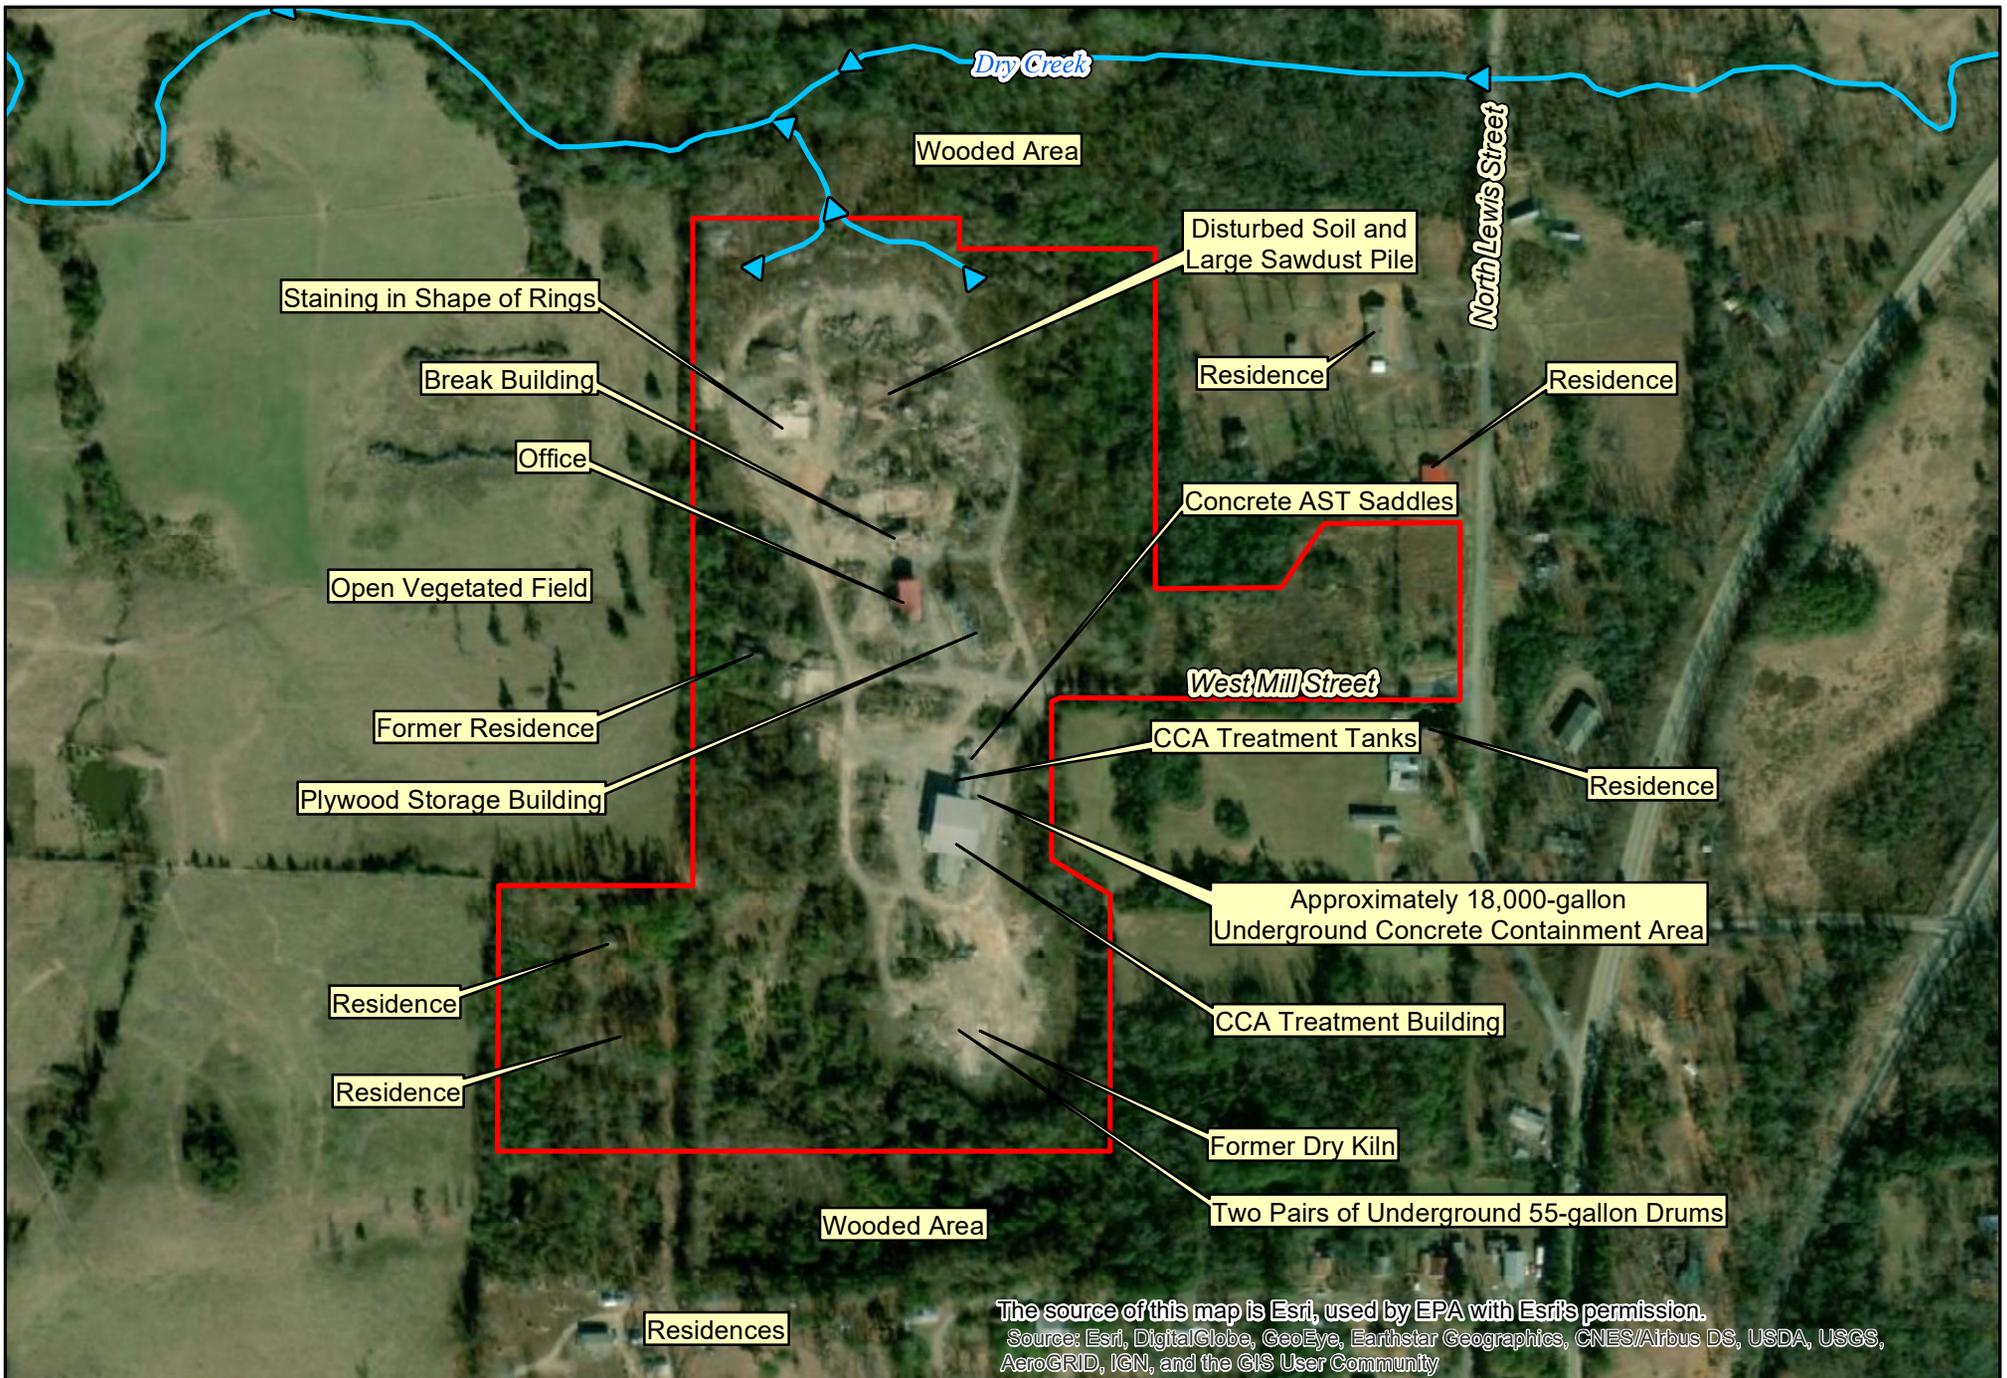
Lewis Lumber
Site Map
Figure 2-2

The Lewis Lumber site is approximately thirty-seven acres in size. The site is situated in a rural residential and agricultural area bordered by a wooded area to the north; residences and North Lewis Street to the east; a wooded area and residences to the south; and residences and an open vegetated field to the west. West Mill Street intersects the site from the east and separates the site into a northern and southern portion. **Figure 2-2** provides an aerial view and shows the site boundary, significant site features, and adjacent properties and roads.

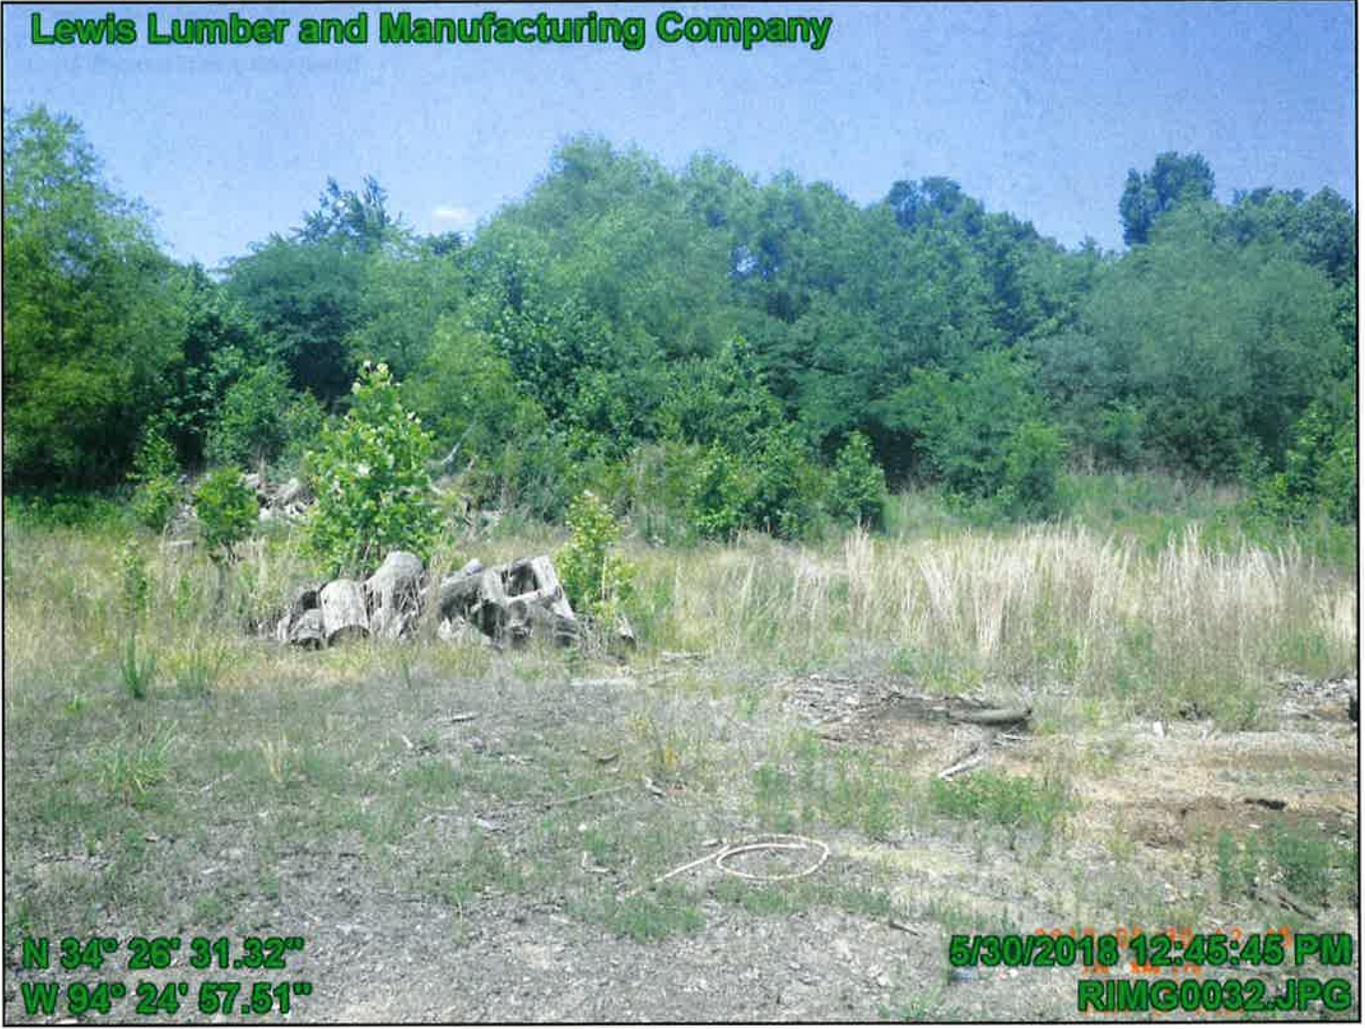
5/30/2018 12:45:45 PM
 RIMG0032.JPG

Attributes	
Photo Number	1
Facility	Lewis Lumber and Manufacturing Company
Event	Preliminary Assessment
AFIN	57-00020
Photographer	Joshua Graham <i>JK GW JB</i>
Witness	Katie Kreps <i>KK</i>
Site Location	Cove, AR
Date/Time	5/30/2018 12:45:45 PM
Make	RICOH
Model	G700 SE
File Name	RIMG0032.JPG
Subject	Wooded area north of the site; staining and debris piles containing wood

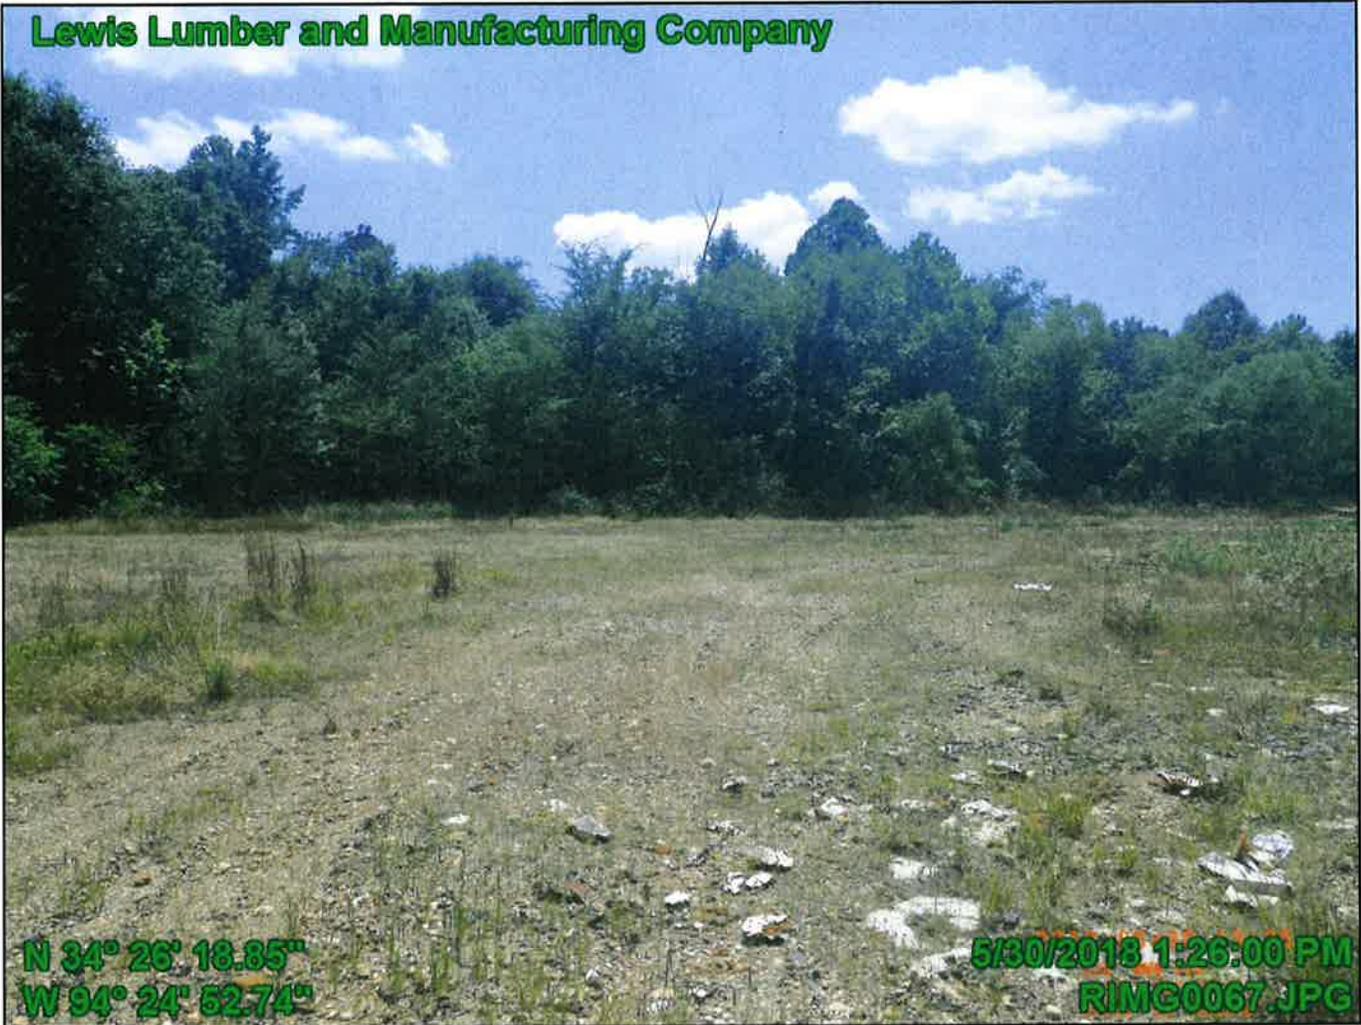
5/30/2018 1:26:00 PM
 RIMG0067.JPG

Attributes	
Photo Number	3
Facility	Lewis Lumber and Manufacturing Company
Event	Preliminary Assessment
AFIN	57-00020
Photographer	Joshua Graham KK for JG
Witness	Katie Kreps KK
Site Location	Cove, AR
Date/Time	5/30/2018 1:26:00 PM
Make	RICOH
Model	G700 SE
File Name	RIMG0067.JPG
Subject	Wooded area south of the site

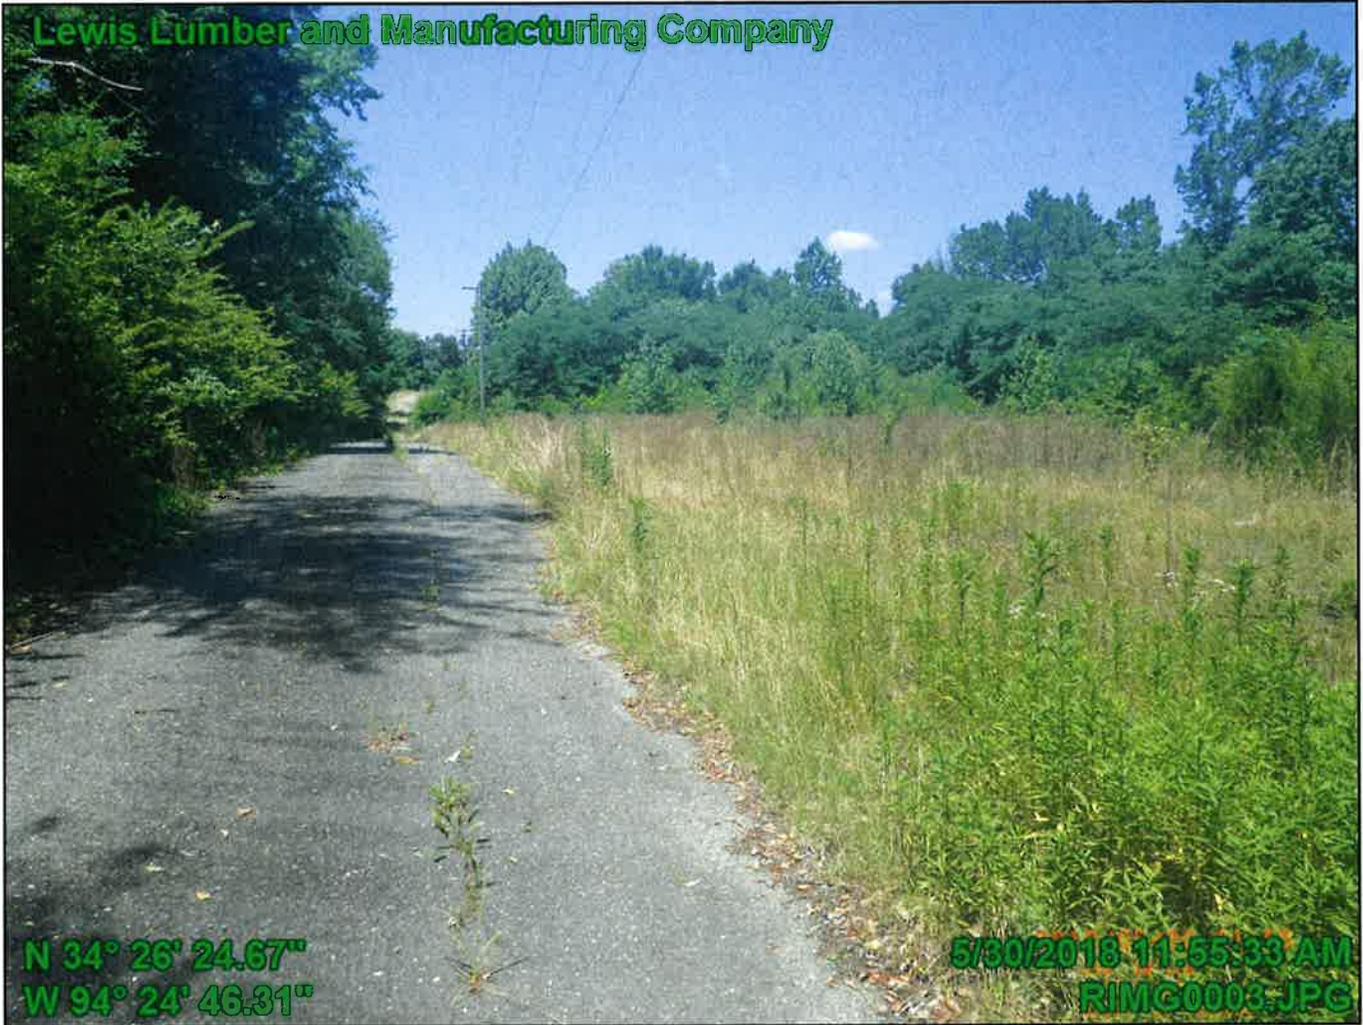
5/30/2018 11:55:33 AM
 RIMG0003.JPG

Attributes	
Photo Number	5
Facility	Lewis Lumber and Manufacturing Company
Event	Preliminary Assessment
AFIN	57-00020
Photographer	Joshua Graham <i>KK for JG</i>
Witness	Katie Kreps <i>KK</i>
Site Location	Cove, AR
Date/Time	5/30/2018 11:55:33 AM
Make	RICOH
Model	G700 SE
File Name	RIMG0003.JPG
Subject	West Mill Street intersecting the site

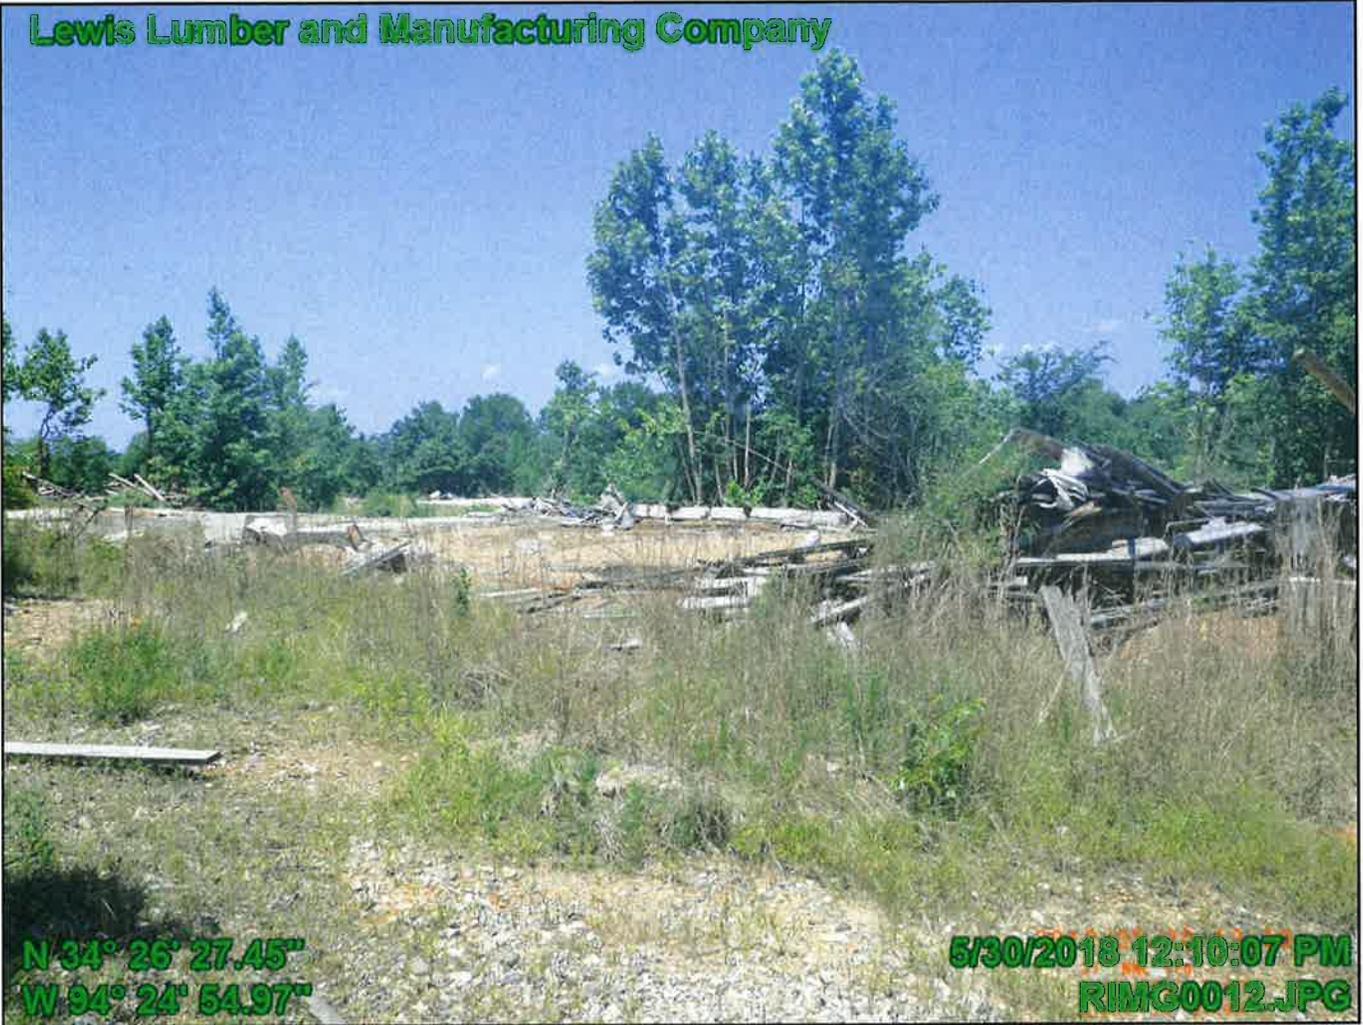
5/30/2018 12:10:07 PM
 RIMG0012.JPG

Attributes	
Photo Number	7
Facility	Lewis Lumber and Manufacturing Company
Event	Preliminary Assessment
AFIN	57-00020
Photographer	Joshua Graham <i>KK for JB</i>
Witness	Katie Kreps <i>KK</i>
Site Location	Cove, AR
Date/Time	5/30/2018 12:10:07 PM
Make	RICOH
Model	G700 SE
File Name	RIMG0012.JPG
Subject	Concrete foundation and demolition debris in location of former building on the north-central portion of the site

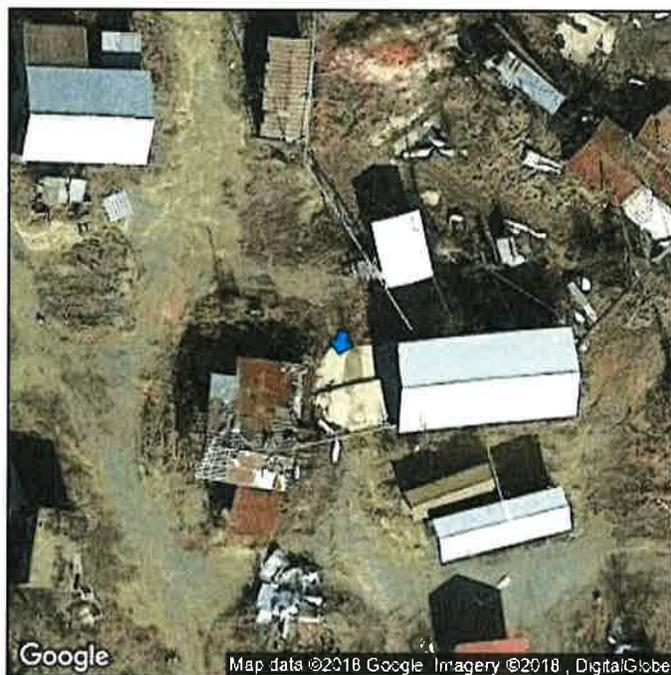
Attributes	
Photo Number	8
Facility	Lewis Lumber and Manufacturing Company
Event	Preliminary Assessment
AFIN	57-00020
Photographer	Joshua Graham <i>JK for JB</i>
Witness	Katie Kreps <i>KK</i>
Site Location	Cove, AR
Date/Time	5/30/2018 12:13:02 PM
Make	RICOH
Model	G700 SE
File Name	RIMG0015.JPG
Subject	Concrete foundation and demolition debris in location of former building on the north-central portion of the site

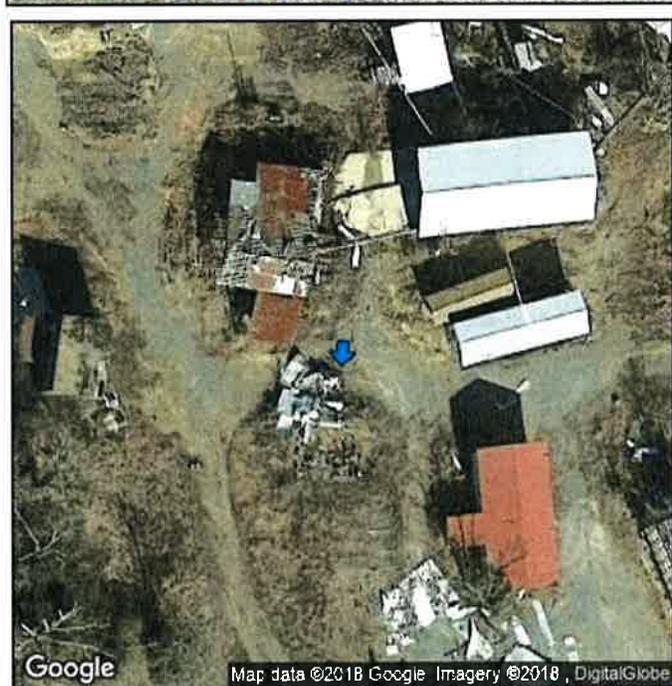
Attributes	
Photo Number	9
Facility	Lewis Lumber and Manufacturing Company
Event	Preliminary Assessment
AFIN	57-00020
Photographer	Joshua Graham <i>KL for JG</i>
Witness	Katie Kreps <i>KL</i>
Site Location	Cove, AR
Date/Time	5/30/2018 12:16:10 PM
Make	RICOH
Model	G700 SE
File Name	RIMG0016.JPG
Subject	Demolition debris in location of former building on the north-central portion of the site

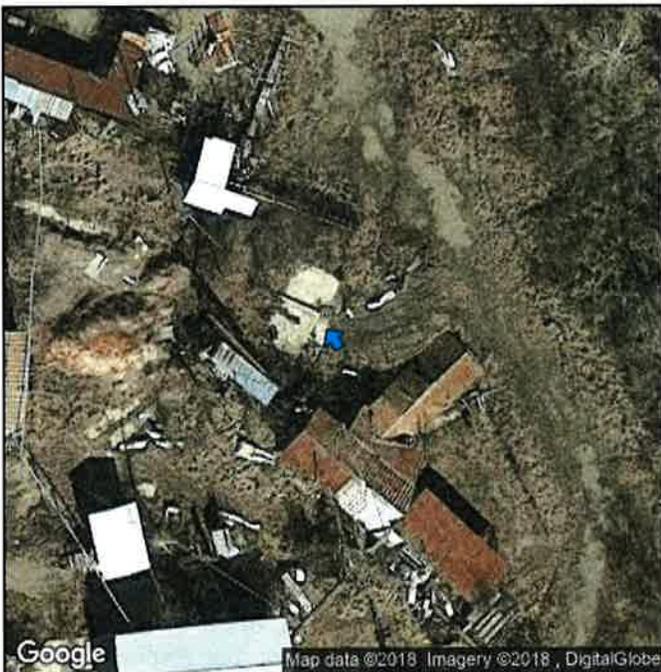
Attributes	
Photo Number	11
Facility	Lewis Lumber and Manufacturing Company
Event	Preliminary Assessment
AFIN	57-00020
Photographer	Joshua Graham <i>JK for JB</i>
Witness	Katie Kreps <i>KK</i>
Site Location	Cove, AR
Date/Time	5/30/2018 12:29:47 PM
Make	RICOH
Model	G700 SE
File Name	RIMG0025.JPG
Subject	Concrete foundation in location of former building on the north-central portion of the site

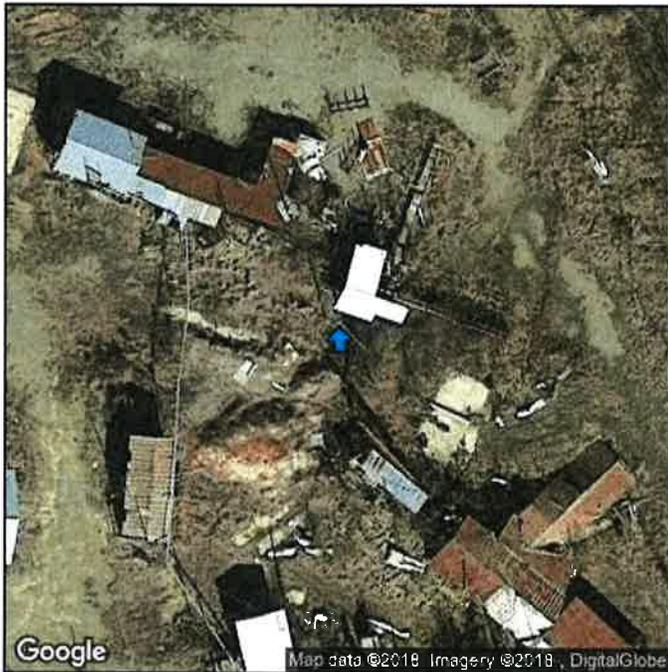
Attributes	
Photo Number	12
Facility	Lewis Lumber and Manufacturing Company
Event	Preliminary Assessment
AFIN	57-00020
Photographer	Joshua Graham <i>KK for JB</i>
Witness	Katie Kreps <i>KK</i>
Site Location	Cove, AR
Date/Time	5/30/2018 12:31:53 PM
Make	RICOH
Model	G700 SE
File Name	RIMG0027.JPG
Subject	Demolition debris and disturbed soil in location of former building on the northeast portion of the site

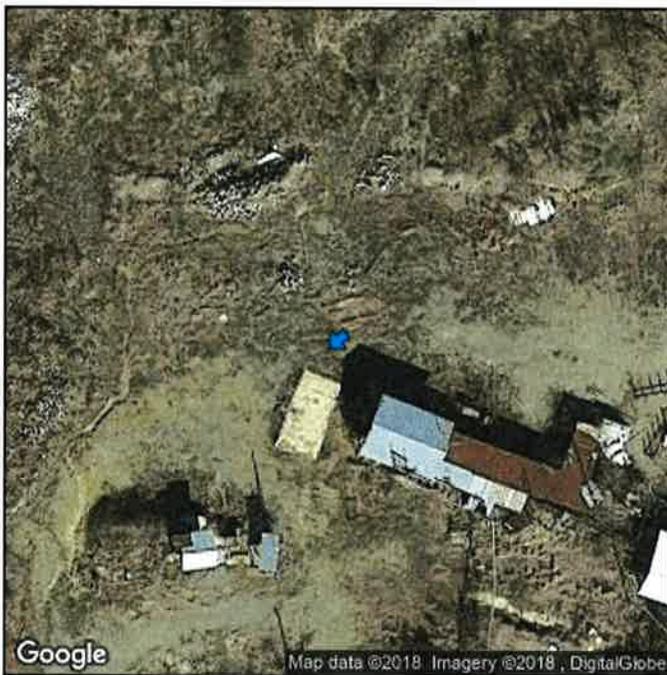
Attributes	
Photo Number	14
Facility	Lewis Lumber and Manufacturing Company
Event	Preliminary Assessment
AFIN	57-00020
Photographer	Joshua Graham <i>KK for JB</i>
Witness	Katie Kreps <i>KK</i>
Site Location	Cove, AR
Date/Time	5/30/2018 12:42:43 PM
Make	RICOH
Model	G700 SE
File Name	RIMG0031.JPG
Subject	Concrete foundation on the northern portion of the site

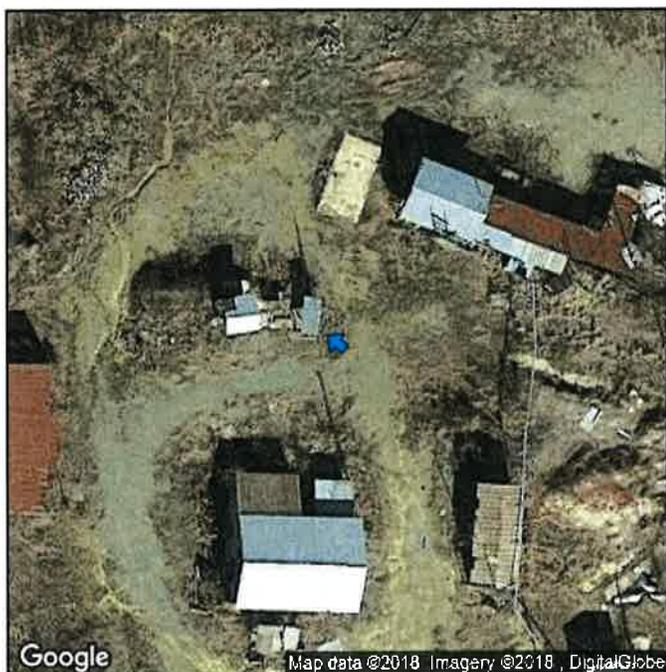
Attributes	
Photo Number	15
Facility	Lewis Lumber and Manufacturing Company
Event	Preliminary Assessment
AFIN	57-00020
Photographer	Joshua Graham <i>KL for J6</i>
Witness	Katie Kreps <i>KK</i>
Site Location	Cove, AR
Date/Time	5/30/2018 12:47:30 PM
Make	RICOH
Model	G700 SE
File Name	RIMG0033.JPG
Subject	Concrete foundation and demolition debris in location of former building on the northwest portion of the site

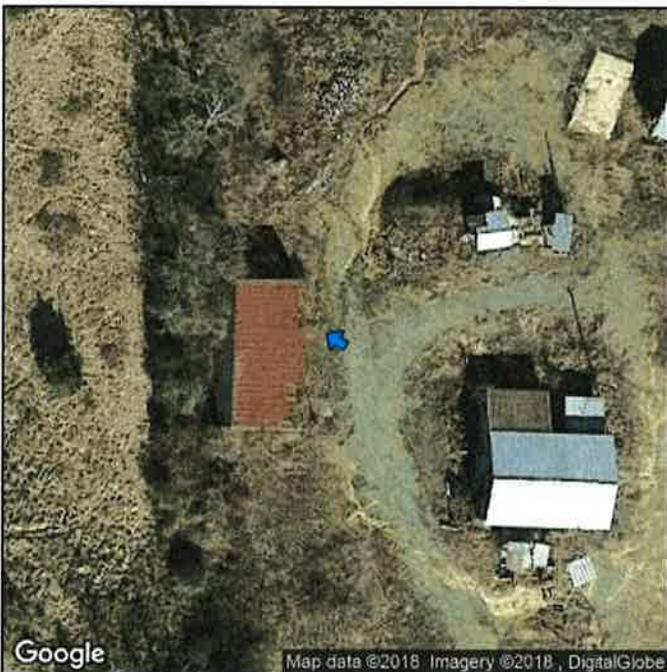
Attributes	
Photo Number	16
Facility	Lewis Lumber and Manufacturing Company
Event	Preliminary Assessment
AFIN	57-00020
Photographer	Joshua Graham <i>KK for JB</i>
Witness	Katie Kreps <i>KK</i>
Site Location	Cove, AR
Date/Time	5/30/2018 12:49:42 PM
Make	RICOH
Model	G700 SE
File Name	RIMG0034.JPG
Subject	Concrete foundation and demolition debris in location of former building on the northwest portion of the site

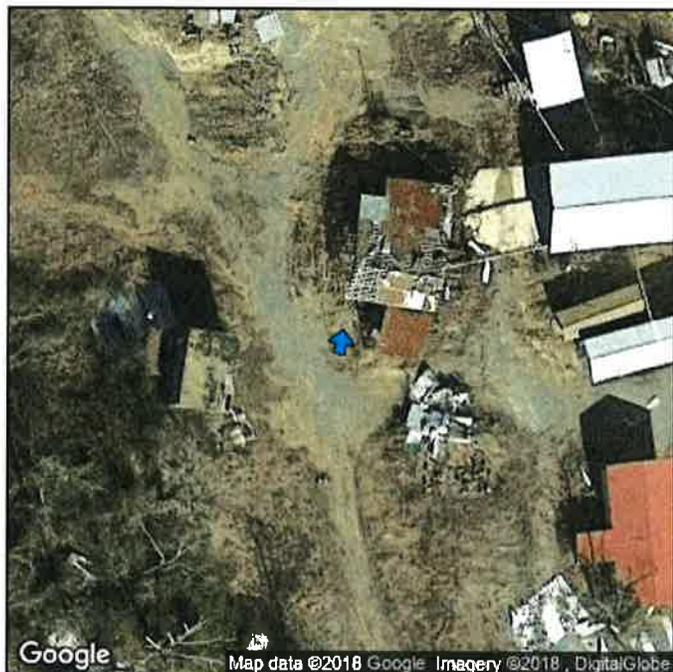
Attributes	
Photo Number	18
Facility	Lewis Lumber and Manufacturing Company
Event	Preliminary Assessment
AFIN	57-00020
Photographer	Joshua Graham <i>JK for JG</i>
Witness	Katie Kreps <i>KK</i>
Site Location	Cove, AR
Date/Time	5/30/2018 12:58:33 PM
Make	RICOH
Model	G700 SE
File Name	RIMG0041.JPG
Subject	Demolition debris in location of former building on the north-central portion of the site

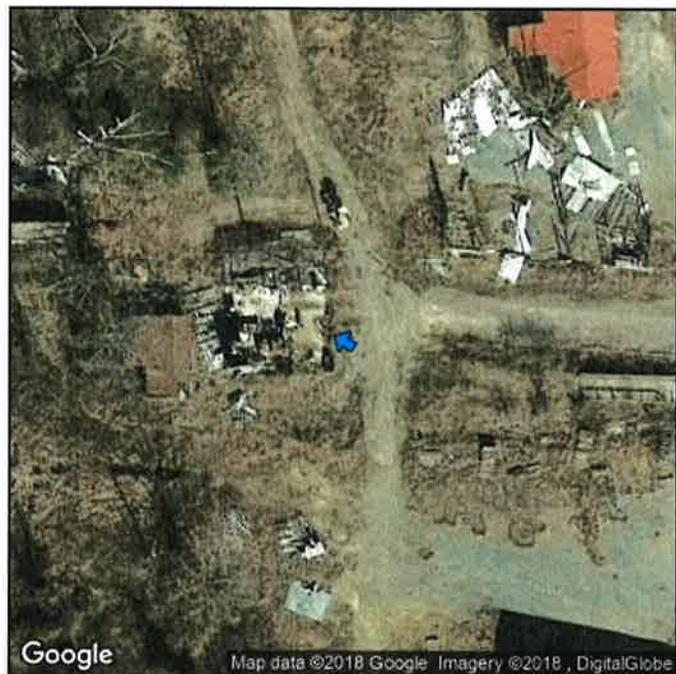
Attributes	
Photo Number	20
Facility	Lewis Lumber and Manufacturing Company
Event	Preliminary Assessment
AFIN	57-00020
Photographer	Joshua Graham <i>KK for JG</i>
Witness	Katie Kreps <i>KK</i>
Site Location	Cove, AR
Date/Time	5/30/2018 1:03:09 PM
Make	RICOH
Model	G700 SE
File Name	RIMG0045.JPG
Subject	Concrete foundation with staining in location of former building on the west portion of the site

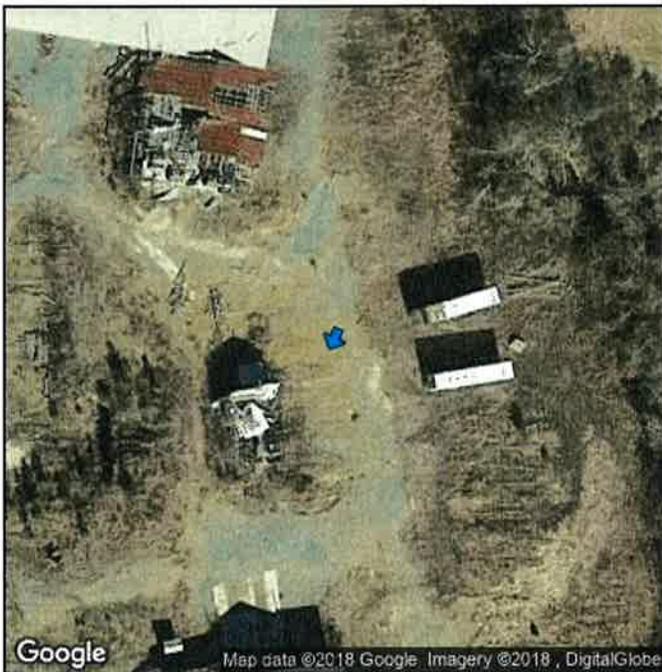
Attributes	
Photo Number	21
Facility	Lewis Lumber and Manufacturing Company
Event	Preliminary Assessment
AFIN	57-00020
Photographer	Joshua Graham <i>JK for JG</i>
Witness	Katie Kreps <i>KK</i>
Site Location	Cove, AR
Date/Time	5/30/2018 1:19:15 PM
Make	RICOH
Model	G700 SE
File Name	RIMG0060.JPG
Subject	Demolition debris in location of former building on the south-central portion of the site

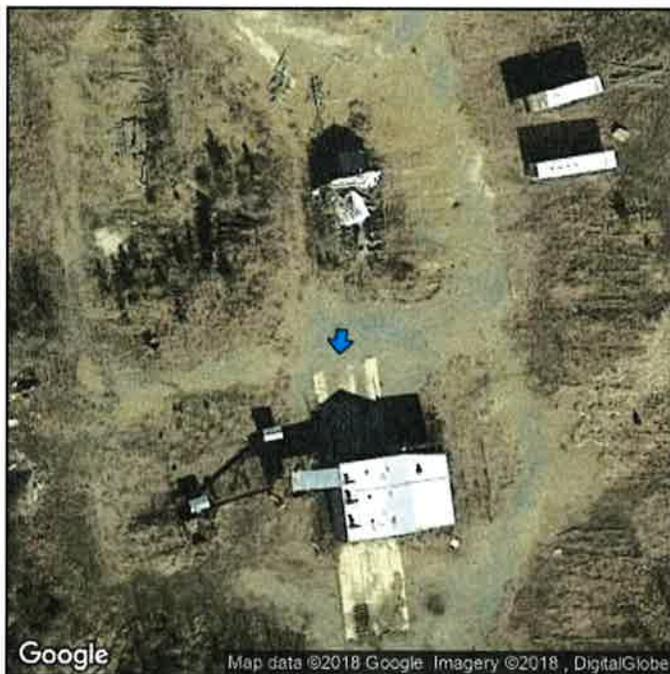
Attributes	
Photo Number	22
Facility	Lewis Lumber and Manufacturing Company
Event	Preliminary Assessment
AFIN	57-00020
Photographer	Joshua Graham <i>KK for JG</i>
Witness	Katie Kreps <i>KK</i>
Site Location	Cove, AR
Date/Time	5/30/2018 1:21:01 PM
Make	RICOH
Model	G700 SE
File Name	RIMG0062.JPG
Subject	Concrete foundation in location of former Dry Kiln on the southern portion of the site

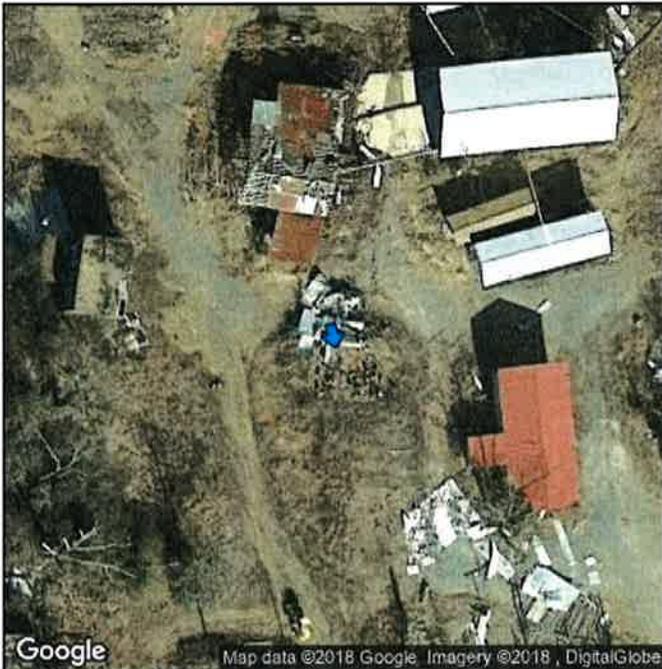
Attributes	
Photo Number	23
Facility	Lewis Lumber and Manufacturing Company
Event	Preliminary Assessment
AFIN	57-00020
Photographer	Joshua Graham <i>JK for J6</i>
Witness	Katie Kreps <i>KK</i>
Site Location	Cove, AR
Date/Time	5/30/2018 12:17:29 PM
Make	RICOH
Model	G700 SE
File Name	RIMG0017.JPG
Subject	Empty 5-gallon hydraulic fluid buckets in debris pile on the north-central portion of the site

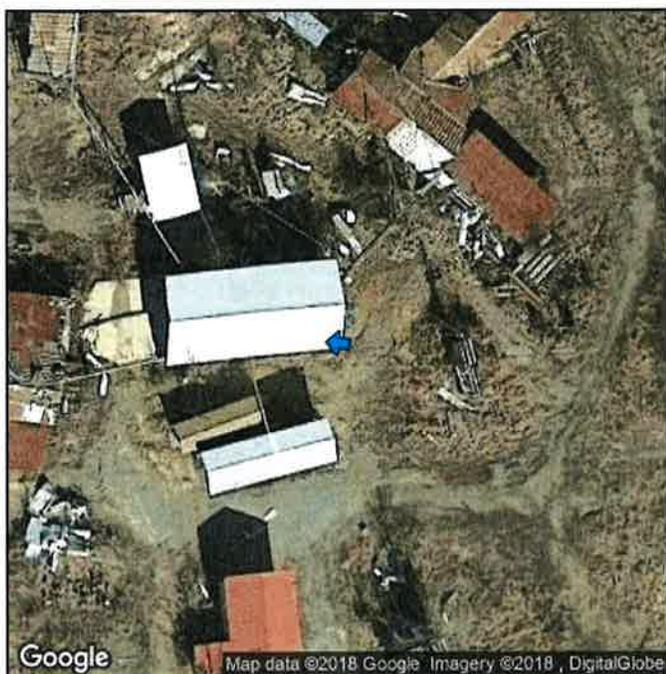
Attributes	
Photo Number	25
Facility	Lewis Lumber and Manufacturing Company
Event	Preliminary Assessment
AFIN	57-00020
Photographer	Joshua Graham <i>KK for J6</i>
Witness	Katie Kreps <i>KK</i>
Site Location	Cove, AR
Date/Time	5/30/2018 12:11:18 PM
Make	RICOH
Model	G700 SE
File Name	RIMG0013.JPG
Subject	Broken universal waste bulb near debris pile on the north-central portion of the site

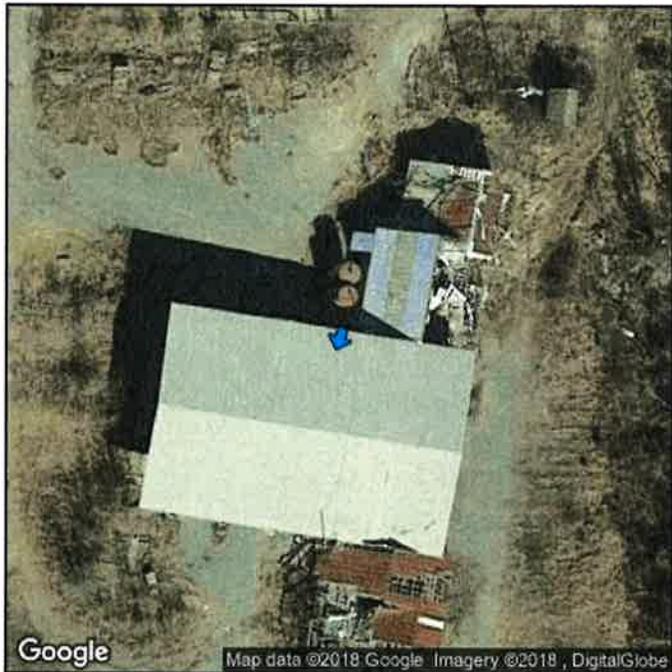
Attributes	
Photo Number	26
Facility	Lewis Lumber and Manufacturing Company
Event	Preliminary Assessment
AFIN	57-00020
Photographer	Joshua Graham <i>KK for JB</i>
Witness	Katie Kreps <i>KK</i>
Site Location	Cove, AR
Date/Time	5/30/2018 1:12:18 PM
Make	RICOH
Model	G700 SE
File Name	RIMG0053.JPG
Subject	Broken universal waste bulb near the CCA Treatment Building on the southern portion of the site

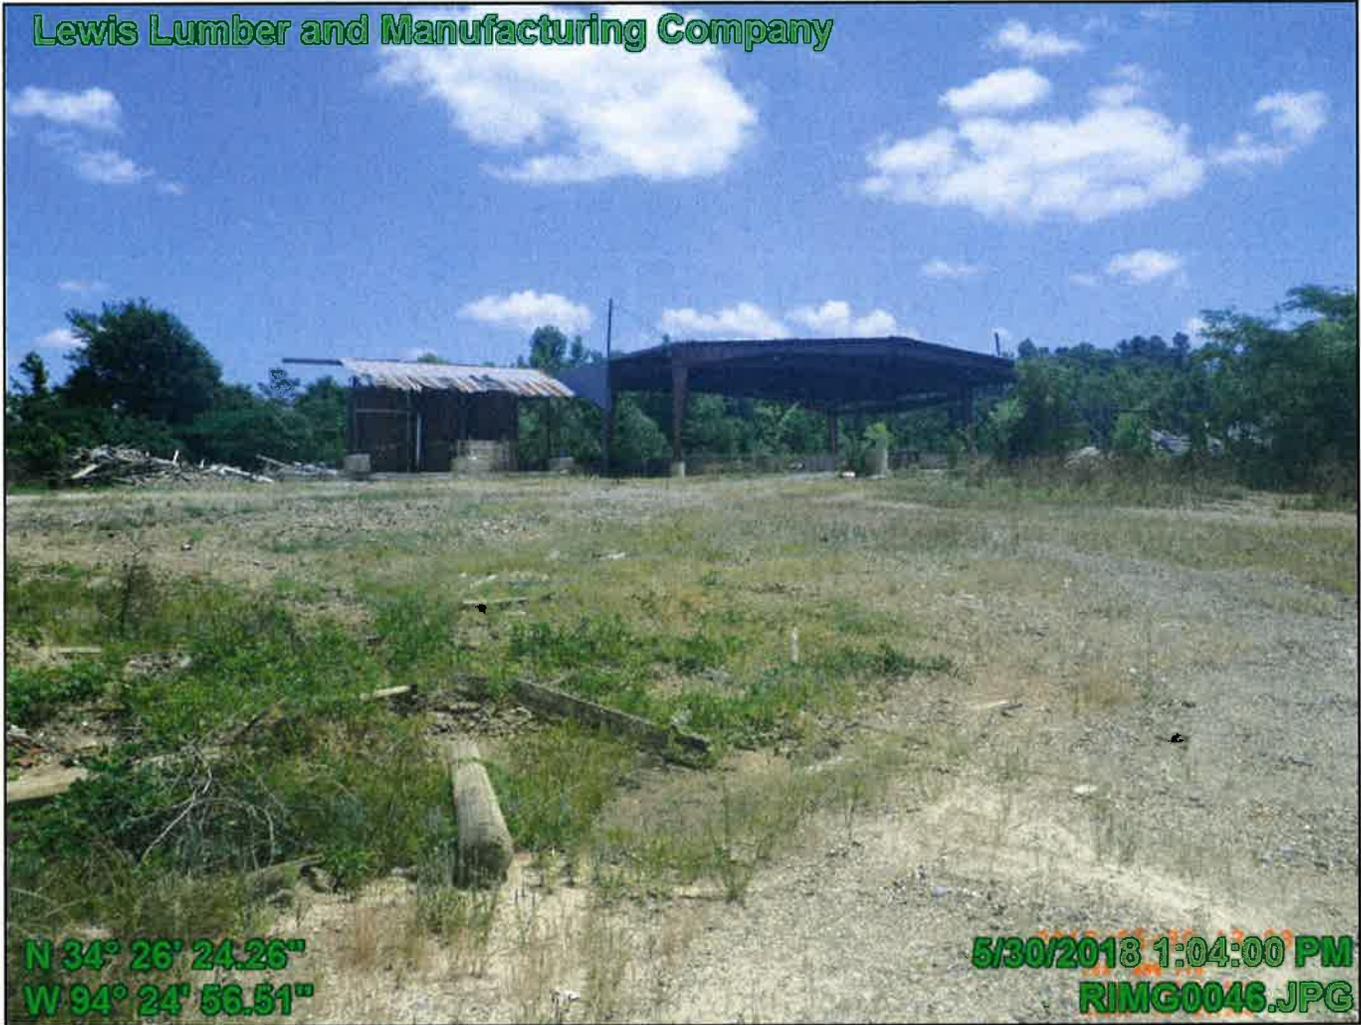
Attributes	
Photo Number	27
Facility	Lewis Lumber and Manufacturing Company
Event	Preliminary Assessment
AFIN	57-00020
Photographer	Joshua Graham KK for JG
Witness	Katie Kreps KK
Site Location	Cove, AR
Date/Time	5/30/2018 1:04:00 PM
Make	RICOH
Model	G700 SE
File Name	RIMG0046.JPG
Subject	CCA Treatment Building on the southern portion of the site

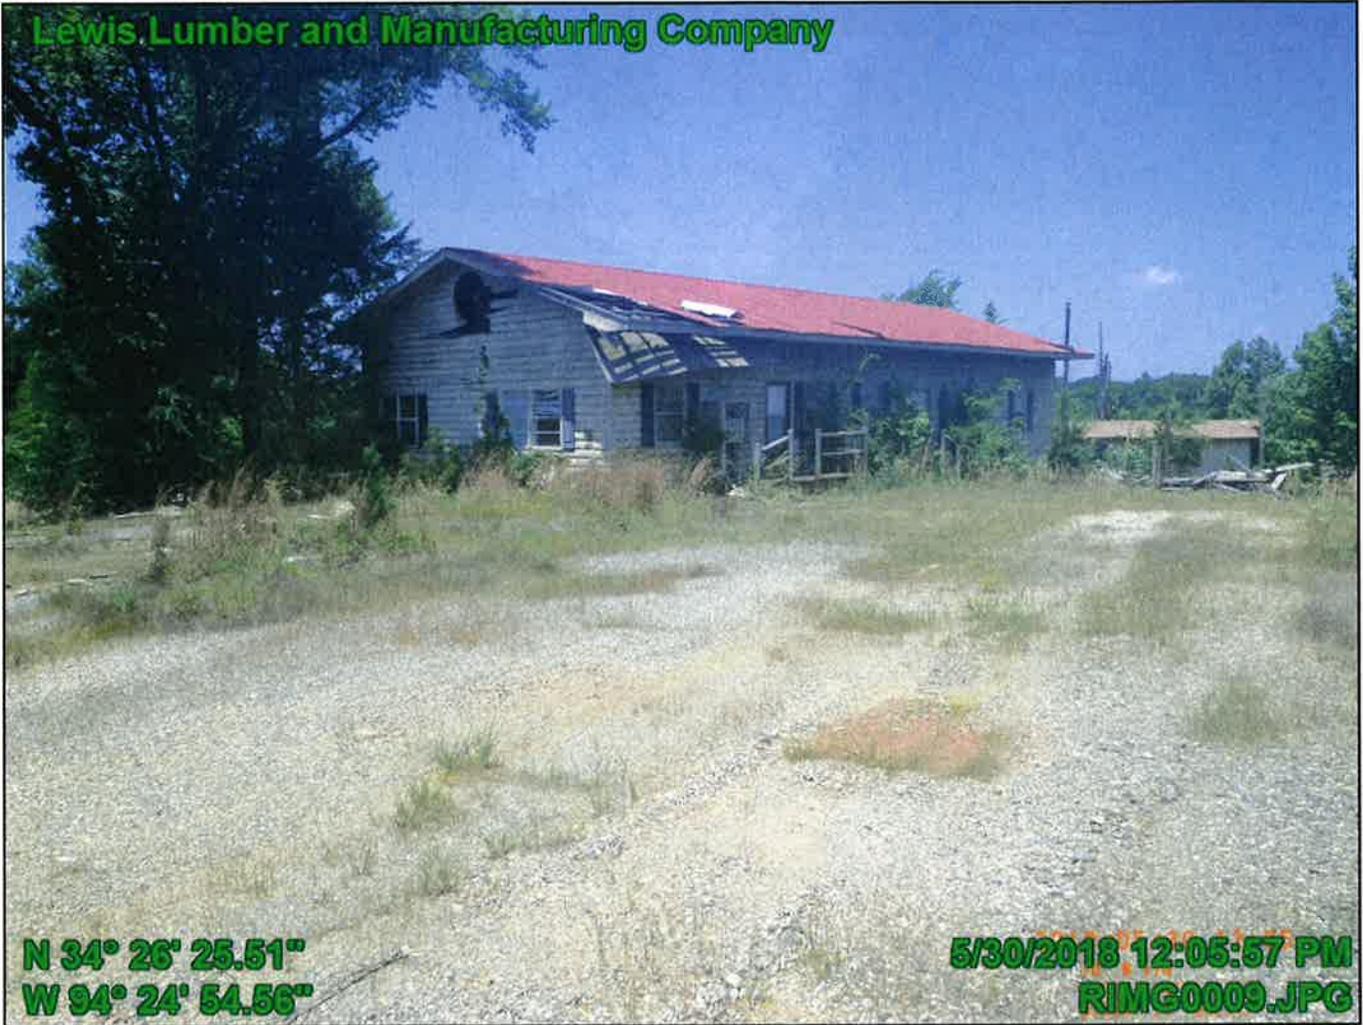
Attributes	
Photo Number	29
Facility	Lewis Lumber and Manufacturing Company
Event	Preliminary Assessment
AFIN	57-00020
Photographer	Joshua Graham <i>KK for JB</i>
Witness	Katie Kreps <i>KK</i>
Site Location	Cove, AR
Date/Time	5/30/2018 12:05:57 PM
Make	RICOH
Model	G700 SE
File Name	RIMG0009.JPG
Subject	Office on the northern portion of the site

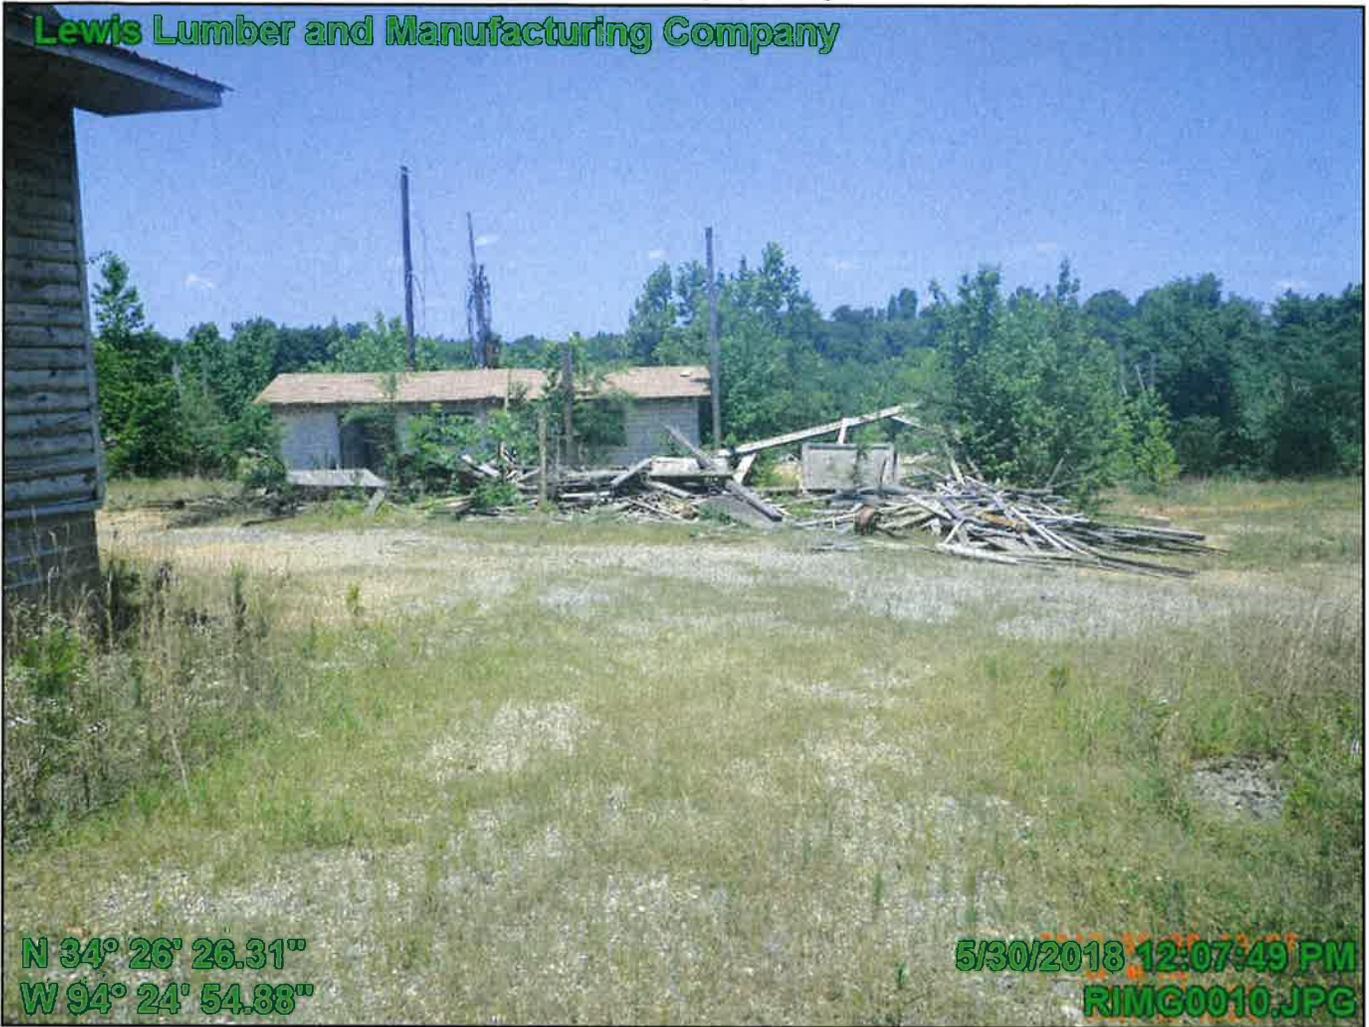
- The historical use of the site as a lumber mill and wood treating facility;
- Demolition debris located throughout the site containing empty 5-gallon hydraulic fluid buckets, small-quantity containers of various contents, broken universal waste bulbs, and various wiring and tubing;

Attributes	
Photo Number	30
Facility	Lewis Lumber and Manufacturing Company
Event	Preliminary Assessment
AFIN	57-00020
Photographer	Joshua Graham <i>KK for JG</i>
Witness	Katie Kreps <i>KK</i>
Site Location	Cove, AR
Date/Time	5/30/2018 12:07:49 PM
Make	RICOH
Model	G700 SE
File Name	RIMG0010.JPG
Subject	Break building and debris pile on the northern portion of the site

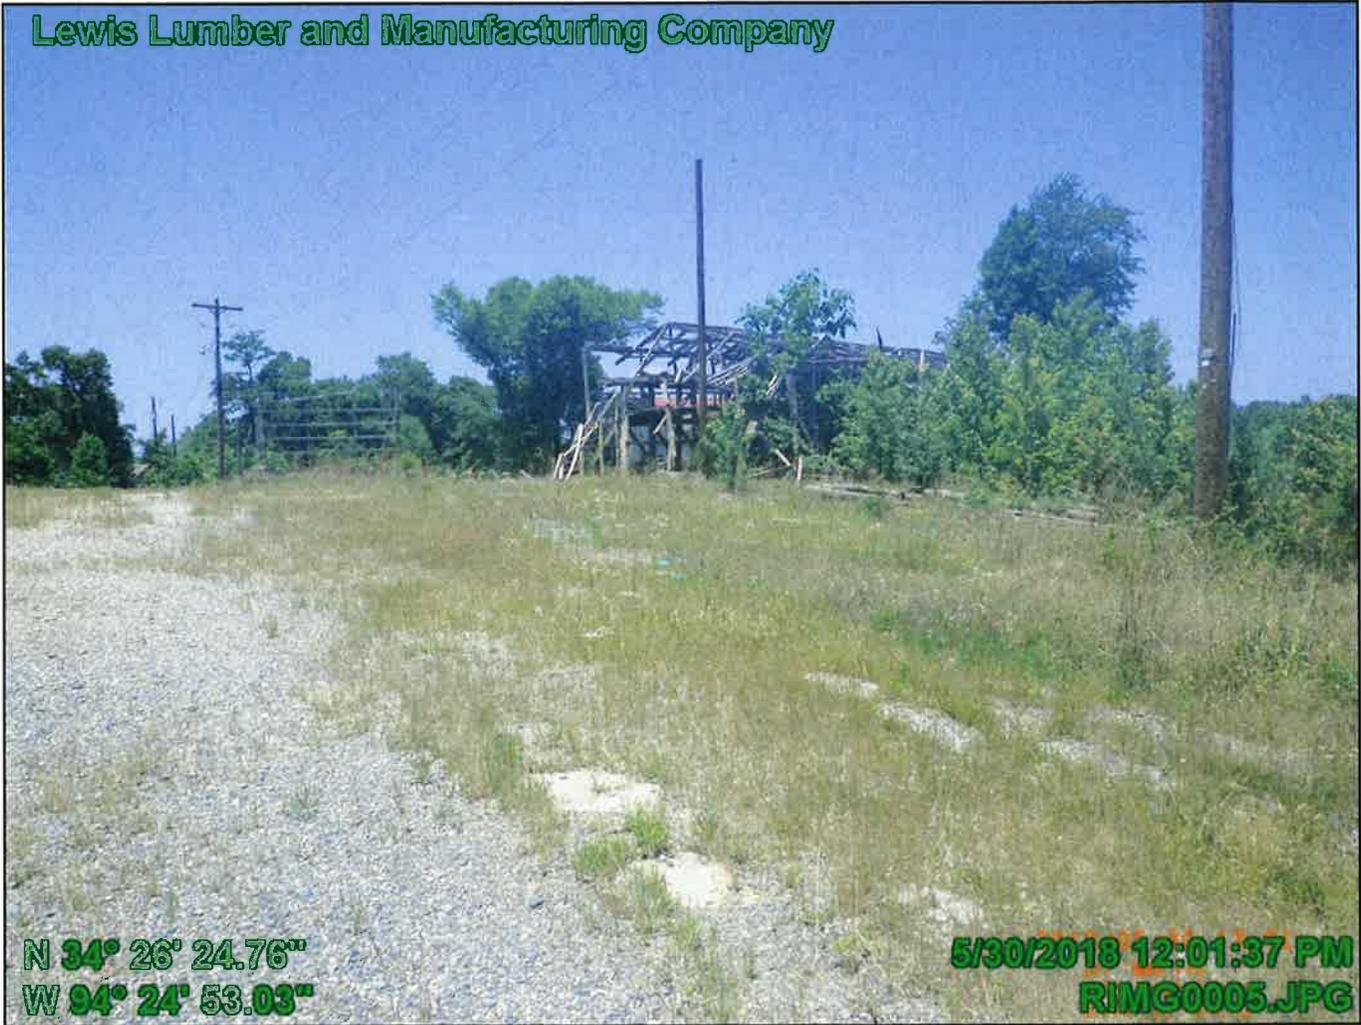
Attributes	
Photo Number	31
Facility	Lewis Lumber and Manufacturing Company
Event	Preliminary Assessment
AFIN	57-00020
Photographer	Joshua Graham <i>KK for JG</i>
Witness	Katie Kreps <i>KK</i>
Site Location	Cove, AR
Date/Time	5/30/2018 12:01:37 PM
Make	RICOH
Model	G700 SE
File Name	RIMG0005.JPG
Subject	Wooden frame of plywood storage building on the northern portion of the site
