**Re: Preliminary Assessment Report for Lewis Lumber and Manufacturing Company
136 West Mill Street
Cove, Polk County, Arkansas
EPA SEMS ID: ARD006348353; AFIN: 57-00020**

**PRELIMINARY ASSESSMENT
FOR
LEWIS LUMBER AND MANUFACTURING COMPANY
EPA SEMS ID: ARD006348353
COVE, POLK COUNTY, ARKANSAS**

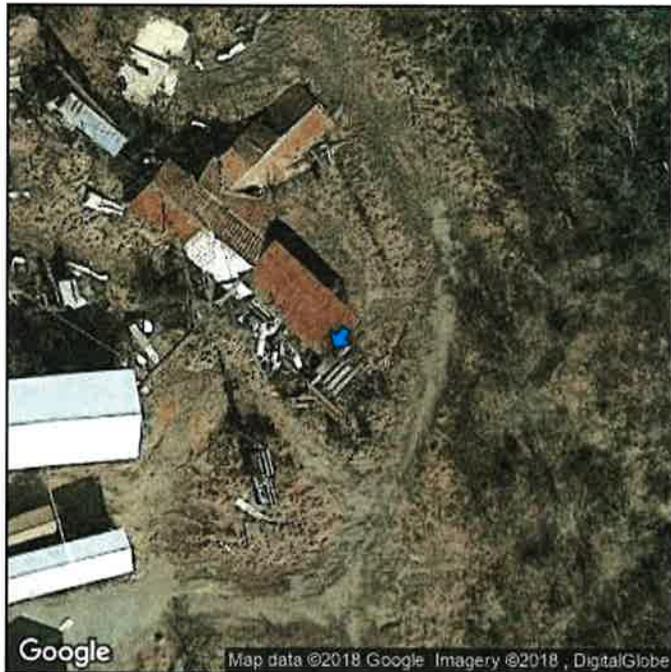
Attributes	
Photo Number	32
Facility	Lewis Lumber and Manufacturing Company
Event	Preliminary Assessment
AFIN	57-00020
Photographer	Joshua Graham <i>KK for JG</i>
Witness	Katie Kreps <i>KK</i>
Site Location	Cove, AR
Date/Time	5/30/2018 12:23:15 PM
Make	RICOH
Model	G700 SE
File Name	RIMG0020.JPG
Subject	Areas of staining and burn piles on the northeast portion of the site

There are multiple burn piles and numerous areas of staining on gravel, concrete foundations, and soil, accompanied by hydrocarbon odor, located throughout the Lewis

- Multiple burn piles and numerous areas of staining on gravel, concrete foundations, and soil, accompanied by hydrocarbon odor;
- Staining in the shape of rings, indicative of former 55-gallon drums, on a concrete foundation;

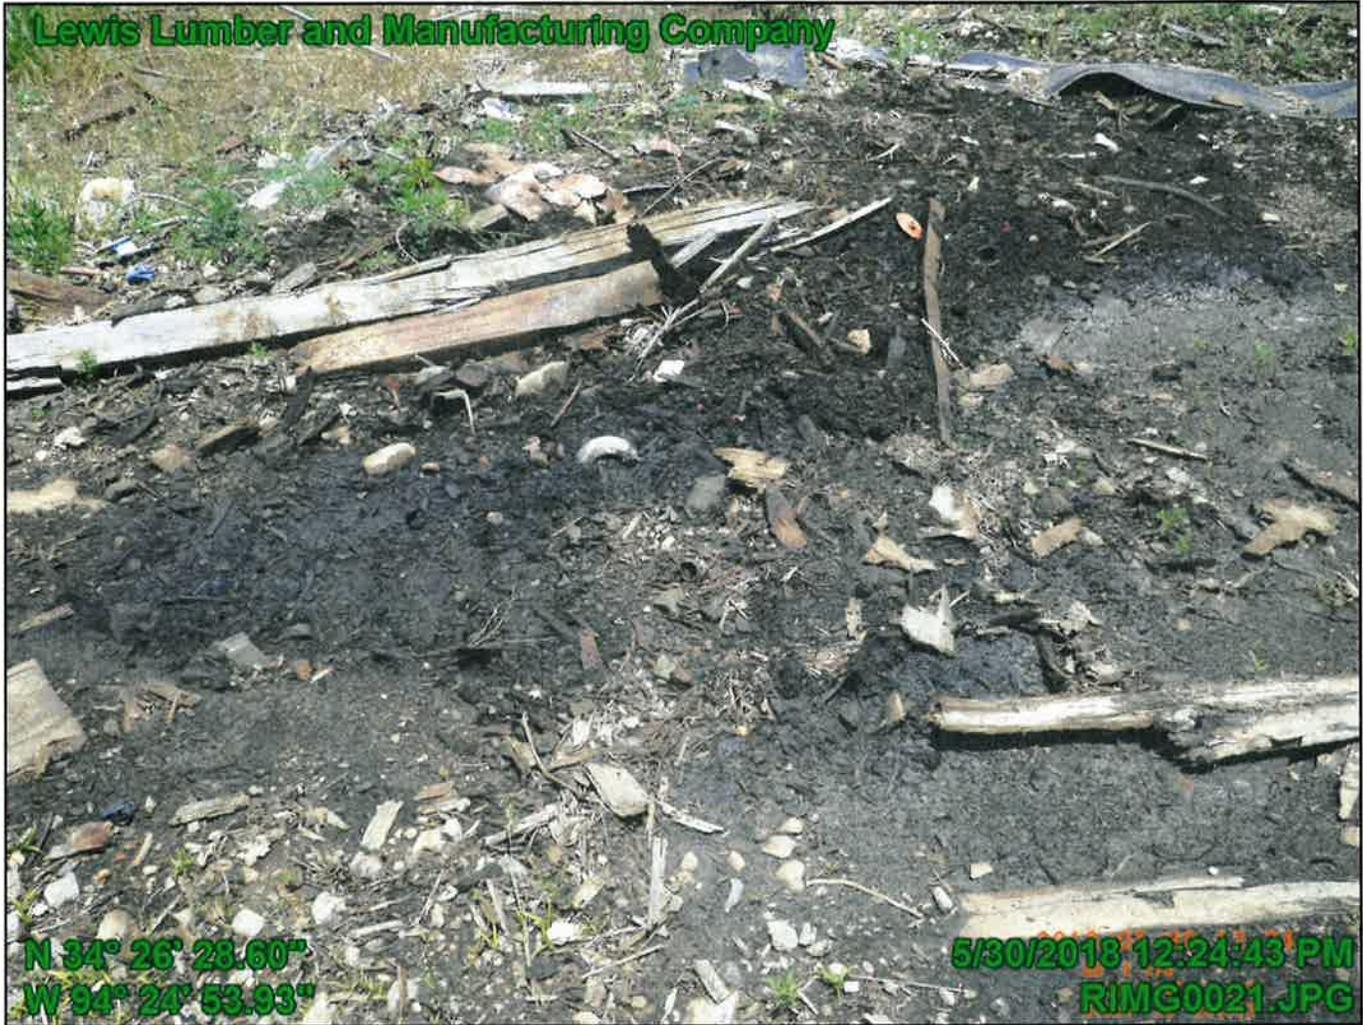
Attributes	
Photo Number	33
Facility	Lewis Lumber and Manufacturing Company
Event	Preliminary Assessment
AFIN	57-00020
Photographer	Joshua Graham <i>KK for JB</i>
Witness	Katie Kreps <i>KK</i>
Site Location	Cove, AR
Date/Time	5/30/2018 12:24:43 PM
Make	RICOH
Model	G700 SE
File Name	RIMG0021.JPG
Subject	Area of staining on the northeast portion of the site

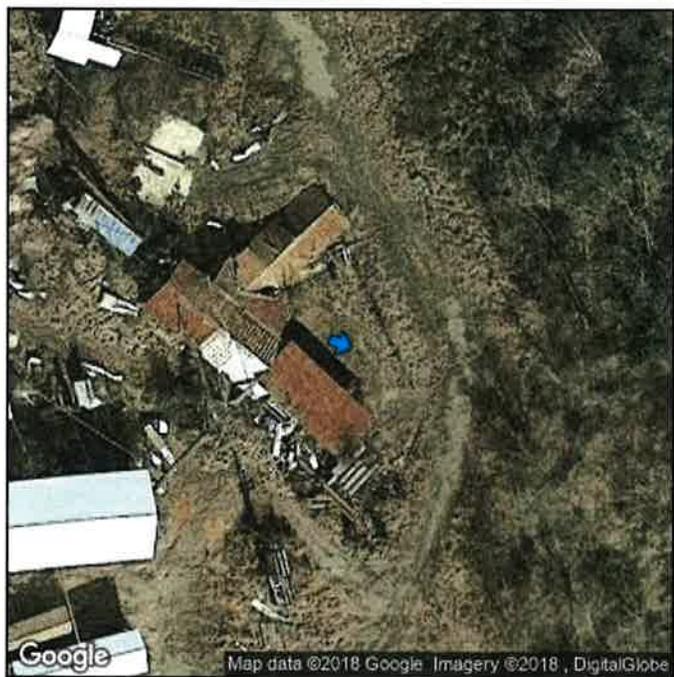
Attributes	
Photo Number	34
Facility	Lewis Lumber and Manufacturing Company
Event	Preliminary Assessment
AFIN	57-00020
Photographer	Joshua Graham <i>KK for JG</i>
Witness	Katie Kreps <i>KK</i>
Site Location	Cove, AR
Date/Time	5/30/2018 12:24:56 PM
Make	RICOH
Model	G700 SE
File Name	RIMG0022.JPG
Subject	Area of staining on the northeast portion of the site

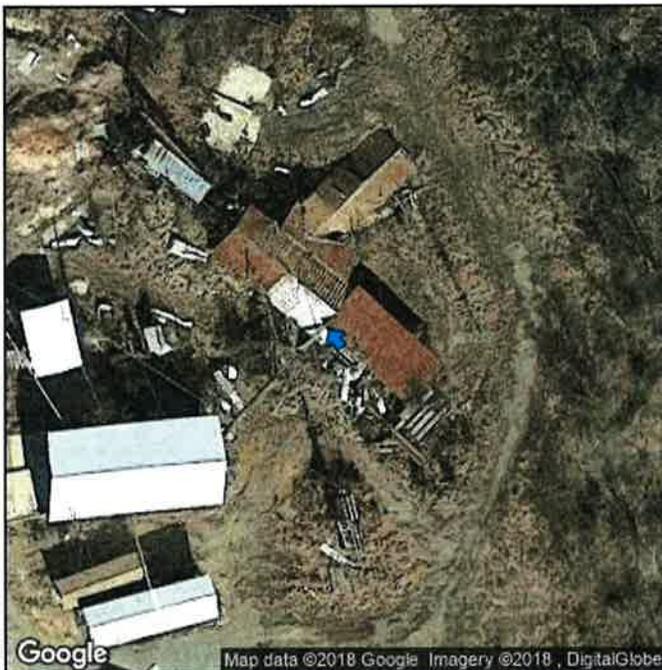
Attributes	
Photo Number	35
Facility	Lewis Lumber and Manufacturing Company
Event	Preliminary Assessment
AFIN	57-00020
Photographer	Joshua Graham <i>KK for JG</i>
Witness	Katie Kreps <i>KK</i>
Site Location	Cove, AR
Date/Time	5/30/2018 12:27:31 PM
Make	RICOH
Model	G700 SE
File Name	RIMG0024.JPG
Subject	Staining and demolition debris on the northeast portion of the site

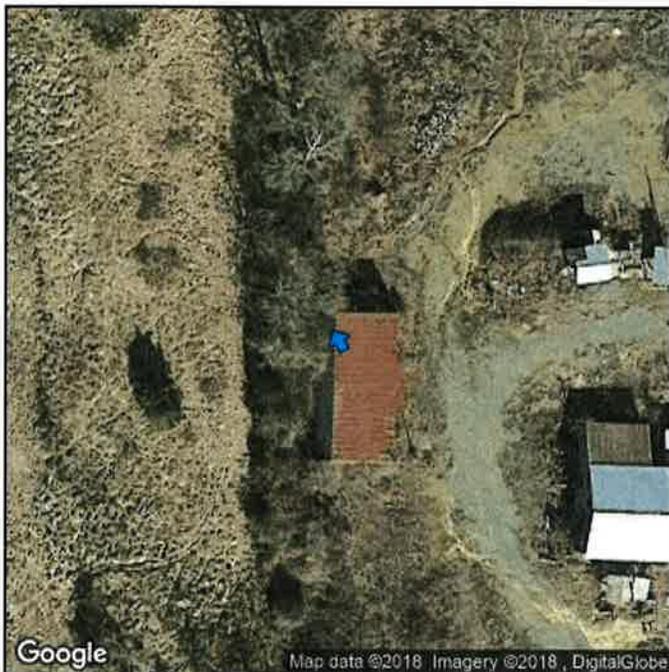
Attributes	
Photo Number	36
Facility	Lewis Lumber and Manufacturing Company
Event	Preliminary Assessment
AFIN	57-00020
Photographer	Joshua Graham <i>KK for JG</i>
Witness	Katie Kreps <i>KK</i>
Site Location	Cove, AR
Date/Time	5/30/2018 12:51:40 PM
Make	RICOH
Model	G700 SE
File Name	RIMG0035.JPG
Subject	Staining and debris on concrete foundation on the northwest portion of the site

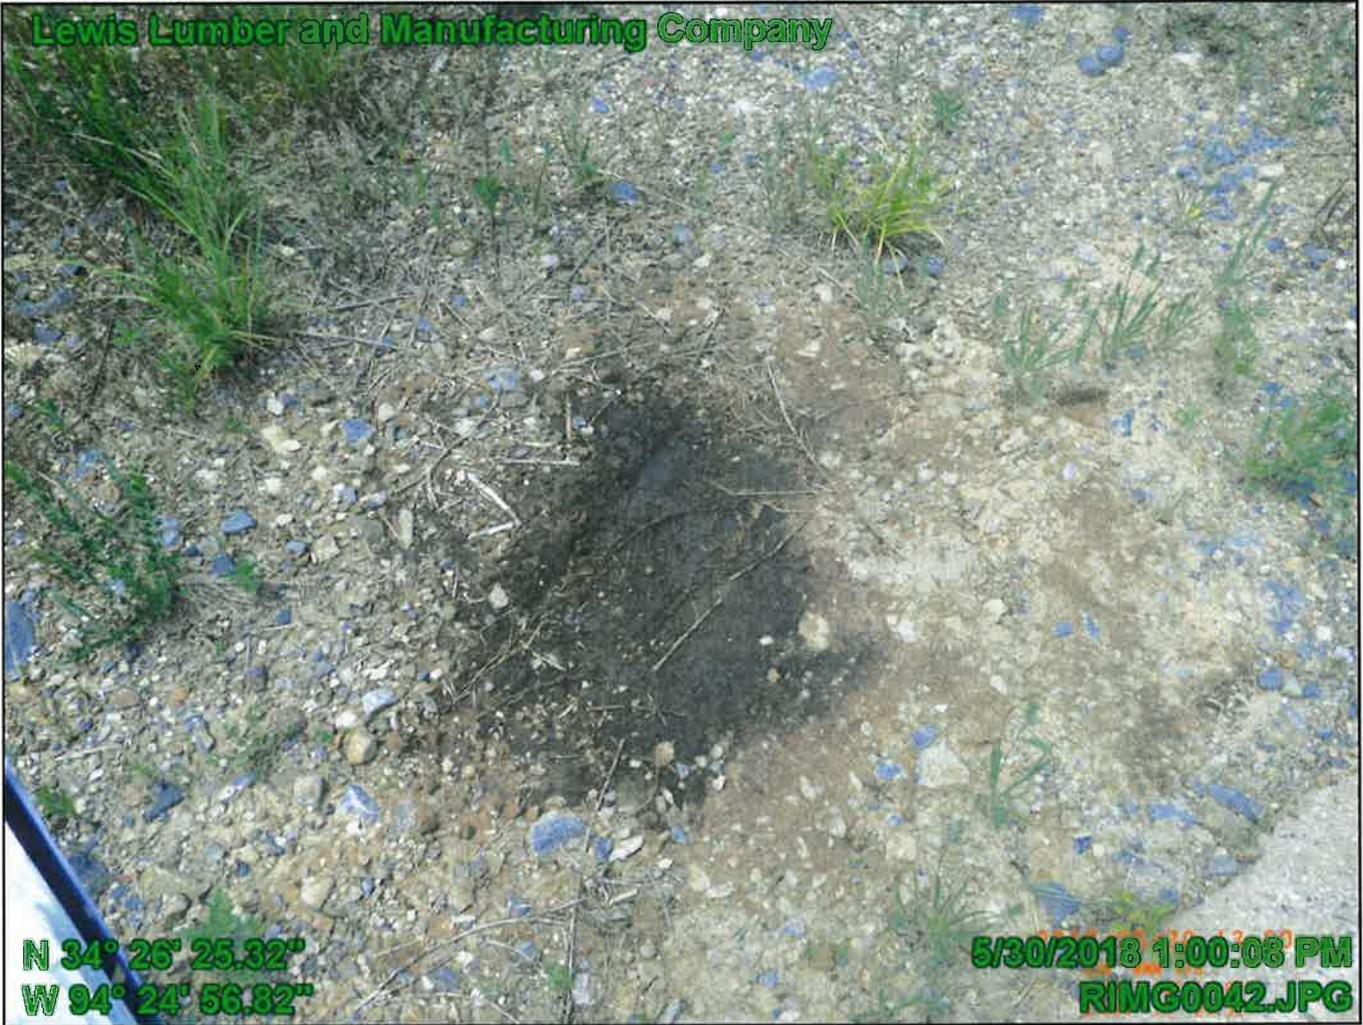
Attributes	
Photo Number	37
Facility	Lewis Lumber and Manufacturing Company
Event	Preliminary Assessment
AFIN	57-00020
Photographer	Joshua Graham <i>KX for JG</i>
Witness	Katie Kreps <i>KK</i>
Site Location	Cove, AR
Date/Time	5/30/2018 1:00:08 PM
Make	RICOH
Model	G700 SE
File Name	RIMG0042.JPG
Subject	Staining on the west portion of the site

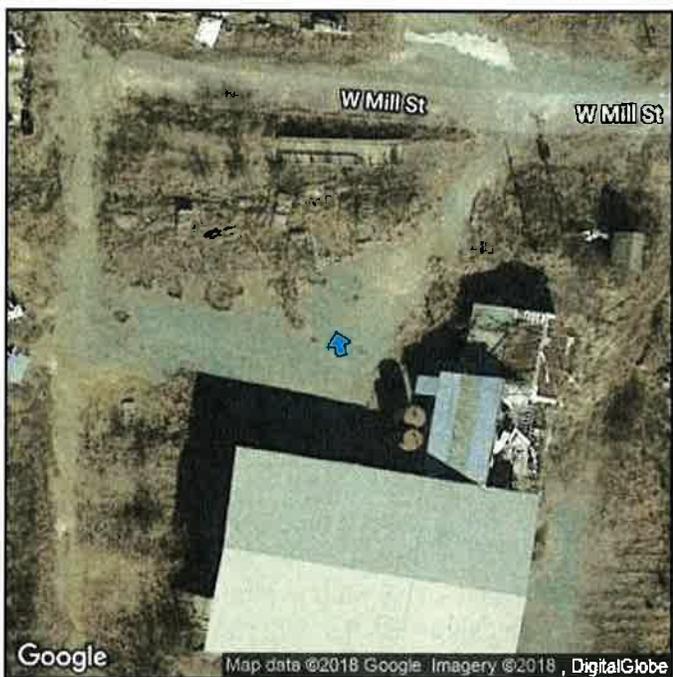
Attributes	
Photo Number	38
Facility	Lewis Lumber and Manufacturing Company
Event	Preliminary Assessment
AFIN	57-00020
Photographer	Joshua Graham <i>KK for JG</i>
Witness	Katie Kreps <i>KK</i>
Site Location	Cove, AR
Date/Time	5/30/2018 1:05:28 PM
Make	RICOH
Model	G700 SE
File Name	RIMG0048.JPG
Subject	Staining on the southern portion of the site, north of the CCA Treatment Building

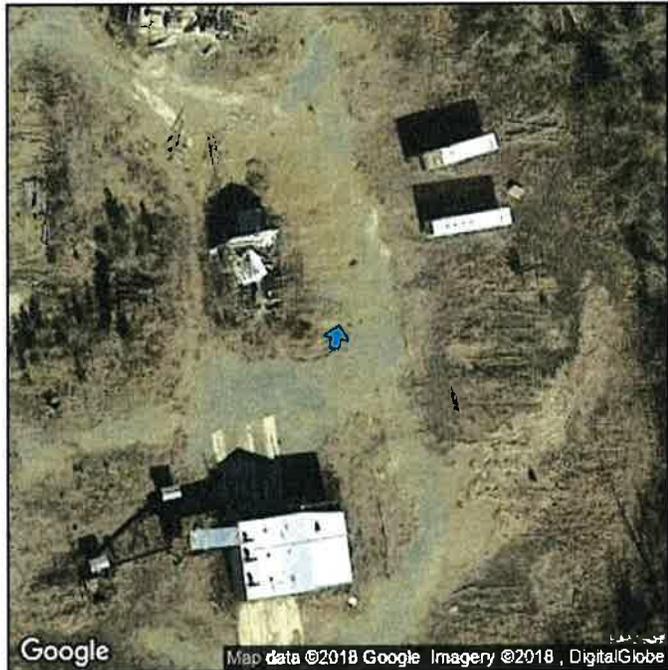
Attributes	
Photo Number	39
Facility	Lewis Lumber and Manufacturing Company
Event	Preliminary Assessment
AFIN	57-00020
Photographer	Joshua Graham <i>KK for JG</i>
Witness	Katie Kreps <i>KK</i>
Site Location	Cove, AR
Date/Time	5/30/2018 1:20:12 PM
Make	RICOH
Model	G700 SE
File Name	RIMG0061.JPG
Subject	Staining on the south-central portion of the site

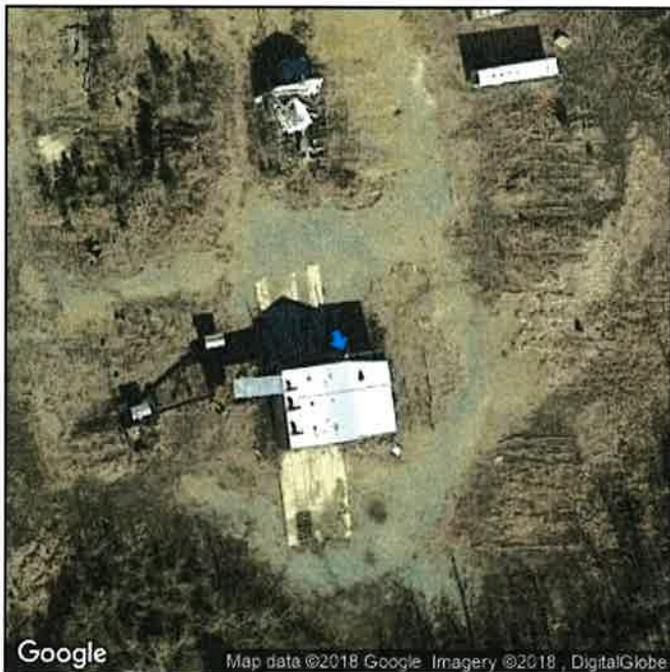
Attributes	
Photo Number	40
Facility	Lewis Lumber and Manufacturing Company
Event	Preliminary Assessment
AFIN	57-00020
Photographer	Joshua Graham <i>JKK for JG</i>
Witness	Katie Kreps <i>KK</i>
Site Location	Cove, AR
Date/Time	5/30/2018 1:22:04 PM
Make	RICOH
Model	G700 SE
File Name	RIMG0063.JPG
Subject	Staining on concrete foundation of the former Dry Kiln on the southern portion of the site

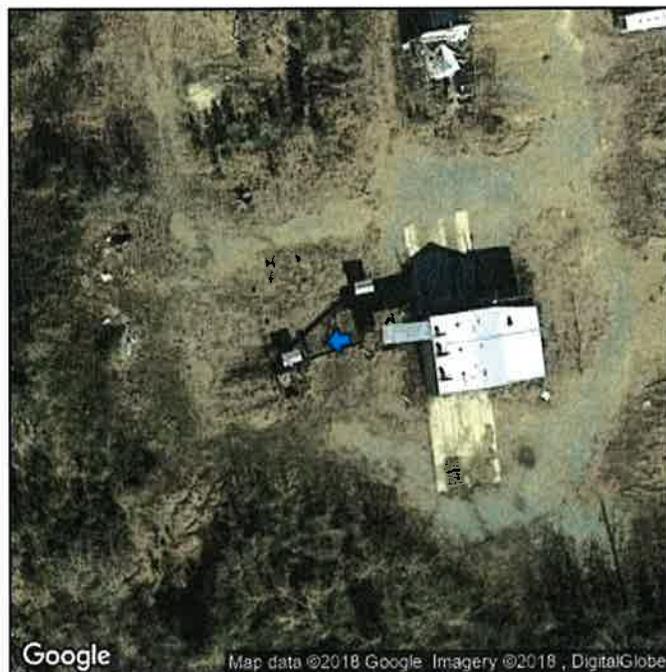
Attributes	
Photo Number	41
Facility	Lewis Lumber and Manufacturing Company
Event	Preliminary Assessment
AFIN	57-00020
Photographer	Joshua Graham <i>KK for JG</i>
Witness	Katie Kreps <i>KK</i>
Site Location	Cove, AR
Date/Time	5/30/2018 1:23:58 PM
Make	RICOH
Model	G700 SE
File Name	RIMG0065.JPG
Subject	Staining west of the former Dry Kiln on the southern portion of the site

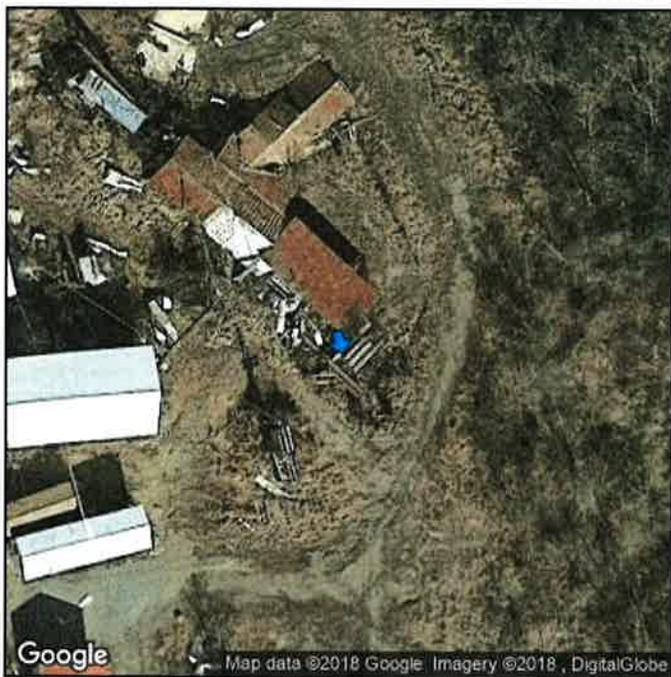
Attributes	
Photo Number	42
Facility	Lewis Lumber and Manufacturing Company
Event	Preliminary Assessment
AFIN	57-00020
Photographer	Joshua Graham <i>JK for JG</i>
Witness	Katie Kreps <i>KK</i>
Site Location	Cove, AR
Date/Time	5/30/2018 12:21:59 PM
Make	RICOH
Model	G700 SE
File Name	RIMG0019.JPG
Subject	Burn pile on the northeast portion of the site

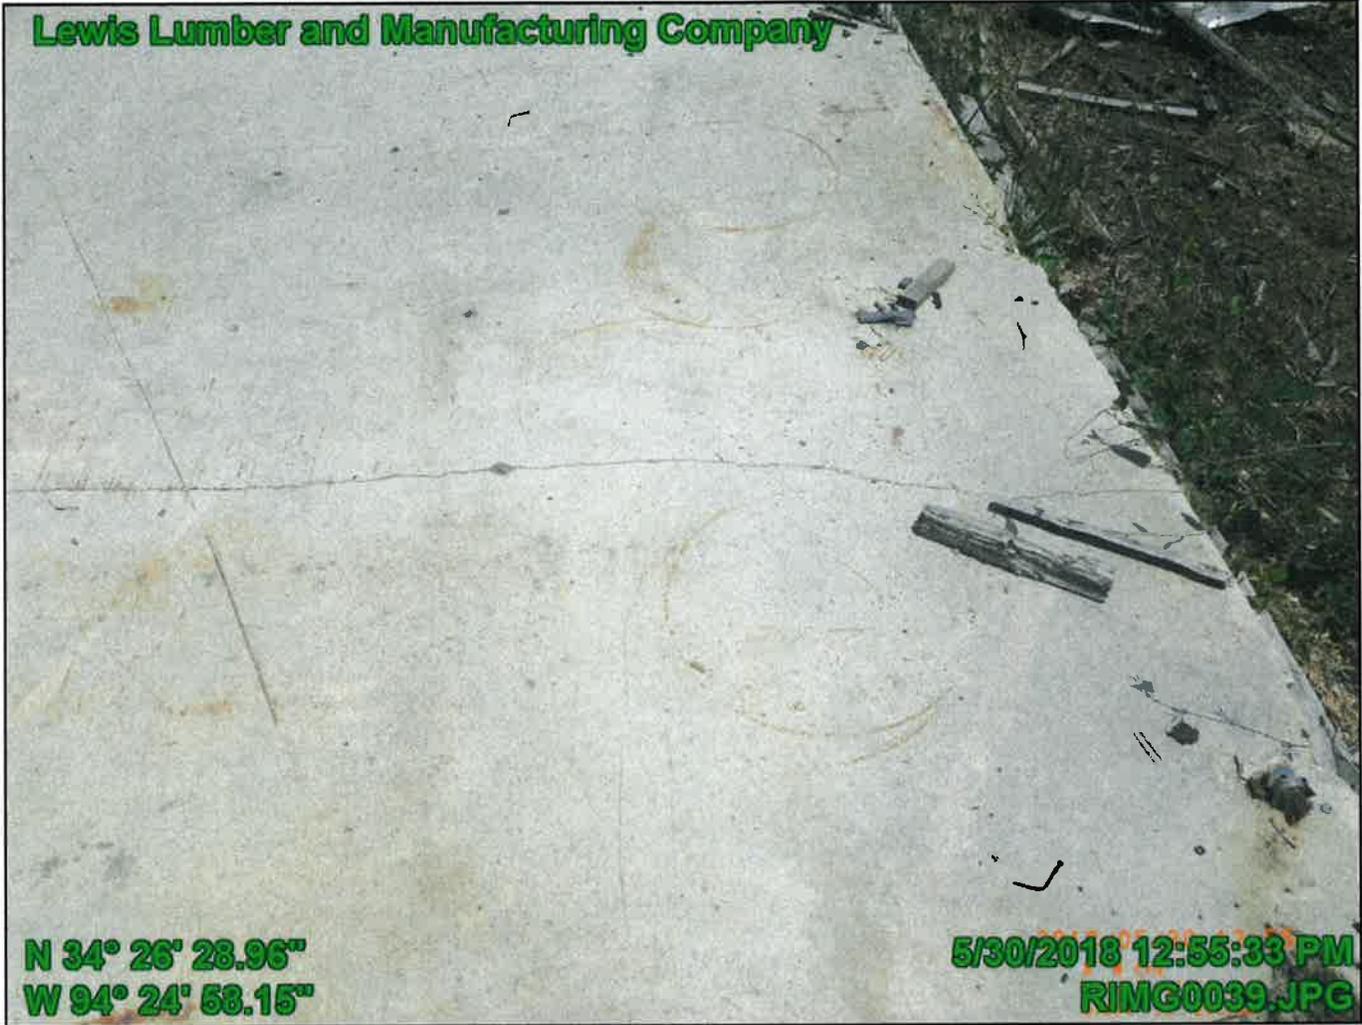
Attributes	
Photo Number	43
Facility	Lewis Lumber and Manufacturing Company
Event	Preliminary Assessment
AFIN	57-00020
Photographer	Joshua Graham <i>KK for JB</i>
Witness	Katie Kreps <i>KK</i>
Site Location	Cove, AR
Date/Time	5/30/2018 12:55:33 PM
Make	RICOH
Model	G700 SE
File Name	RIMG0039.JPG
Subject	Staining in the shape of rings on a concrete foundation on the northern portion of the site

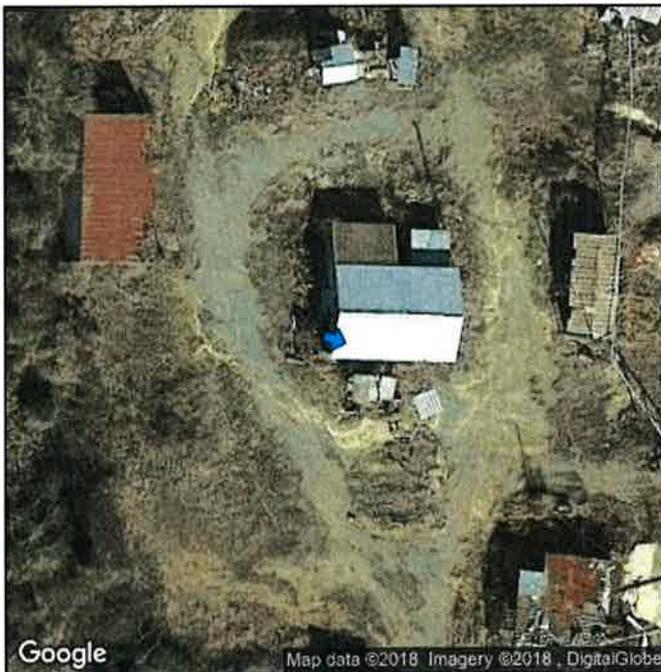
Lumber site (Refer to Photographic Log, Photos 32–42). In addition, one concrete foundation on the northern portion of the site had staining in the shape of rings indicative of former 55-gallon drums (Refer to Photographic Log, Photo 43). Areas of disturbed soil, presumably resulting from demolition activities, and a large sawdust pile are located on the north-central portion of the site (Refer to Photographic Log, Photo 44).

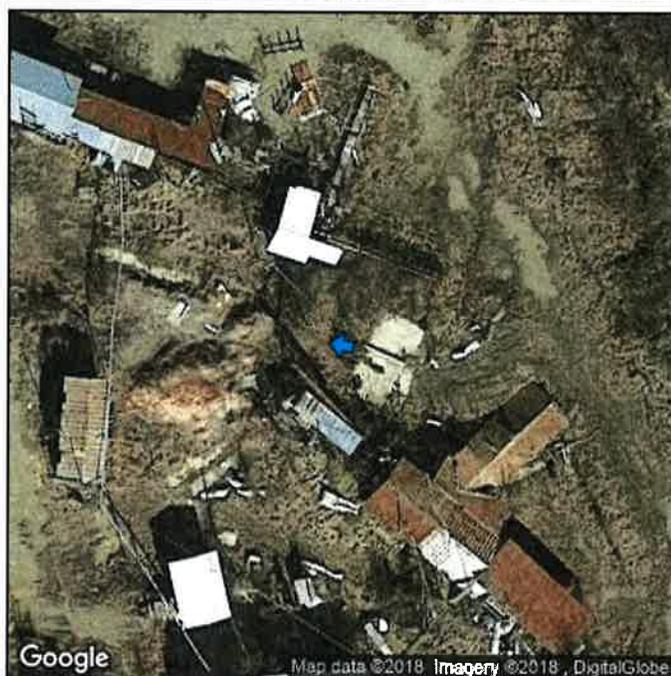
Attributes	
Photo Number	44
Facility	Lewis Lumber and Manufacturing Company
Event	Preliminary Assessment
AFIN	57-00020
Photographer	Joshua Graham <i>KK for JG</i>
Witness	Katie Kreps <i>KK</i>
Site Location	Cove, AR
Date/Time	5/30/2018 12:30:57 PM
Make	RICOH
Model	G700 SE
File Name	RIMG0026.JPG
Subject	Large sawdust pile and areas of disturbed soil on the north-central portion of the site

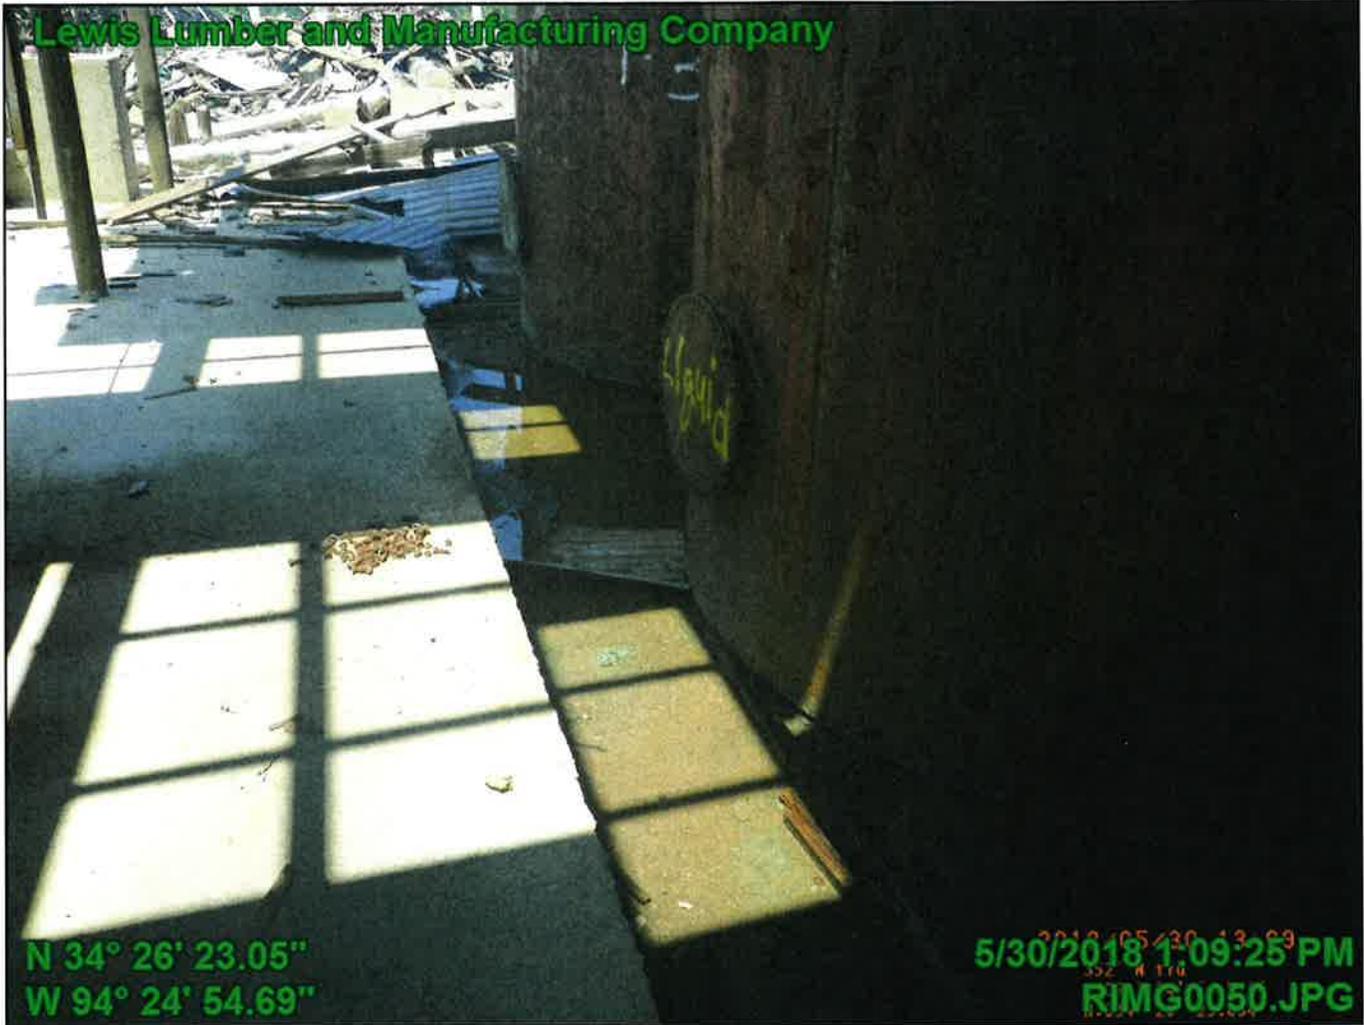
Attributes	
Photo Number	47
Facility	Lewis Lumber and Manufacturing Company
Event	Preliminary Assessment
AFIN	57-00020
Photographer	Joshua Graham <i>KK for JG</i>
Witness	Katie Kreps <i>KK</i>
Site Location	Cove, AR
Date/Time	5/30/2018 1:09:25 PM
Make	RICOH
Model	G700 SE
File Name	RIMG0050.JPG
Subject	Green staining on the CCA Tanks and inside the concrete containment area with liquid

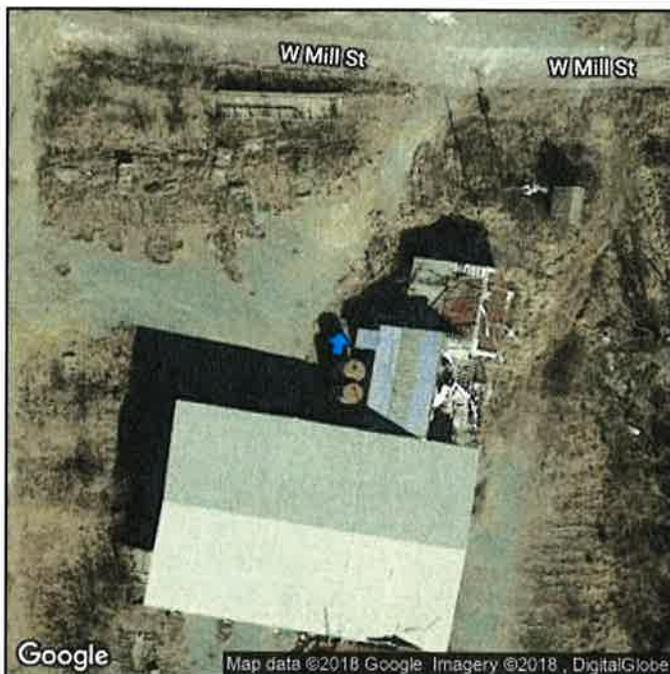
Concrete saddles for additional former ASTs are located north of the CCA Treatment Tanks (Refer to Photographic Log, Photo 48). A concrete catch/recirculation basin with a metal tank and sump on each side is located south of the CCA Treatment Tanks (Refer to Photographic Log, Photo 49). The concrete catch/recirculation basin was stained and contained liquid presumed to be rainwater during site reconnaissance. A covered concrete drip pad and treatment area is located south of the catch/recirculation basin. During site reconnaissance, staining was visible on the concrete drip pad and treatment area; in particular, dense green staining was located on the south portion of the concrete drip pad (Refer to Photographic Log, Photos 50 and 51). An approximately 18,000-gallon underground concrete containment area is located east of the CCA Treatment Tanks (Refer to Photographic Log, Photo 52). During site reconnaissance, the approximately 18,000-gallon underground concrete containment area contained liquid presumed to be rainwater with sheen on the surface (Refer to Photographic Log, Photo 53).

Attributes	
Photo Number	48
Facility	Lewis Lumber and Manufacturing Company
Event	Preliminary Assessment
AFIN	57-00020
Photographer	Joshua Graham <i>KK for JG</i>
Witness	Katie Kreps <i>KK</i>
Site Location	Cove, AR
Date/Time	5/30/2018 1:11:16 PM
Make	RICOH
Model	G700 SE
File Name	RIMG0052.JPG
Subject	Concrete saddles for ASTs north of the CCA Tanks

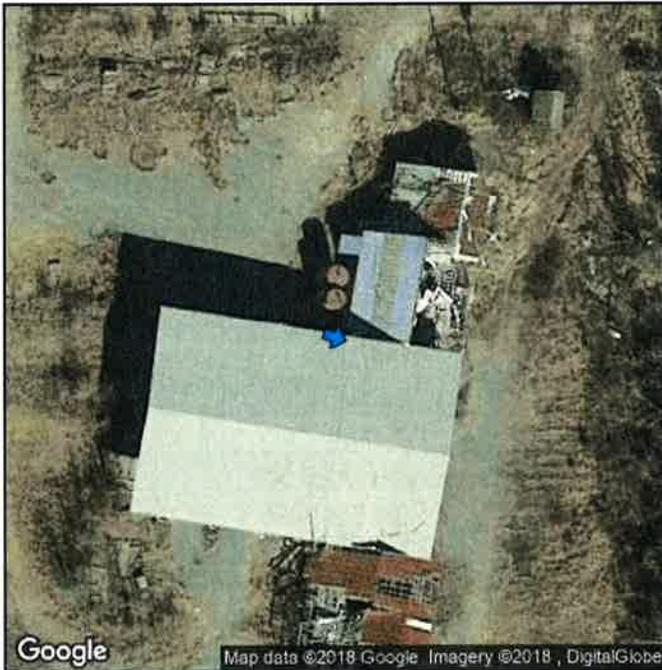
Attributes	
Photo Number	49
Facility	Lewis Lumber and Manufacturing Company
Event	Preliminary Assessment
AFIN	57-00020
Photographer	Joshua Graham <i>KK for J6</i>
Witness	Katie Kreps <i>KK</i>
Site Location	Cove, AR
Date/Time	5/30/2018 1:13:35 PM
Make	RICOH
Model	G700 SE
File Name	RIMG0055.JPG
Subject	Stained concrete catch/recirculation basin containing liquid

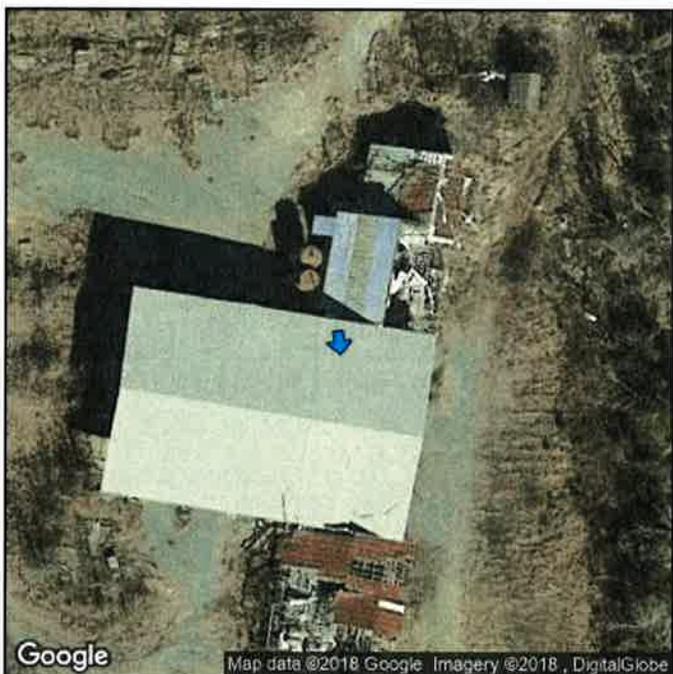
Attributes	
Photo Number	50
Facility	Lewis Lumber and Manufacturing Company
Event	Preliminary Assessment
AFIN	57-00020
Photographer	Joshua Graham <i>KK for JB</i>
Witness	Katie Kreps <i>KK</i>
Site Location	Cove, AR
Date/Time	5/30/2018 1:14:57 PM
Make	RICOH
Model	G700 SE
File Name	RIMG0057.JPG
Subject	Covered concrete drip pad and treatment area with staining

- Staining on the concrete drip pad and treatment area, in particular, dense green staining on the south portion;

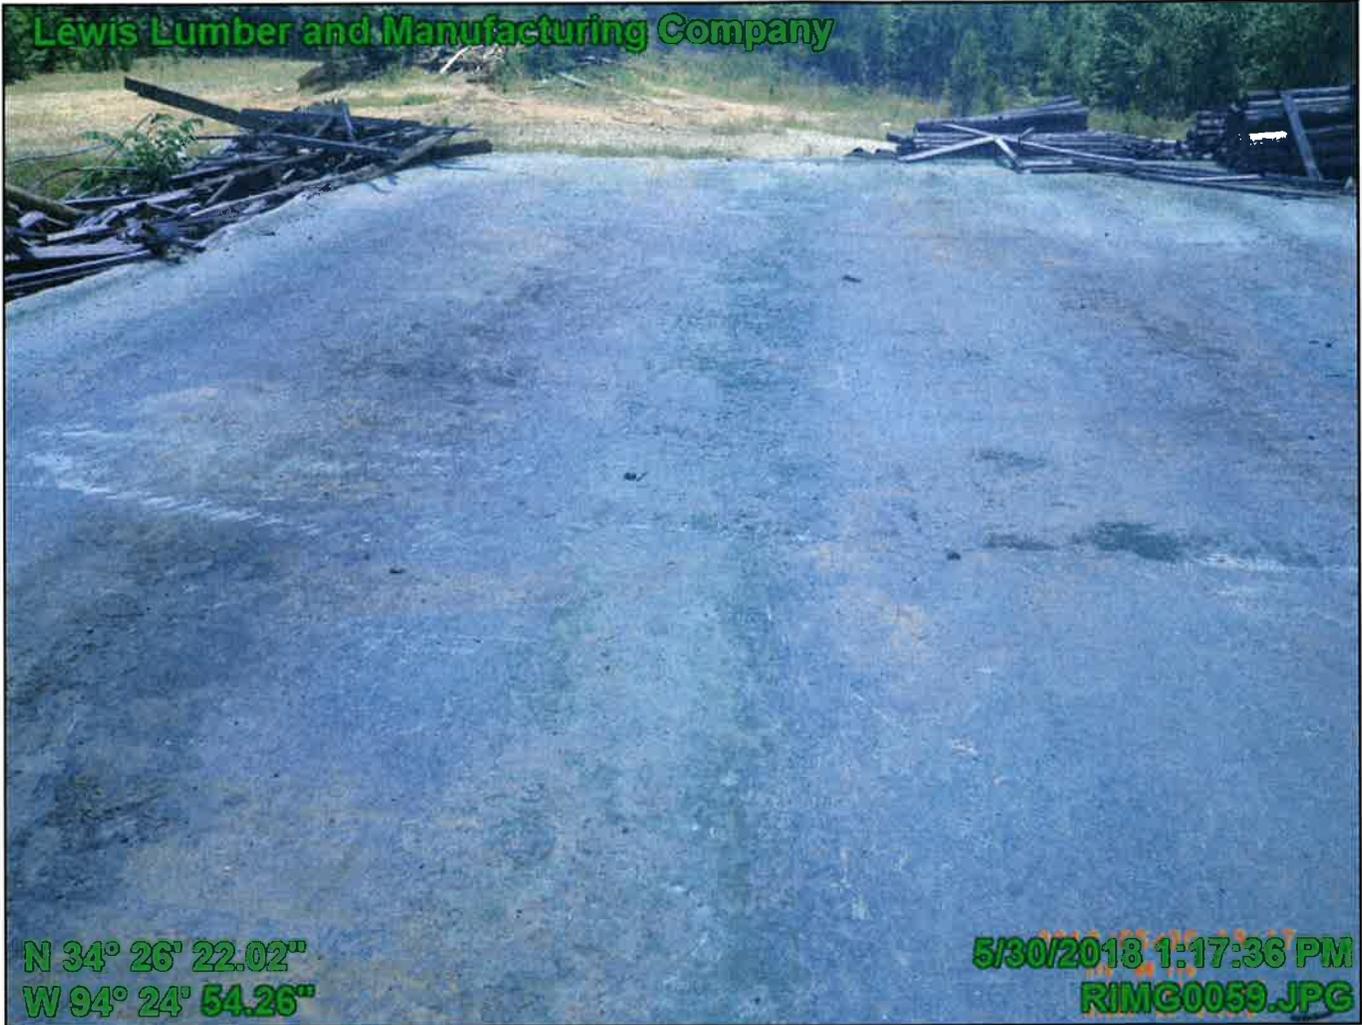
Attributes	
Photo Number	51
Facility	Lewis Lumber and Manufacturing Company
Event	Preliminary Assessment
AFIN	57-00020
Photographer	Joshua Graham <i>KK for JB</i>
Witness	Katie Kreps <i>KK</i>
Site Location	Cove, AR
Date/Time	5/30/2018 1:17:36 PM
Make	RICOH
Model	G700 SE
File Name	RIMG0059.JPG
Subject	Dense green staining on the south portion of the concrete drip pad
