**Re: Task Work Plan for Lewis Lumber and Manufacturing
136 W Mill Street
Cove, Polk County, Arkansas
EPA ID ARD006348353; AFIN 57-00020**

**TASK WORK PLAN
FOR
LEWIS LUMBER AND MANUFACTURING
EPA ID No. ARD006348353
COVE, POLK COUNTY, ARKANSAS**

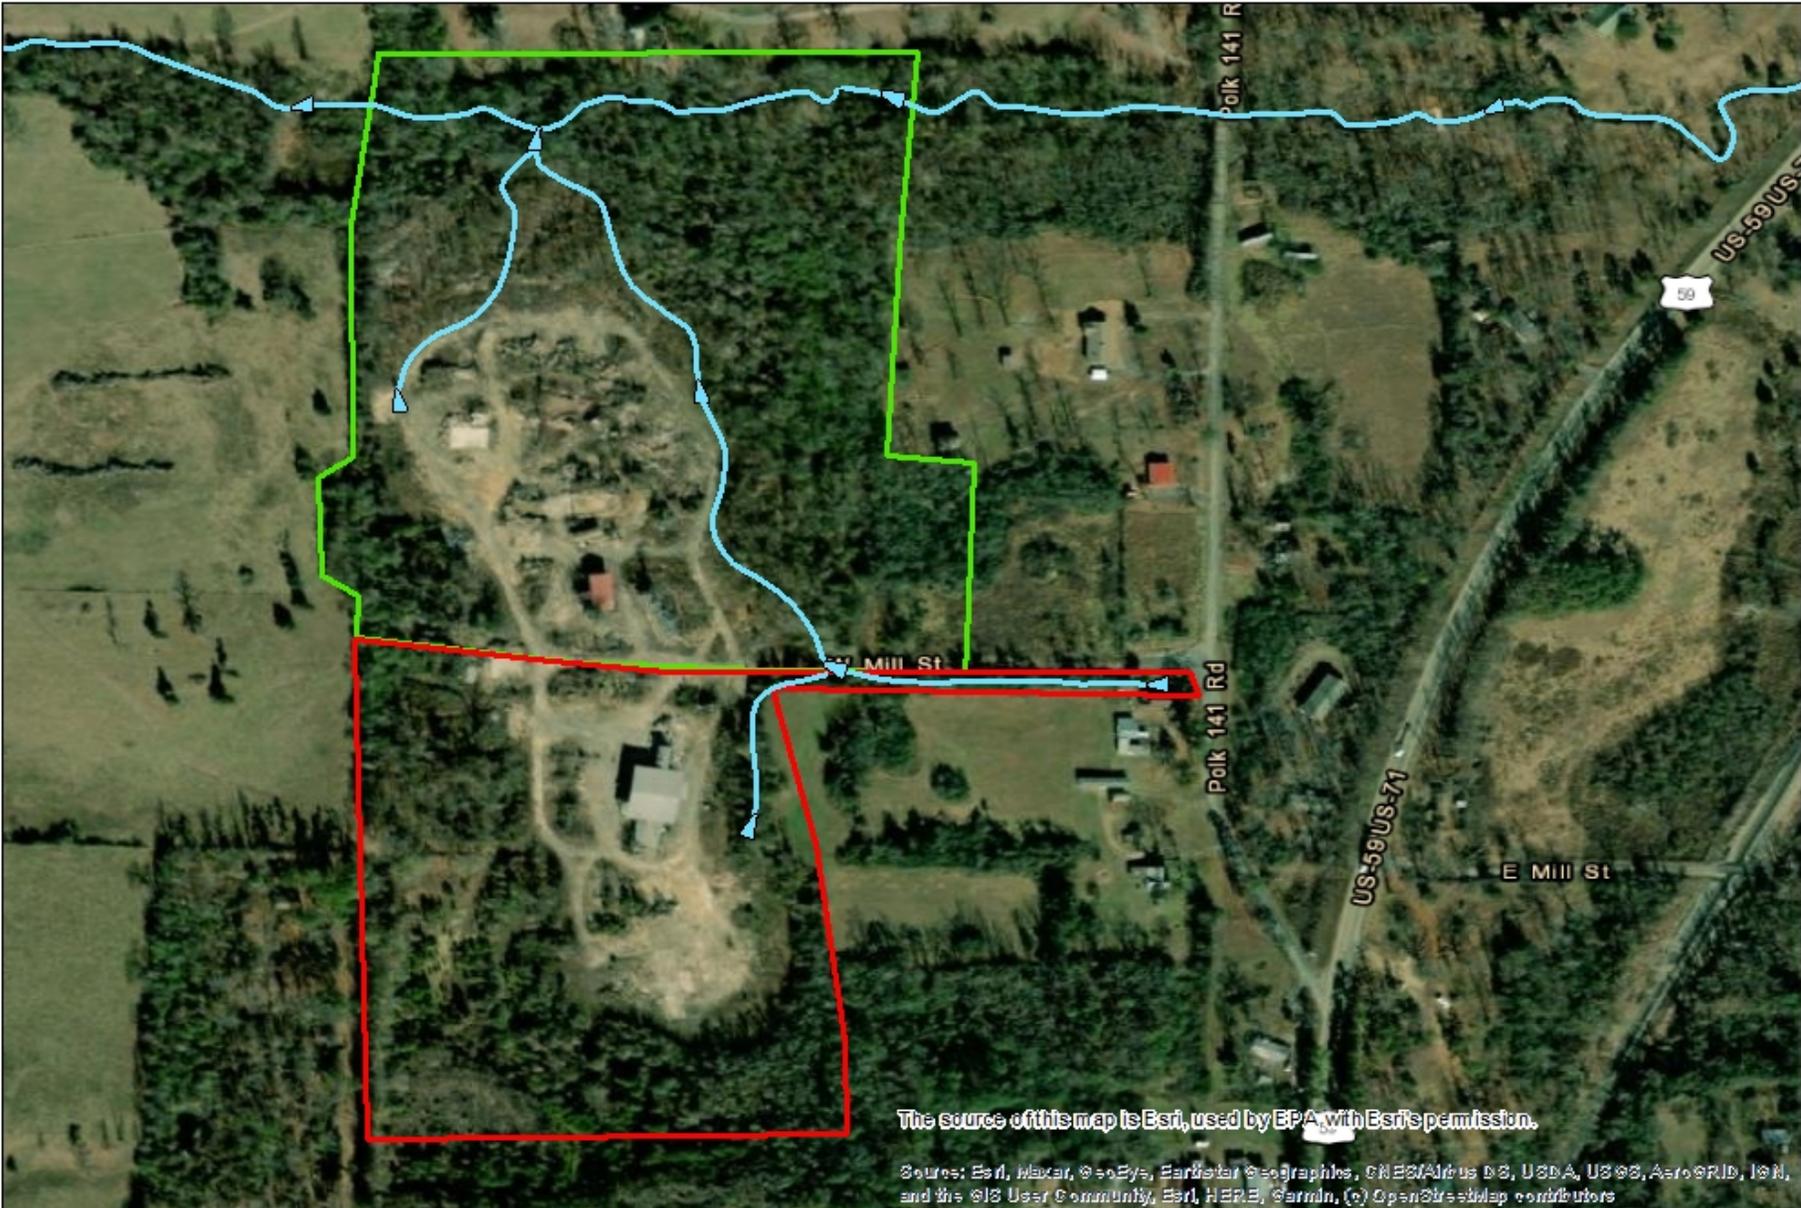
**Lewis Lumber
Areas of Concern
Figure 5-1**

- Legend:**
- AOC 1
 - AOC 2
 - / Site Drainage

A judgmental, or biased, sampling design was used to select the sampling locations. As noted in Section 2.2 of this TWP, the 2019 Lewis Lumber PA Report identified multiple potential sources or AOCs. The AOCs and associated sampling media considered in the sampling design are provided below and shown in **Figure 5-1**.
