Re: Street & Performance, Inc.
1 Hot Rod Lane, Mena, Polk County, Arkansas
Preliminary Assessment Report
EPA SEMS ID: ARR000006957; AFIN: 57-00259

The Arkansas Department of Environmental Quality Office of Land Resources (ADEQ) has completed the Preliminary Assessment (PA) for the Street & Performance, Inc. ("Street & Performance") site located in Mena, Polk County, Arkansas. Enclosed are one (1) hard copy and one (1) CD of the PA Report.

**PRELIMINARY ASSESSMENT
FOR
STREET & PERFORMANCE, INC.
EPA SEMS ID: ARR000006957
MENA, POLK COUNTY, ARKANSAS**

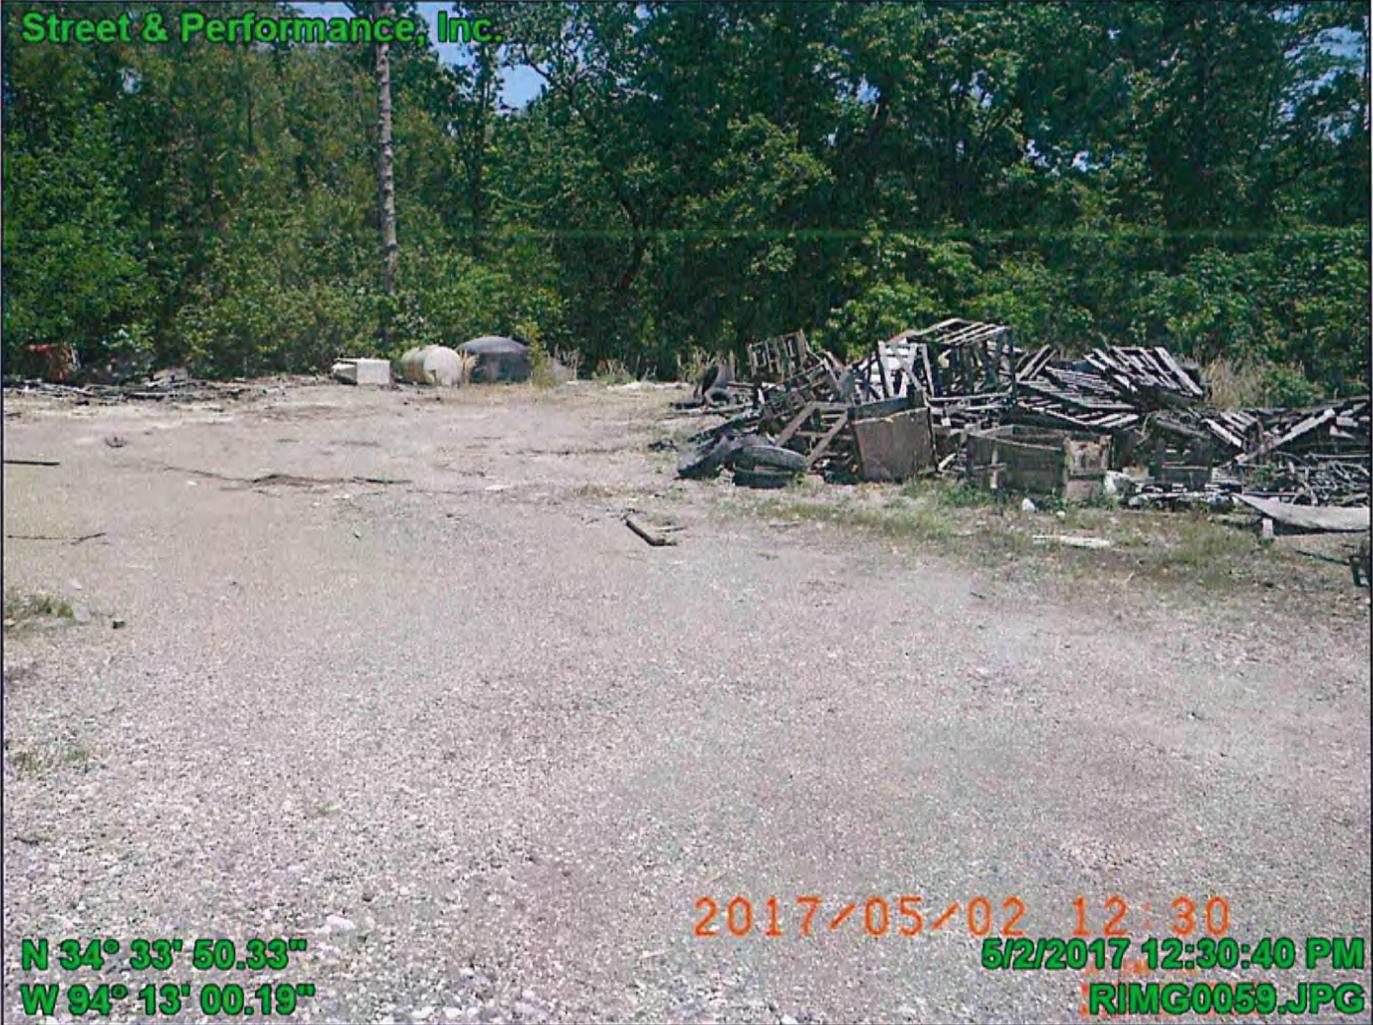
Attributes	
Facility	Street & Performance, Inc.
Event	Preliminary Assessment
AFIN	57-00259
Photo Number	2
Photographer	Joshua Graham <i>JG</i>
Witness	Carolyn Pollard <i>CP</i>
Site Location	Mena, Arkansas
Date Time Stamp	5/2/2017 12:08:13 PM
Make	RICOH
Model	G700 SE
File Name	RIMG0059.JPG
Subject	Wooded area east of the site, two (2) empty approximately 250-gallon plastic totes, and a debris pile containing wood pallets, tires, and lumber on the northeast portion of the site

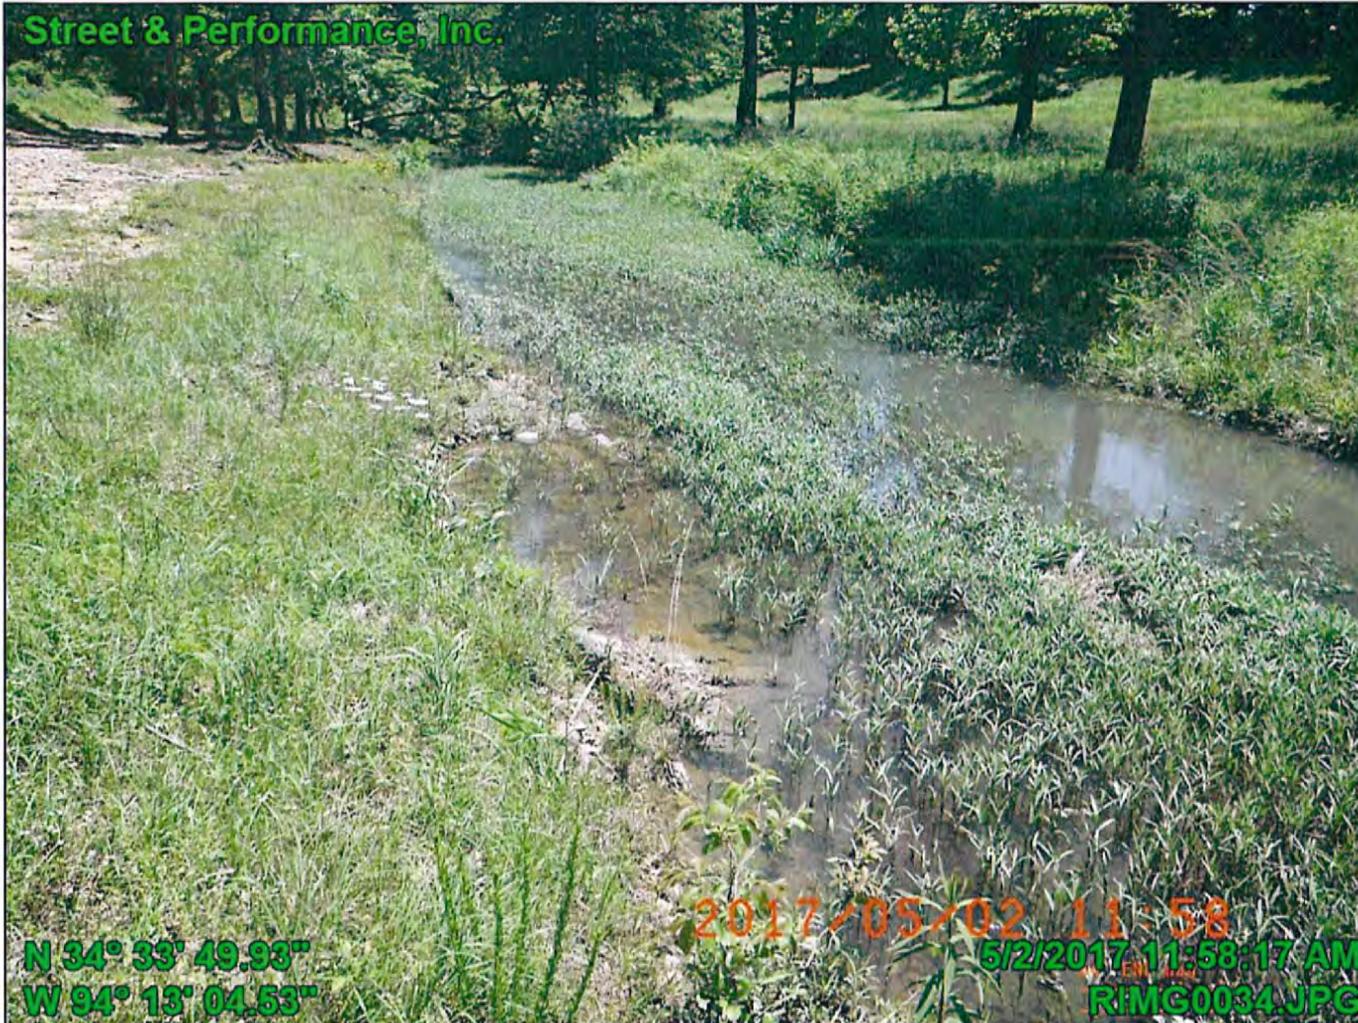
Surface water runoff at the Street & Performance site is considered moderate based on soil type and a few areas of standing water observed during site reconnaissance. Surface water runoff flows directly into Prairie Creek along the south site boundary, and into unnamed drainage that runs throughout the site eventually flowing into Prairie Creek. Prairie Creek flows east along the south site boundary, eventually reaching the Ouachita River approximately 3.8 miles northeast of the Street & Performance site. The 15-mile Target Distance Limit (TDL) is estimated to occur in the Ouachita River.

Attributes	
Facility	Street & Performance, Inc.
Event	Preliminary Assessment
AFIN	57-00259
Photo Number	3
Photographer	Joshua Graham <i>JG</i>
Witness	Carolyn Pollard <i>CP</i>
Site Location	Mena, Arkansas
Date Time Stamp	5/2/2017 12:11:31 PM
Make	RICOH
Model	G700 SE
File Name	RIMG0034.JPG
Subject	Prairie Creek south of the site

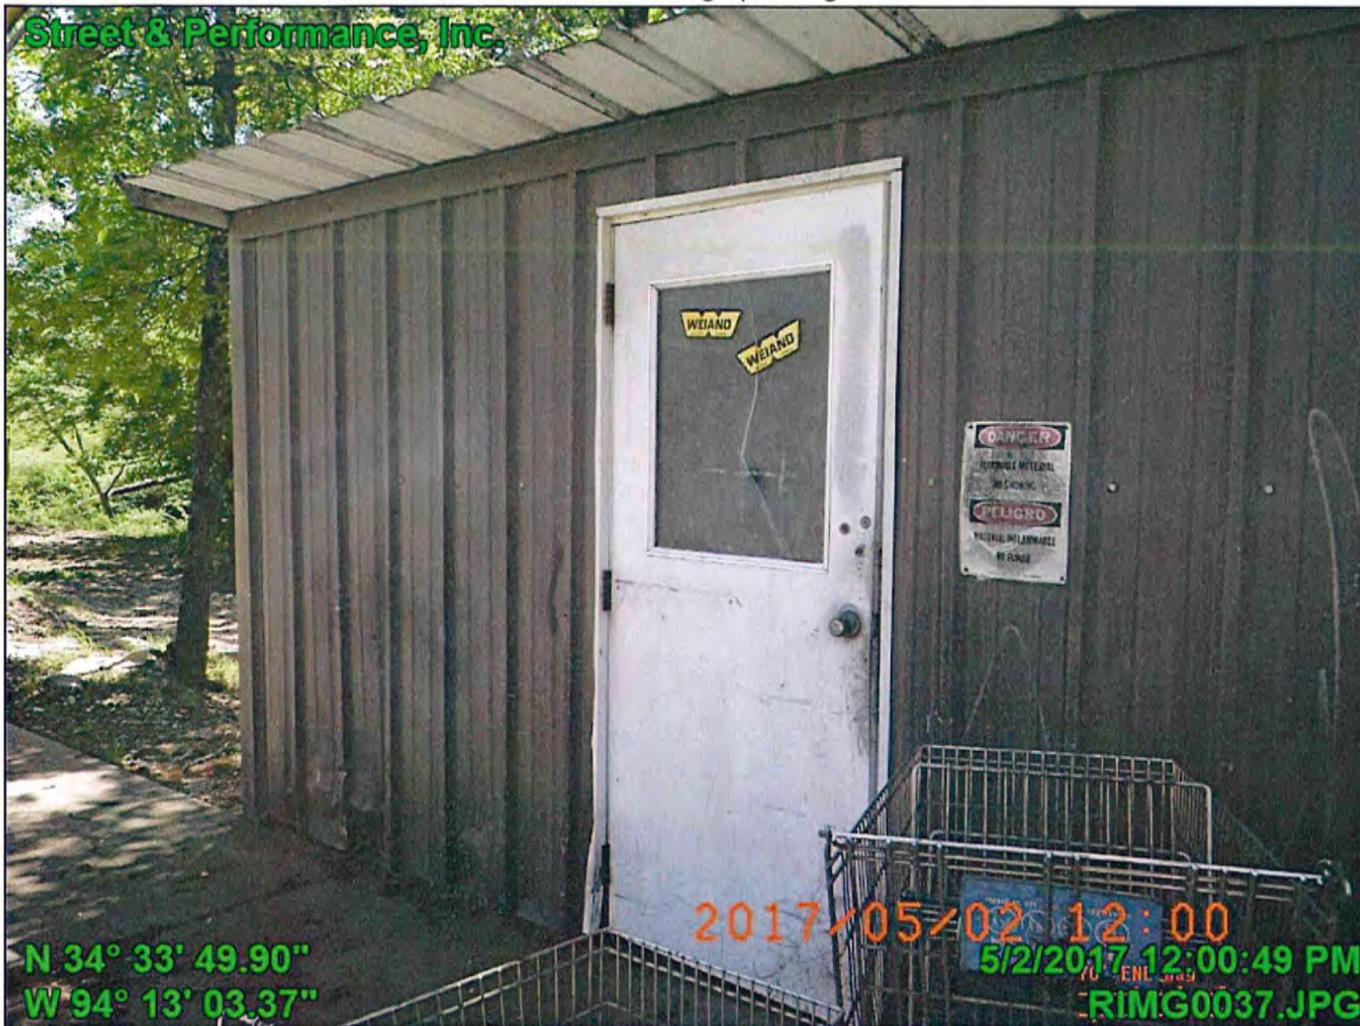
The Street & Performance site consists mostly of concrete, gravel, vegetated areas, and some areas of exposed soil. One (1) approximately 30,000 square foot metal-sided building ("South Building") and one (1) approximately 25,000 square foot metal-sided building ("North Building"), both with concrete foundations, are located on the site (Refer to Photographic Log, Photos 7–10). In addition, a small metal-sided shed is located on the south portion and a trailer is located on the northwest portion of the site (Refer to Photographic Log, Photos 11 and 12).

Attributes	
Facility	Street & Performance, Inc.
Event	Preliminary Assessment
AFIN	57-00259
Photo Number	11
Photographer	Joshua Graham <i>JG</i>
Witness	Carolyn Pollard <i>CP</i>
Site Location	Mena, Arkansas
Date Time Stamp	5/2/2017 12:26:05 PM
Make	RICOH
Model	G700 SE
File Name	RIMG0037.JPG
Subject	Small metal-sided shed on the south portion of the site

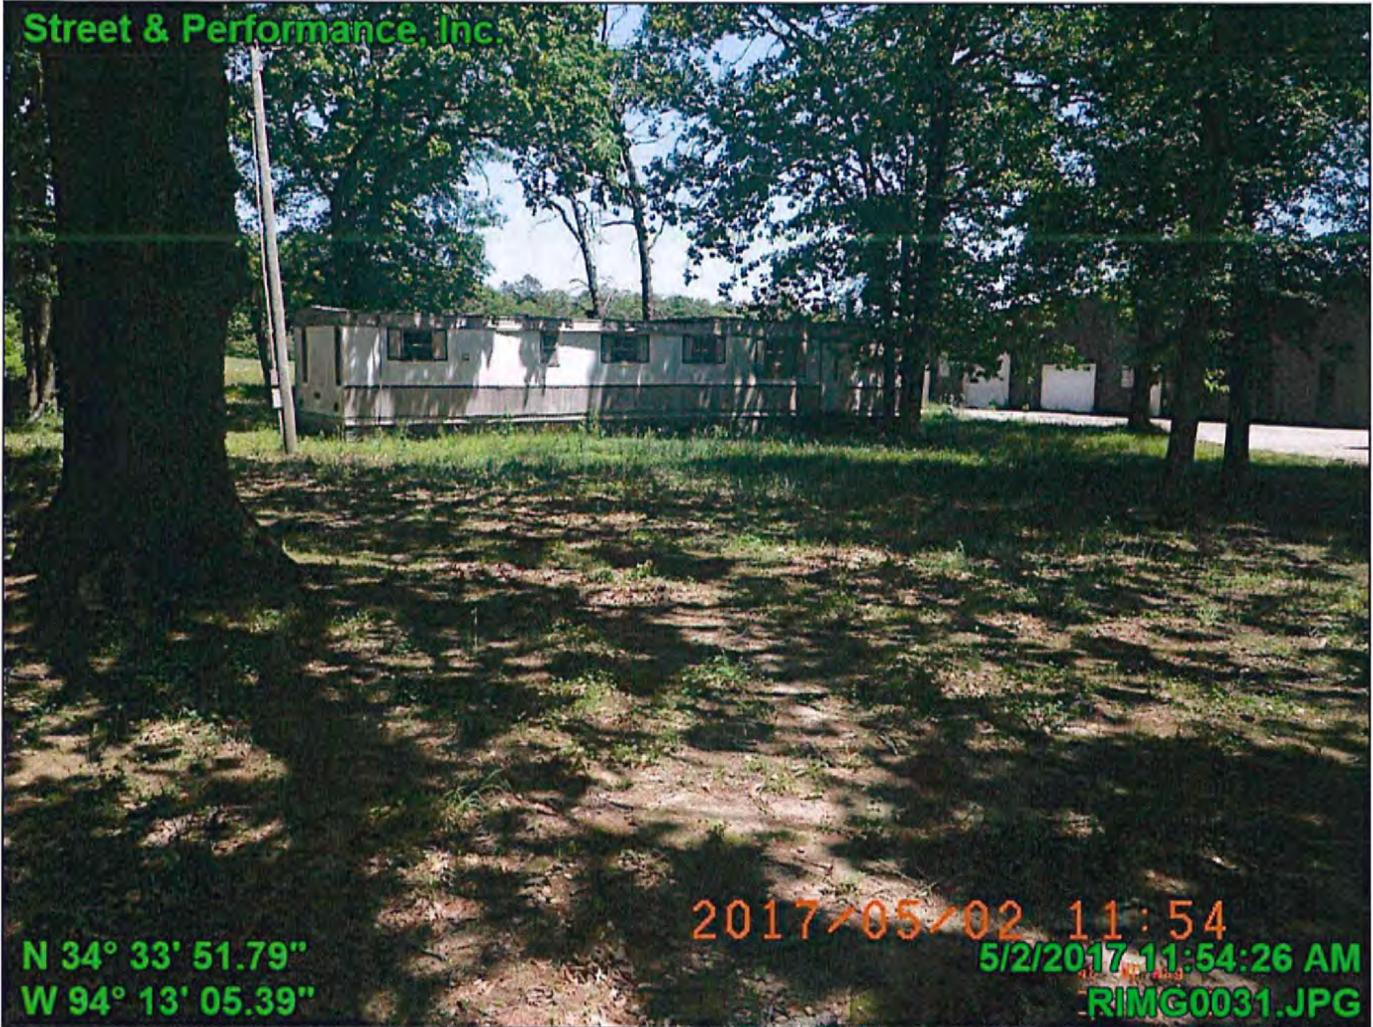
Attributes	
Facility	Street & Performance, Inc.
Event	Preliminary Assessment
AFIN	57-00259
Photo Number	12
Photographer	Joshua Graham
Witness	Carolyn Pollard <i>JG</i>
Site Location	Mena, Arkansas
Date Time Stamp	5/2/2017 12:27:34 PM
Make	RICOH
Model	G700 SE
File Name	RIMG0031.JPG
Subject	Trailer on the northwest portion of the site

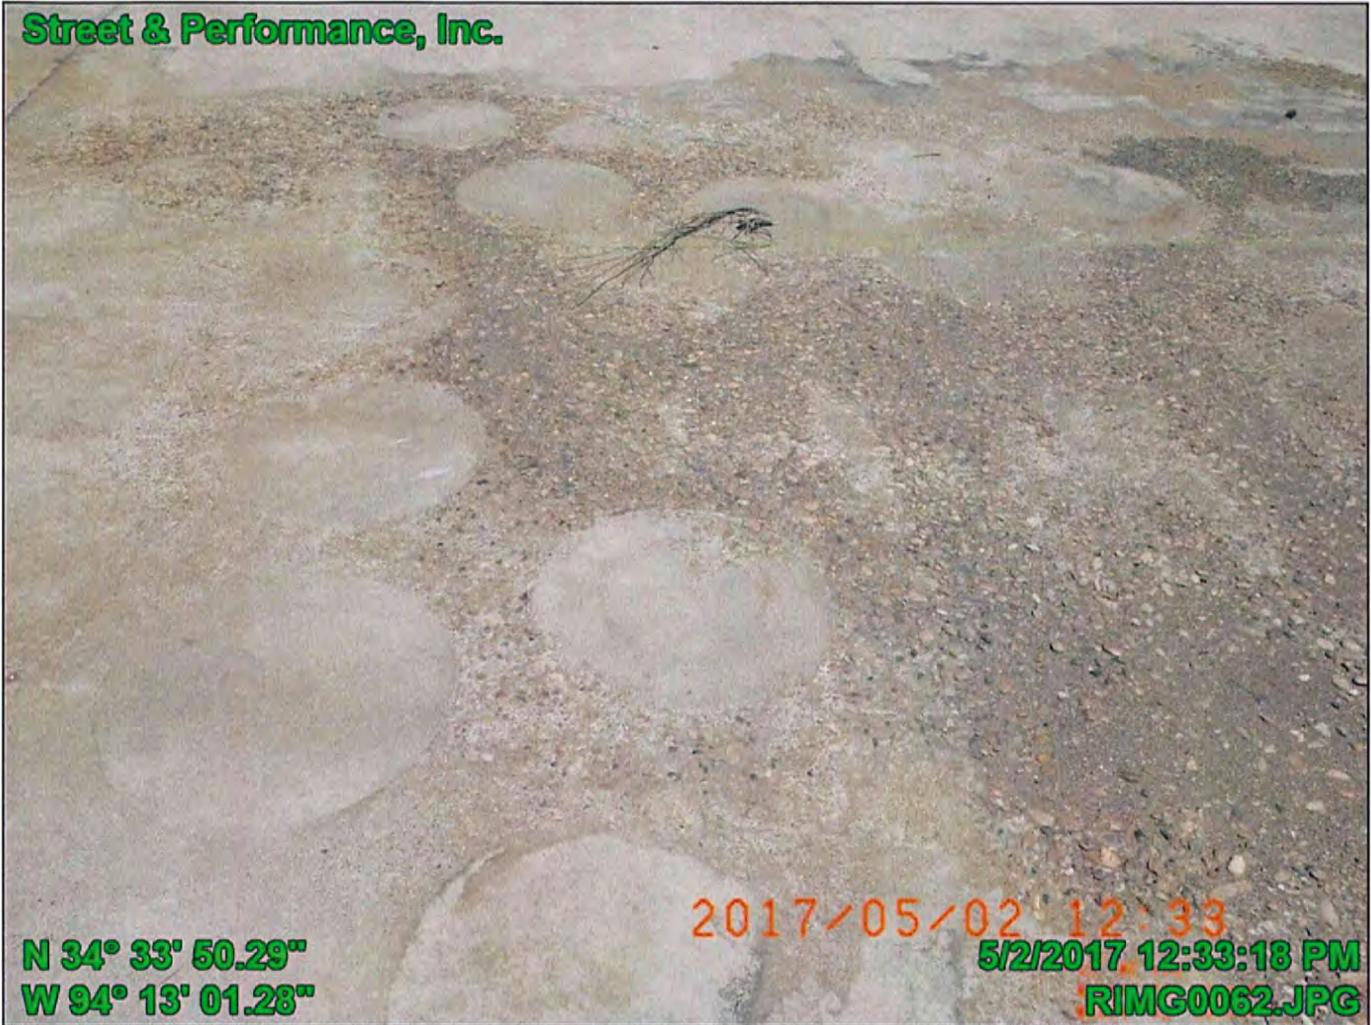
Building. In addition, an approximately 2,000 square foot concrete area formerly used for storage of 55-gallon drums (“Concrete Storage Area”) is located on the east portion between these two (2) buildings. During site reconnaissance, the Concrete Storage Area had staining in the shape of rings indicative of former 55-gallon drums (Refer to Photographic Log, Photo 13).

Attributes	
Facility	Street & Performance, Inc.
Event	Preliminary Assessment
AFIN	57-00259
Photo Number	13
Photographer	Joshua Graham <i>JG</i>
Witness	Carolyn Pollard <i>CP</i>
Site Location	Mena, Arkansas
Date Time Stamp	5/2/2017 12:30:40 PM
Make	RICOH
Model	G700 SE
File Name	RIMG0062.JPG
Subject	Staining in the shape of rings on the Concrete Storage Area on the east portion between the two (2) buildings

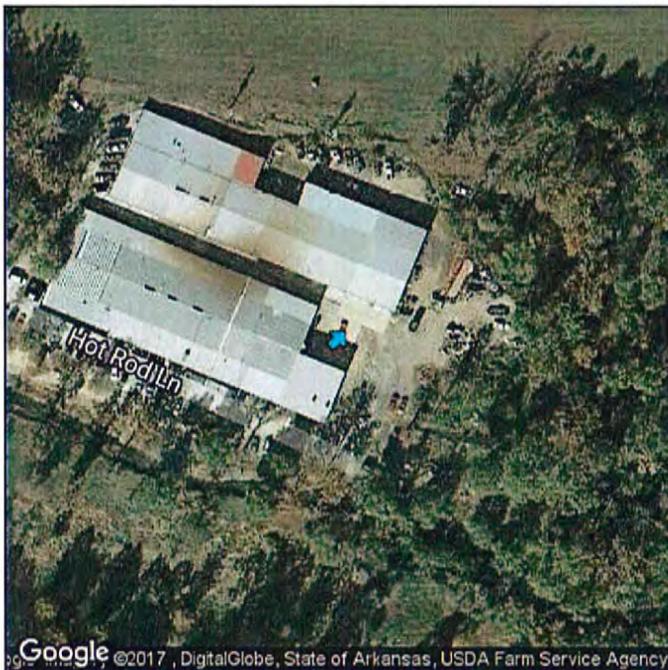
- Staining in the shape of rings on the Concrete Storage Area indicative of former 55-gallon drums;
- Multiple areas of disturbed soil and gravel located throughout the site, primarily on the east portion;

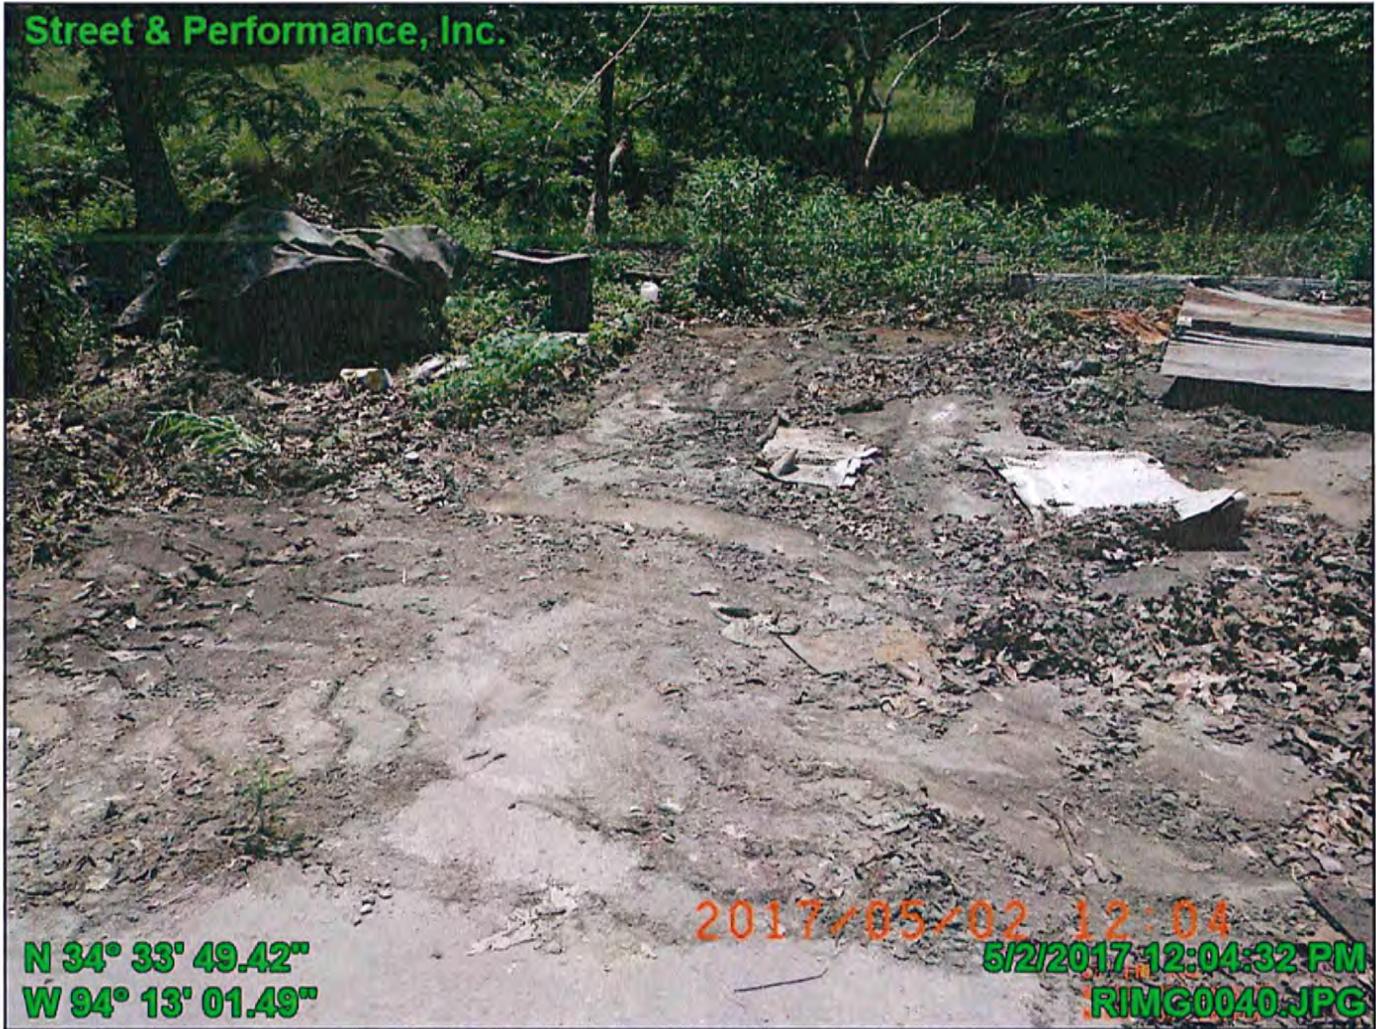
During site reconnaissance, multiple areas of disturbed soil and gravel, and debris including scrap metal, wood pallets, lumber, and tires were located throughout the site, primarily on the east portion (Refer to Photographic Log, Photos 14–16). A burn pile was located in a vegetated area on the east portion of the site (Refer to Photographic Log, Photo 17). Two (2) empty approximately 250-gallon plastic totes were located on the northeast portion of the site. The former contents of these totes are unknown. An approximately six (6) inch diameter plastic pipe extending underground is located on the northeast portion of the site (Refer to Photographic Log, Photo 18). The purpose of this pipe could not be determined during this PA investigation. Multiple smaller plastic and metal pipes are extending from the northeast portion of the North Building, and are presumed to be for air conditioning purposes (Refer to Photographic Log, Photo 19).

Attributes	
Facility	Street & Performance, Inc.
Event	Preliminary Assessment
AFIN	57-00259
Photo Number	14
Photographer	Joshua Graham
Witness	Carolyn Pollard <i>CP</i>
Site Location	Mena, Arkansas
Date Time Stamp	5/2/2017 12:33:18 PM
Make	RICOH
Model	G700 SE
File Name	RIMG0040.JPG
Subject	Disturbed soil and scrap metal debris on the southeast portion of the site

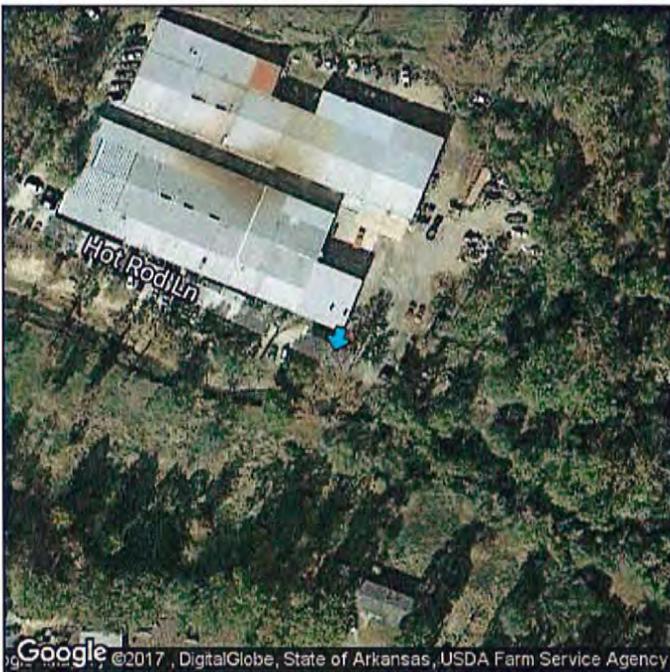
- Debris including scrap metal, wood pallets, lumber, and tires located throughout the site, primarily on the east portion;
- The burn pile located in a vegetated area on the east portion of the site;

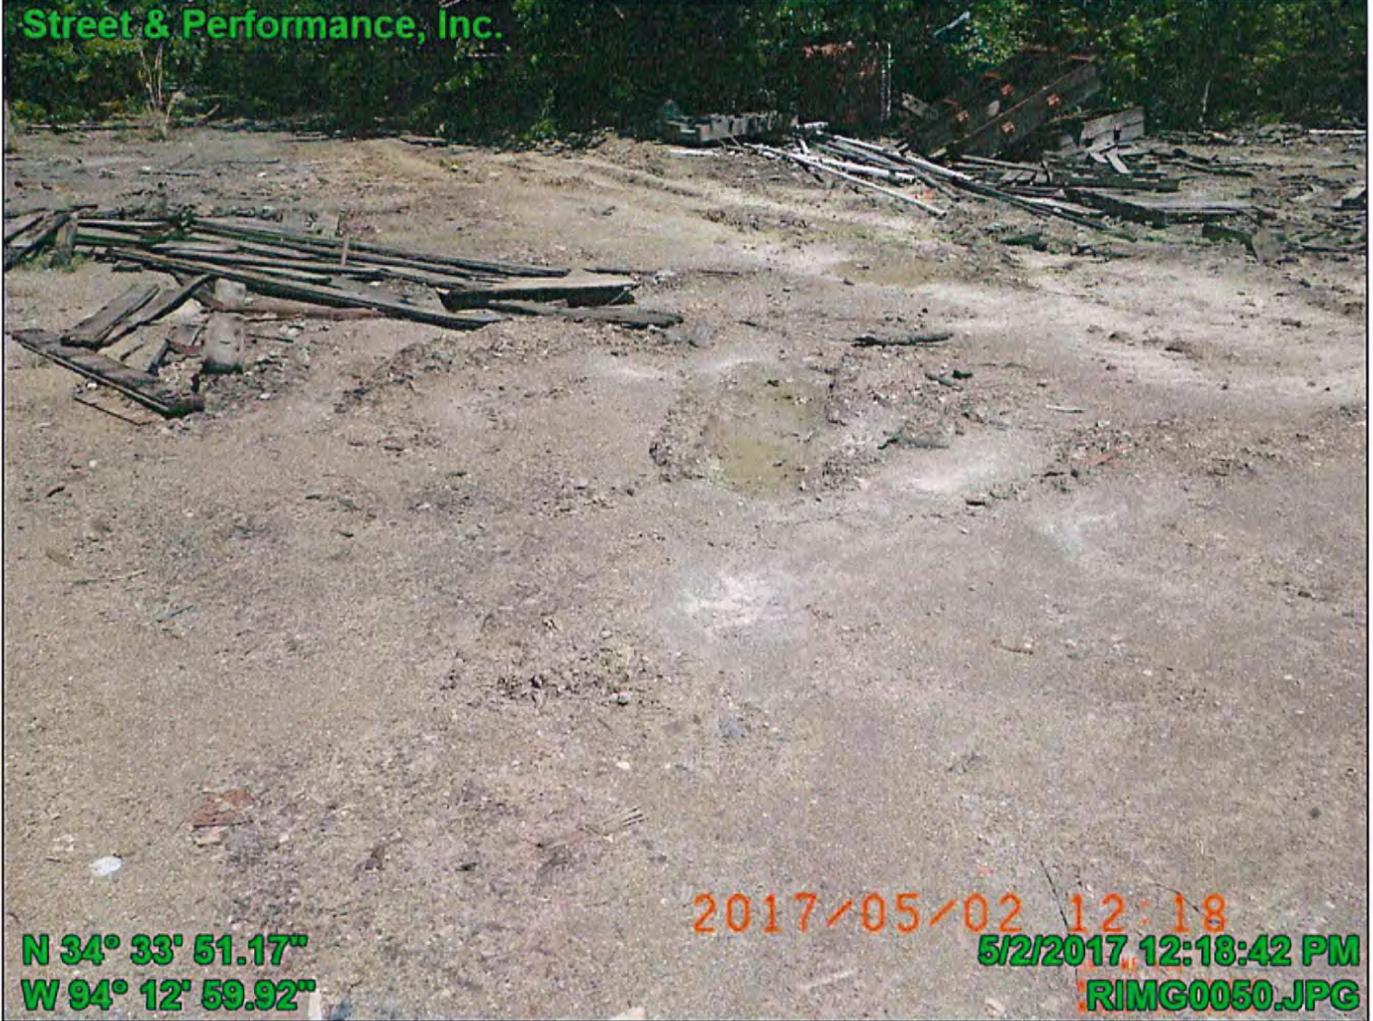
Attributes	
Facility	Street & Performance, Inc.
Event	Preliminary Assessment
AFIN	57-00259
Photo Number	15
Photographer	Joshua Graham <i>JG</i>
Witness	Carolyn Pollard <i>CP</i>
Site Location	Mena, Arkansas
Date Time Stamp	5/2/2017 12:38:40 PM
Make	RICOH
Model	G700 SE
File Name	RIMG0050.JPG
Subject	Disturbed soil and gravel and debris including wood pallets and lumber on the northeast portion of the site

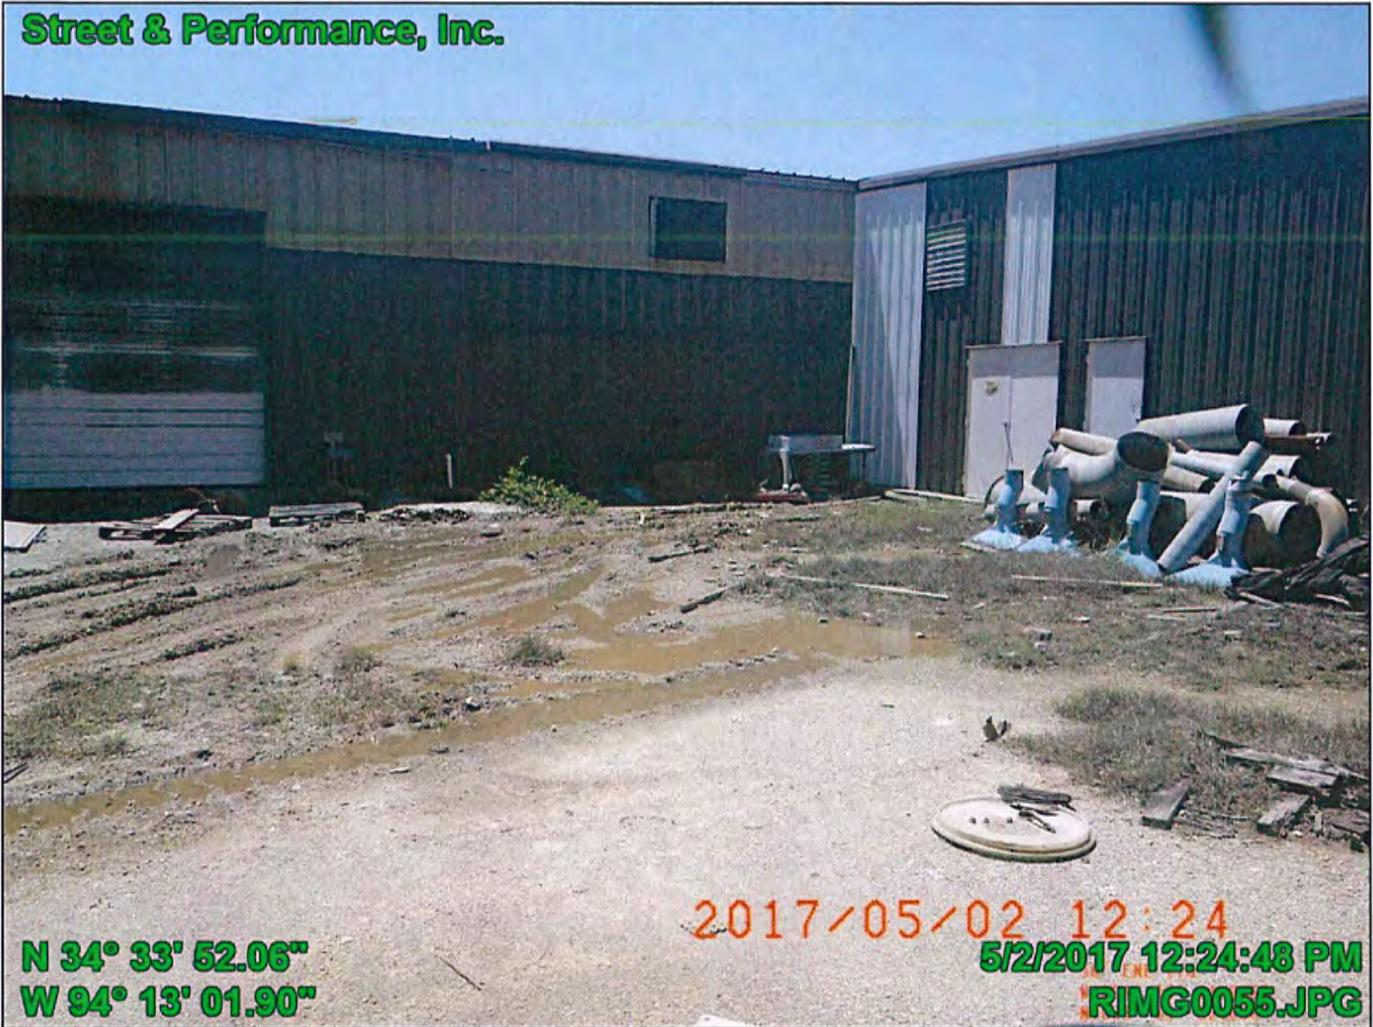
Attributes	
Facility	Street & Performance, Inc.
Event	Preliminary Assessment
AFIN	57-00259
Photo Number	16
Photographer	Joshua Graham
Witness	Carolyn Pollard <i>[Signature]</i>
Site Location	Mena, Arkansas
Date Time Stamp	5/2/2017 12:47:50 PM
Make	RICOH
Model	G700 SE
File Name	RIMG0055.JPG
Subject	Disturbed gravel and debris including scrap metal, lumber, and pallets on the north portion of the site

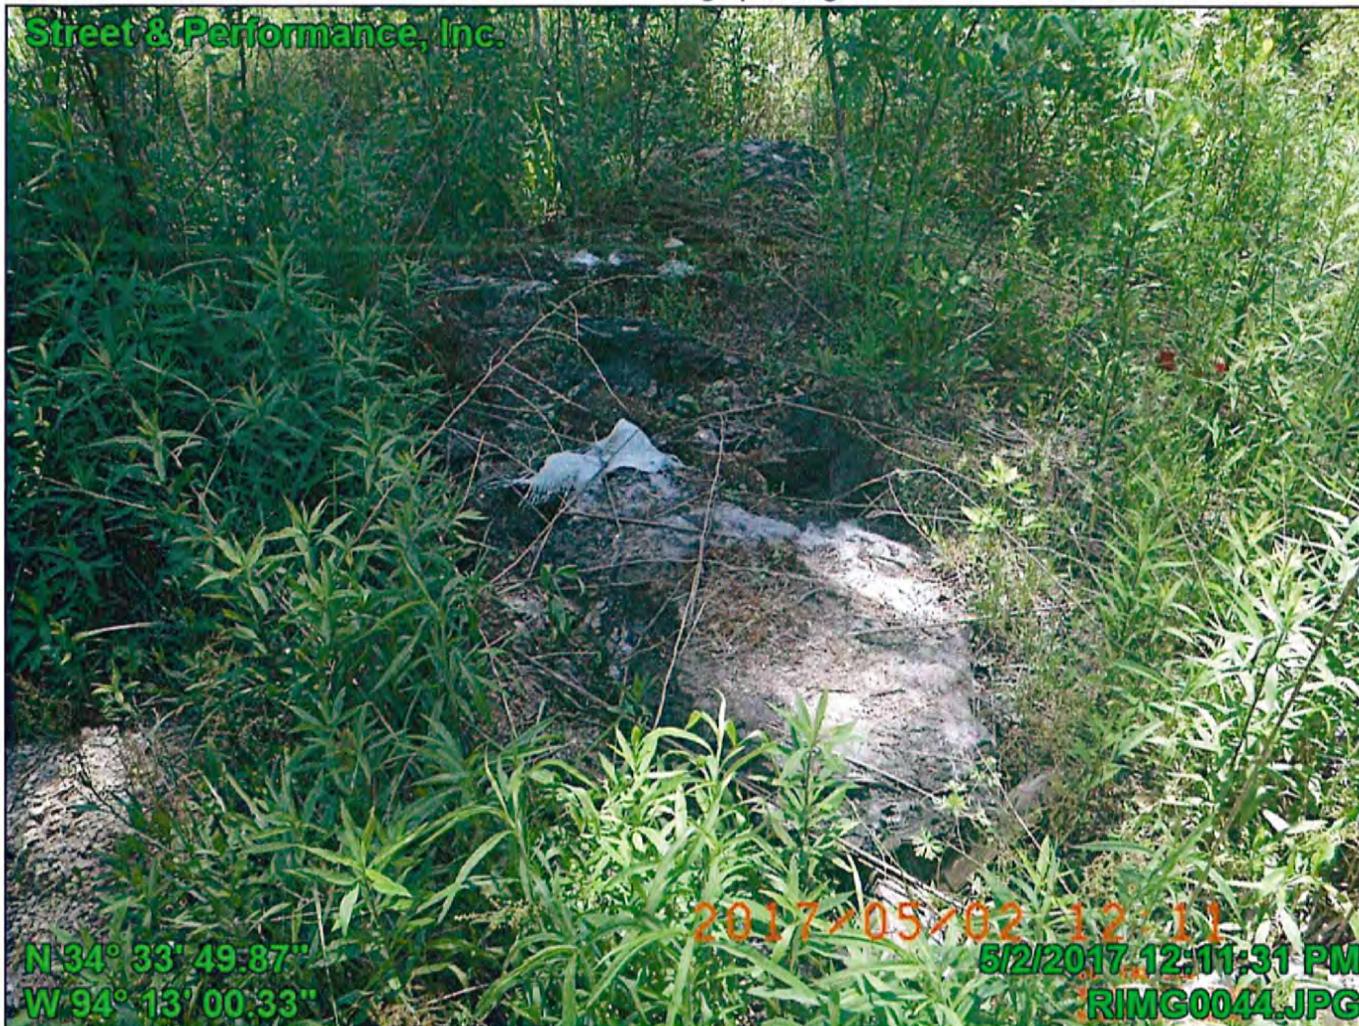
- The CAO (LIS 08-040) entered on June 9, 2008, regarding numerous hazardous waste management violations;
- Violations in 2009 regarding an Industrial Stormwater Permit that was needed for the site and a pile of waste sand and a burn pile that needed to be removed from the site and properly disposed;

Site Location	Mena, Arkansas
Date Time Stamp	5/2/2017 11:52:17 AM
Make	RICOH
Model	G700 SE
File Name	RIMG0044.JPG
Subject	Burn pile in a vegetated area on the east portion of the site

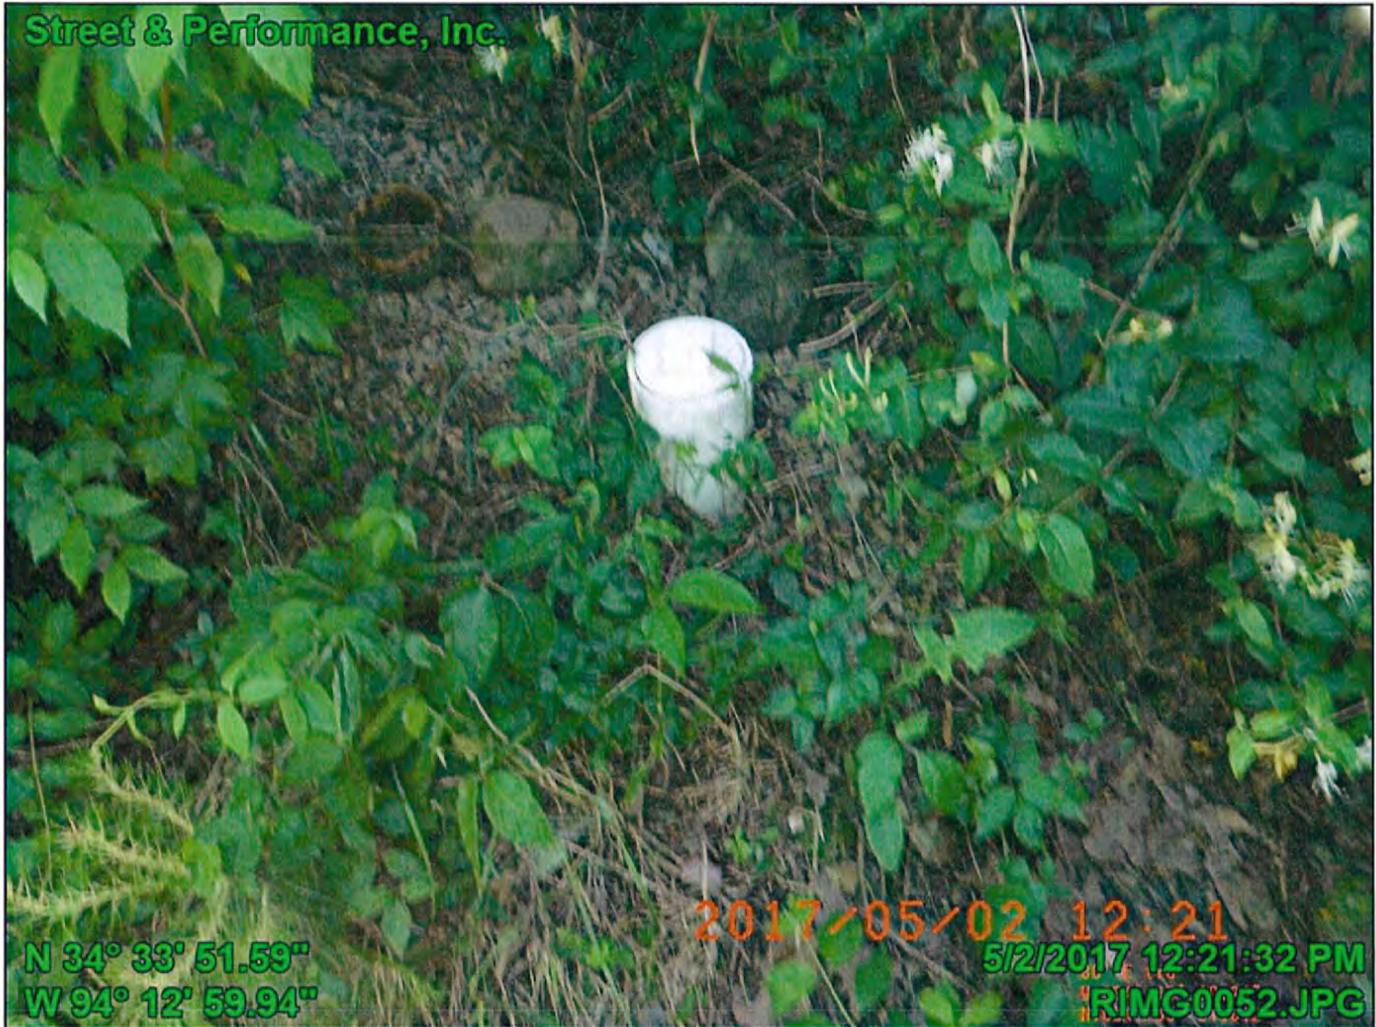
Attributes	
Facility	Street & Performance, Inc.
Event	Preliminary Assessment
AFIN	57-00259
Photo Number	18
Photographer	Joshua Graham <i>JG</i>
Witness	Carolyn Pollard <i>CP</i>
Site Location	Mena, Arkansas
Date Time Stamp	5/2/2017 11:53:06 AM
Make	RICOH
Model	G700 SE
File Name	RIMG0052.JPG
Subject	Approximately six (6) inch diameter plastic pipe extending underground on the northeast portion of the site

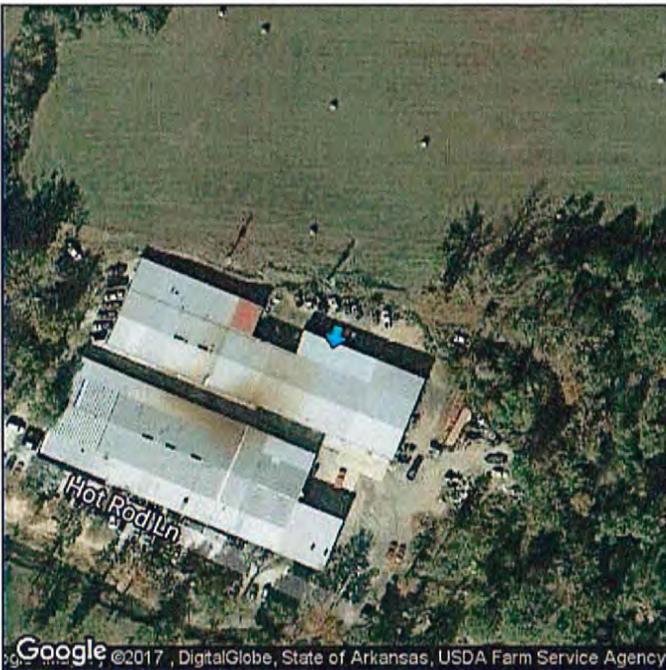
Site Location	Mena, Arkansas
Date Time Stamp	5/2/2017 11:53:33 AM
Make	RICOH
Model	G700 SE
File Name	RIMG0058.JPG
Subject	Small plastic and metal pipes extending from the northeast portion of the North Building

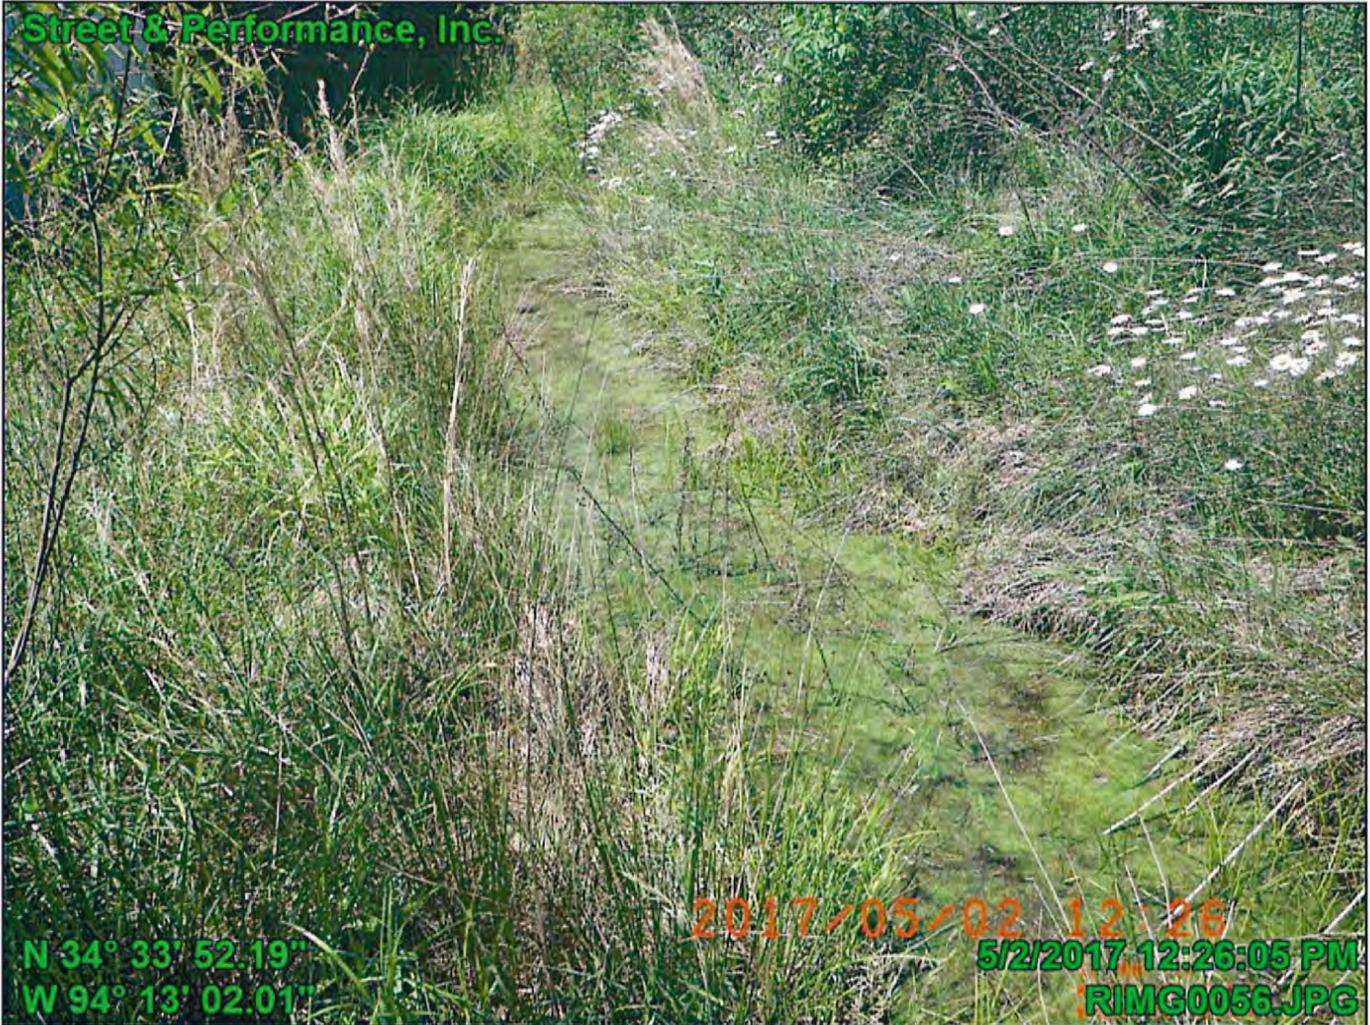
Attributes	
Facility	Street & Performance, Inc.
Event	Preliminary Assessment
AFIN	57-00259
Photo Number	21
Photographer	Joshua Graham <i>JG</i>
Witness	Carolyn Pollard <i>CP</i>
Site Location	Mena, Arkansas
Date Time Stamp	5/2/2017 11:55:41 AM
Make	RICOH
Model	G700 SE
File Name	RIMG0056.JPG
Subject	Drainage on the north portion of the site
