LUST Site Corrective Action in Ozark Karst - Yellville, Arkansas

ASTSWMO Mid-Year Meeting
North Little Rock, Arkansas
April 23, 2015

Mikel R. Shinn, P.G.
Professional Geologist
- Regulated Storage
Tanks Division

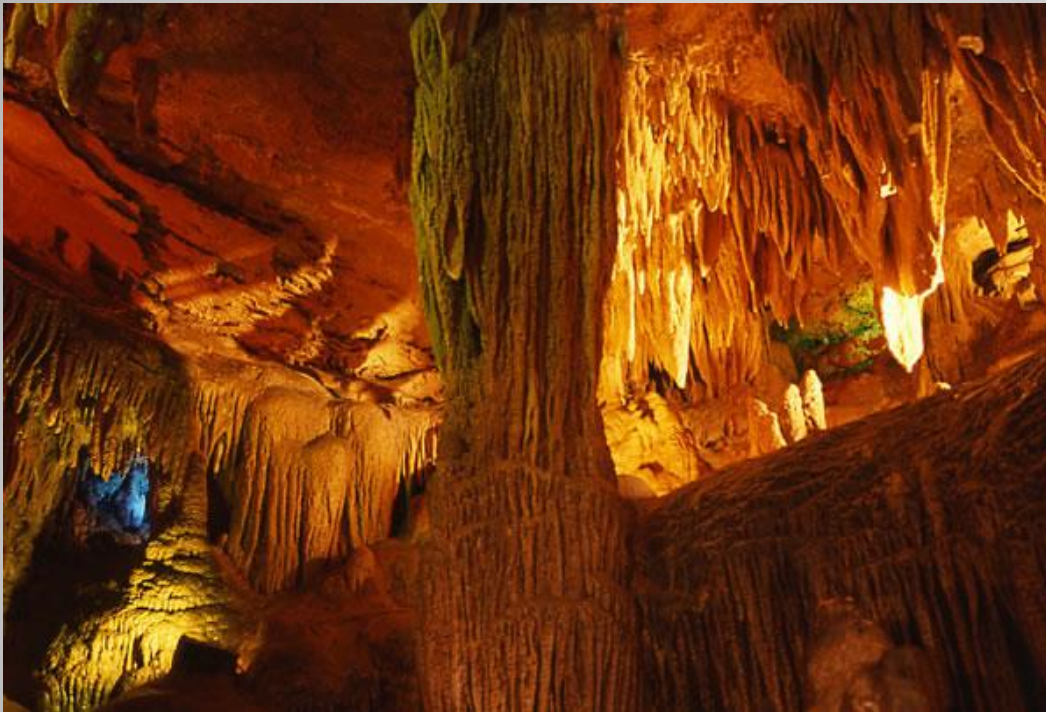
Bull Shoals Caverns
– developed in
Lower Ordovician
dolomite, 12 miles
north of Yellville, AR

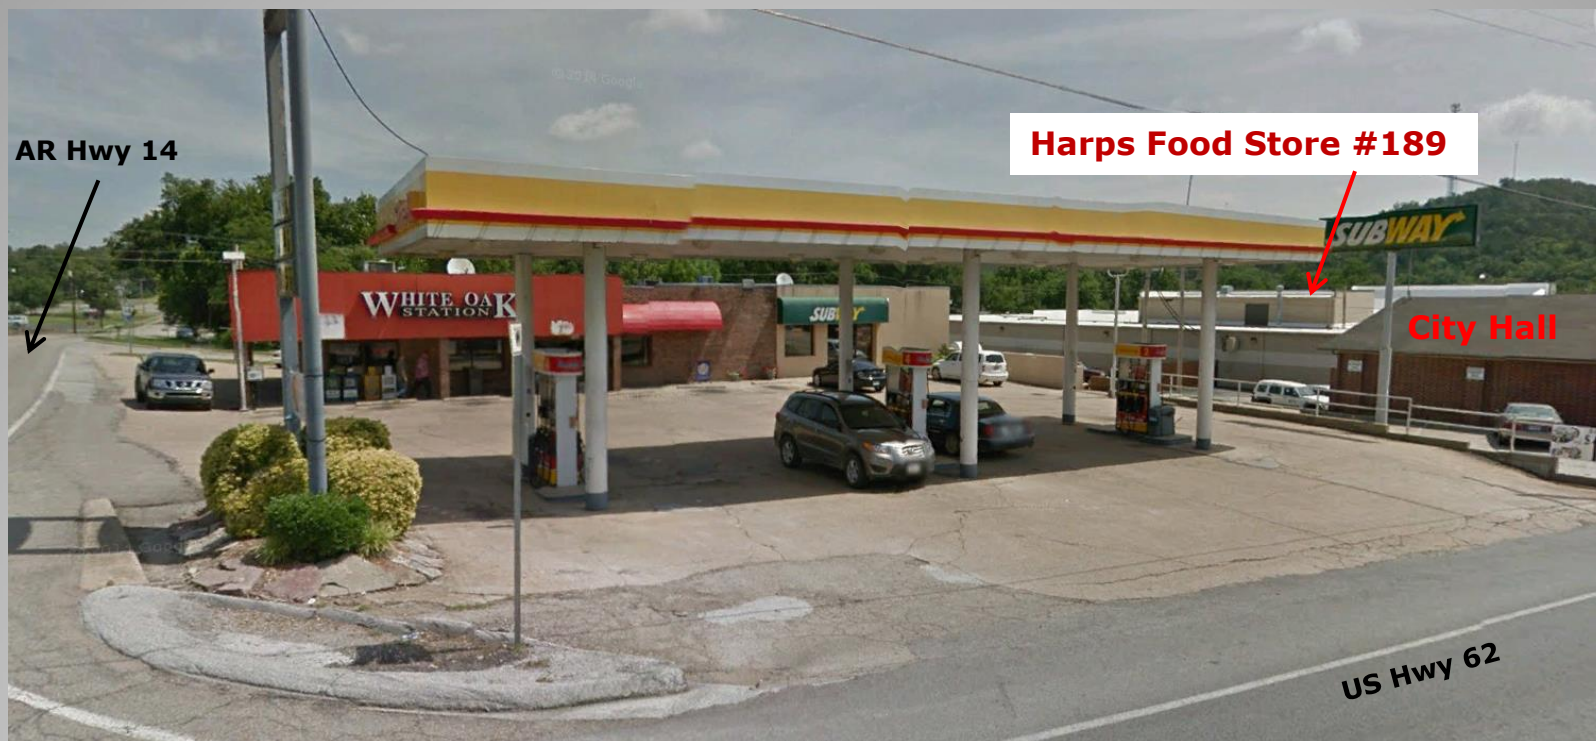
White Oak Station #3
102 East US Highway 62 - Yellville, Arkansas
ADEQ RST Division Facility ID #45001606
View to northeast at intersection of US Highway 62 and
Arkansas Highway 14

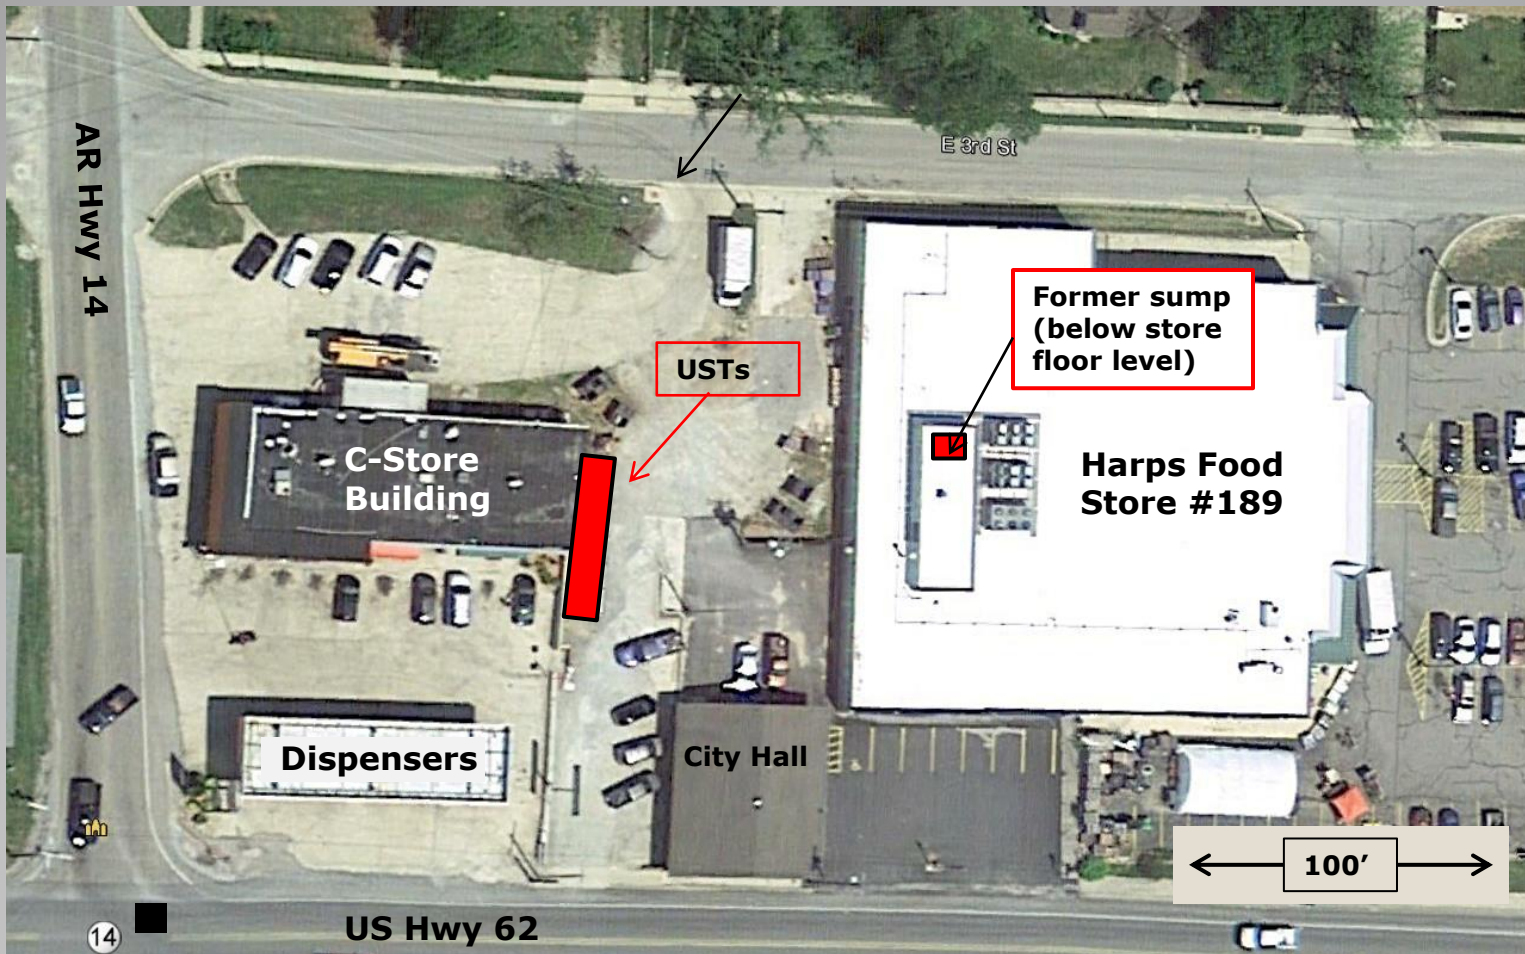
Aerial Photo of White Oak #3 LUST site and adjoining properties, May 2014

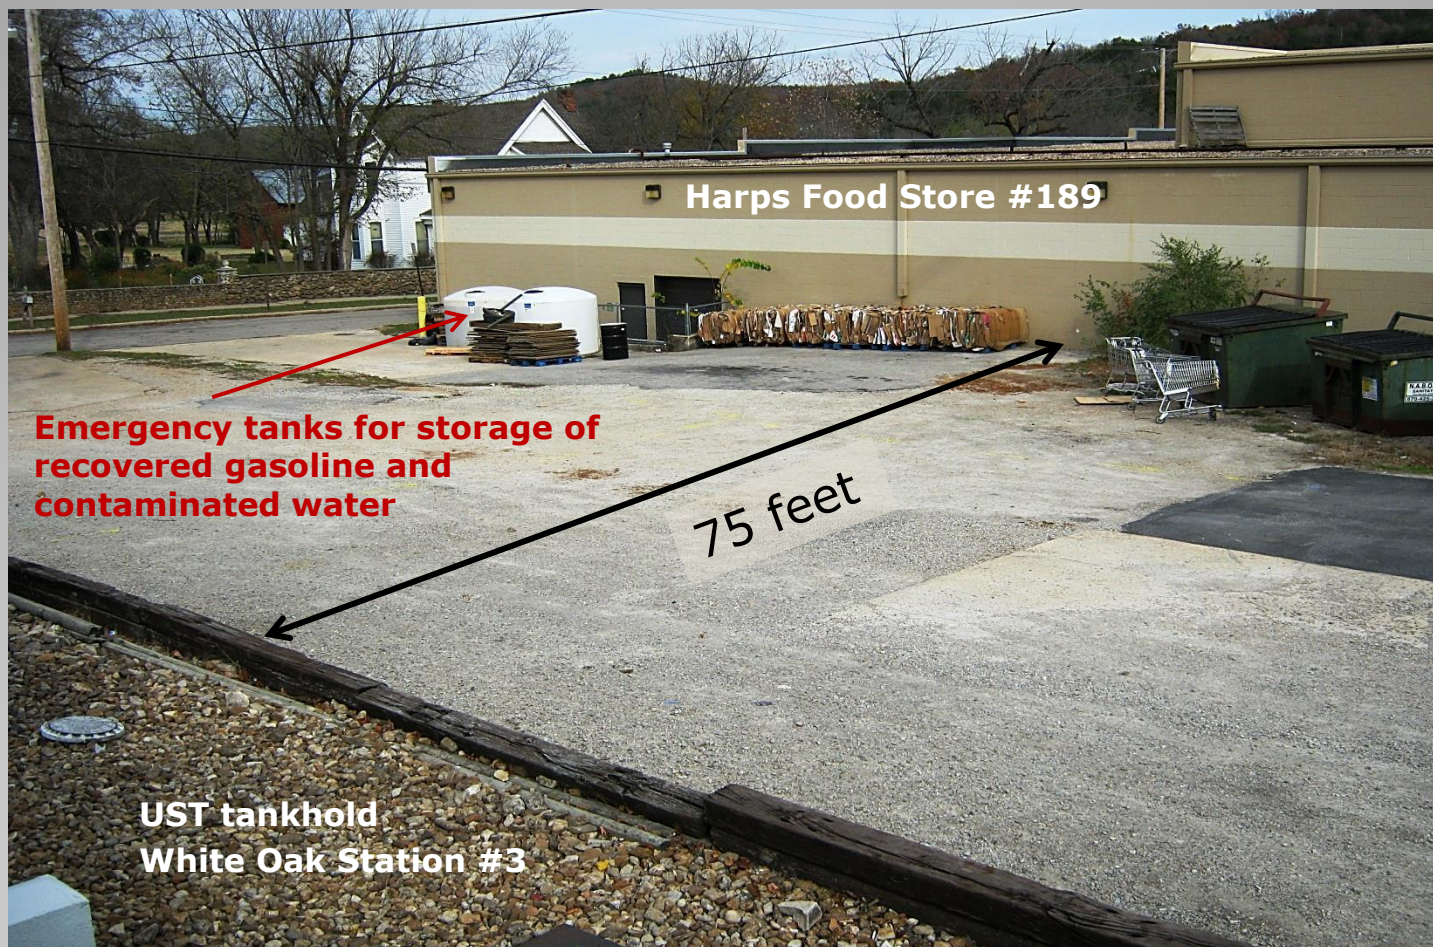
Rear of Harps Food Store #189 from UST tankhold at White Oak #3, November 13, 2011, during emergency response.

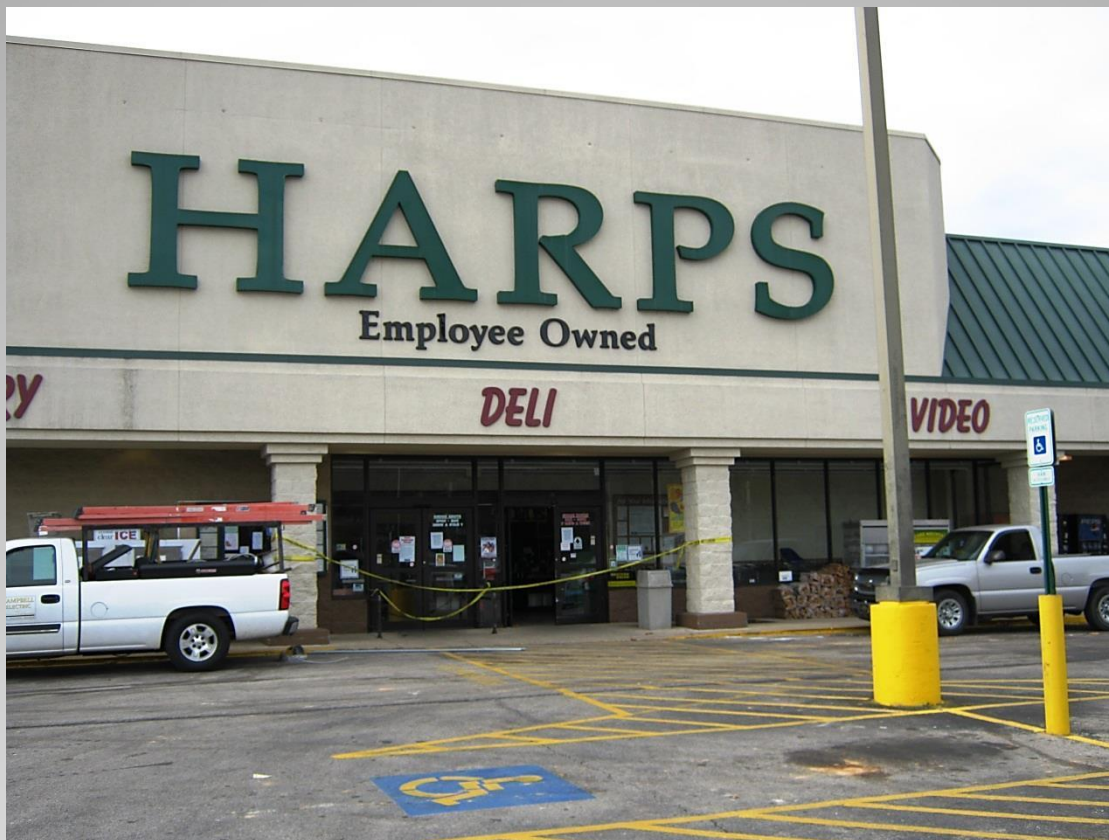
Harps Food Store #189 – November 13, 2011 - Store had been closed by Yellville Fire Department on November 8th, after acute gasoline vapor impact.

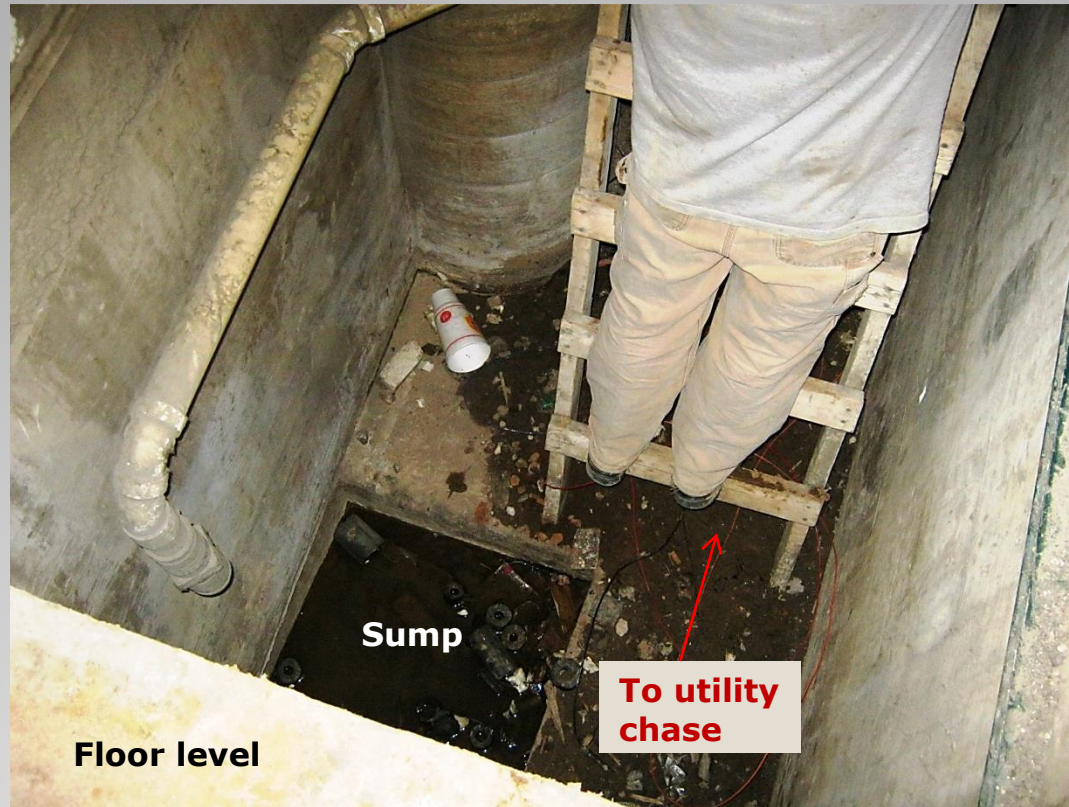
Ground water sump at base of access shaft, inside Harps #189, November 13, 2011. On afternoon of November 8th, following a heavy rainfall event, sump had filled with free product gasoline and contaminated ground water, with ensuing vapor impact throughout the grocery.

LUST response by Harps Food Stores and contractors:
2) On 11/14/11, Harps plugged the ground water sump and adjacent utility chase with approximately 90 yards of concrete, effectively eliminating the acute vapor impact.

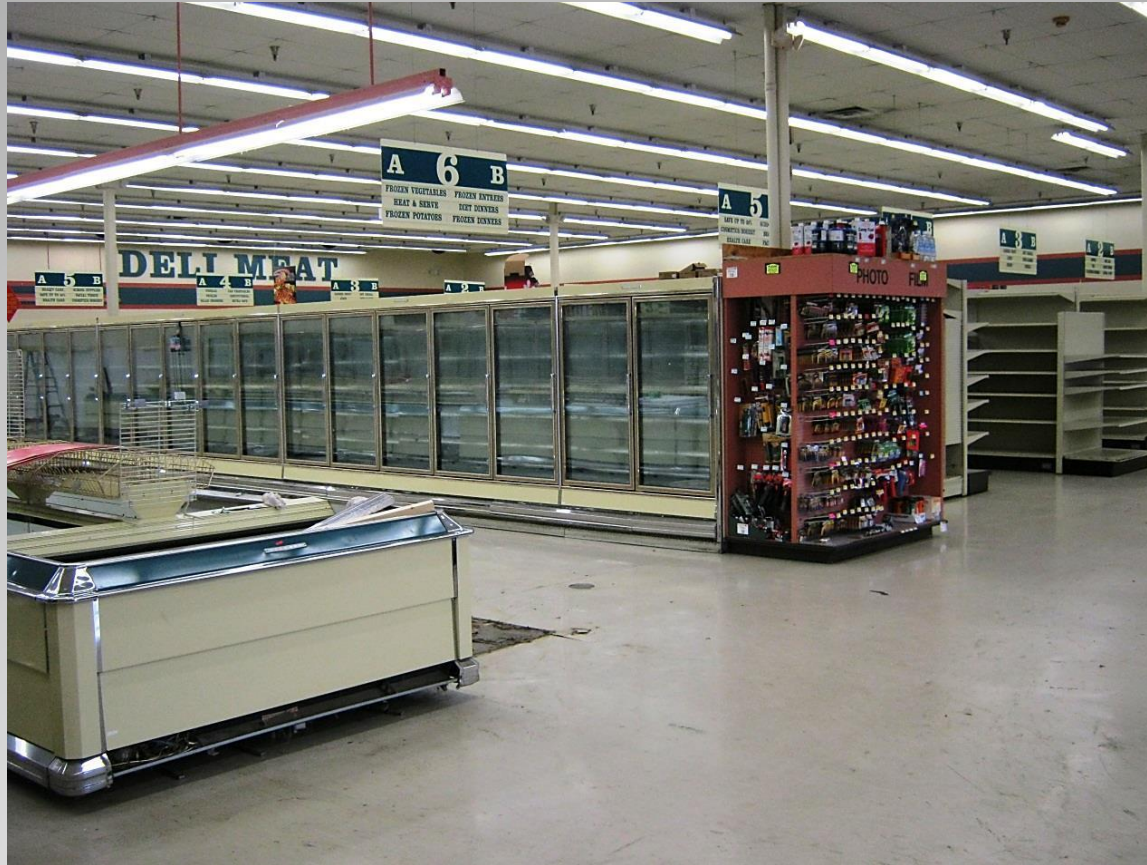
Interior of Harps #189 on November 13, 2011. On November 10th, the Arkansas Department of Health had ordered the removal and landfill disposal of all consumable food items.

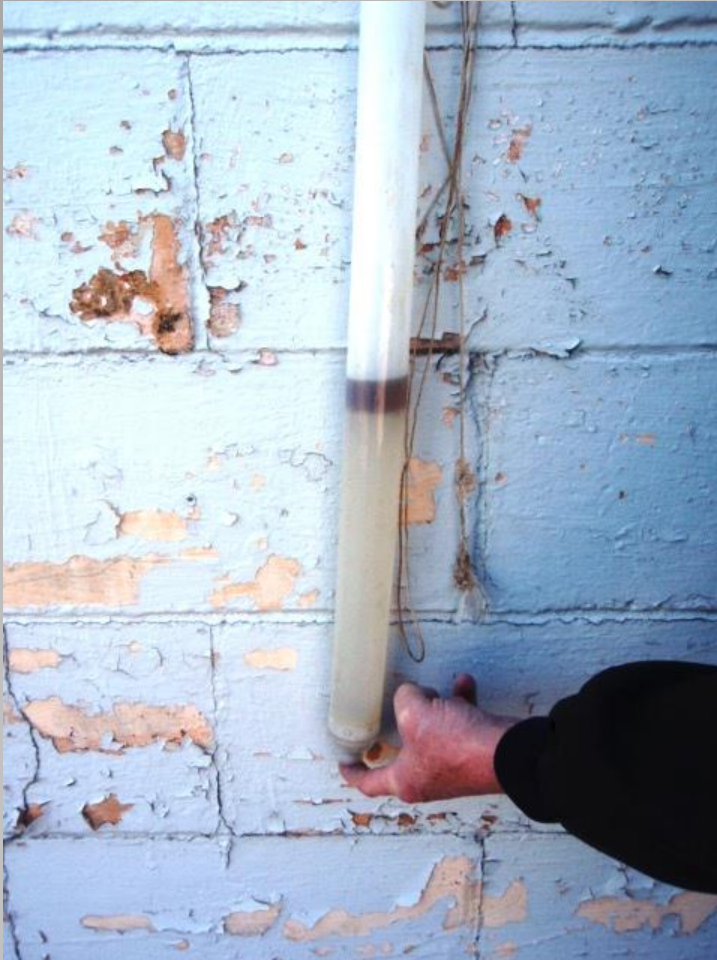
Source of the release: On November 9, 2011, RST Enforcement checked the two observation wells in the UST tankhold at White Oak Station #3 and confirmed the presence of free product gasoline in both wells.

Inventory records did not indicate a recent system release and the USTs and lines passed pressure tests conducted on November 10th.

Product losses during fuel deliveries are now suspected to have been the source of the release.

In April, 2014, a concrete cover was installed over the UST tankhead, minimizing rain water infiltration and further flushing of residual contaminants.

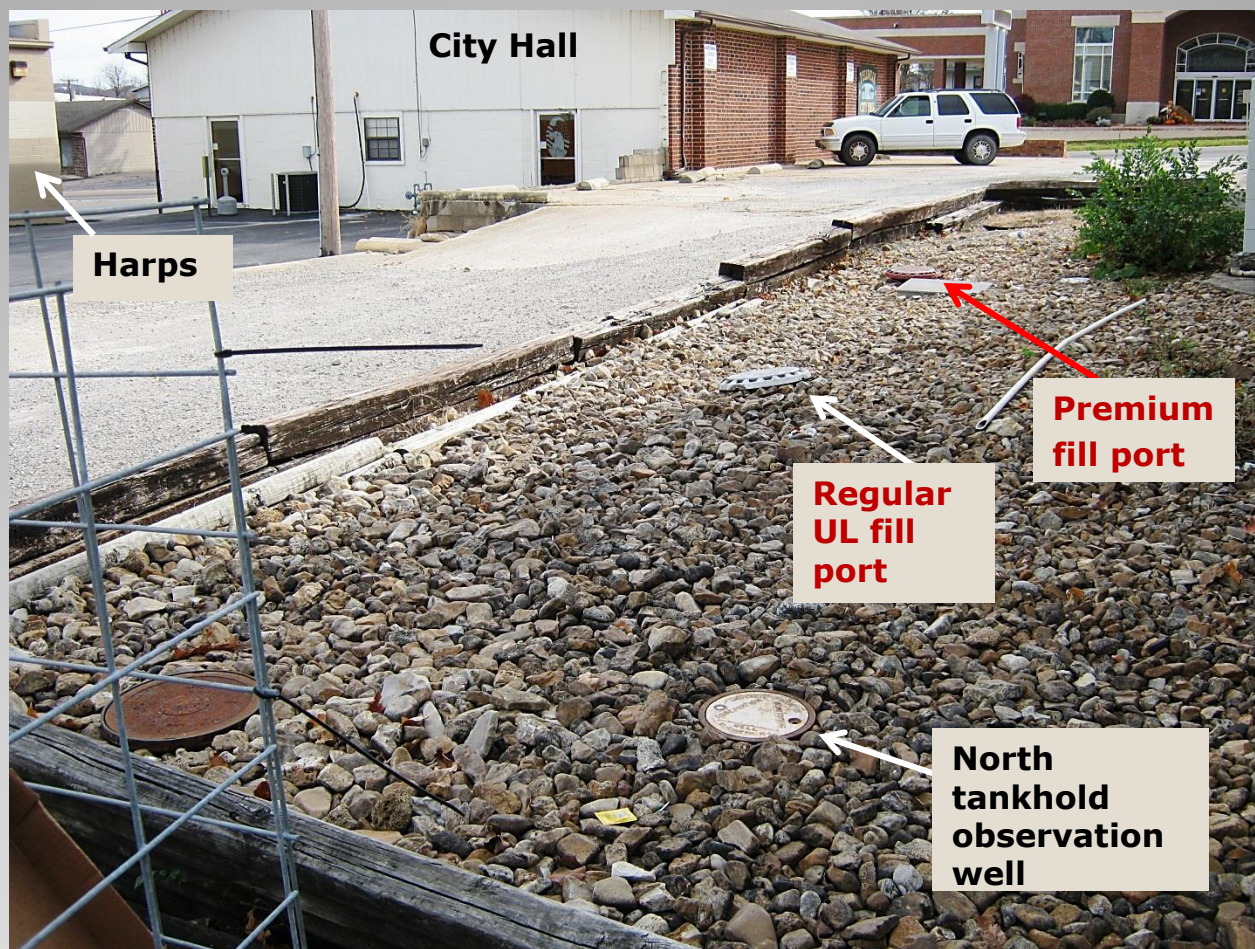
UST tankhold at White Oak #3, November 13, 2011. Note lack of an impermeable cover over gravel backfill.

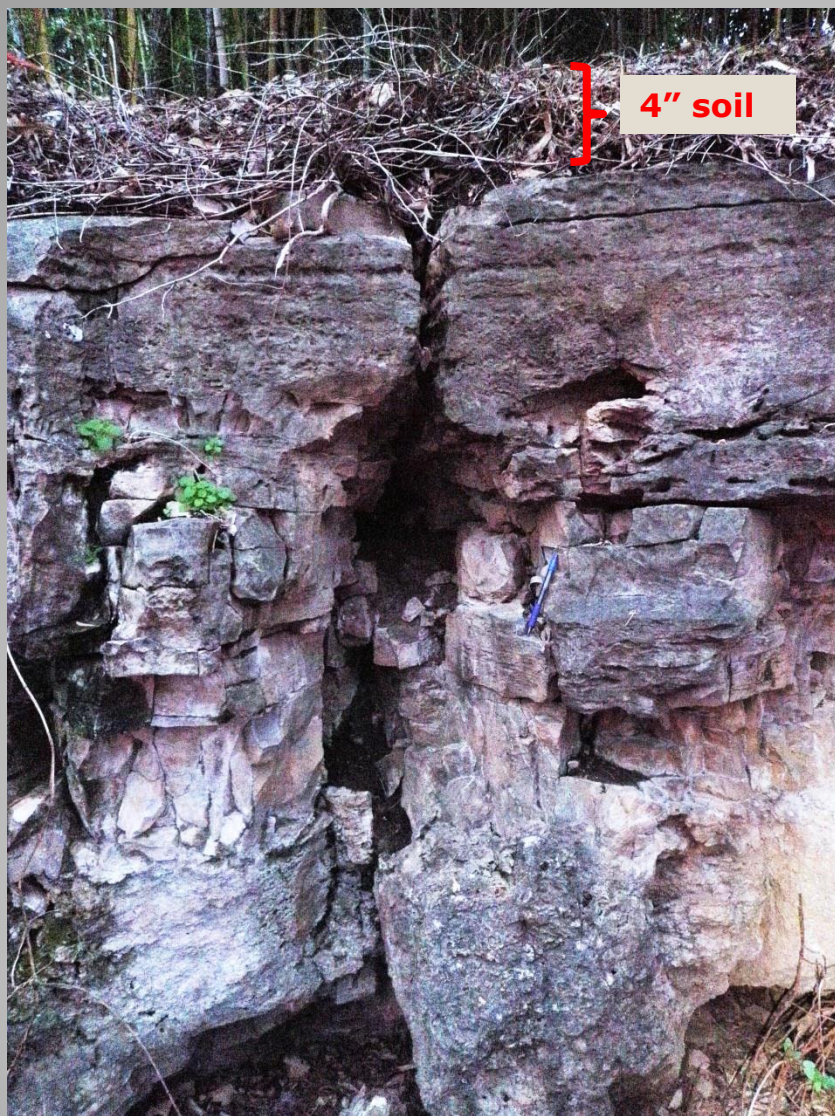
**"Karst" bedrock exposure
in Lower Ordovician
Cotter Dolomite
Formation, Yellville, AR.**

**Location is at top of a
bluff, 600 feet south of
White Oak #3 site.
Dissolution of carbonate
bedrock has occurred
along vertical fractures
and horizontal bedding
planes.**

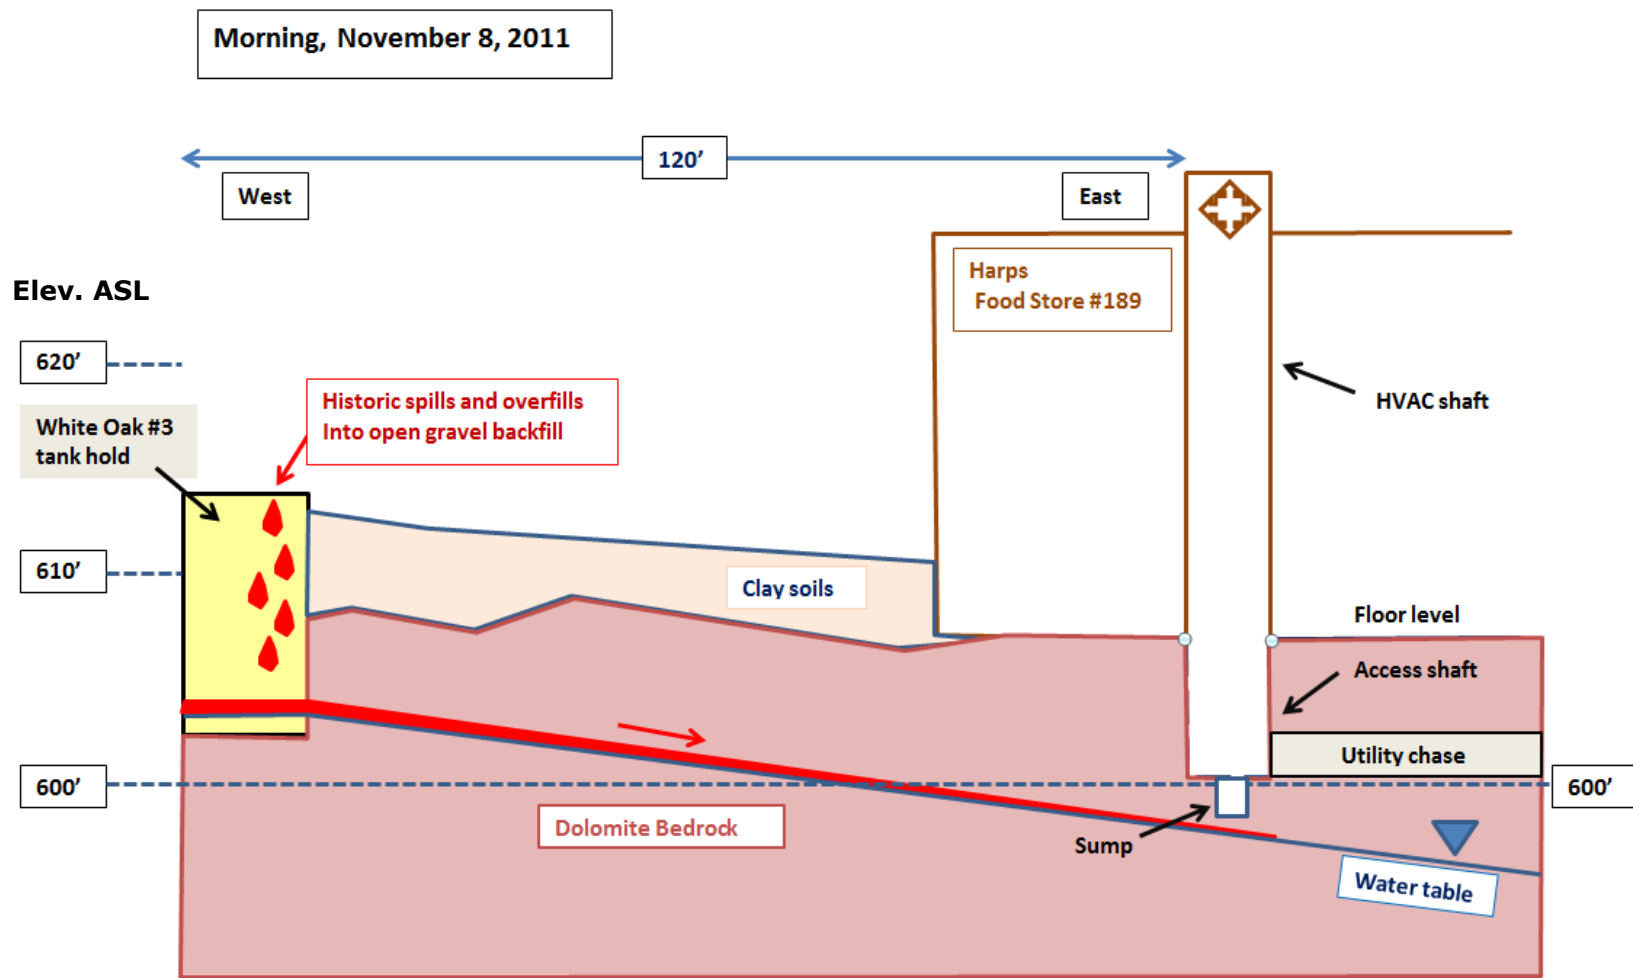
**Site conditions prior to vapor impact at
Harps Food Store, November 8, 2011**

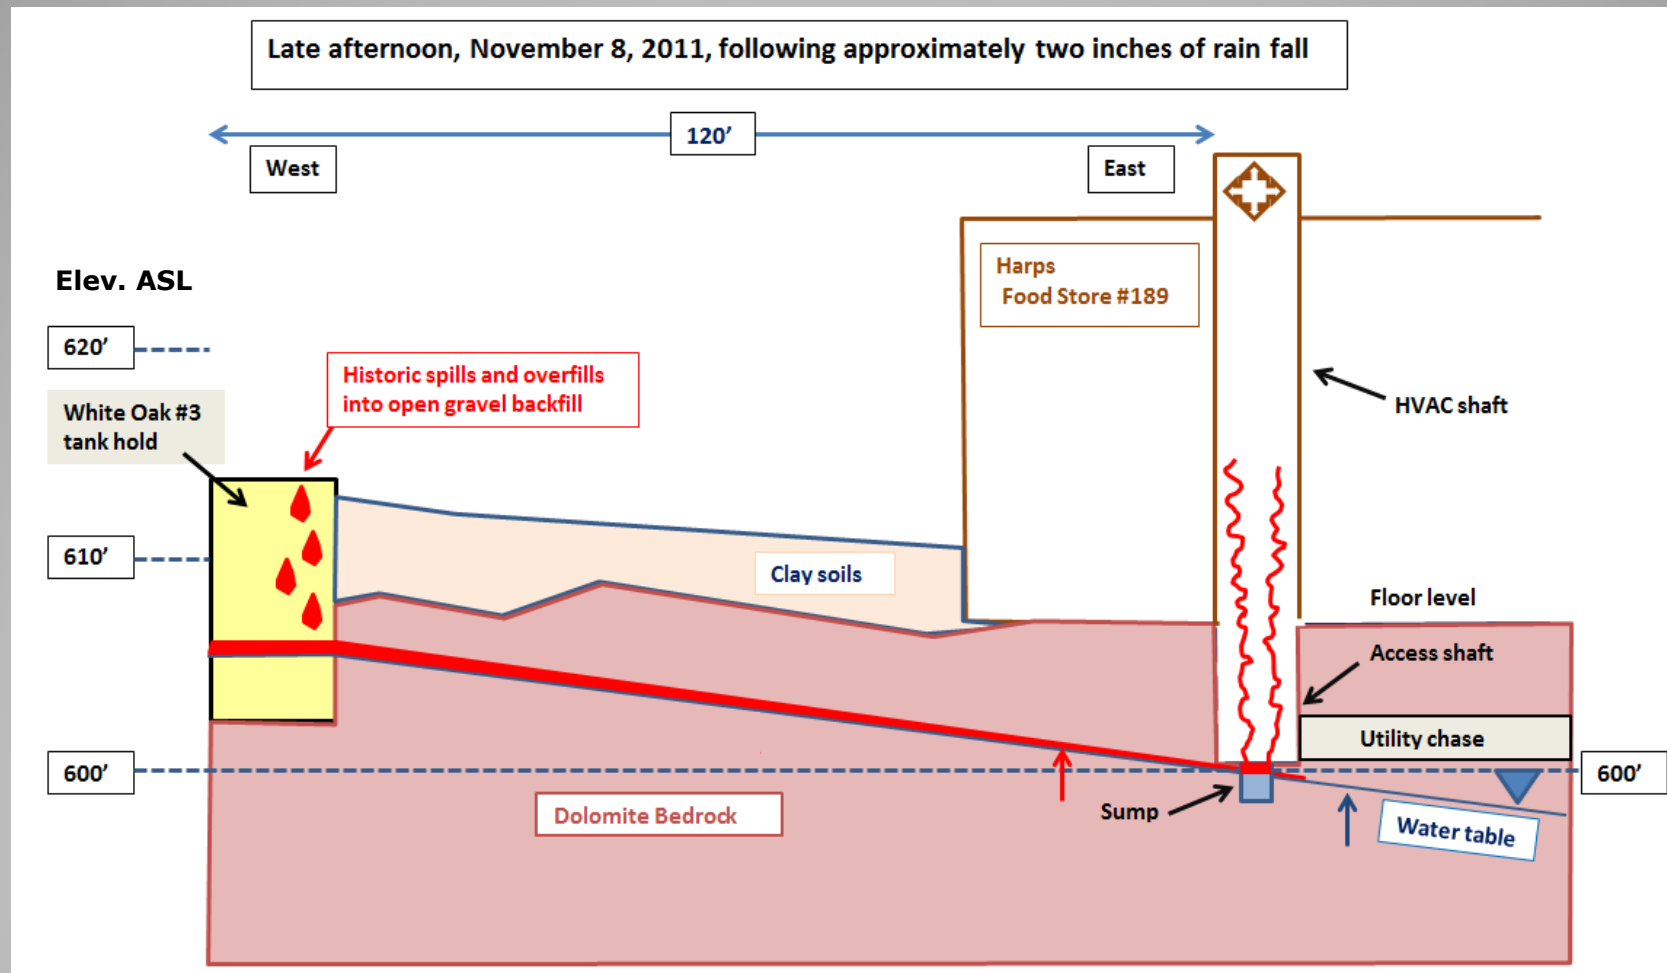
Site conditions following water table rise and vapor impact at Harps Food Store, November 8, 2011

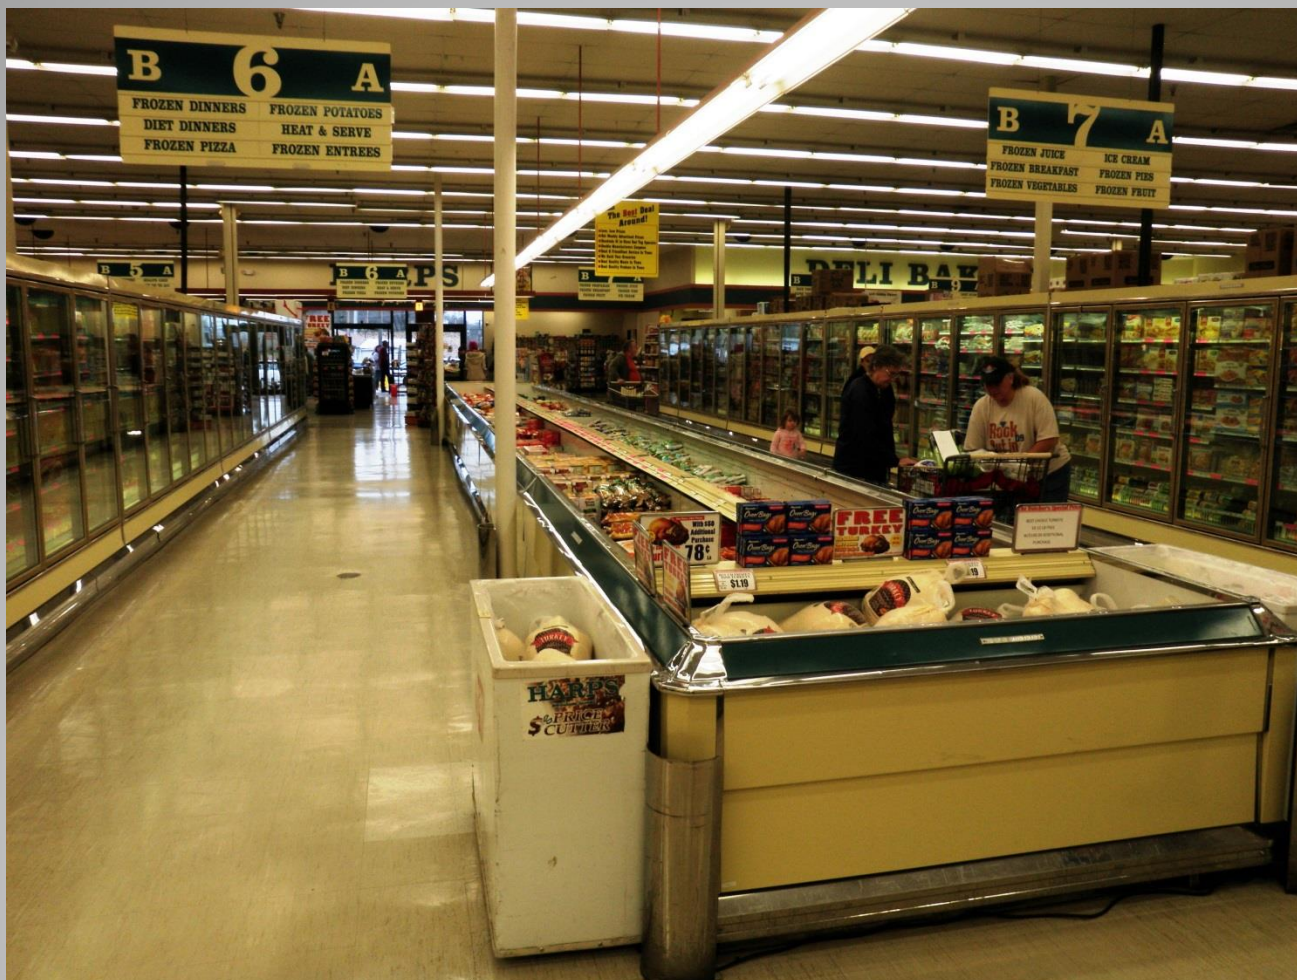
After re-stocking the shelves and completing utility repairs and replacement, Harps #189 re-opened on the morning of November 21, 2011.

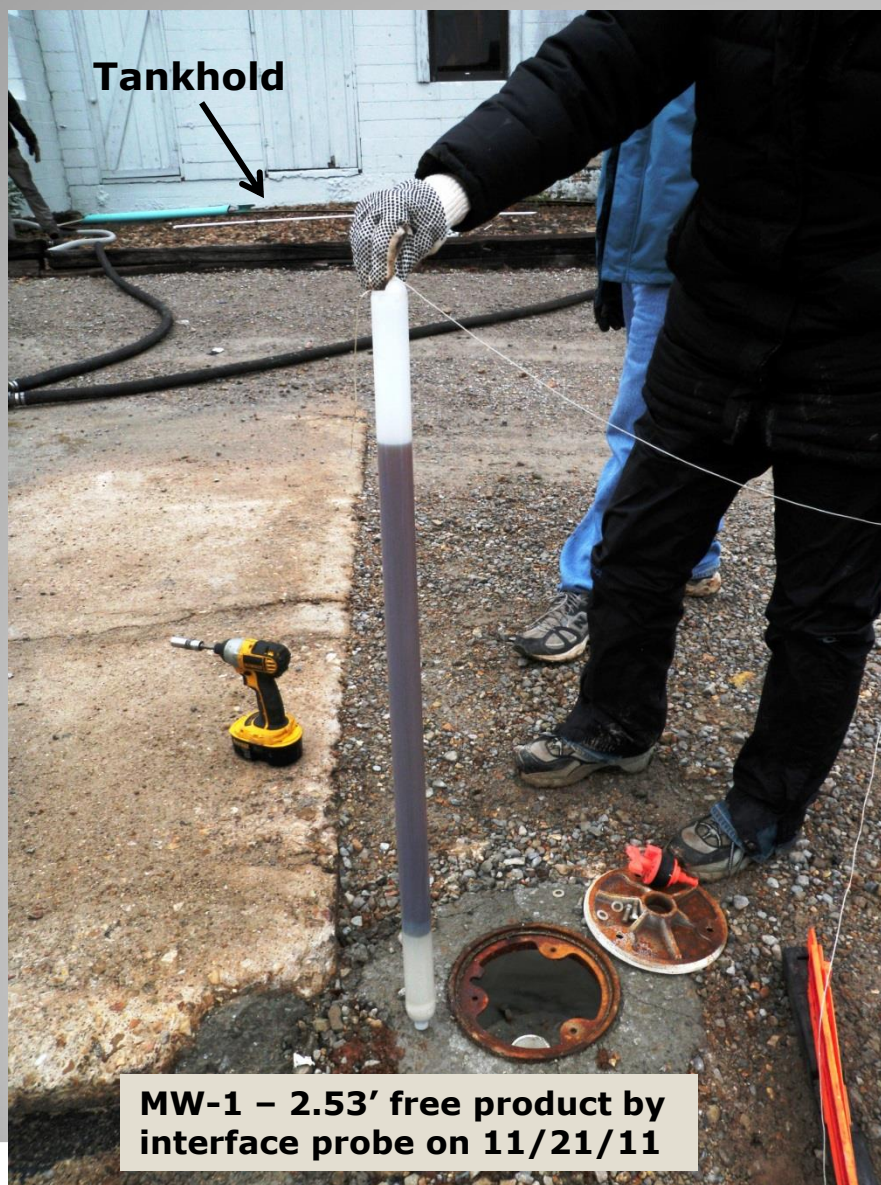
LUST response by the Responsible Party (Petromark, Inc.) and contractor (Jones Environmental, Inc.) during November, 2011 consisted of the drilling of three groundwater monitoring wells at the White Oak #3 site and the recovery of free product from the UST tankhold and the three new wells, through bailing and Mobile Dual Phase Extraction.

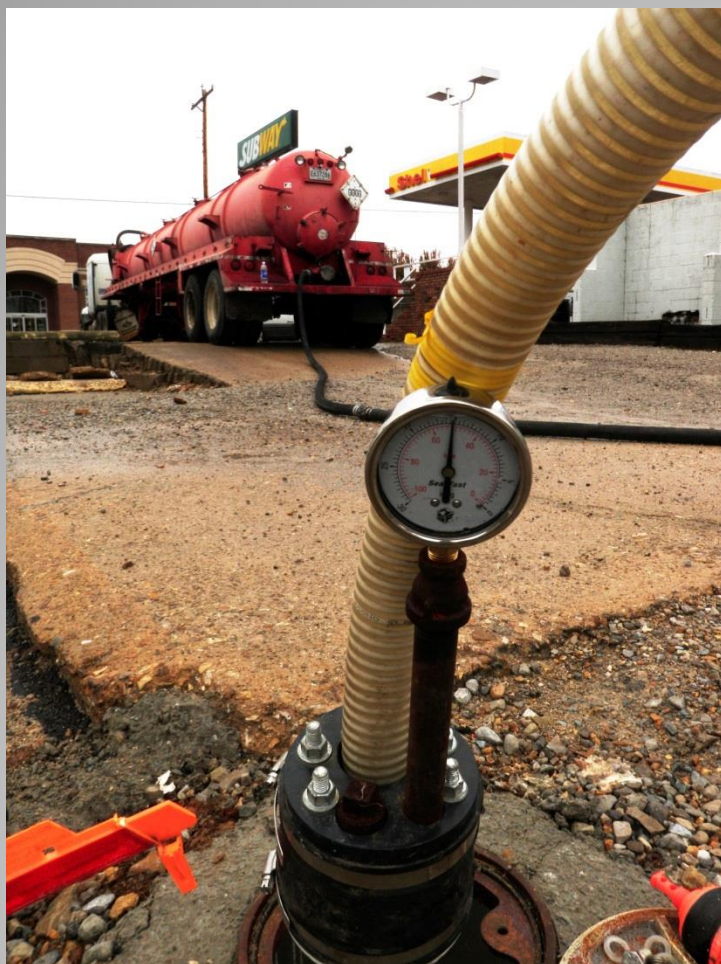
Vacuum extraction from monitoring well MW-1 during 11/21/11 MDPE event

An 8-hour Mobile Dual Phase Extraction event on November 21, 2011 recovered 300 gallons of free product, 2,052 gallons of dissolved-phase contaminated water and approximately 47 gallons of vapor equivalent gasoline.

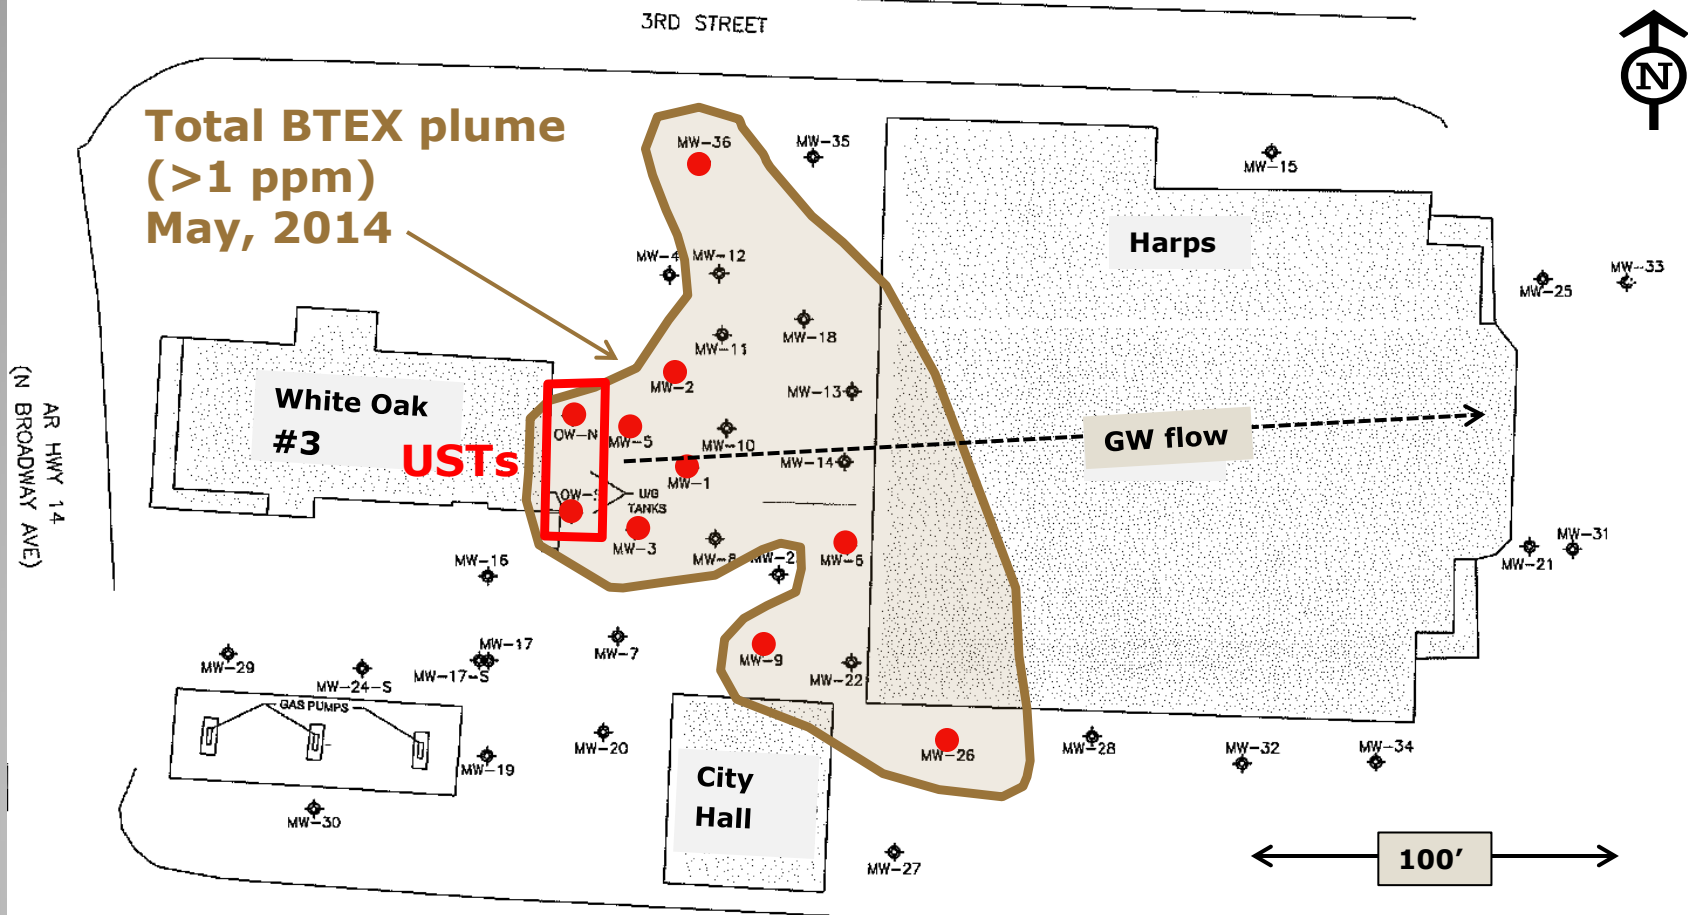
**Monitoring well location map
White Oak #3 - LUST #45-0008
(All wells installed by 9/7/12)**

● - Free Product wells in
bedrock aquifer

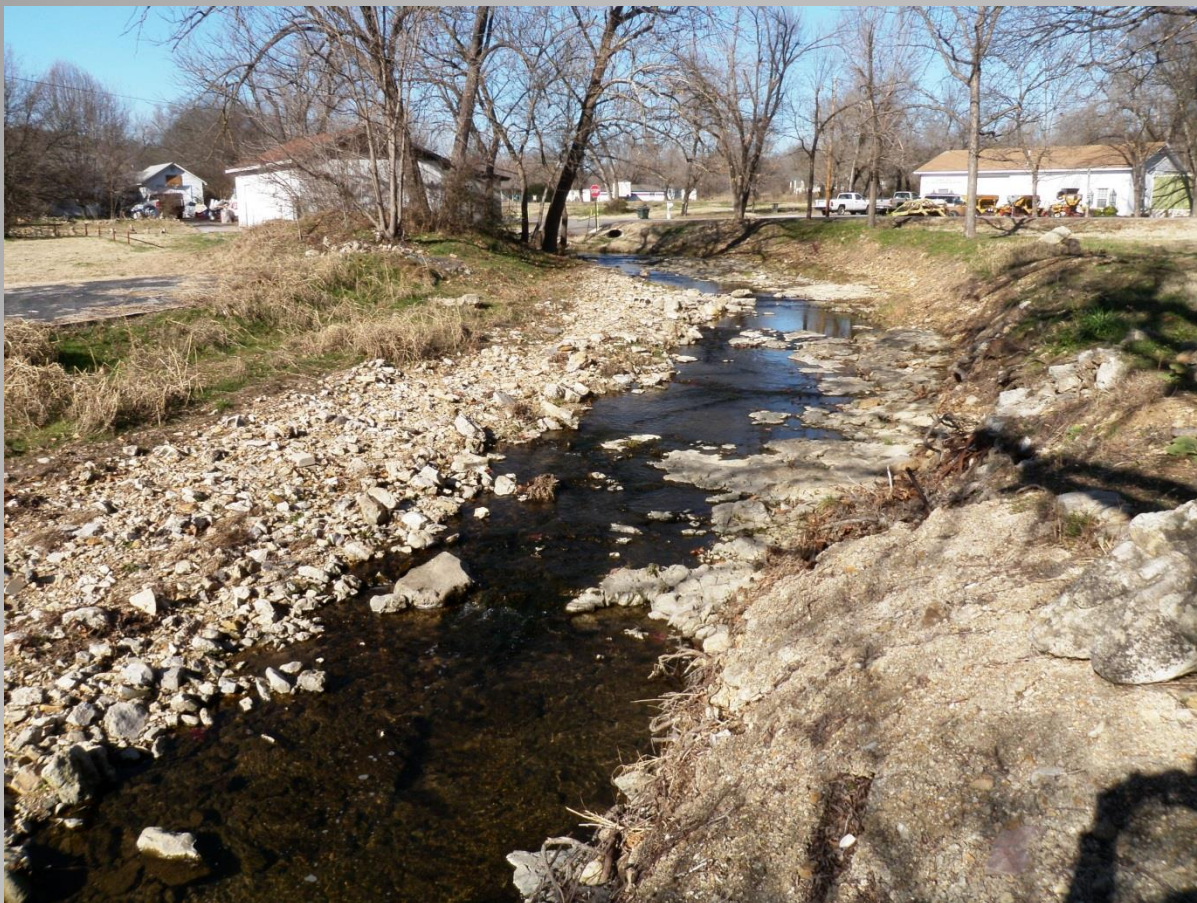
Surface water samples were taken from Town Branch at three locations from September, 2012 through May, 2014.

All samples have tested "non-detect" for dissolved hydrocarbons.

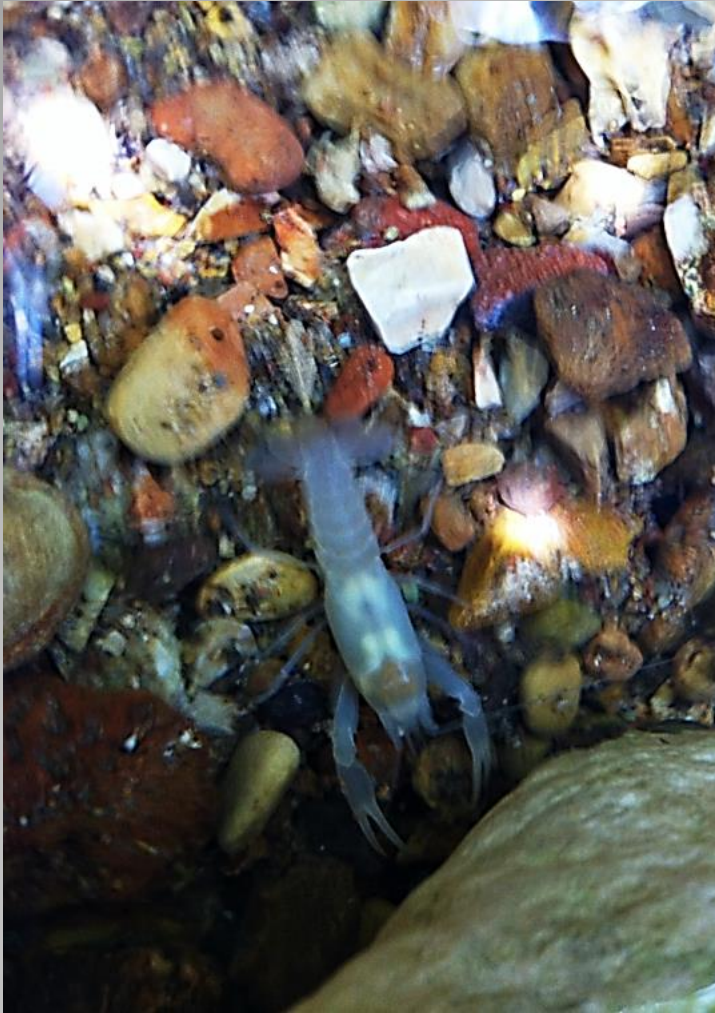
Cave crayfish (*Cambarus zophonastes*), photographed in Town Branch, immediately below Legion Spring, Yellville, Arkansas, by Ozark Underground Laboratory, April 3, 2012.

***C. zophonastes* is a federally-listed endangered species and is known to exist at only two other sites in the Arkansas Ozarks. A contract study of the Legion Spring site and its recharge area (including the White Oak #3 LUST site), was conducted by Ozark Underground Laboratory in 2011-2012, on behalf of The Nature Conservancy.**

No evidence of adverse impact to the *C. zophonastes* population as a result of the White Oak #3 release has been reported.

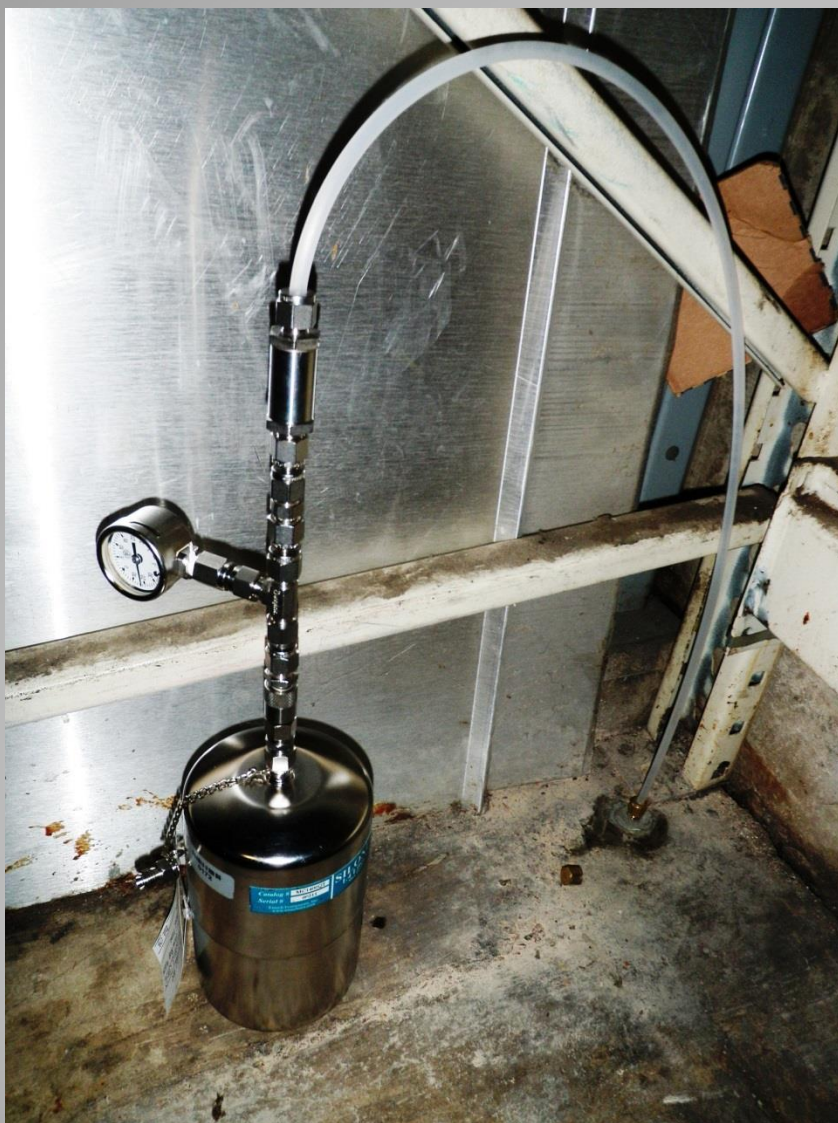
Six sub-slab vapor monitoring points were installed and sampled at the Harps store and at City Hall in September, 2012.

Analyses for Benzene did not exceed the RST risk-based screening value of 49.3 ug/m³ in any of the air samples.
