LUST Site Corrective Action in Ozark Karst - Yellville, Arkansas

ASTSWMO Mid-Year Meeting
North Little Rock, Arkansas
April 23, 2015

Mikel R. Shinn, P.G.
Professional Geologist
- Regulated Storage
Tanks Division

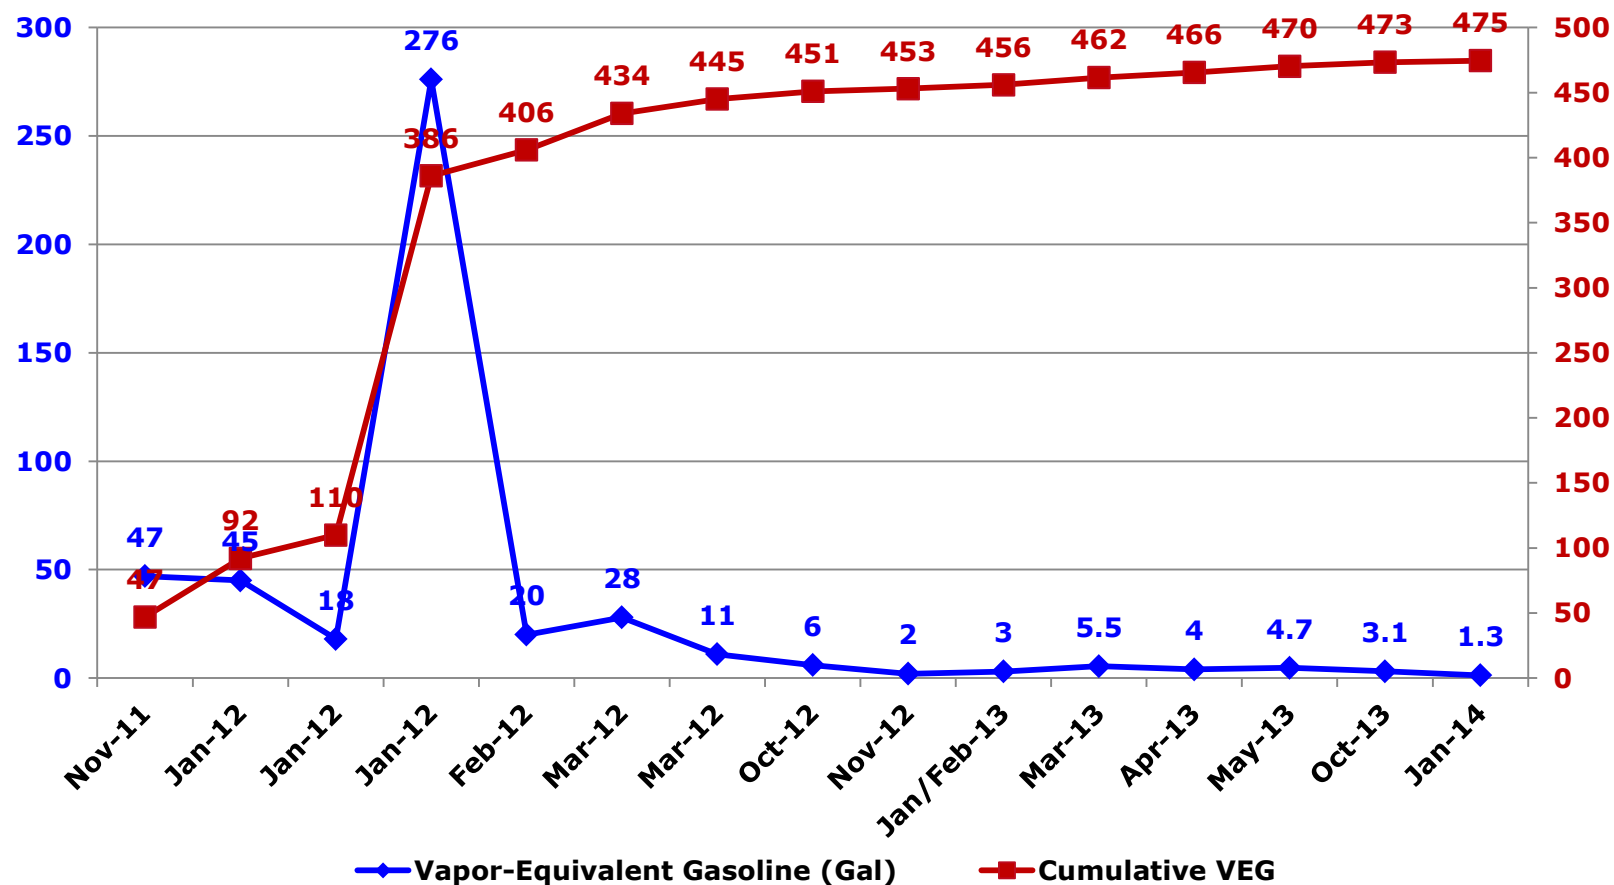
Gasoline recovery (vapor-equivalent gallons per eight-hour event) by Mobile Dual Phase Extraction, 2011-2014

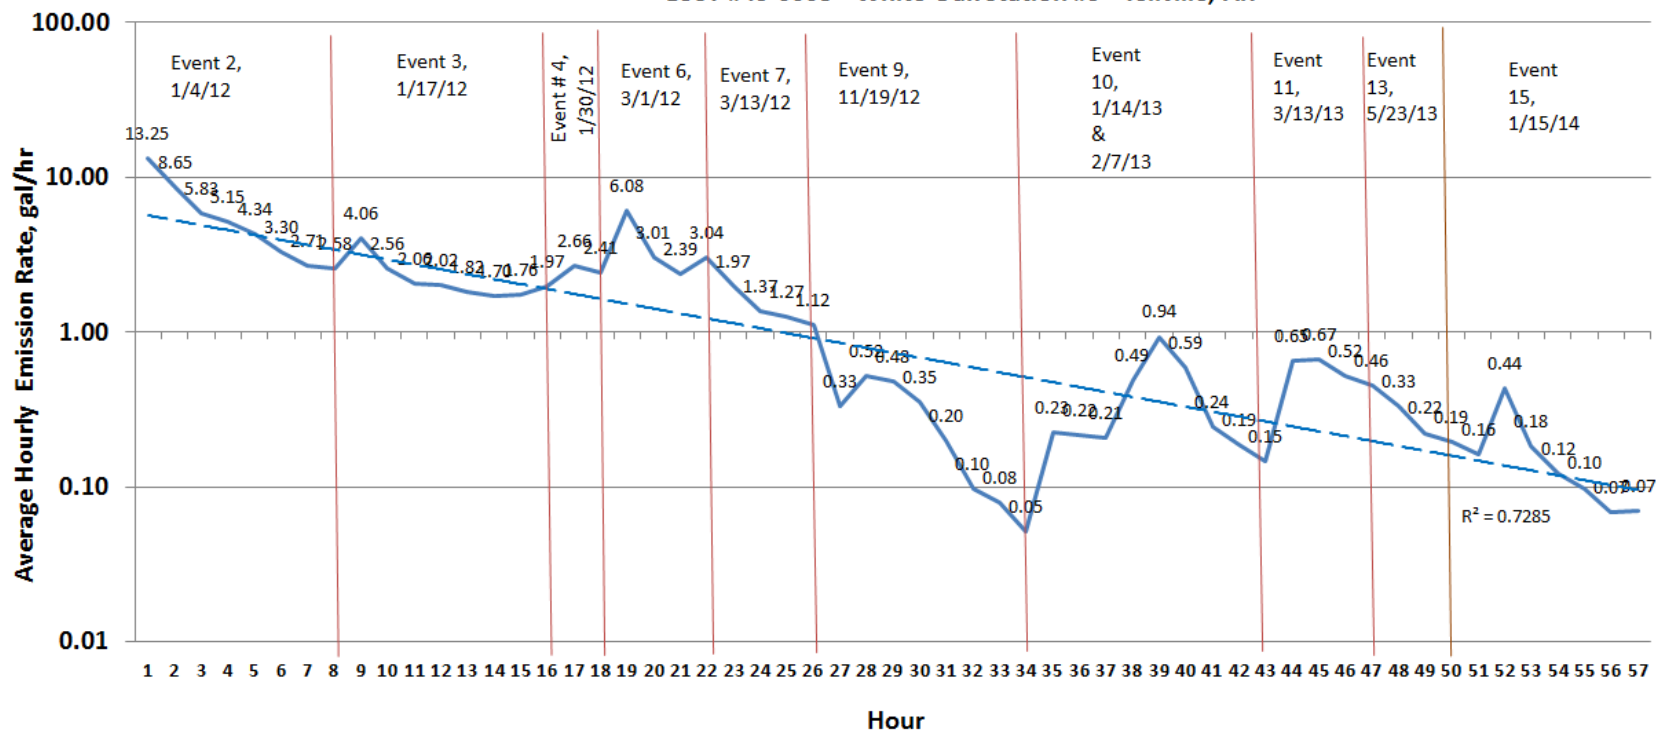
Average hourly emission rates, (gal/hr),
Wells MW-1, MW-2 and MW-3 - MDPE Events 2, 3, 4, 6, 7, 9, 10 and 11, January 2012 - January 2014
LUST #45-0008 - White Oak Station #3 - Yellville, AR

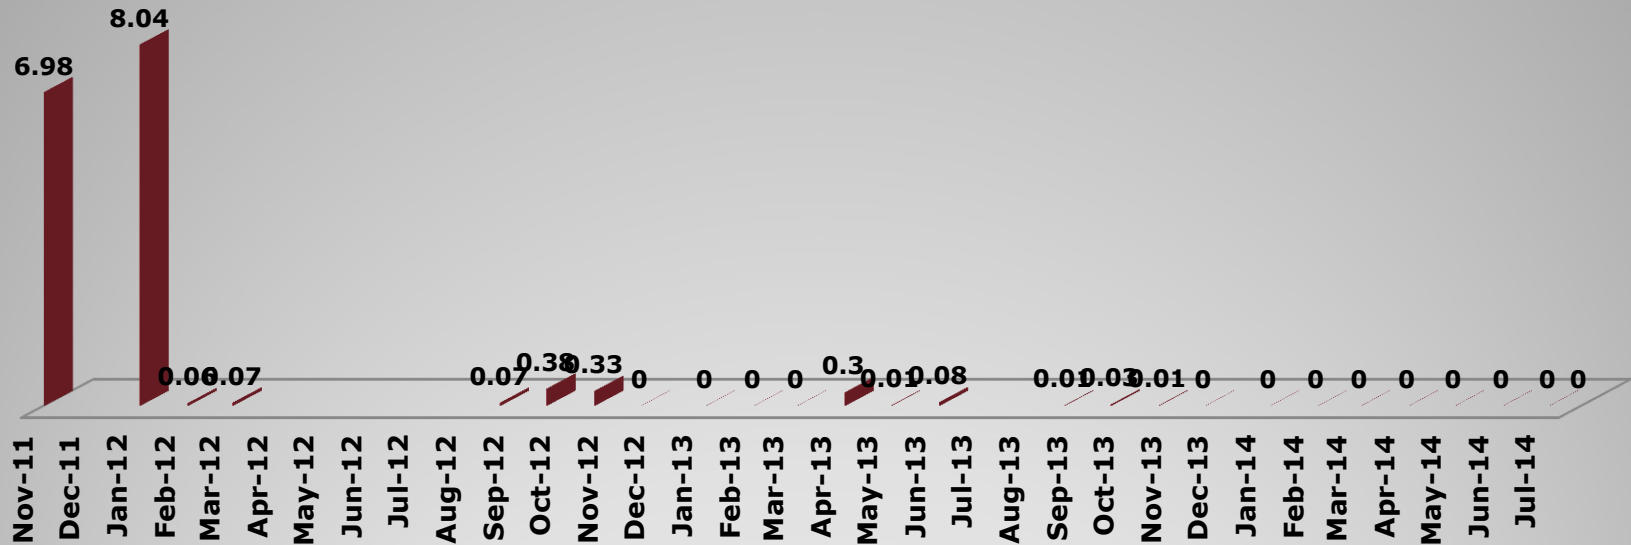
Total Free Product thicknesses in feet (all wells), 2011-2014
White Oak Station #3 – LUST #45-0008

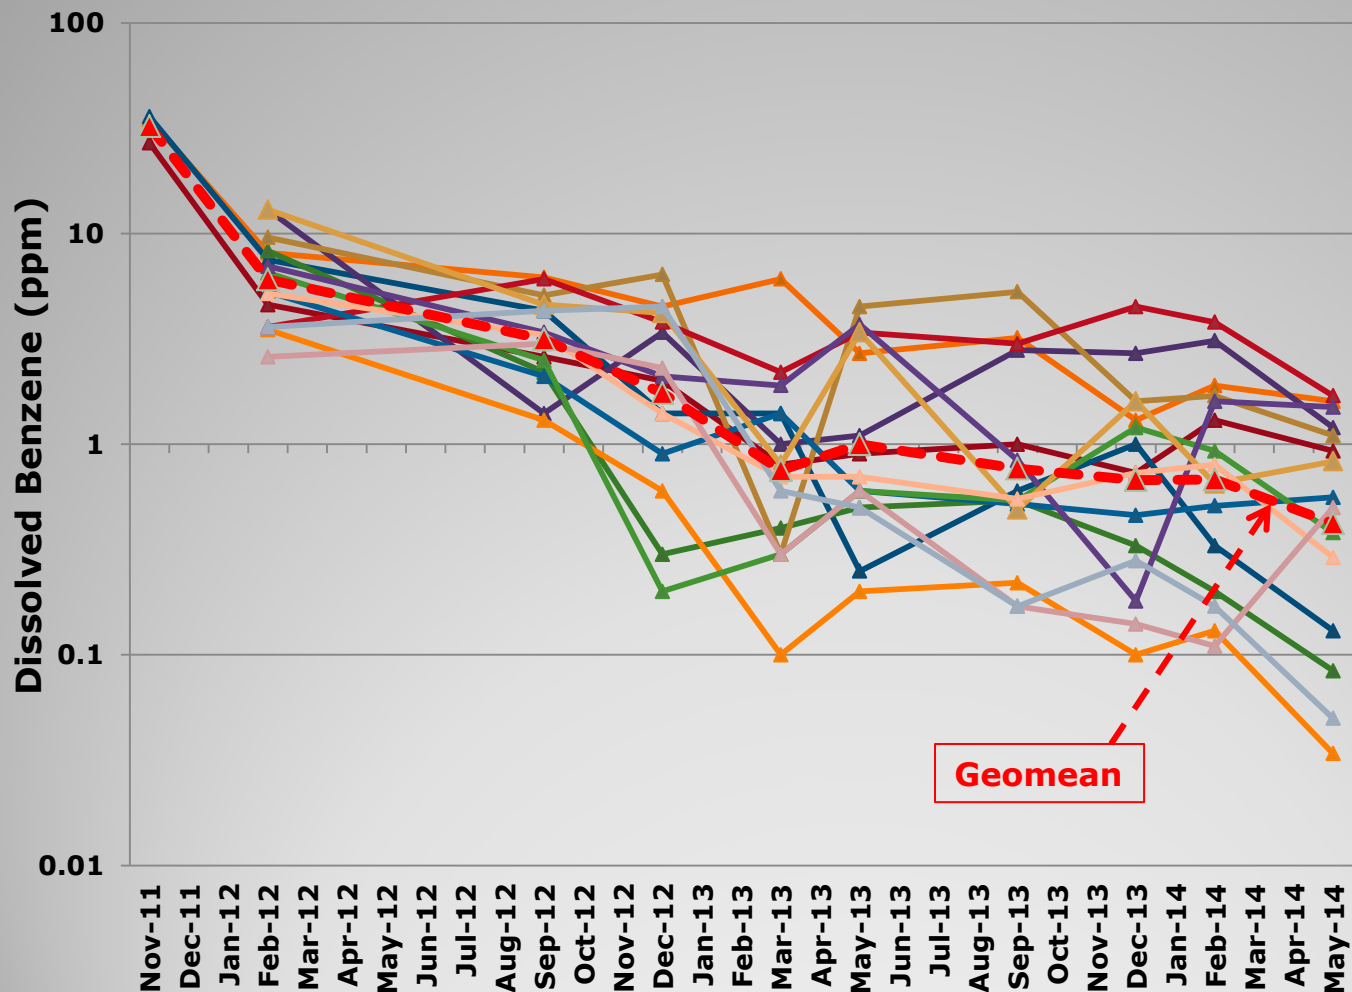
Chart depicts the reduction in dissolved Benzene in core monitoring wells at the White Oak #3 site during ten sampling events from November, 2011 through May, 2014.
