Introduction

Drilling Fluid Disposal Site Sampling Plan

Summary of Findings

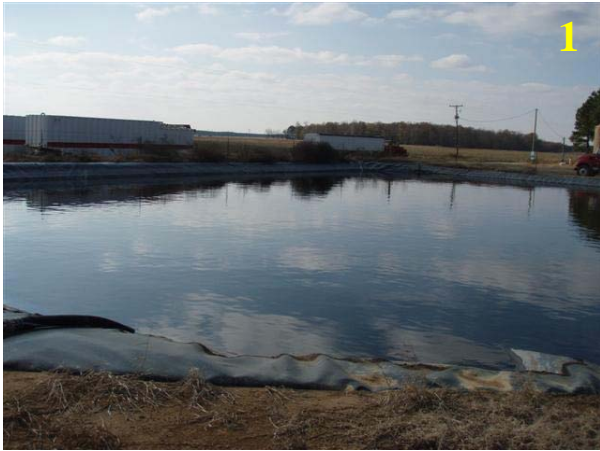
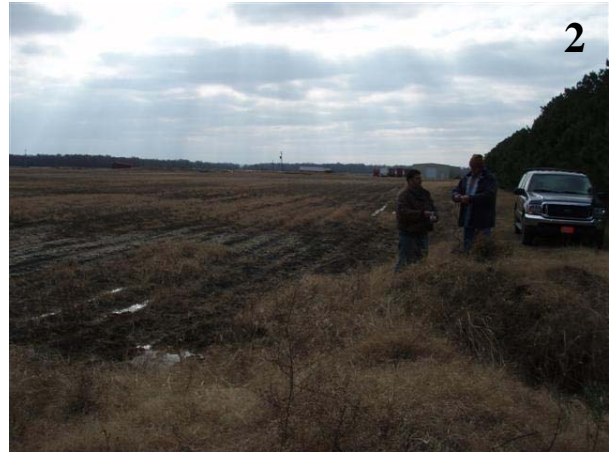
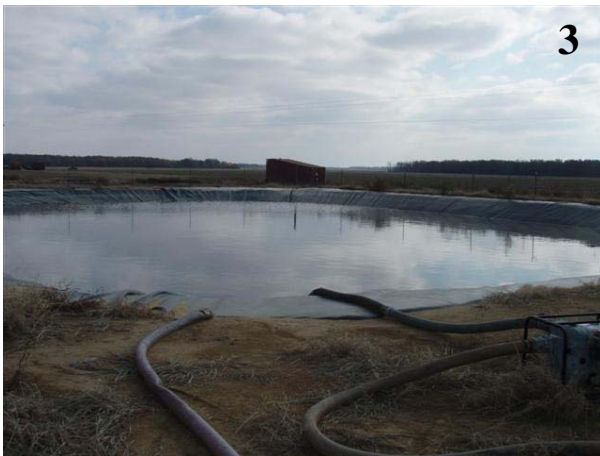
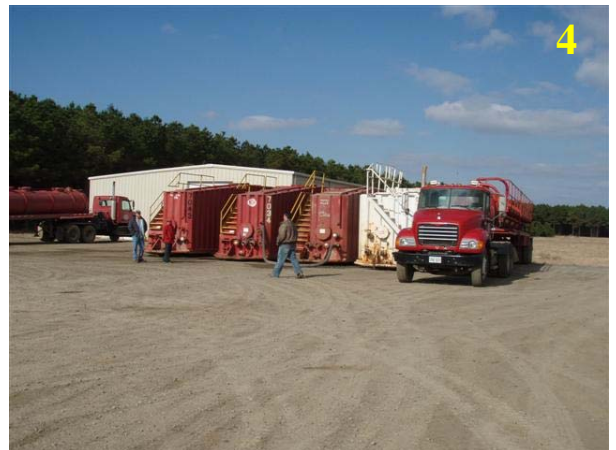
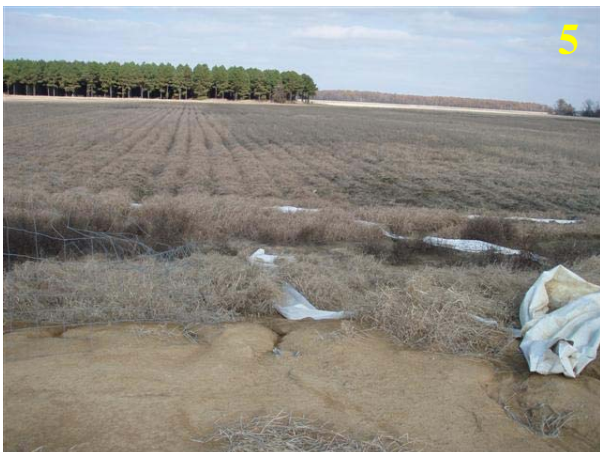
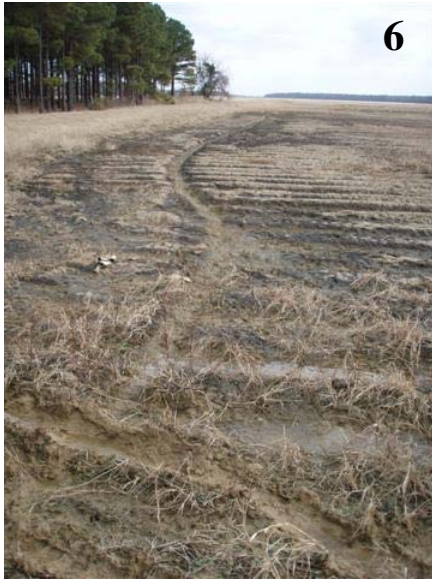
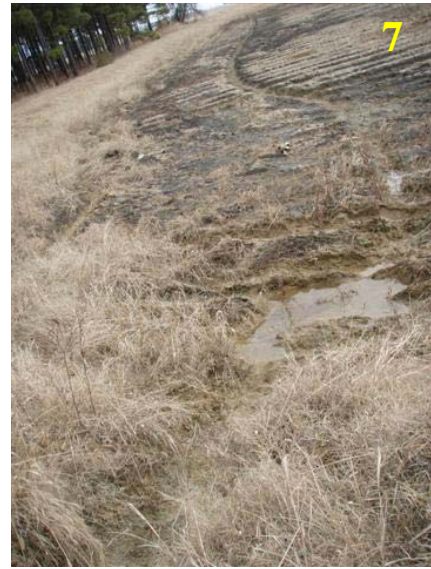
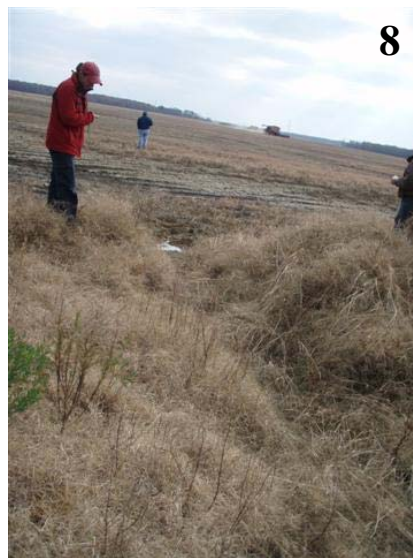
Pictures of Big Mac Tank Farm

1. Holding pond
2. East end of application area
3. Holding pond with hoses to irrigation system
4. Application field (soybean stalks were present)
5. Frac tanks that were to be removed (according to inspector)
6. East end of application area showing “furrow”
7. Furrow as it goes off to watercourse
8. Furrow as it continues off field into watercourse

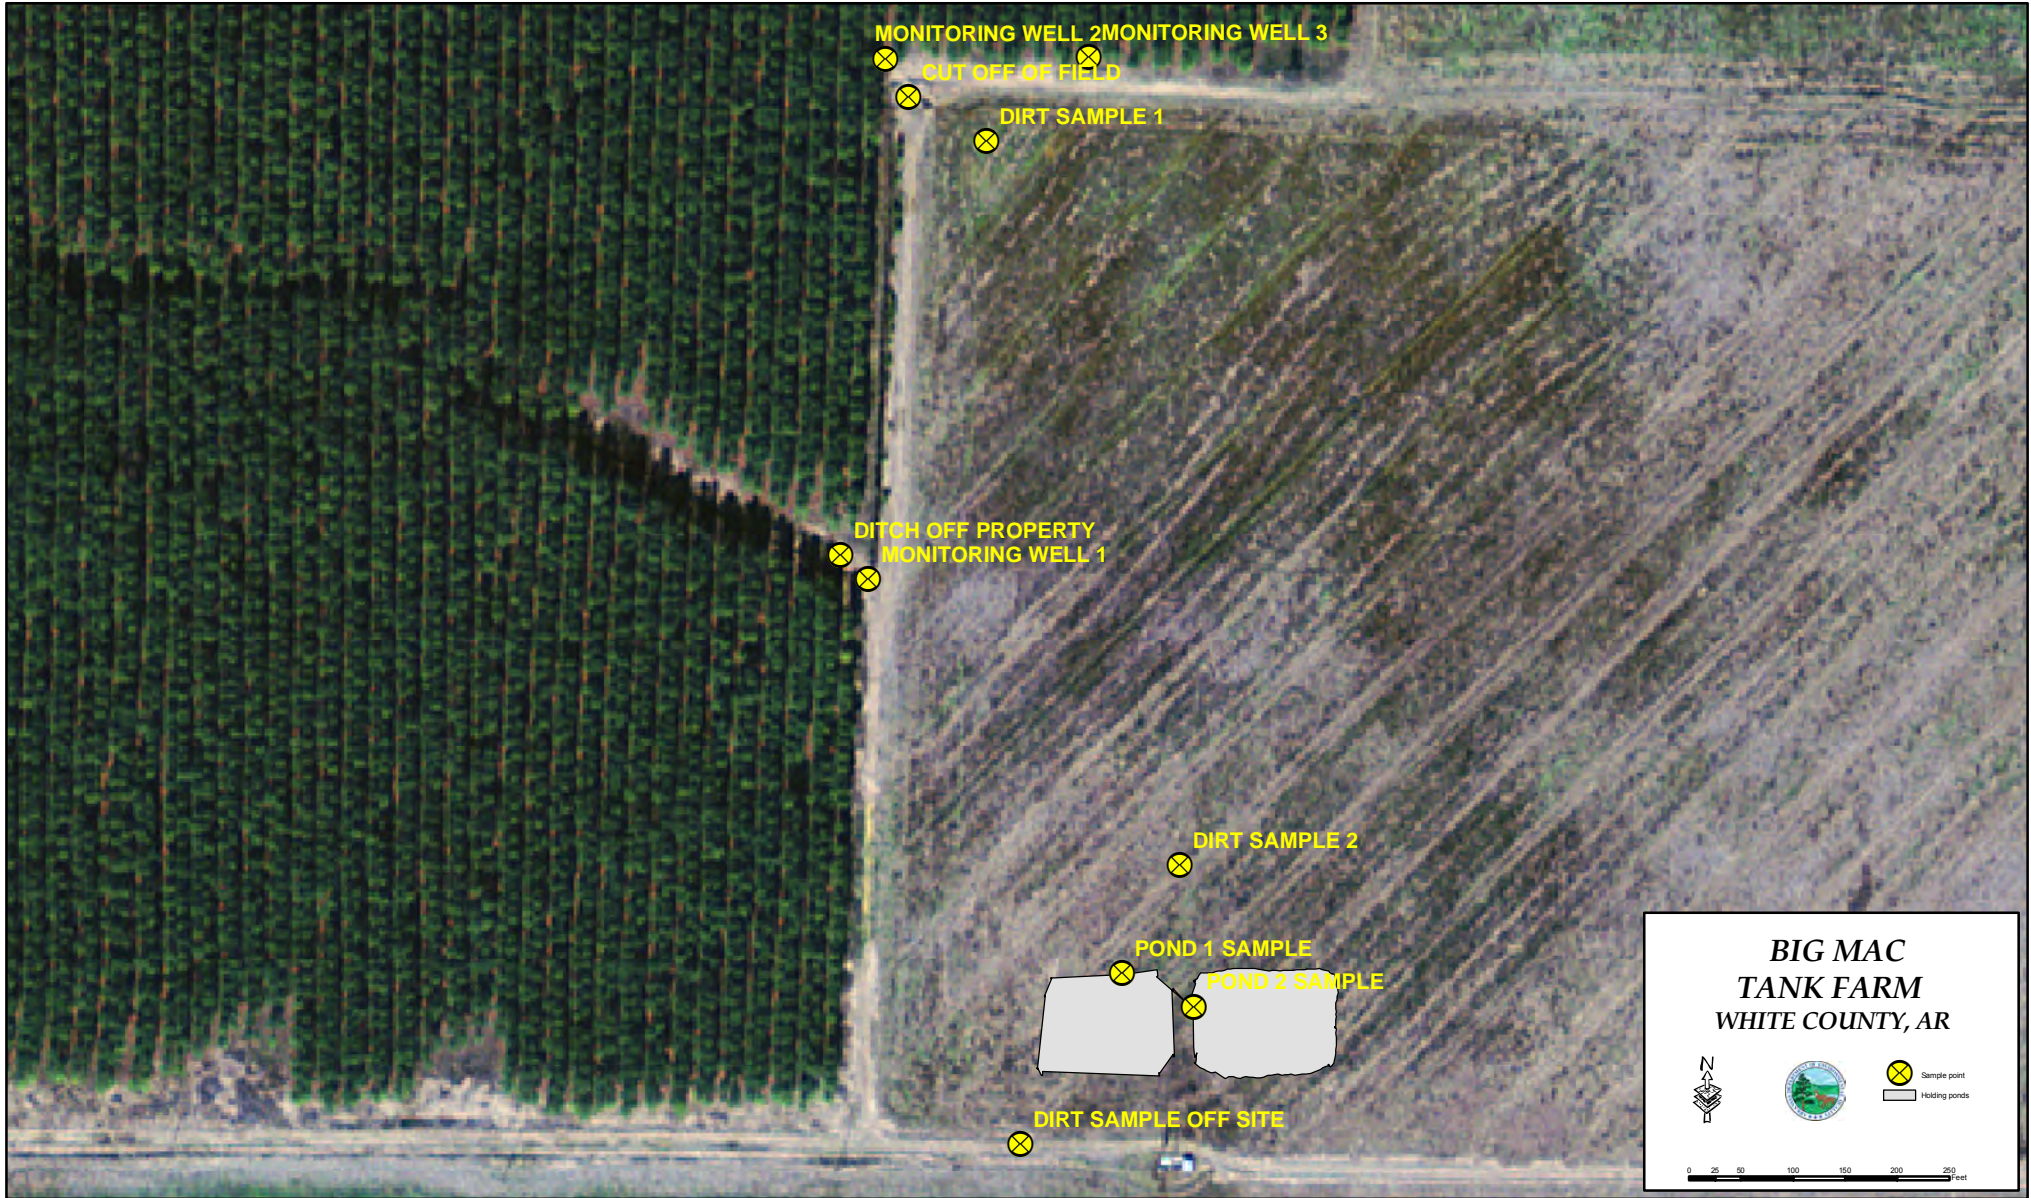
Big Mac Tank Farm

Sample description for diagram
12/1/08

X₁- Ditch off property

X₂- Pond water sample #1

X₃- Pond water sample #2

C₁-Northeast corner land application area

Furthest distance from irrigation pipe
Conductivity: 1184 $\mu\text{S}/\text{cm}$

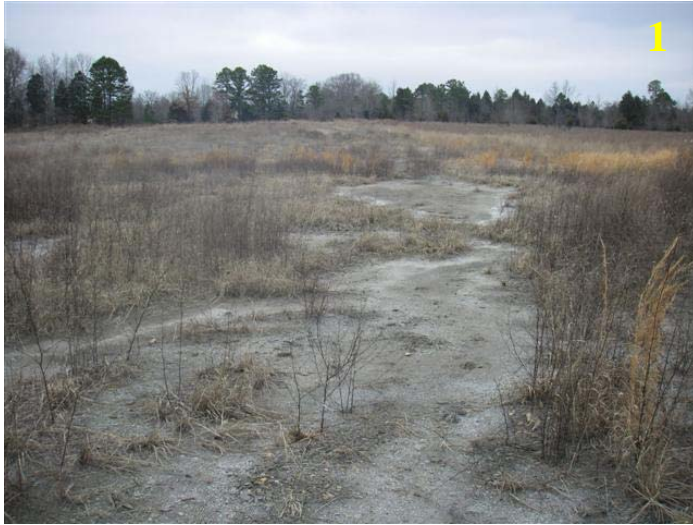
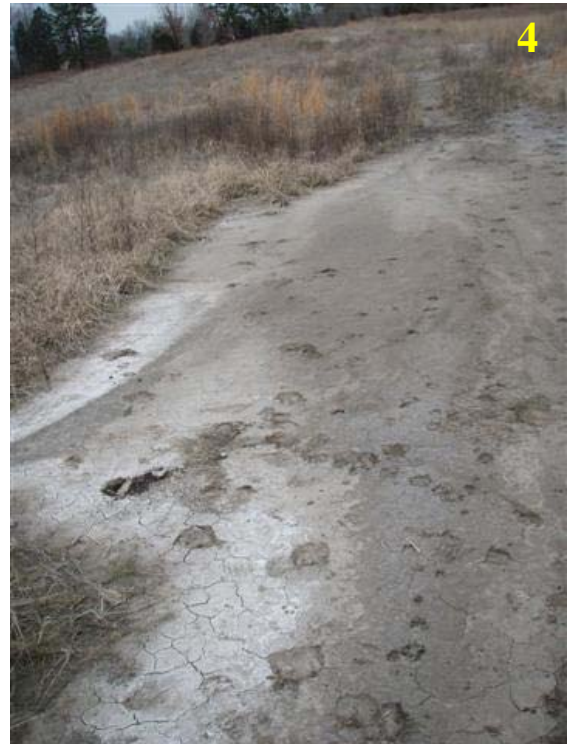
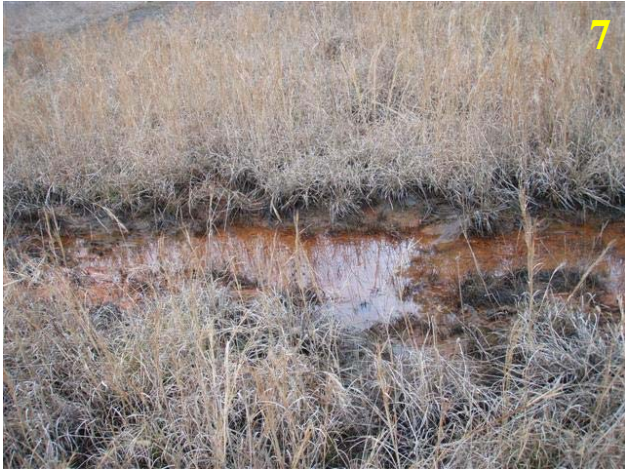
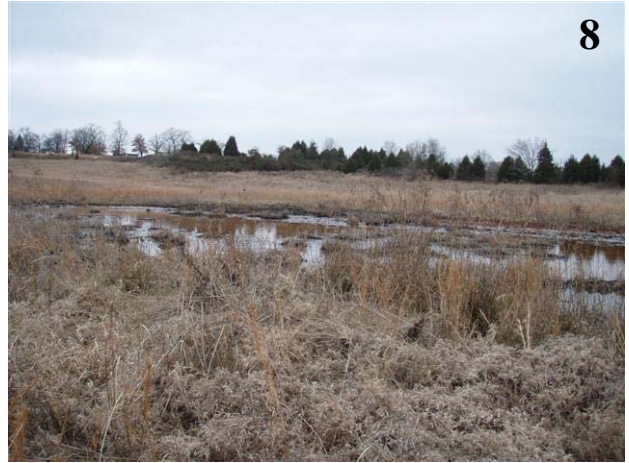
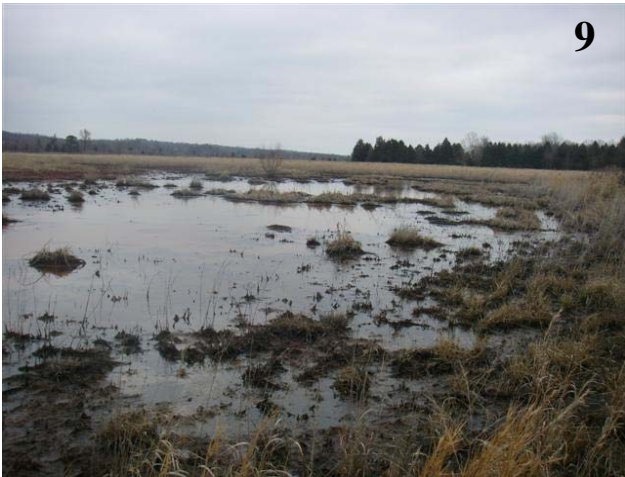
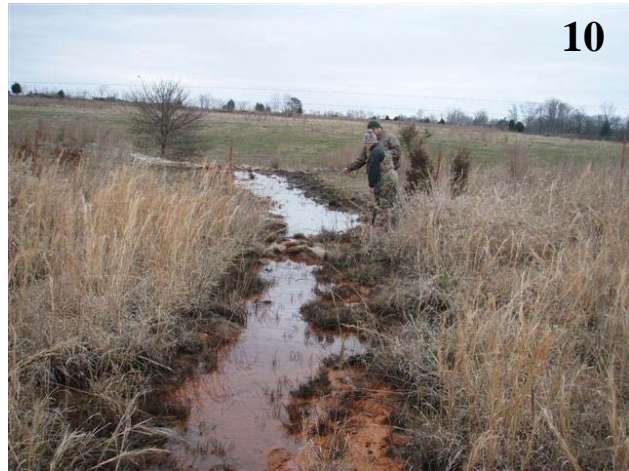
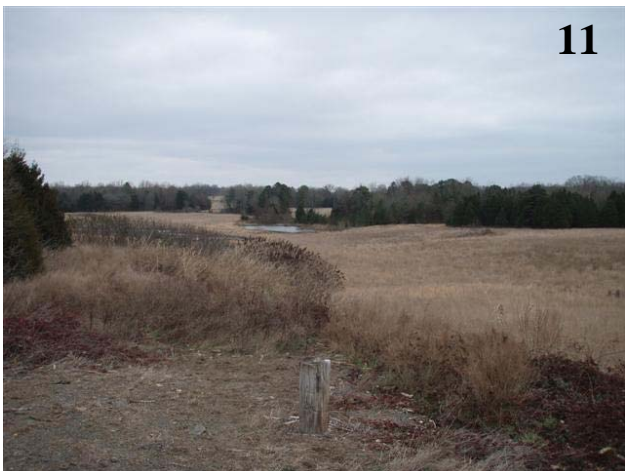
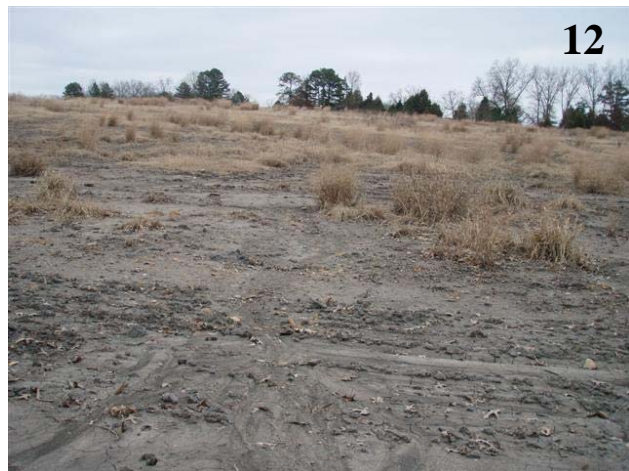
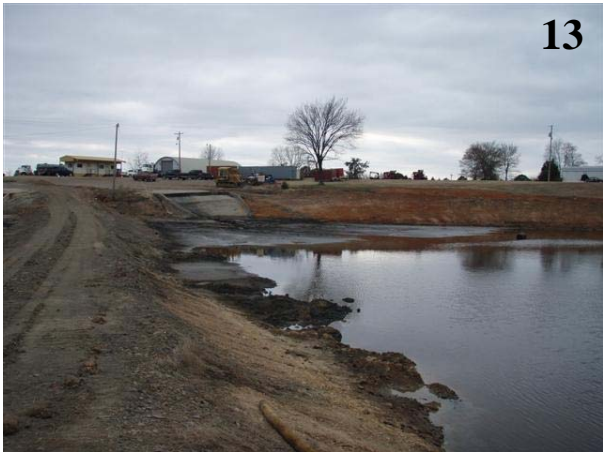
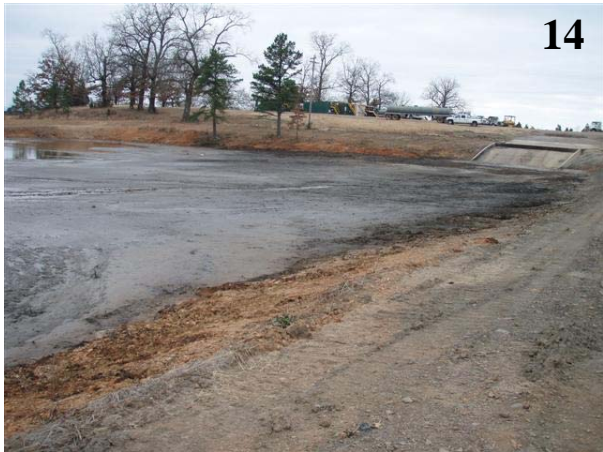
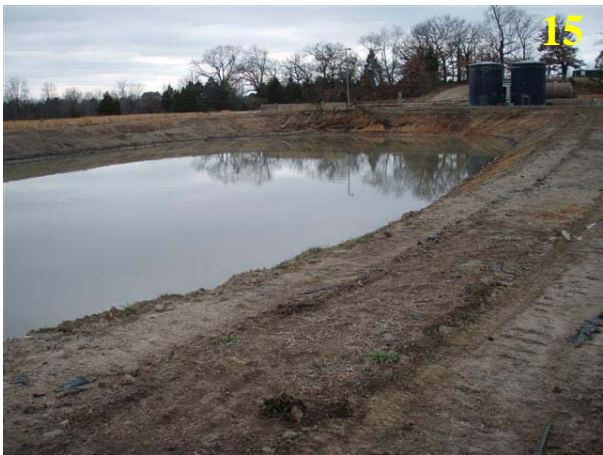
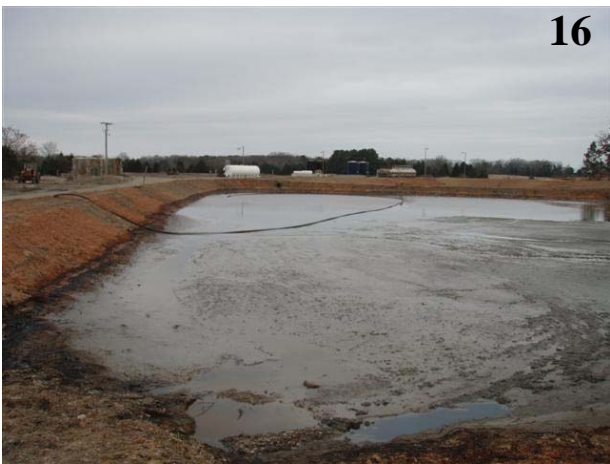
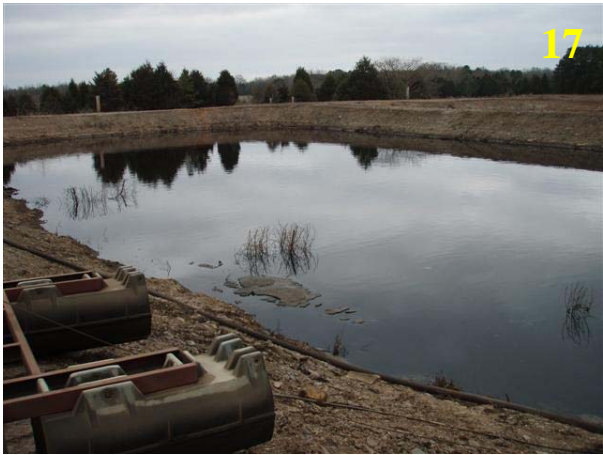
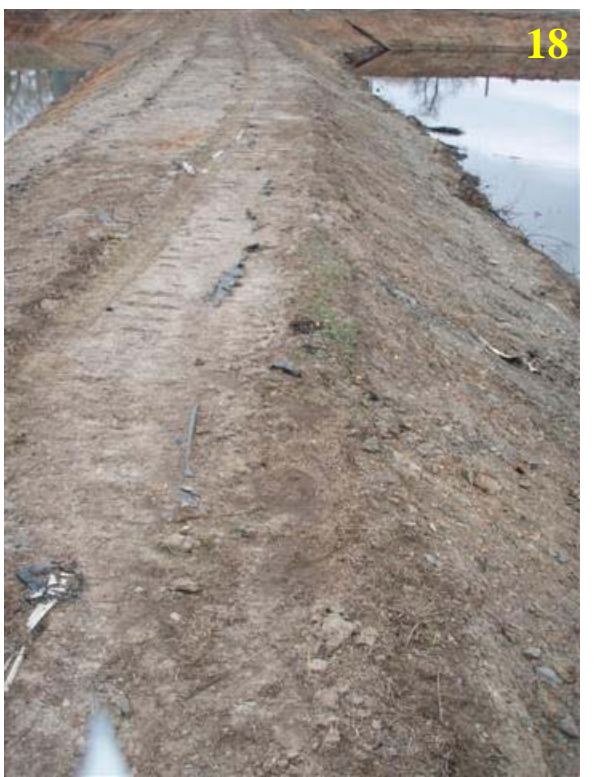
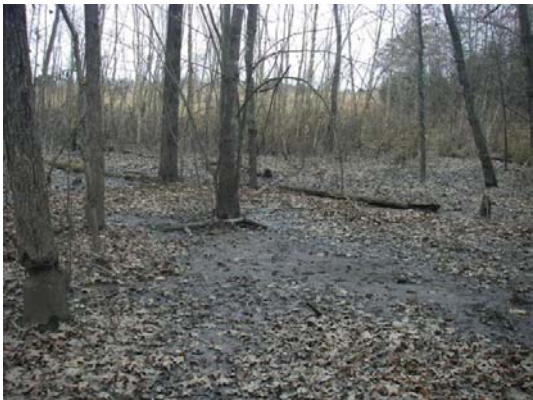
Pictures of Capstone Oilfield Disposal

1. Application field
2. Application field salt deposits and debris
3. Application field
4. Application field salt deposits
5. Monitoring well sampling
6. Drainage channel flowing off property
7. Close up of drainage channel flowing off property
8. Low area pooling in application field
9. Low area pooling in application field
10. Drainage channel flowing off property
11. Overlook of application area
12. Application area
13. Holding pond
14. Holding pond
15. Holding pond
16. Holding pond
17. Holding pond
18. Deteriorated plastic liner for holding ponds
19. Part of application field

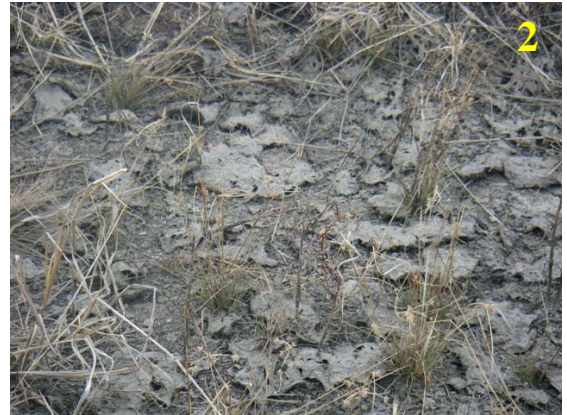
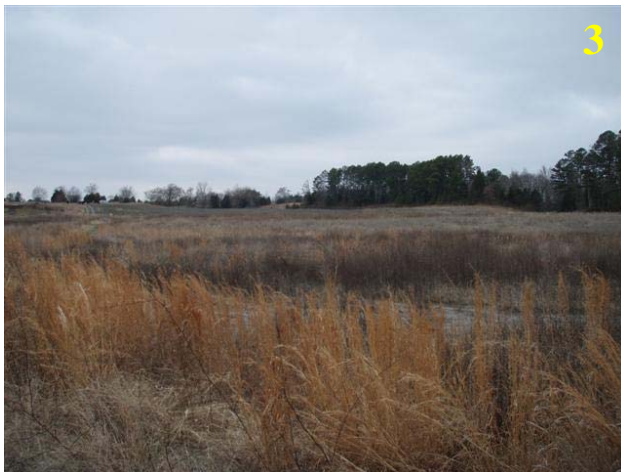
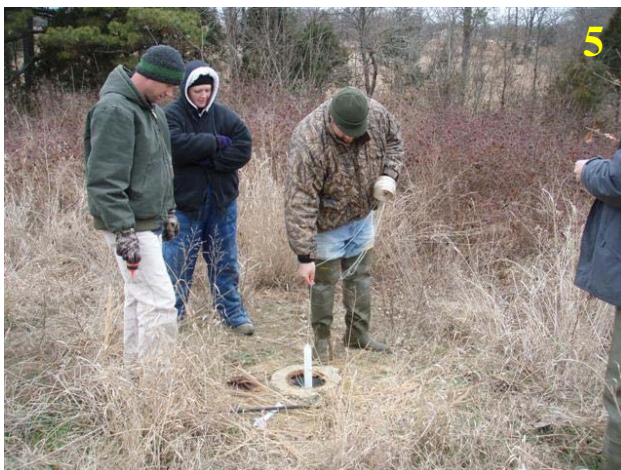
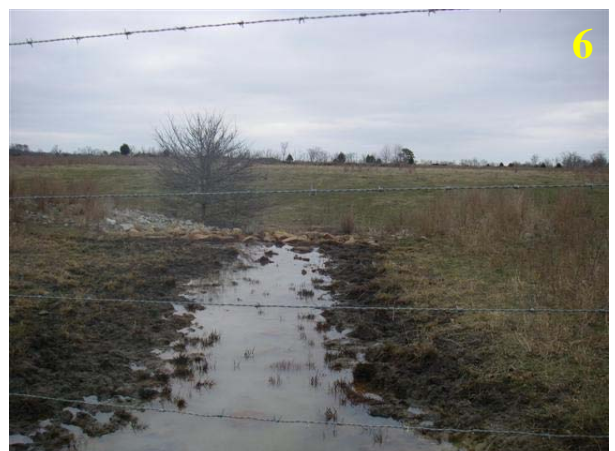
- Holding ponds are clay lined and those that aren't historically had plastic liners which have since deteriorated.
- Both application fields are covered with dormant vegetation.
- A drainage creek that runs through field 1 flows directly off site (eastern border) onto adjoining property.
- Not sure of application method.
- Site has 2 monitoring wells, both of which appear to be up-gradient of application areas.

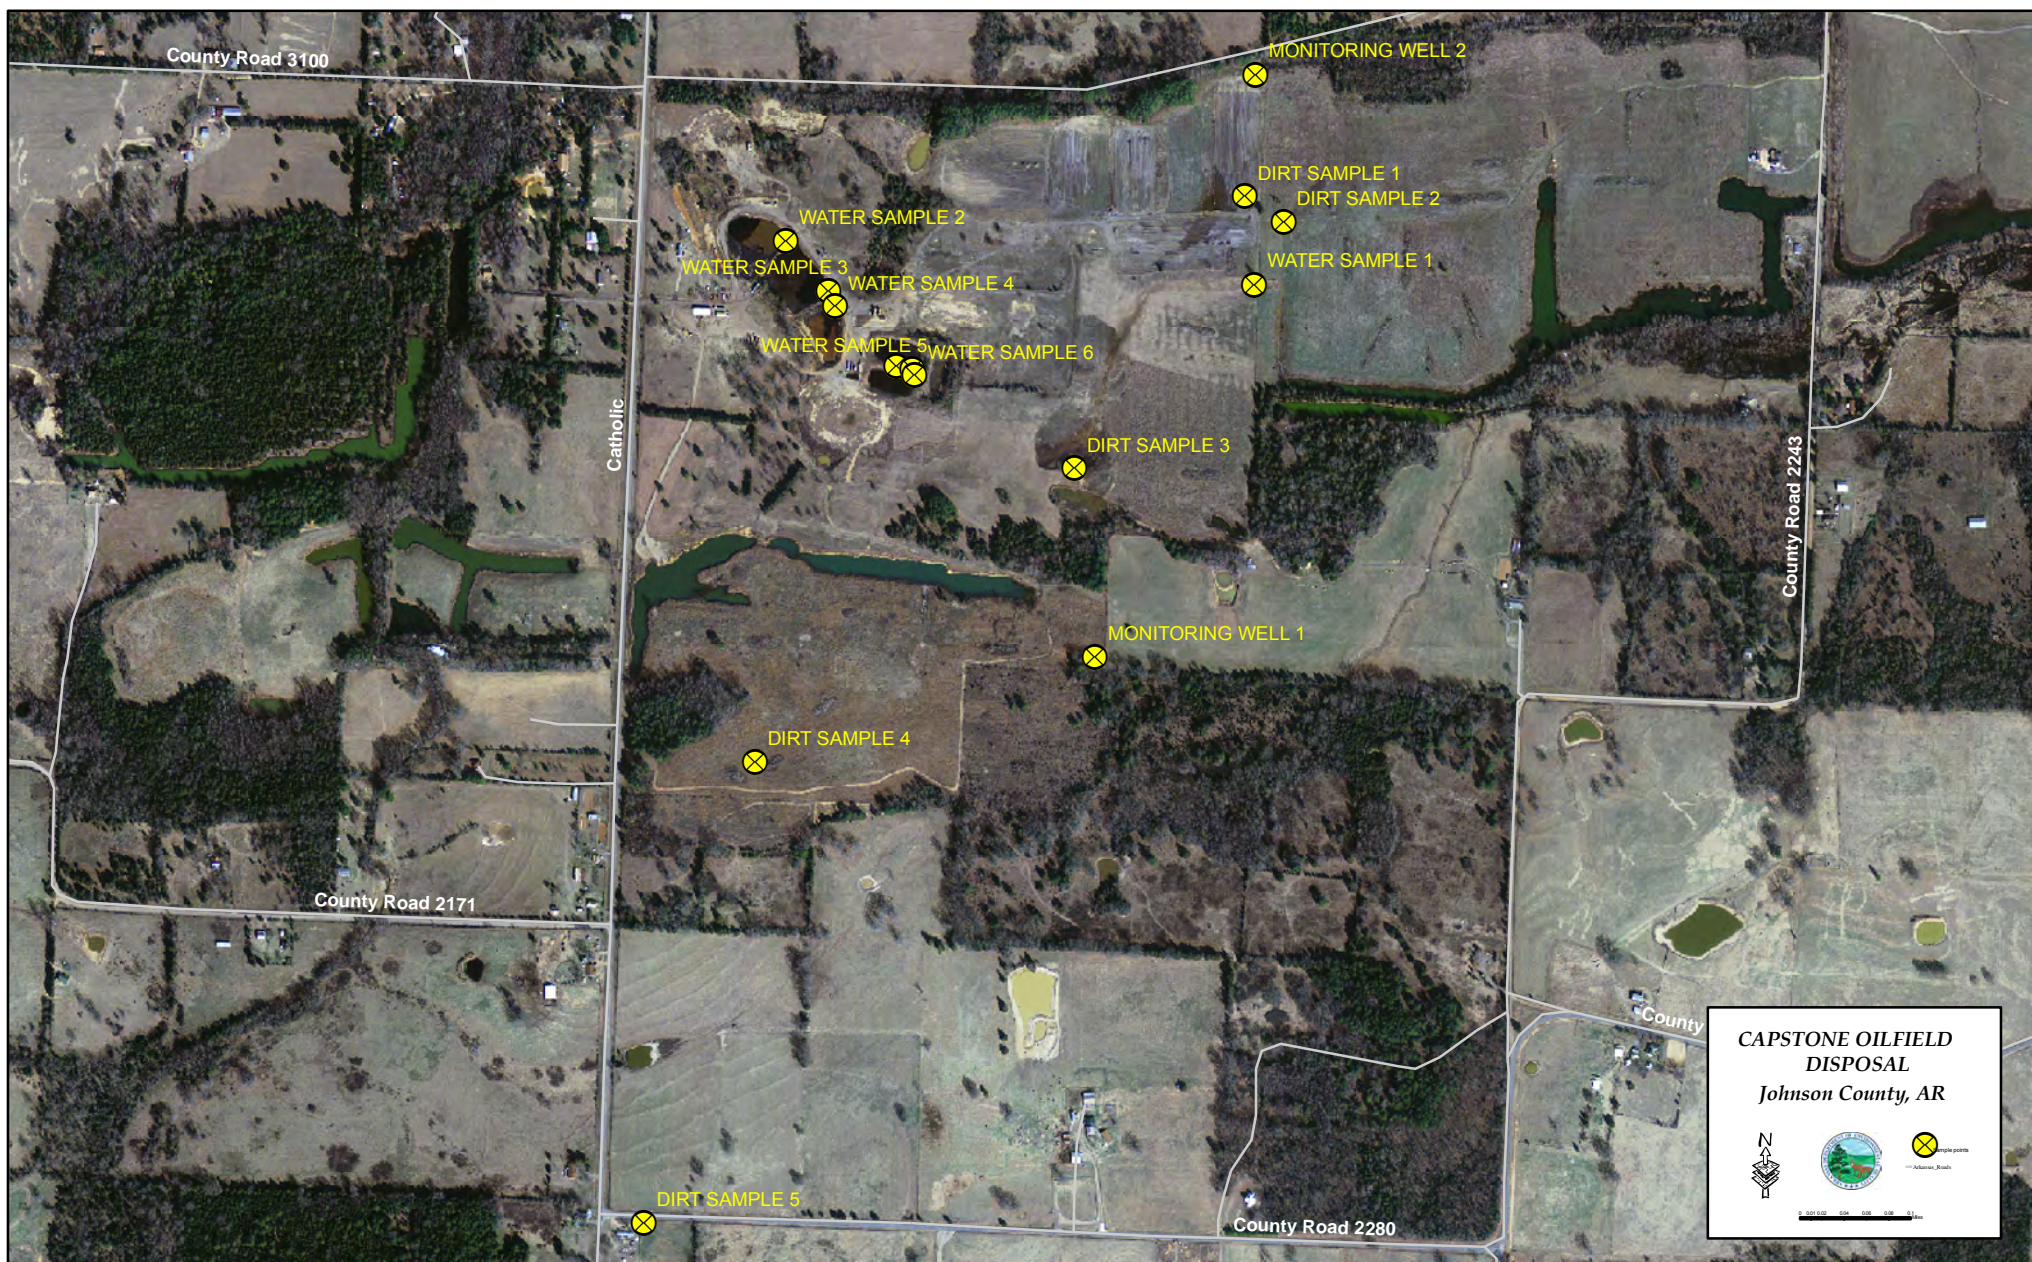
Capstone Oilfield Disposal of AR

Sample description for diagram

m₁-Monitoring well #1

m₂-Monitoring well #2

C₂-Pooling at southside of field 1

C₃-Low area behind ponds south field 1

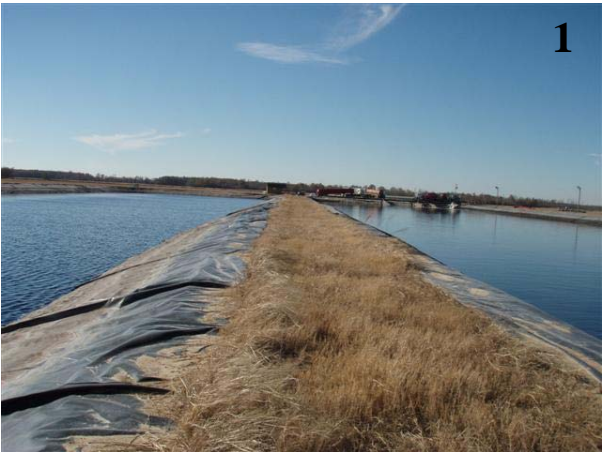
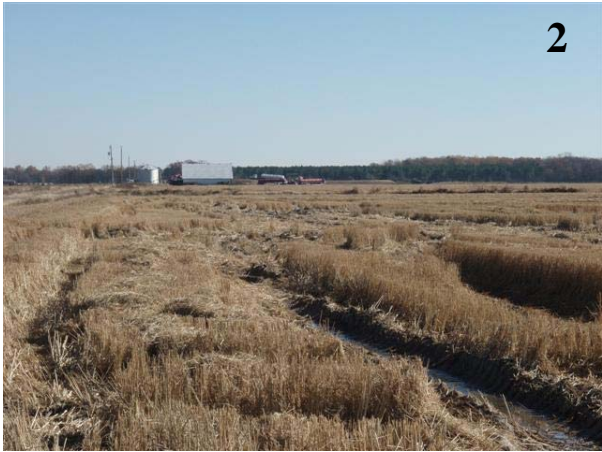
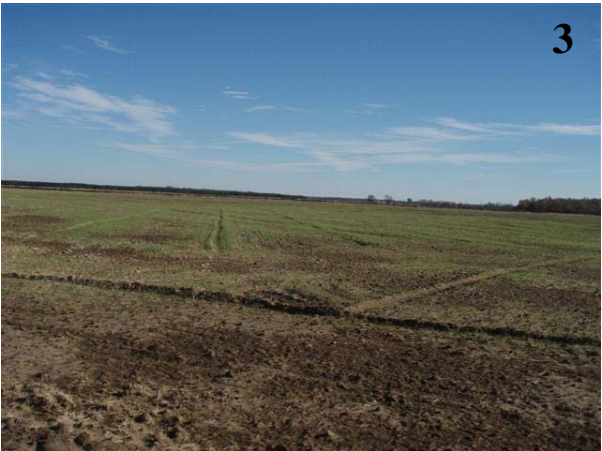
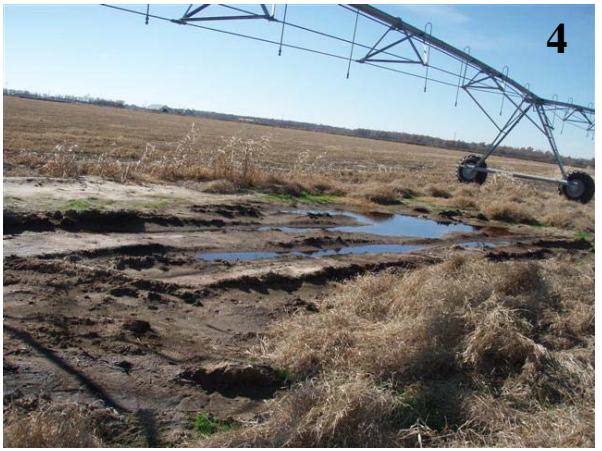
Pictures of Central Arkansas Waste Recovery

1. Holding ponds showing liner
2. Rice field that is included in permitted application area
3. Application area
4. Application area showing pooled water near center pivot irrigation system
5. Holding pond with trucks offloading product

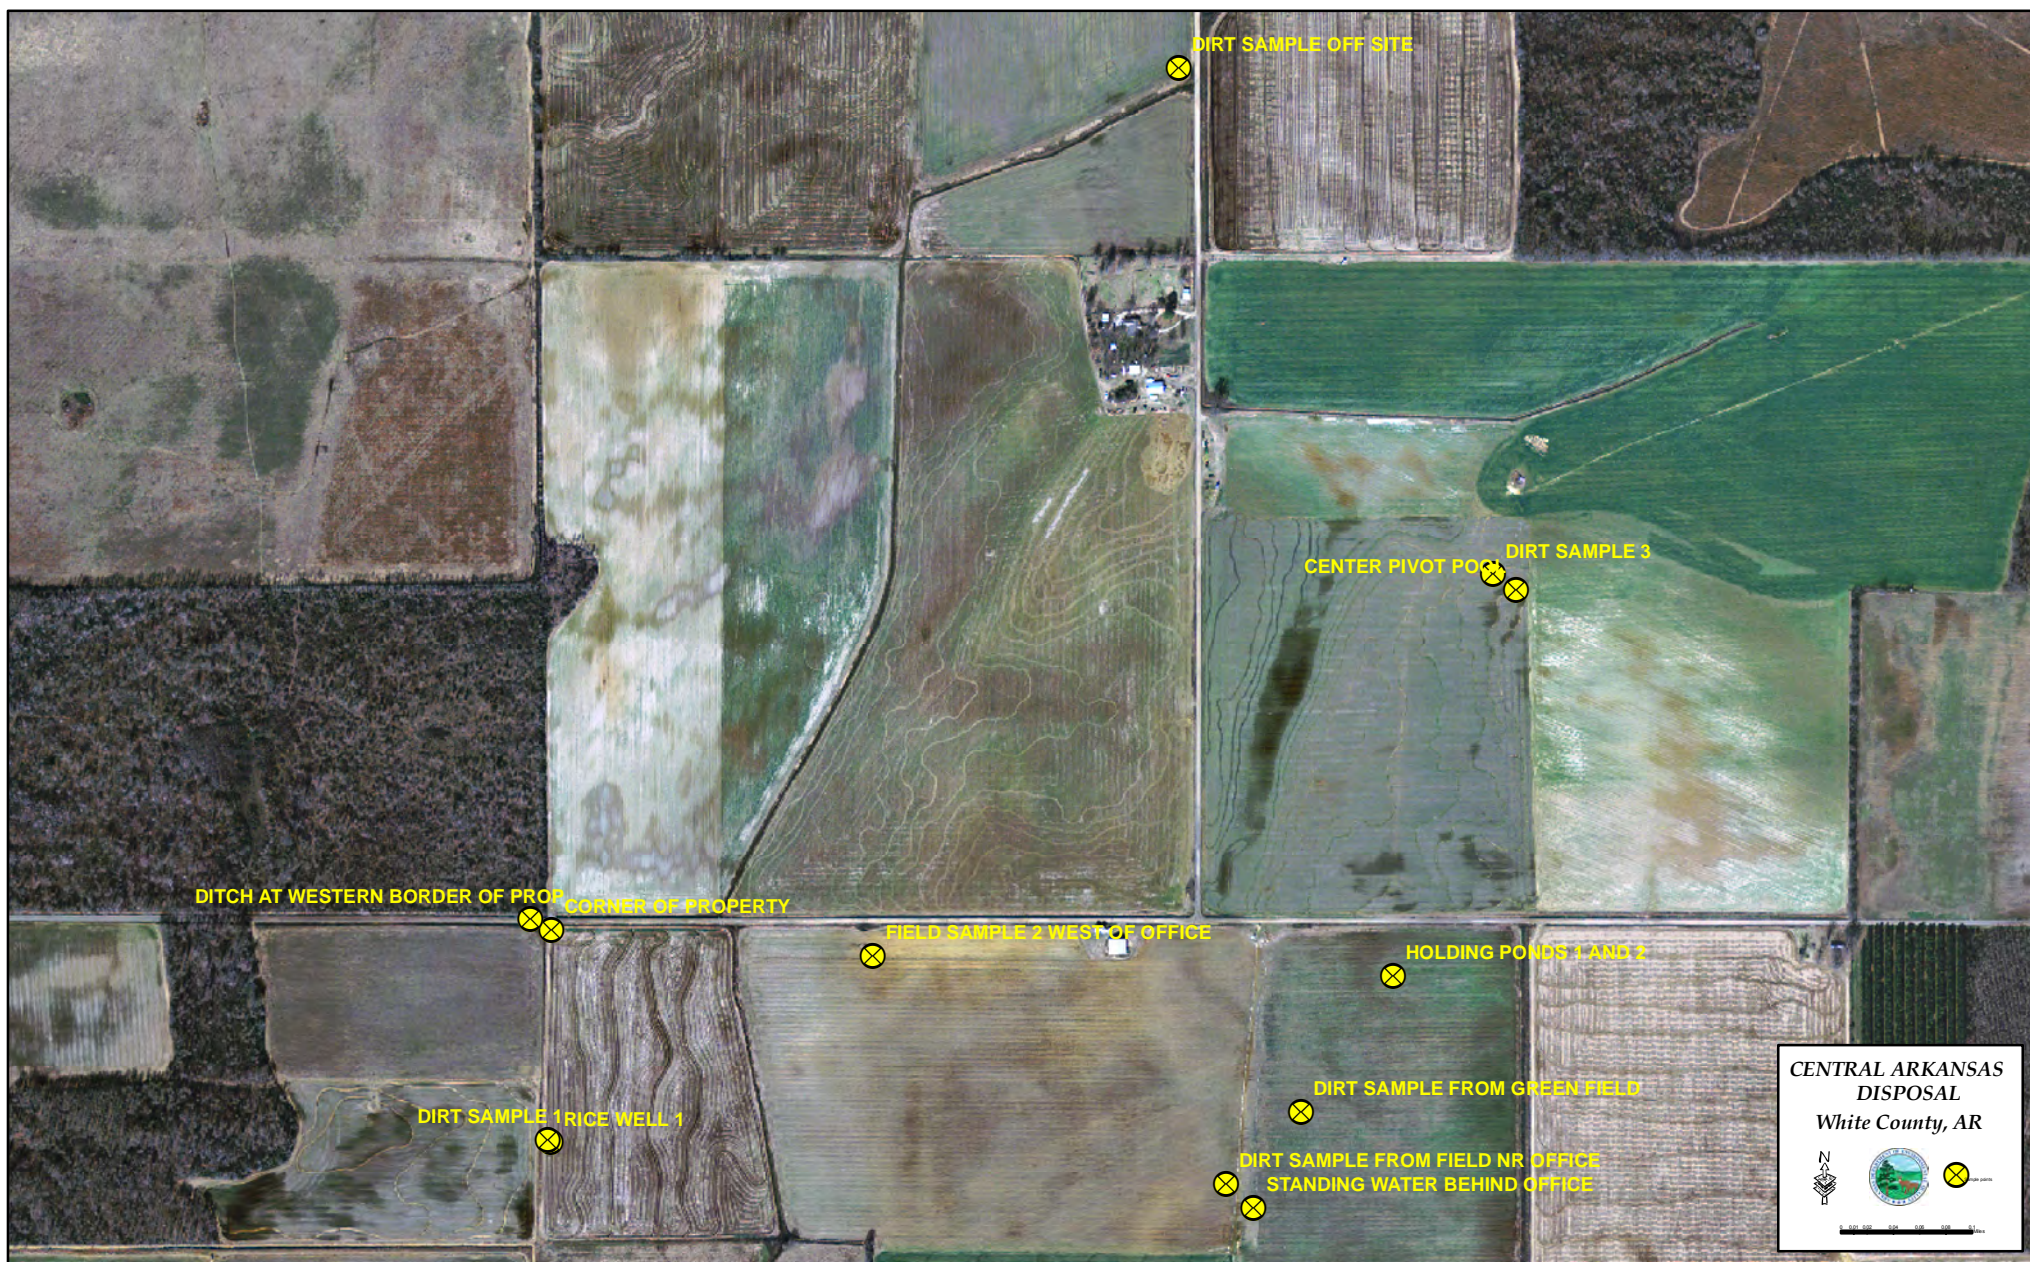
Central Arkansas Waste Recovery

Sample description for diagram

X4- Below irrigation equipment

Conductivity: 12,000 $\mu\text{S}/\text{cm}$

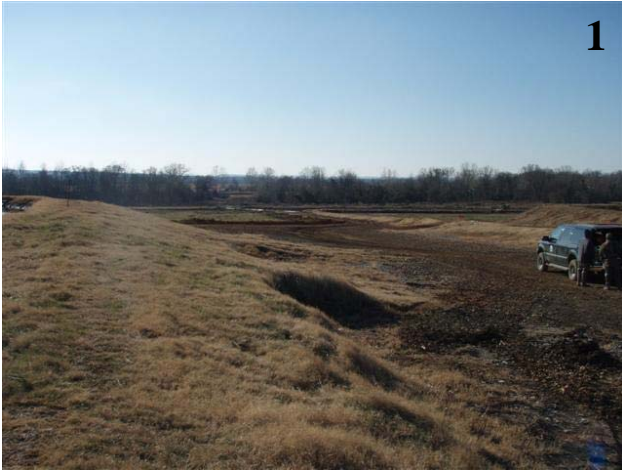
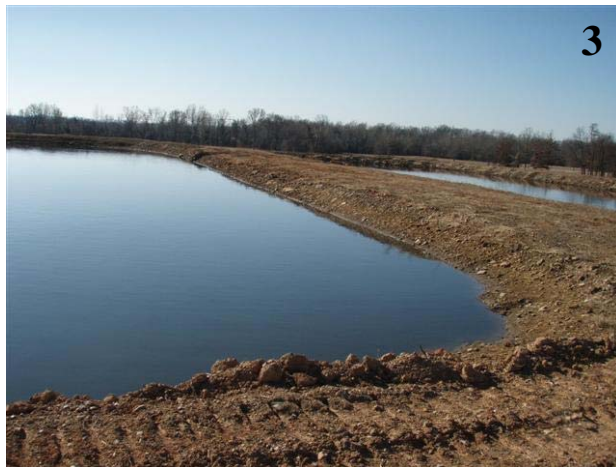
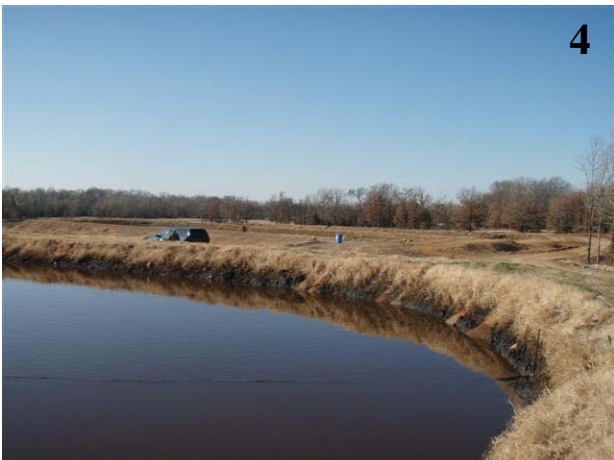
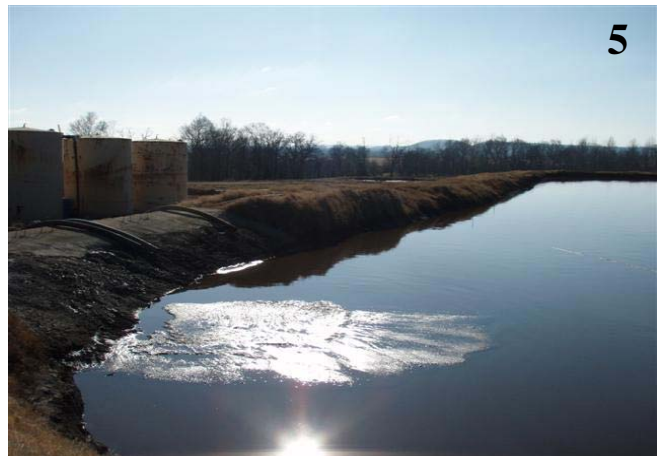
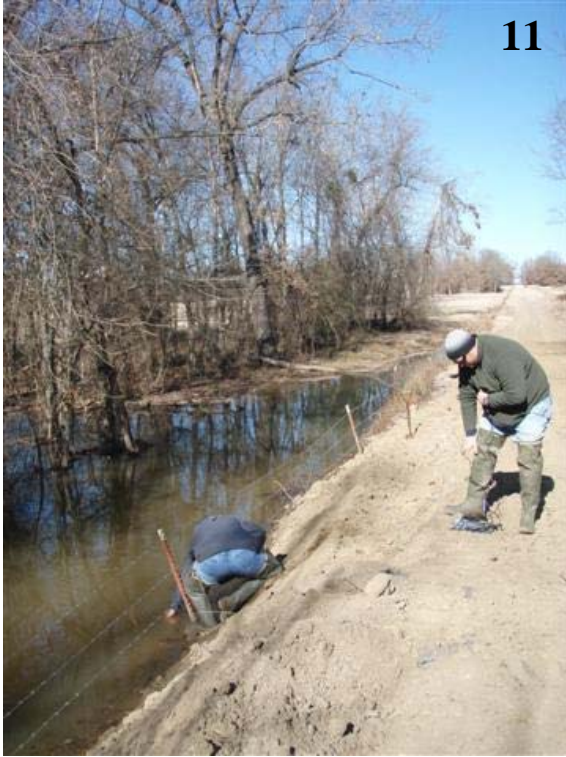
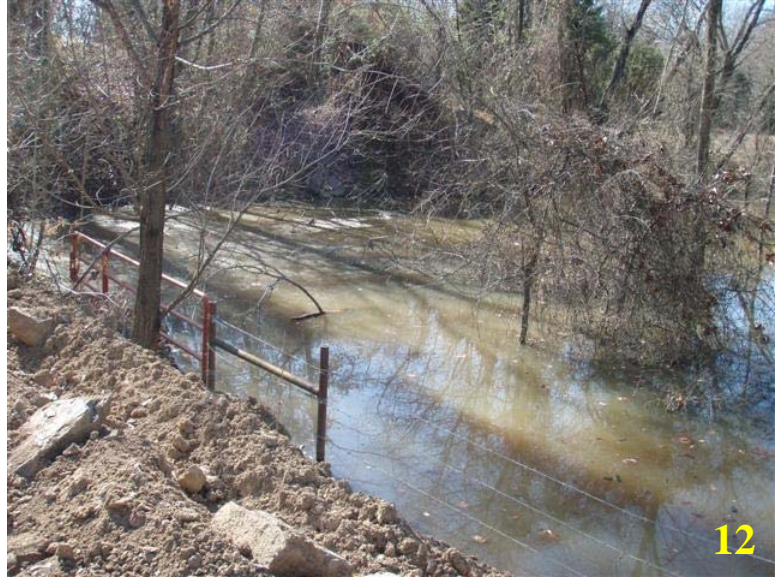
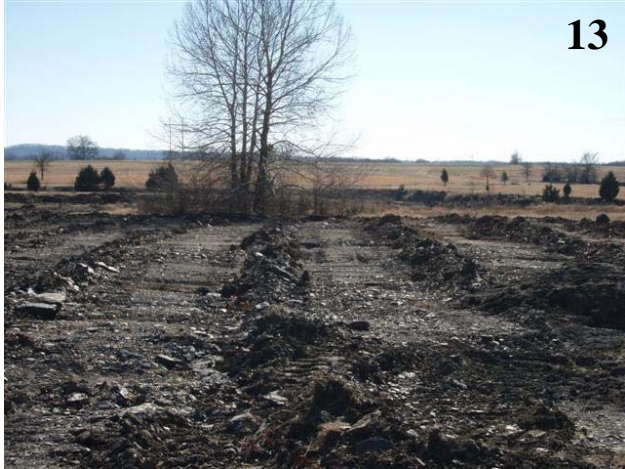
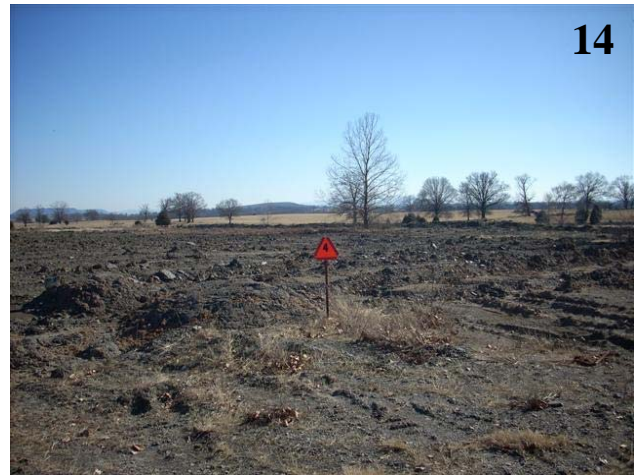
Pictures of Eastern Tank-Branch

- Holding ponds are clay lined.
- On-site conductivity checks seem to indicate that pond 3 is leaking. A puddle directly down gradient of pond 3 had a conductivity reading of 16,000 $\mu\text{S}/\text{cm}$.
- Application field 3 appeared to have high oil content.
- Fluids are applied using a spray gun system.
- Spray gun set up to spray into swamp area behind application field 3. Facility had a pipe going from ponds 1 and 2, which was flowing by gravity down to a low-lying wetland area. This discharge had a conductivity of 40,000 $\mu\text{S}/\text{cm}$, which is the highest value we have ever documented.
- Partial grass on fields 1 and 2. Fields 3 and 4 solid dirt and/or rocks, no vegetation.
- Direct discharge to waters of the state.
- Mangled channel with undersized culvert under new road.

1. Levee of holding pond
 2. Application area
 3. Holding pond
 4. Holding pond
 5. Holding pond
 6. Application pipe and hose run through wetland area in which creek flows through property
 7. Wetland area in which creek flows through property
 8. Application field
 9. Application field
 10. Applicator in middle of wetland area through which creek flows
 11. Road that has been constructed along border of property with culvert insufficient to handle flow of creek
 12. Water dammed up by construction of road
 13. Application area number 4
- Application area number 4
