Introduction

Drilling Fluid Disposal Site Sampling Plan

Summary of Findings

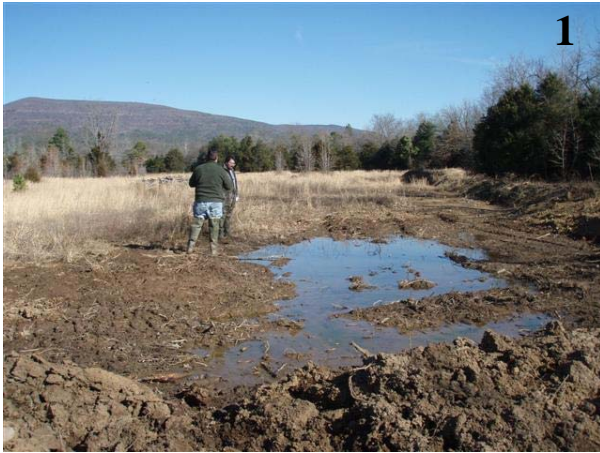
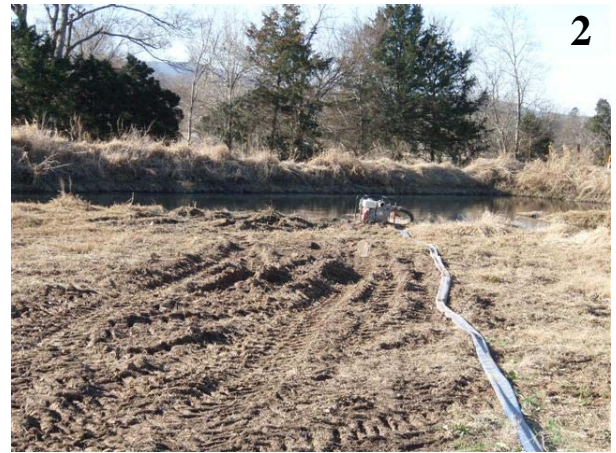
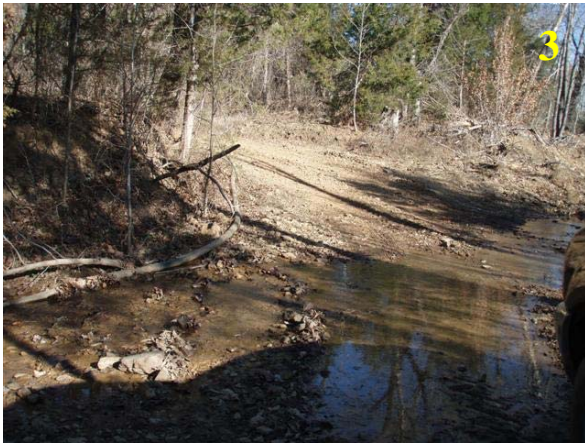
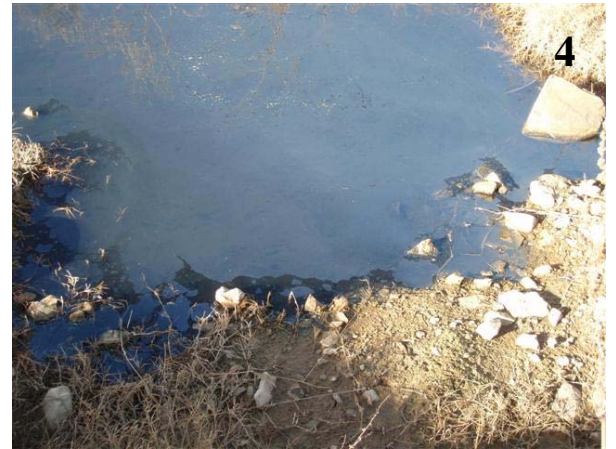
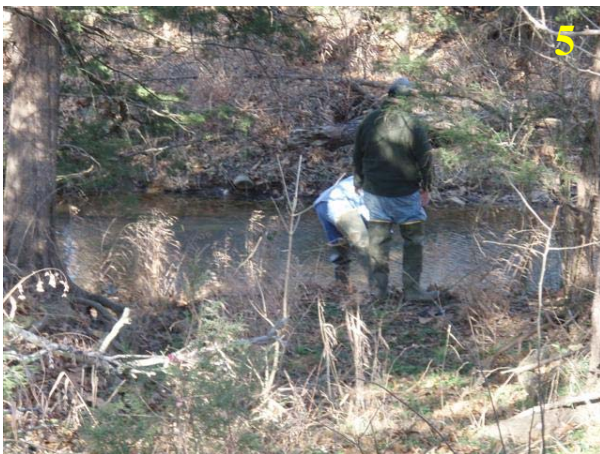
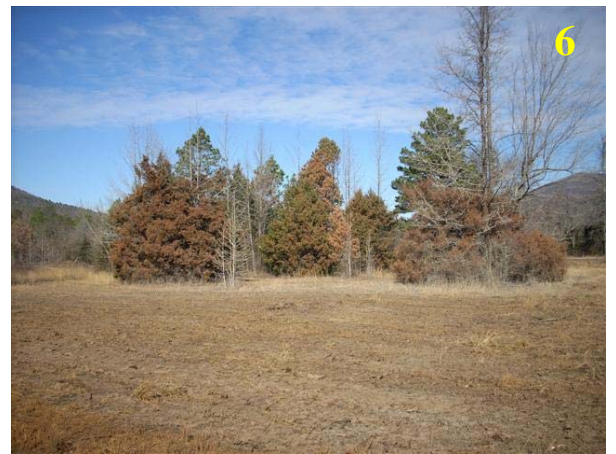
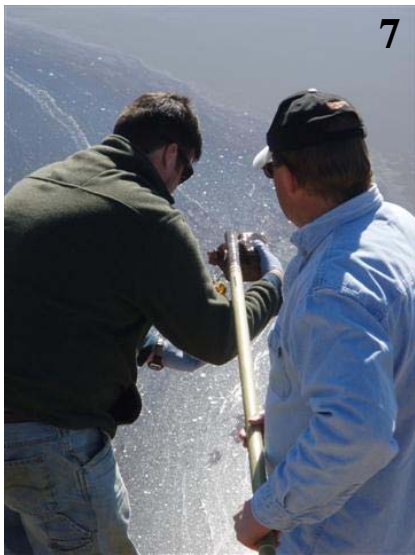
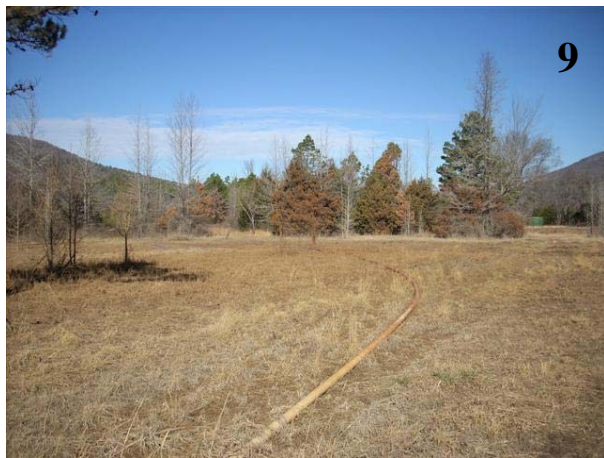
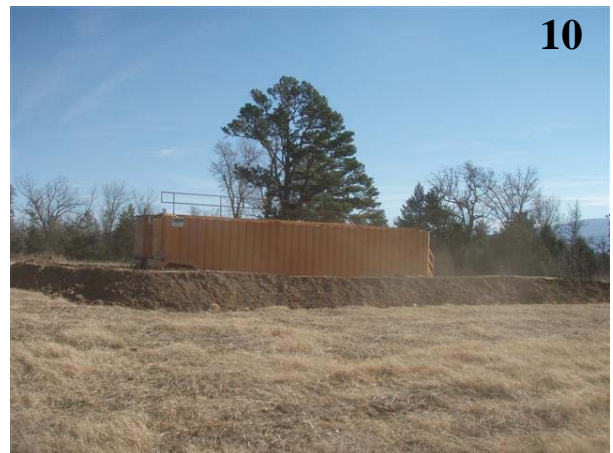
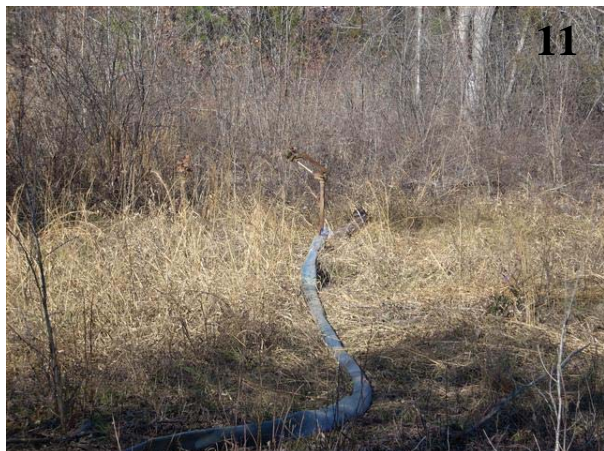
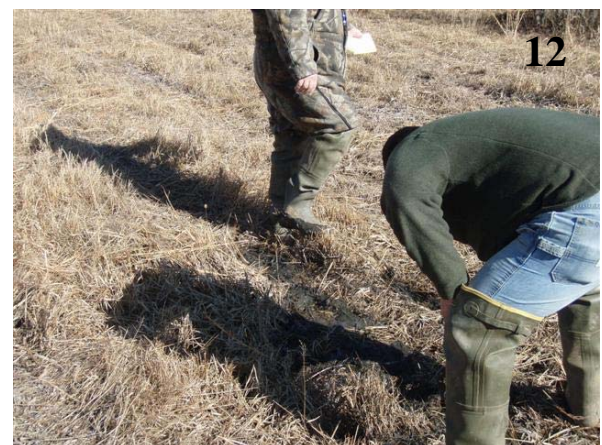
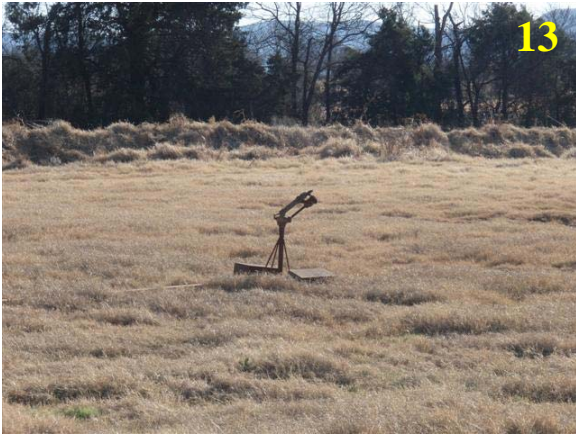
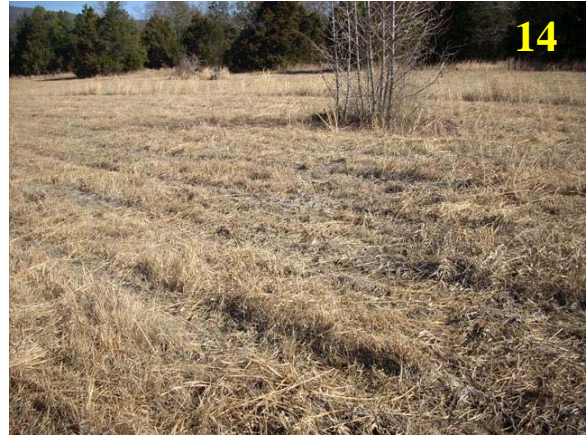
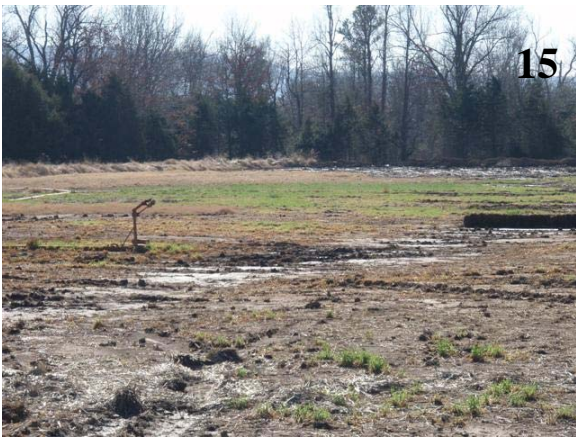
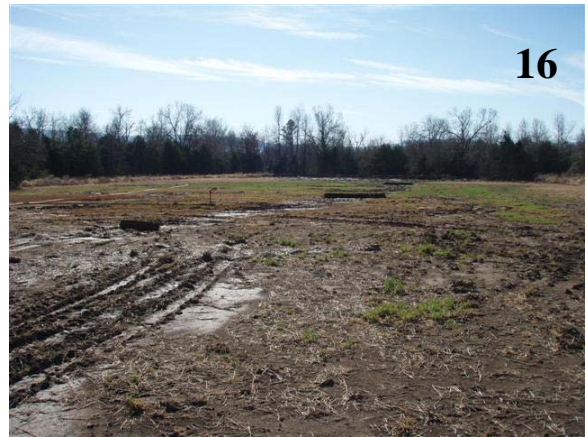
Pictures of Eastern Tank-Hartford

1. Application area with standing water
2. Application area where standing water is being pumped off
3. Creek crossing
4. Standing water in application area with sheen

5. Sampling crew sampling stream between application areas
6. Application area where evergreens haven't been removed prior to application. Evergreens showing signs of distress due to application of fluids on foliage.

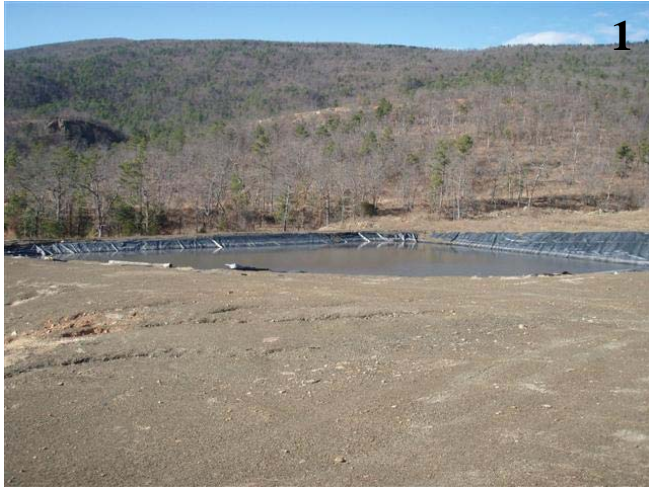
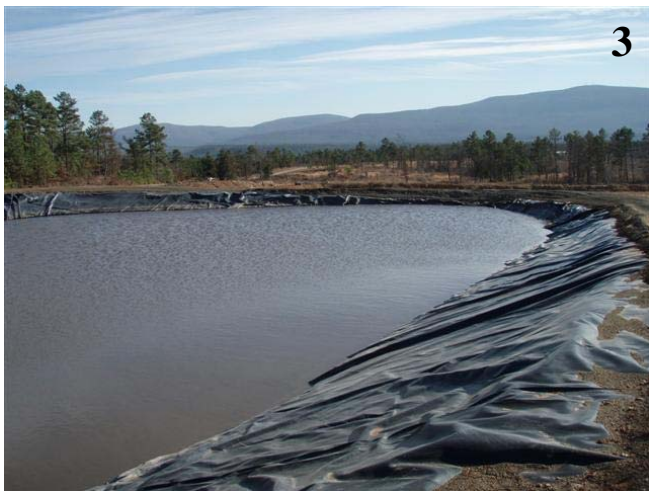
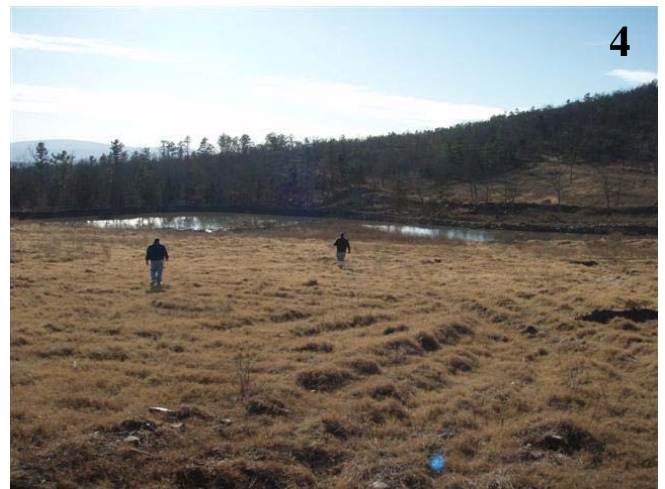
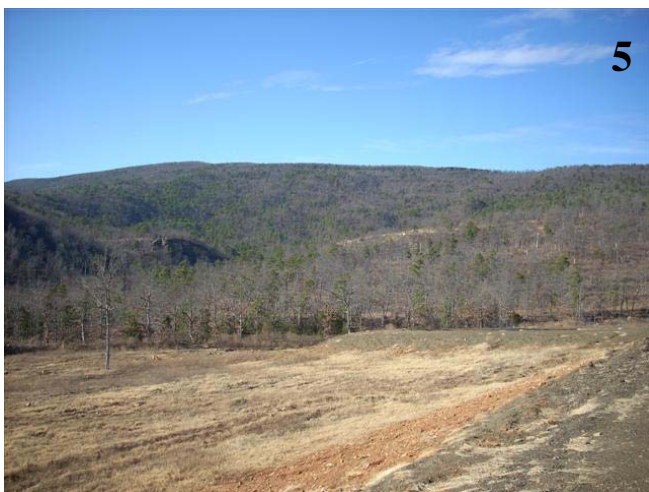
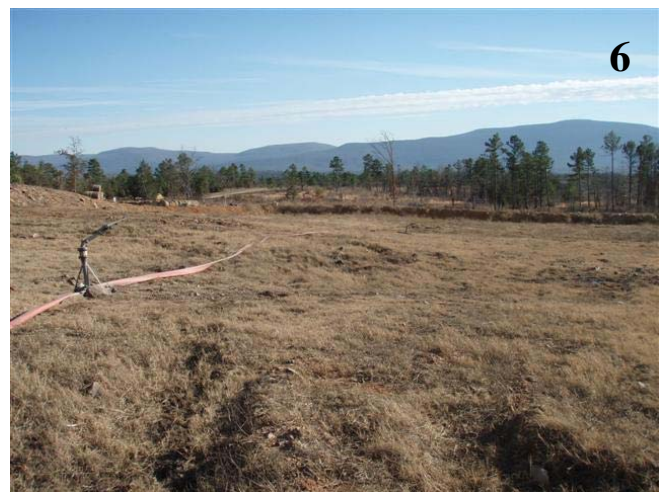
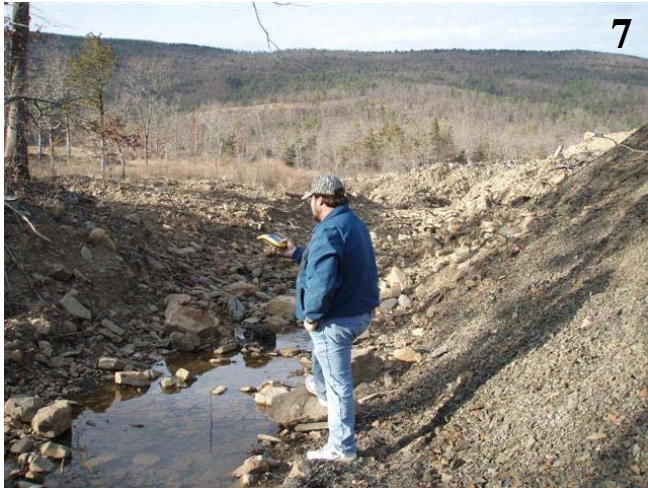
Pictures of Enviro Disposal

1. One of the holding ponds
2. Holding pond with pump and pipe to applicator
3. Holding pond
4. Water being retained by berm at end of application area
5. Application area
6. Application area that was being used
7. Creek that flows through property (berm behind individual is constructed near (in) creek and retains water that flows off property)
8. Creek that flows on below site
9. Lysimeter from which we were unable to obtain enough water to sample

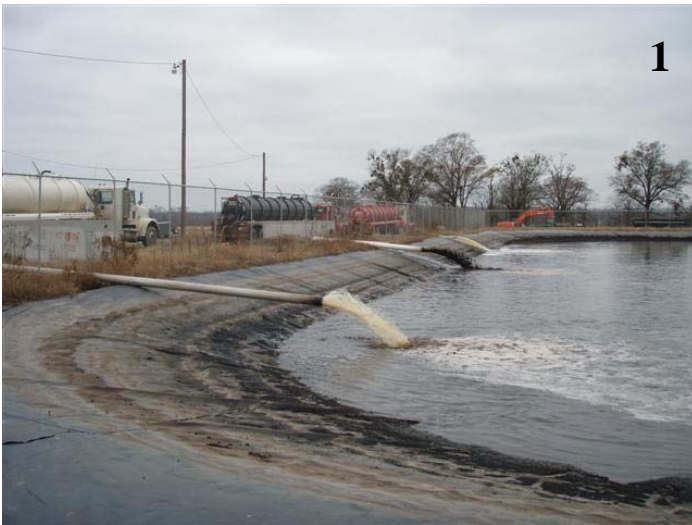
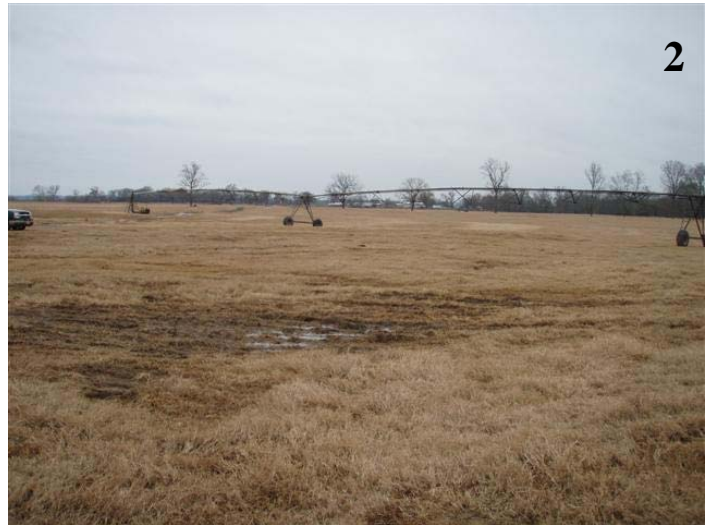
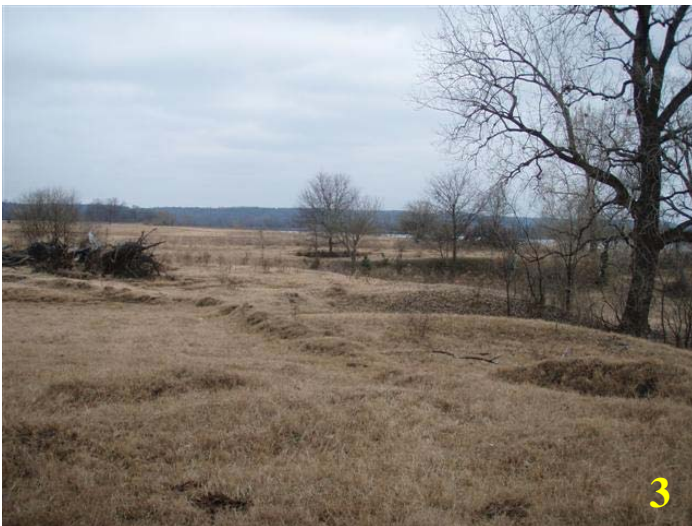
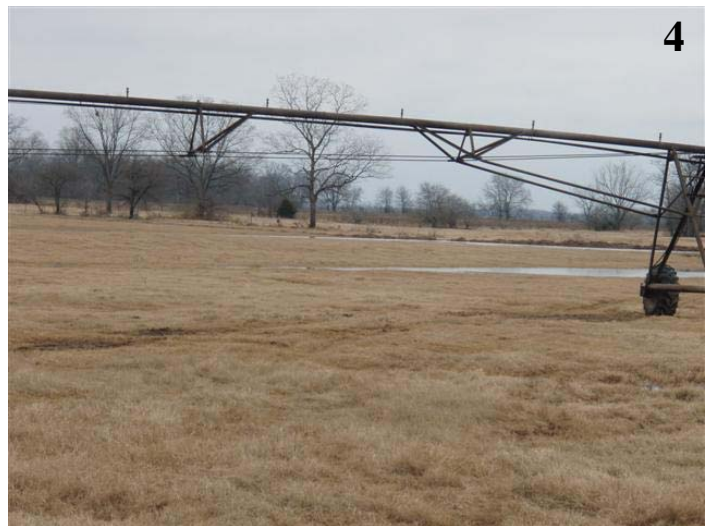
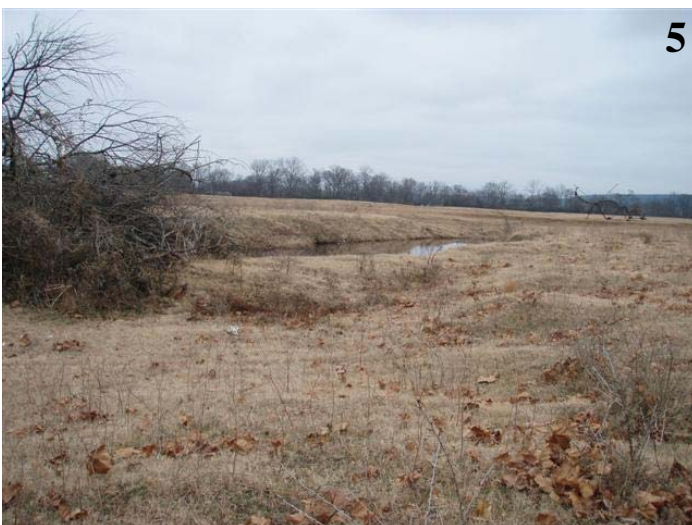
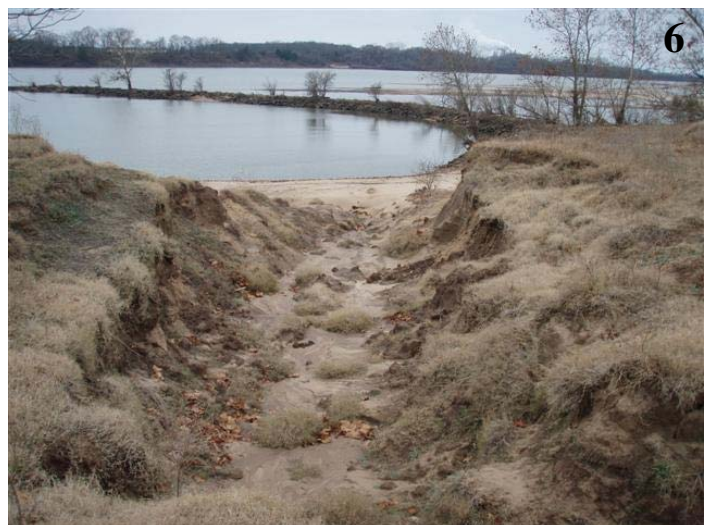
Pictures of Environmental Solutions and Services

1. Holding pond and trucks emptying into it
2. Application area with center pivot irrigation system
3. Berm around land application area
4. Application area with standing water that we offsite out of picture
5. Standing water near a berm
6. Ditch leading to Arkansas River

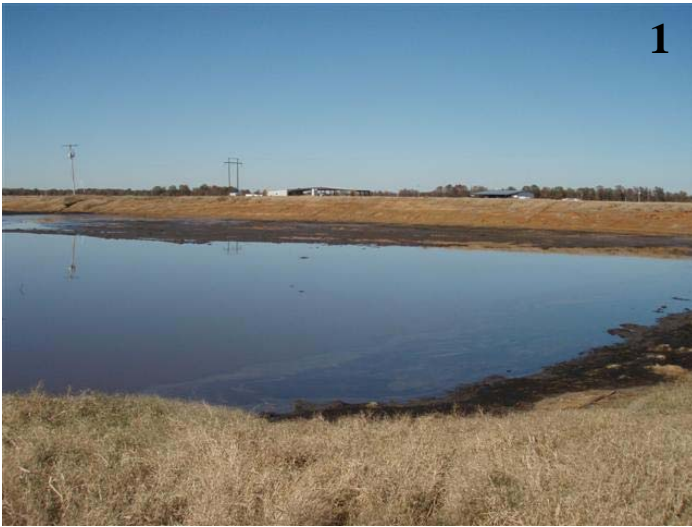
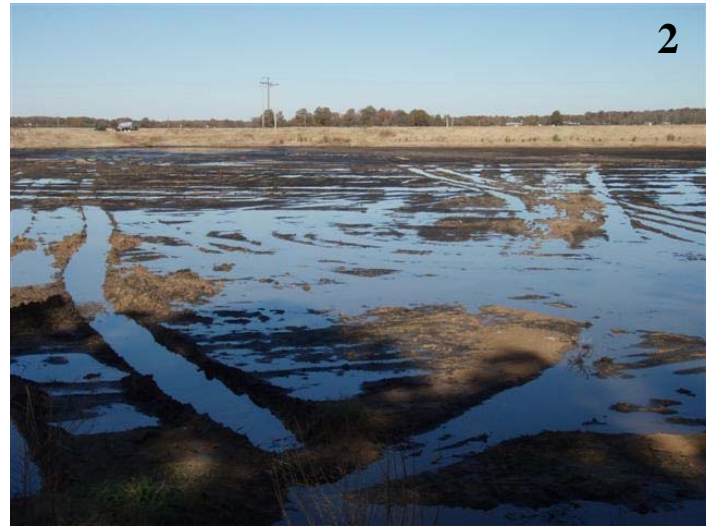
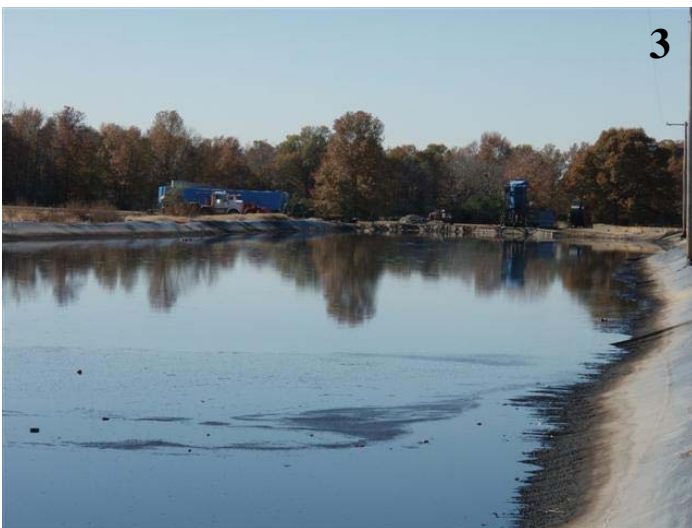
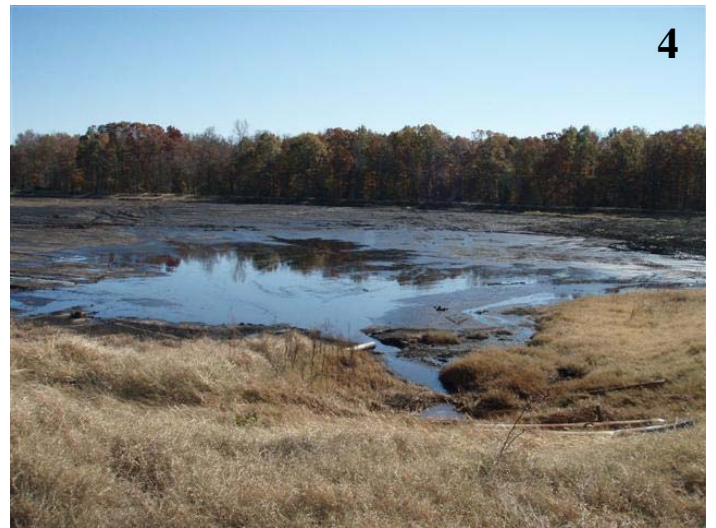
Pictures of Fayetteville Shale Land Farm

1. Pooled water at end of application area
2. Application area where fluids were being applied
3. Holding pond (oil skimmer seen at far end of pond)
4. Application area where fluids were just being piped into area

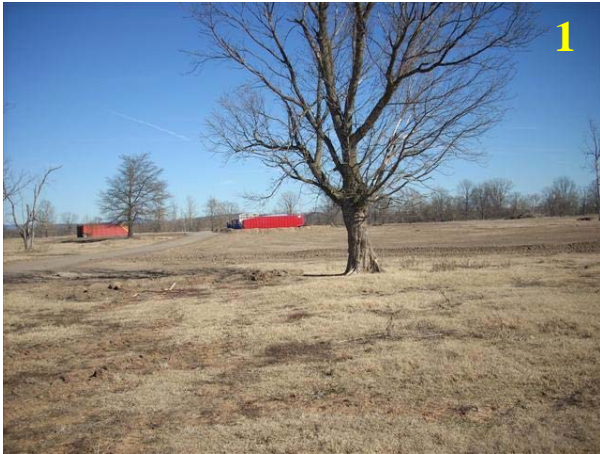
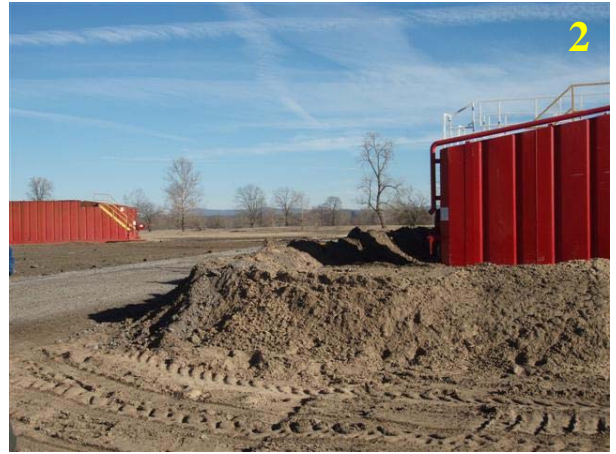
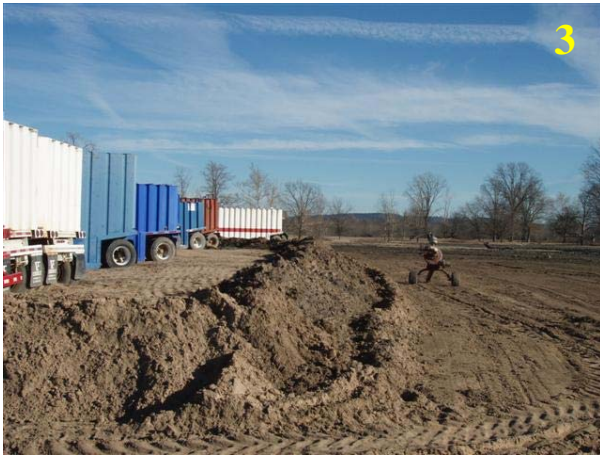
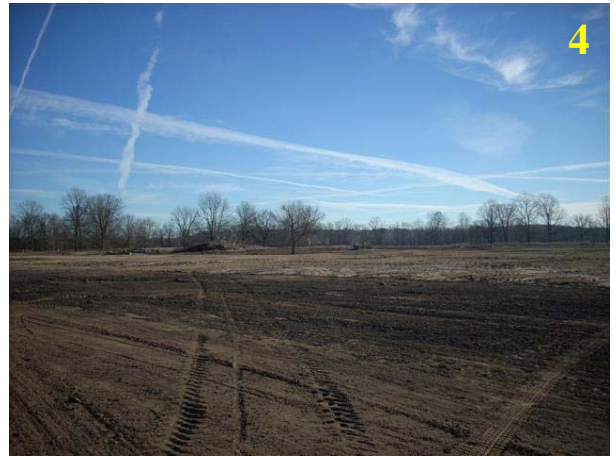
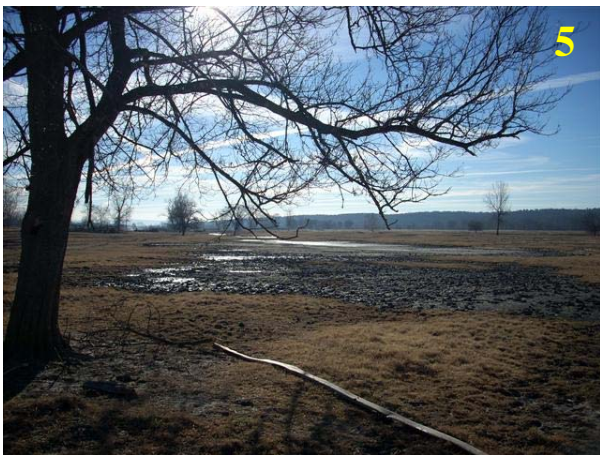
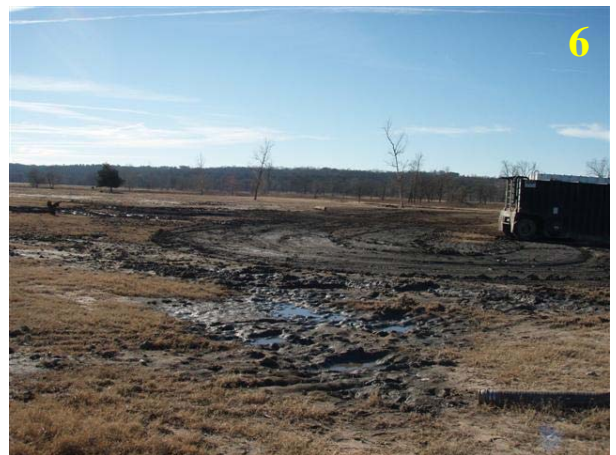
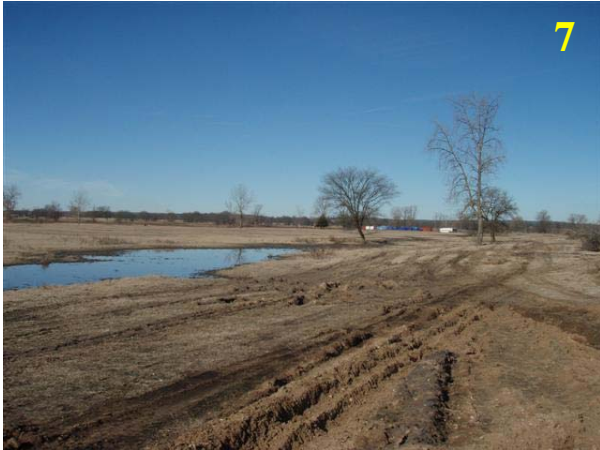
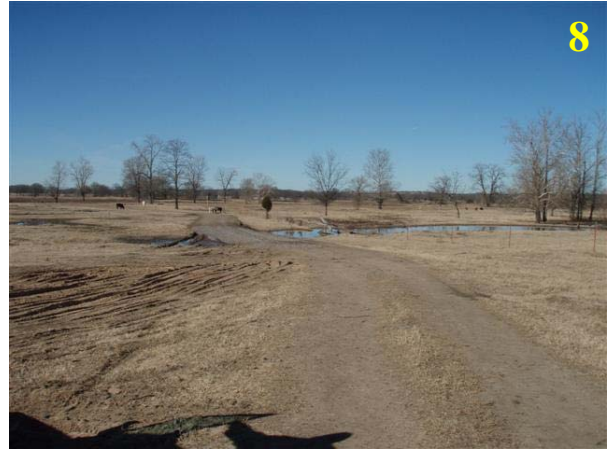
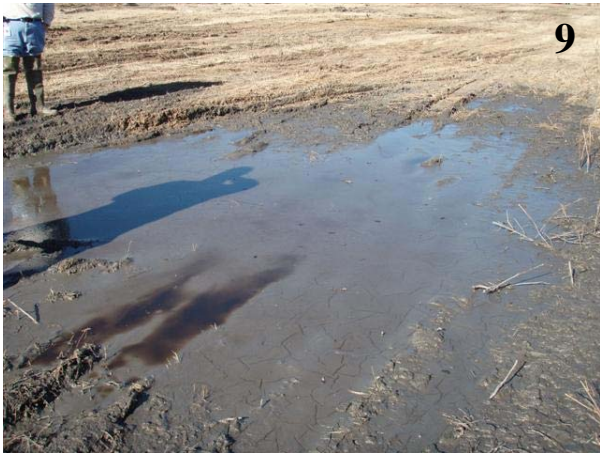
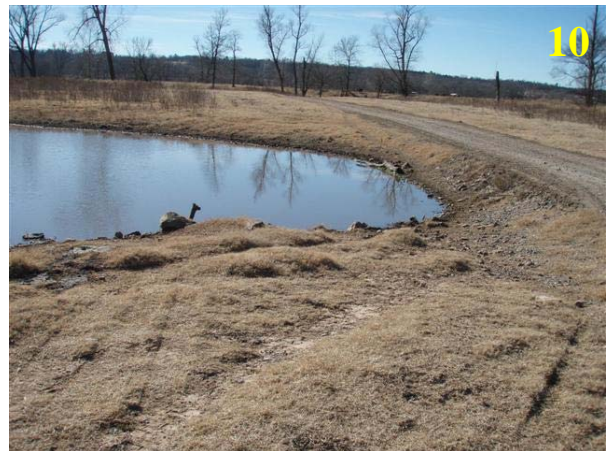
Pictures of Fugo Services

1. Picture showing frac tanks and application area
2. Picture of frac tanks showing containment
3. Rear view of frac tanks showing containment
4. Application area
5. Application area with hose
6. Area near frac tanks with standing water (probably from rainfall event)
7. Application area near back of property with standing water that continued off property
8. Swale where water collects across from application area (accessible to livestock)
9. Pooled water in application area
10. Pond at "entrance" to facility.

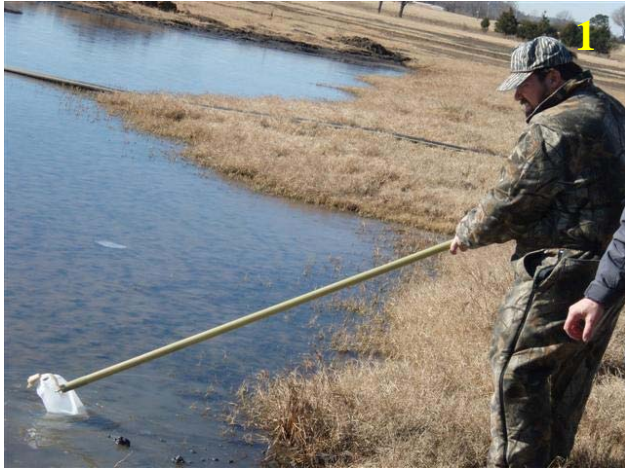
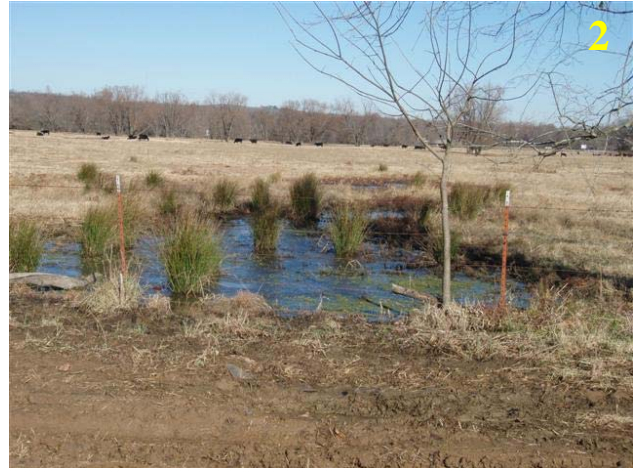
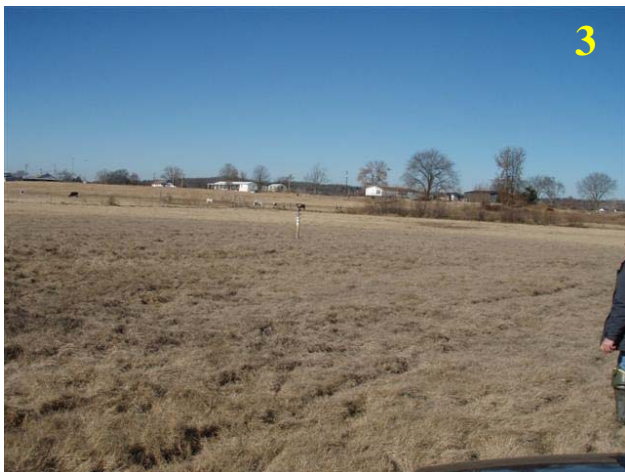
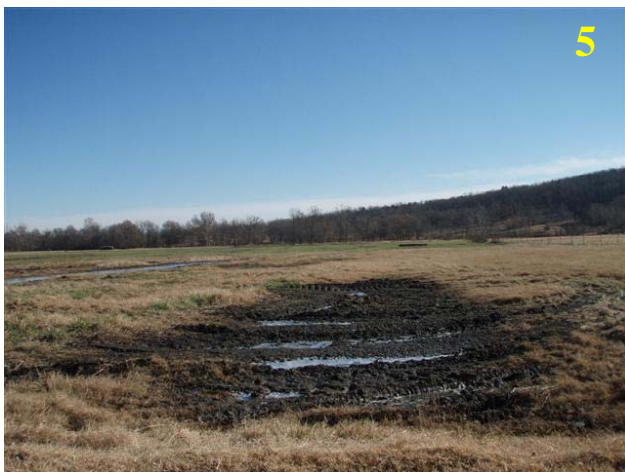
Pictures of Green Grow Disposal

1. Sample from pond where drilling mud has been deposited.
2. Swale where crosses into neighboring property
3. Application Field
4. Application Field
5. Application Field
6. Application Field
7. Baler from well sampled near holding pond
8. Crew sampling well

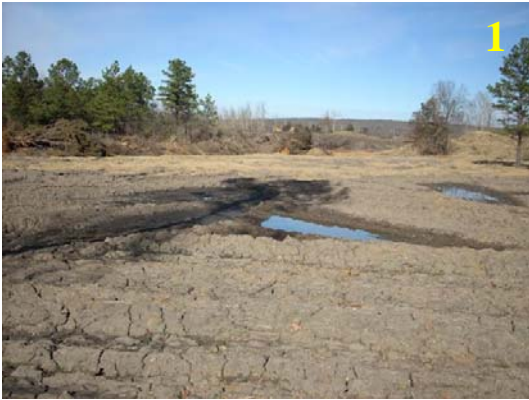
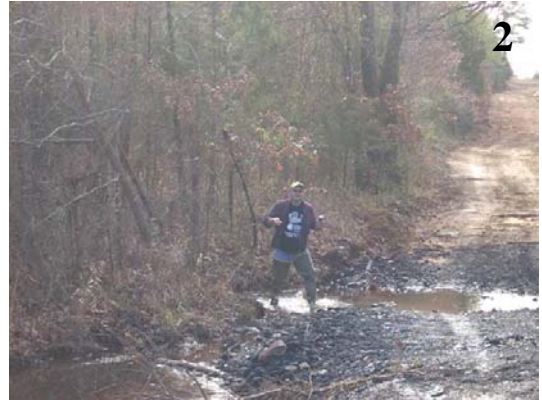
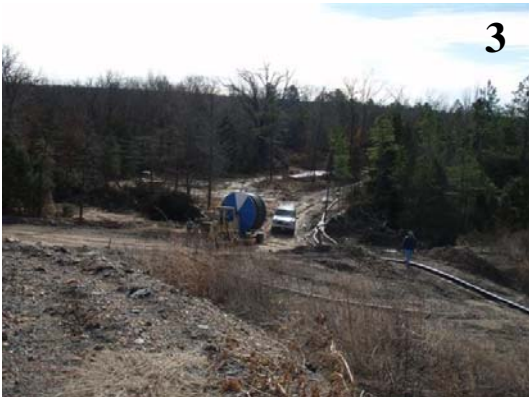
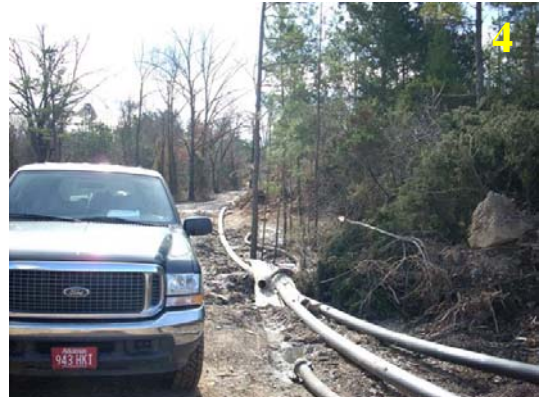
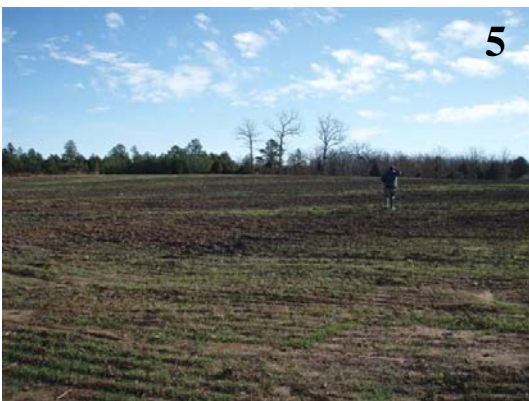
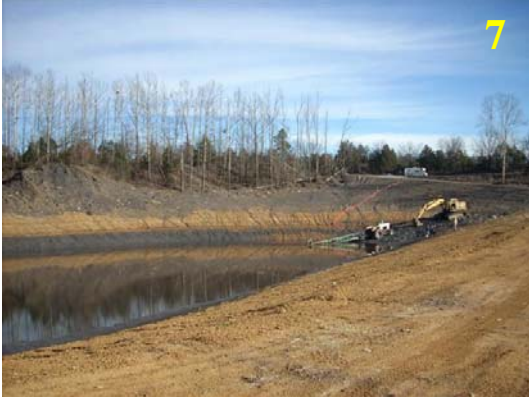
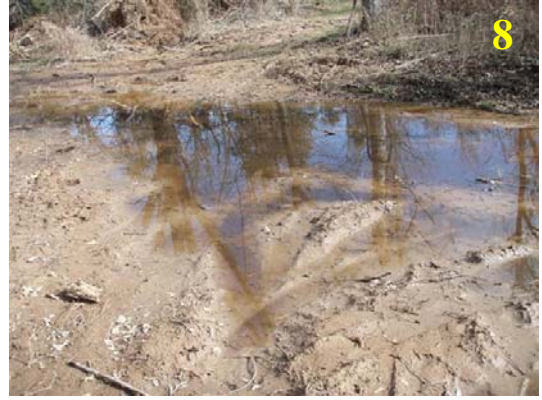
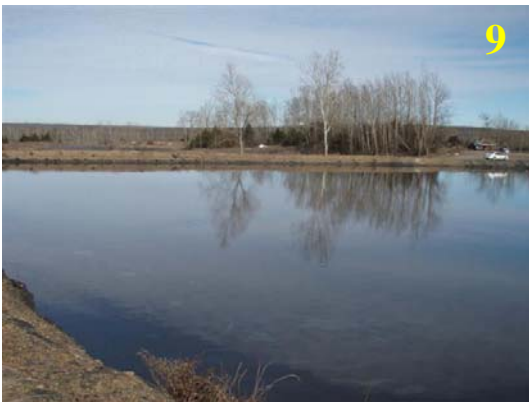
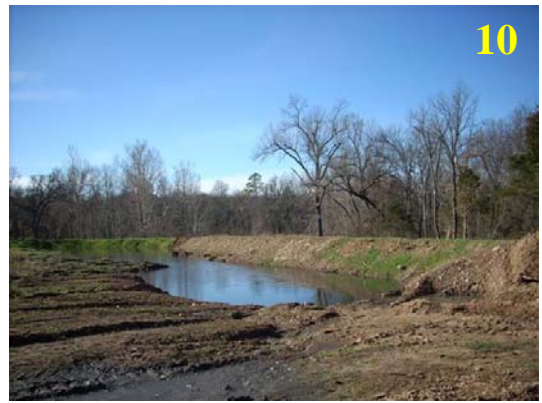
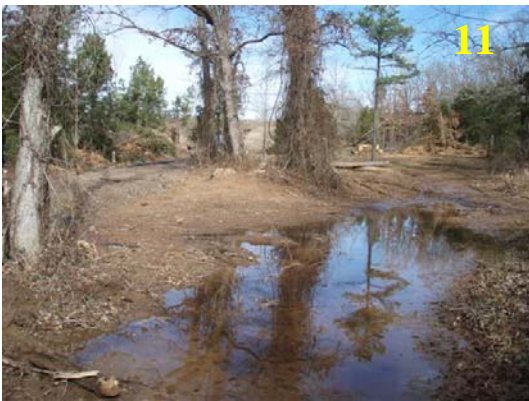
Pictures of Henry Comer Disposal

1. Application area with standing water
2. Nat sampling near application area number 4
3. Applicator with application area number 4
4. Application area number 4 with water distribution system
5. Application field
6. MacKenay Creek and discharge from pond on Comer property
7. Holding pond number 2
8. Pooled water in application area
9. Holding pond
10. Mine pit
11. Unknown
