A R K A N S A S
Department of Environmental Quality

RE: Rogers Pollution Control Fac. Inspection
AFIN: 04-00155 Permit No.: AR0043397

# WATER DIVISION INSPECTION REPORT

**PRETREATMENT COMPLIANCE INSPECTION (PCI) REPORT**

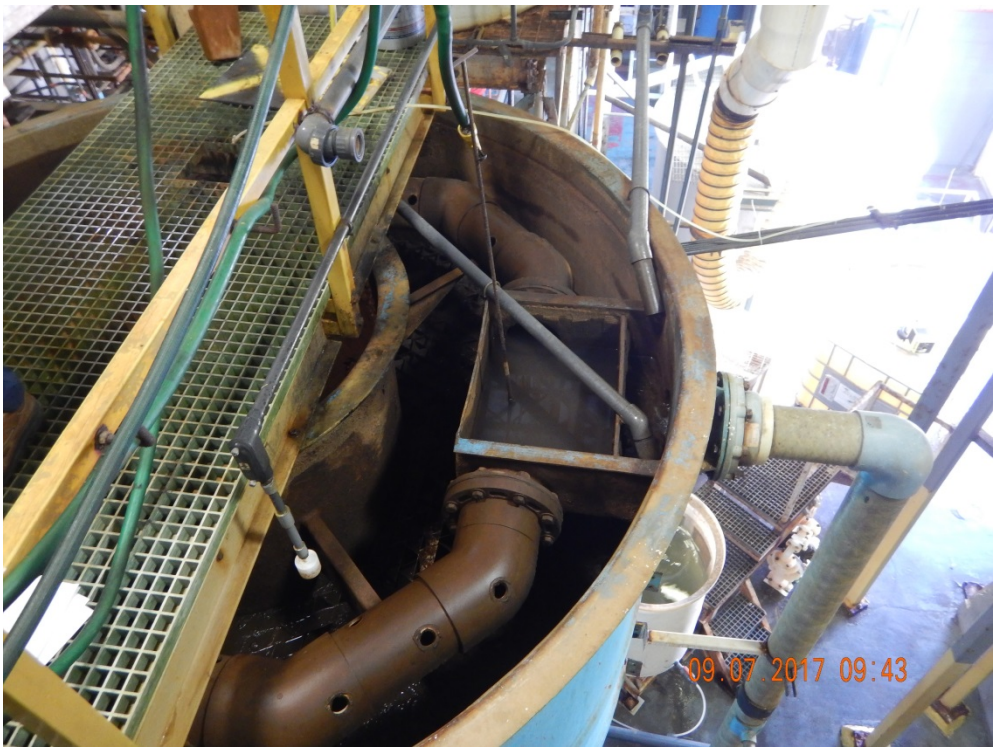
| Water Division Photographic Evidence Sheet | | | | | |
|---|---|---|---|---|---|
| Witness: | | | | Photo #: | **3** |

| Water Division Photographic Evidence Sheet | | | | | |
|---|---|---|---|---|---|
| Description: | **6,000 gallon clarifier.** | | | | |

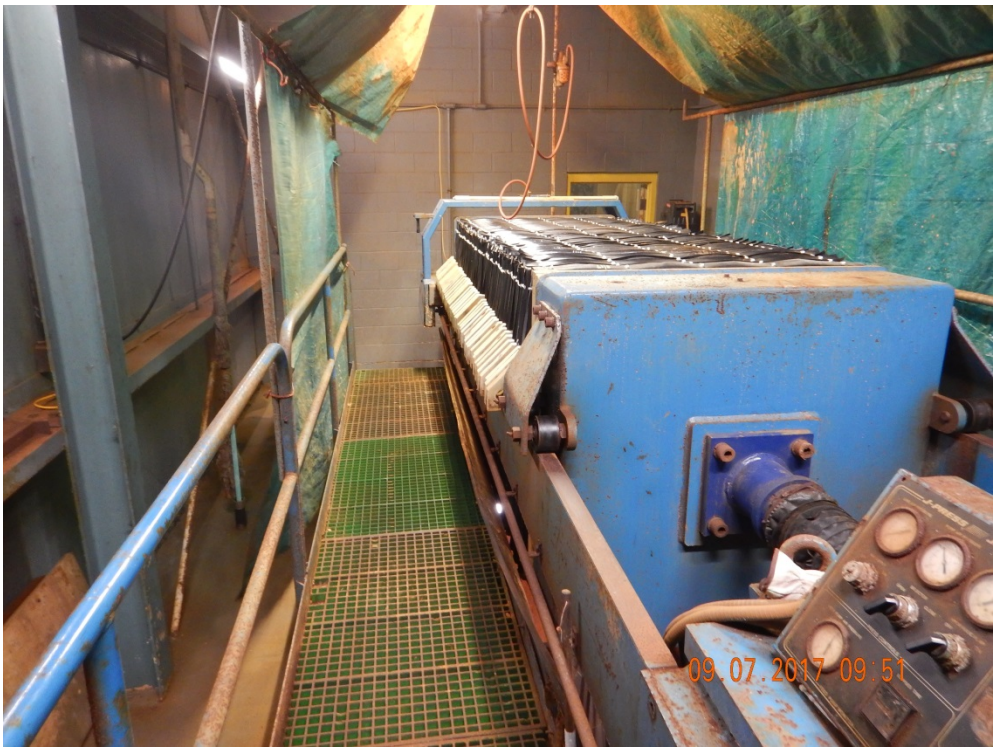
| Water Division Photographic Evidence Sheet | | | | | |
|---|---|---|---|---|---|
| Witness: | | | | Photo #: | **5** |

| Water Division Photographic Evidence Sheet | | | | | |
|---|---|---|---|---|---|
| Description: | **Filter press system.** | | | | |

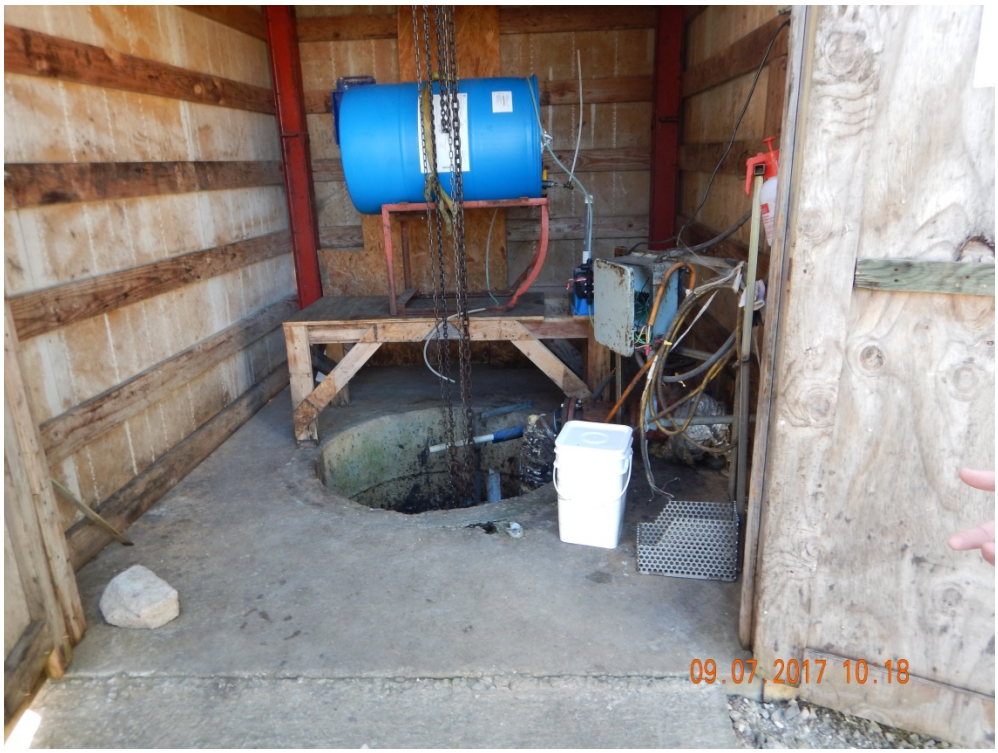
| Water Division Photographic Evidence Sheet | | | | | |
|---|---|---|---|---|---|
| Witness: | | | | Photo #: | **9** |

| Water Division Photographic Evidence Sheet | | | | | |
|---|---|---|---|---|---|
| Description: | **Wastewater wet well with dry bacteria additive.** | | | | |

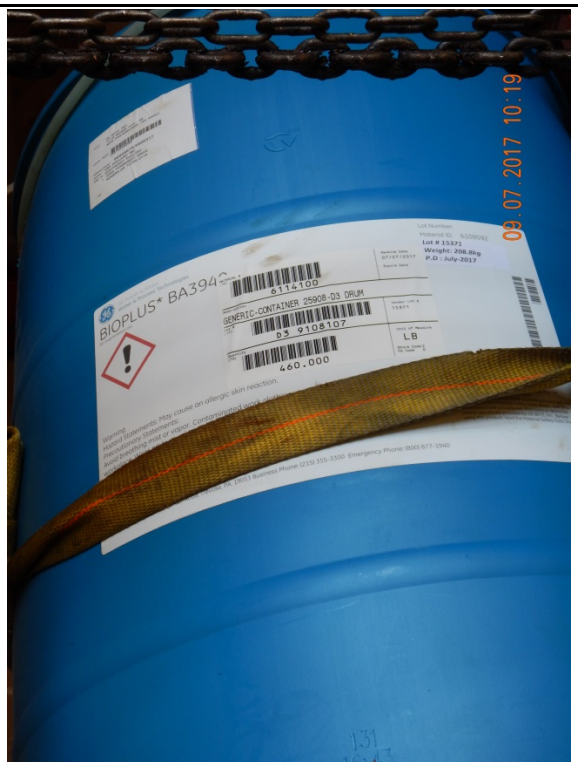
| Water Division Photographic Evidence Sheet | | | | | |
|---|---|---|---|---|---|
| Witness: | | | | Photo #: | **11** |

| Water Division Photographic Evidence Sheet | | | | | |
|---|---|---|---|---|---|
| Description: | **Bacteria additive** | | | | |

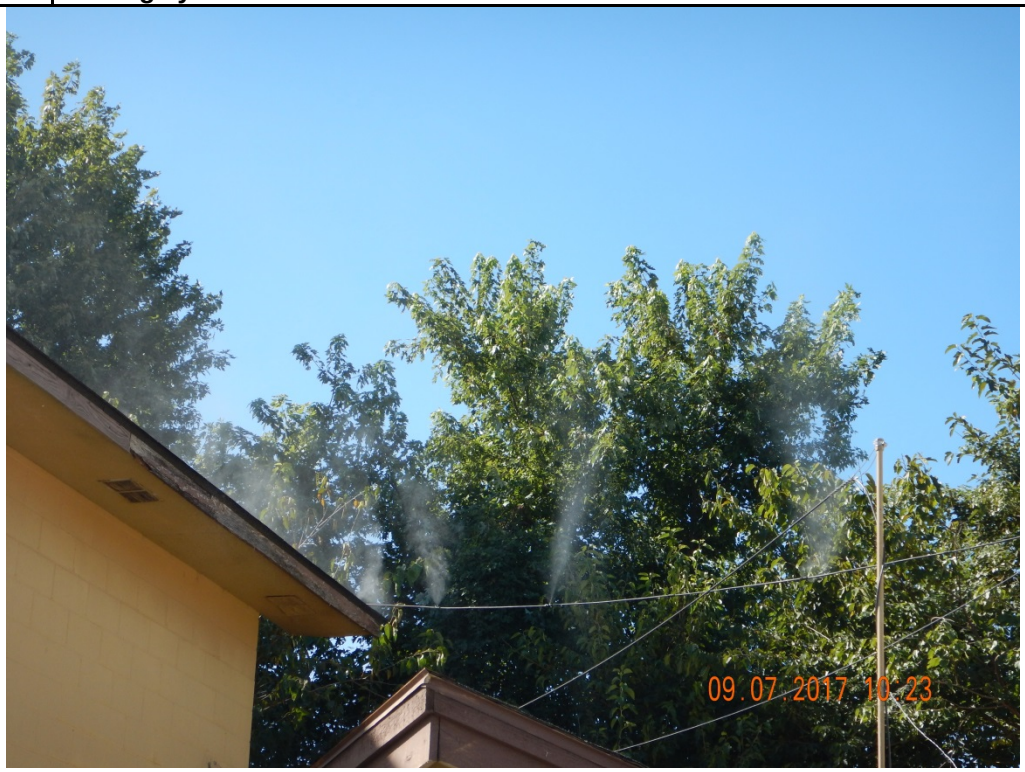
| Water Division Photographic Evidence Sheet | | | | | |
|---|---|---|---|---|---|
| Witness: | | | | Photo #: | **13** |

| Water Division Photographic Evidence Sheet | | | | | |
|---|---|---|---|---|---|
| Description: | **Misting system to reduce noxious odors.** | | | | |
