RE: Searcy WWTF Inspection AFIN: 73-00055 Permit No.: AR0021601

Inspection Report:	Searcy WWTF.	AFIN: 73-00055.	Permit #:	AR0021601

Issues and actions from ADEQ inspection of 10/8/2014

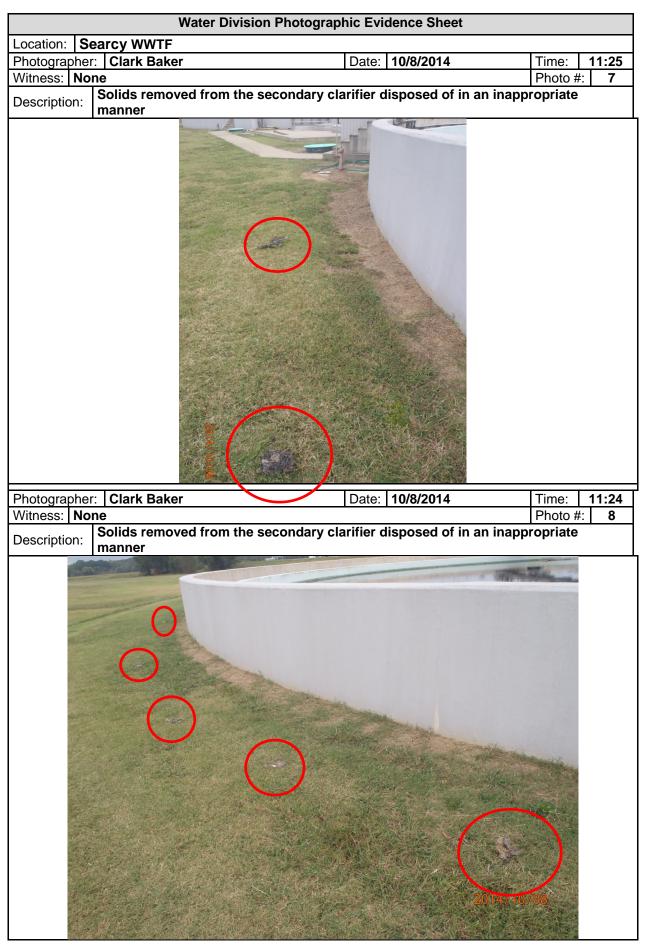
1. TREATMENT UNITS PROPERLY OPERATED:	Øs Om Ou Ona One
2. TREATMENT UNITS PROPERLY MAINTAINED: Vegetation in treatment units. Some algae on the weirs of the secondary clarifier, the brushes on the scraper used to prevent the buildup of algae may need to be replaced. There is evidence of algae and other solids recovered from the secondary clarifier being wasted on the ground instead of being properly disposed of.	⊡s Øm ⊡u ⊡na ⊡ne

Action Taken: Algae has been removed and disposed of properly. Weir brushes have been replaced. The weirs are now being constantly chlorinated to prevent regrowth.
