ARKANSAS
Department of Environmental Quality

RE: Stuttgart WWT Facility Inspection (Arkansas Co)
AFIN: 01-00214 NPDES Permit No.: AR0034380

A R K A N S A S Department of Environmental Quality		WATER DIVISION INSPECTION REPORT				
		AFIN: 01-00214		PERMIT #: AR0034380		DATE: 3/11/2015
		COUNTY: 01 Arkansas		PDS #: 082569		MEDIA: WN
		GPS LAT: 34.493917 LONG: -91.564159 LOCATION: Entrance				
FACILITY INFORMATION			INSPECTION INFORMATION			
NAME: Stuttgart WWT Facility LOCATION: 1011 West 10th Street CITY: Stuttgart, AR 72160			FACILITY TYPE: 1 - Municipal			
			INSPECTOR ID#: 84022 S - State			
			FACILITY EVALUATION RATING: 1 - Unsatisfactory		INSPECTION TYPE: Reconnaissance	
			DATE(S): 3/11/2015	ENTRY TIME: 09:45	EXIT TIME: 11:15	
			PERMIT EFFECTIVE DATE:			
RESPONSIBLE OFFICIAL						
NAME / TITLE: JW Green / Mayor COMPANY: Stuttgart WWT Facility MAILING ADDRESS: 612 S. College CITY, STATE, ZIP: Stuttgart AR 72160 PHONE & EXT. / FAX: 8706733246 / EMAIL: stuttgartarwater@centurytel.net			PERMIT EXPIRATION DATE: FAYETTEVILLE SHALE RELATED: N FAYETTEVILLE SHALE VIOLATIONS: N

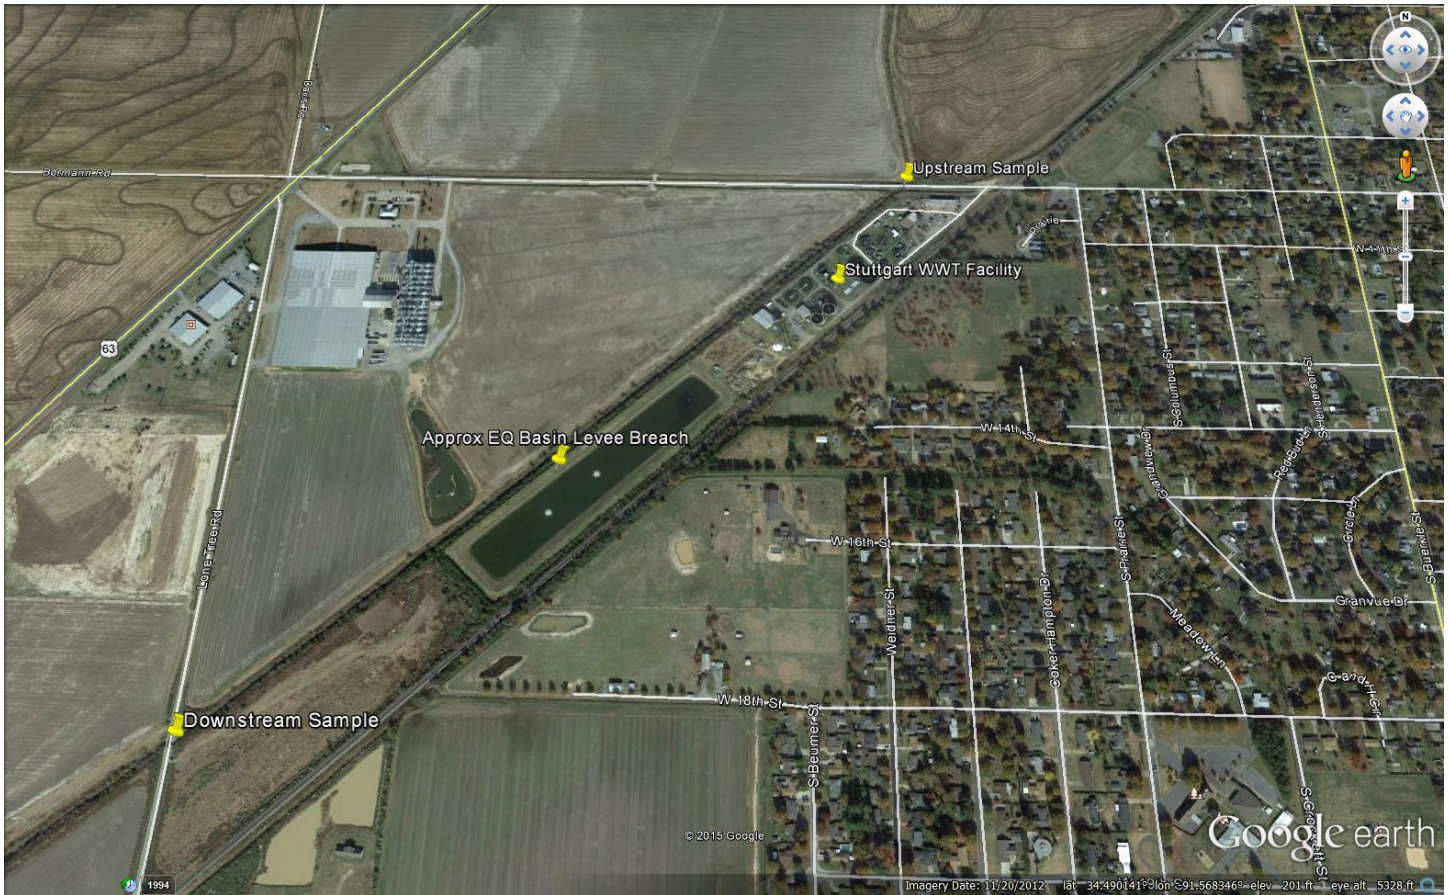
Figure 1. Google Earth image dated Nov 20, 2012 of Stuttgart WWT Facility, flow EQ basin breach and unpermitted discharge sample location, upstream sample location, and downstream sample location.
