RE: Stuttgart Municipal Water Works Inspections (Arkansas Co)
AFIN: 01-00214 NPDES Permit No.: AR0034380

On December 12, 2019, I performed a Compliance Evaluation Inspection, an SSO/Collection System Inspection, and an Industrial Stormwater Inspection of the above-referenced facility in accordance with the provisions of the Federal Clean Water Act, the Arkansas Water and Air Pollution Control Act, and the regulations promulgated thereunder. A copy of each of the inspection reports is enclosed for your records.

| ADEO | WATER | DIVISION I | NSPEC [*] | TIOI | N REF | PORT |

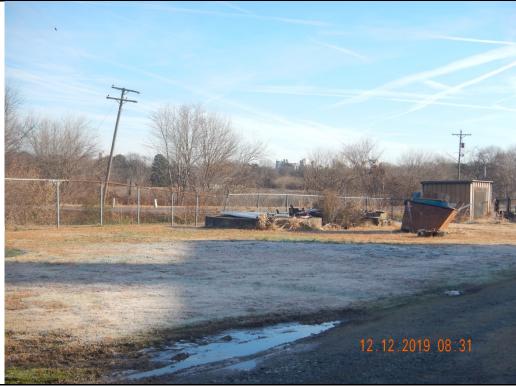
| Water Division Photographic Evidence Sheet | | | | | | | | | |
|--|---|---|---|---|---|---|--|--|--|
| Witness: | Witness: Photo #: 1 | | | | | | | | |

Description: Main wet well for city's influent to the treatment plant.

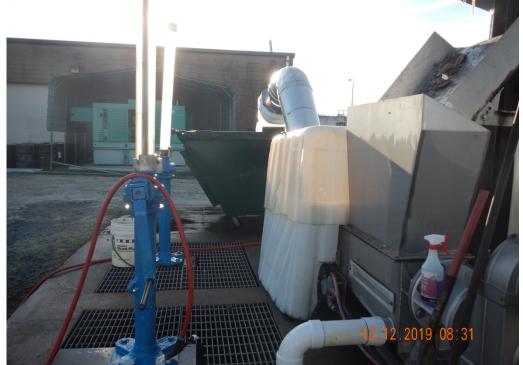
Photographer:Kerri McCabeDate:Dec 12, 2019Time:0831Witness:Photo #:2

Description: Automatic bar screen and trash bagging system.

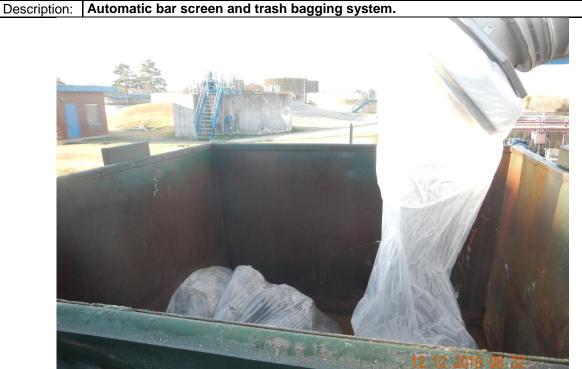
| Water Division Photographic Evidence Sheet | | | | | | | | |
|--|---|---|---|---|---|---|--|--|
| Witness: | | | | | Photo #: | 3 | | |

Description: Automatic bar screen and trash bagging system.

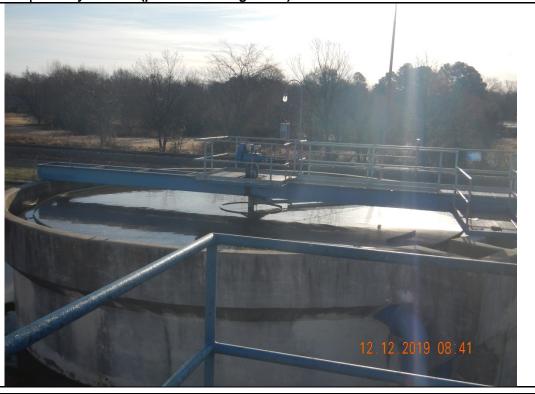
| | Water Division Photographic Evidence Sheet | | | | | |
|---|--|---|---|---|---|---|
| Witness: | | | | | Photo #: | 9 |

Description: Primary clarifier (prior to trickling filters)

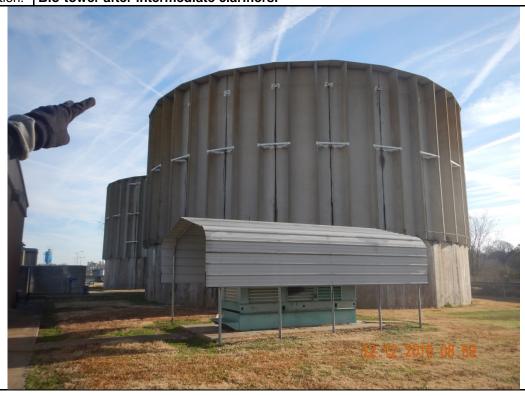
| | | Water Division | Photographic Evi | dence Sheet | | |
|---|---|---|---|---|---|---|
| Witness: | | | | | Photo #: | 11 |

| | | Water Division | Photographic Evi | dence Sheet | | |
|---|---|---|---|---|---|---|
| Description | 1: E | Bio-tower after intermediate | e clarifiers. | | | |

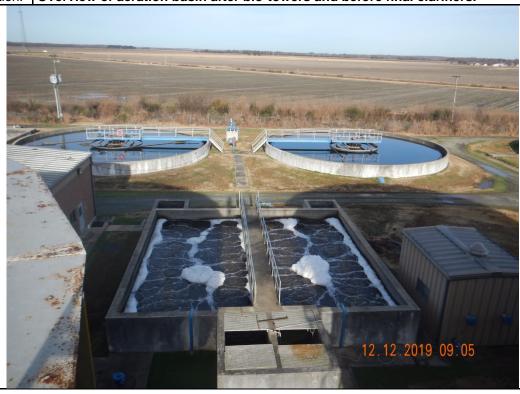
| | Water Division Photographic Evidence Sheet | | | | | |
|---|--|---|---|---|---|---|
| Witness: | | | | | Photo # | : 13 |

| | Water Division Photographic Evidence Sheet | | | | | |
|---|--|---|---|---|---|---|
| Description | า: (| Overview of aeration basin | after bio-towers ar | nd before final clari | fiers. | |

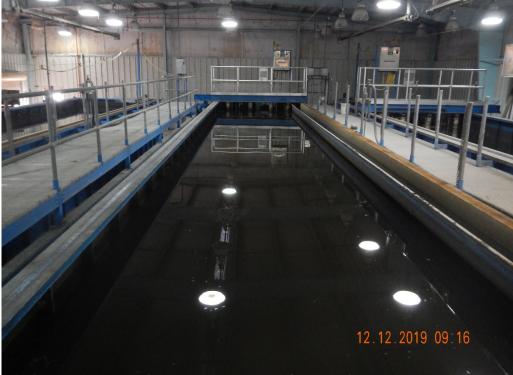
| | Water Division Photographic Evidence Sheet | | | | | | | |
|---|--|---|---|---|---|---|---|---|
| Witness: | | | | | | | Photo # | : 15 |

| | Water Division Photographic Evidence Sheet | | | | | | | |
|---|--|---|---|---|---|---|---|---|
| Description | Description: Distribution system from final clarifiers to the traveling bridge filters (tertiary). | | | | | | | |

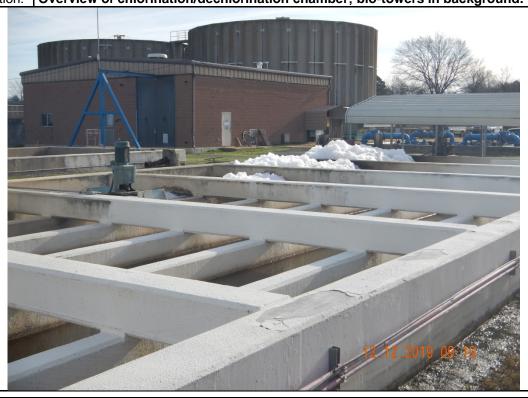
| | Water Division Photographic Evidence Sheet | | | | | |
|---|---|---|--|---|---|--|
| Description | Description: Overview of chlorination/dechlorination chamber; bio-towers in background. | | | | | |

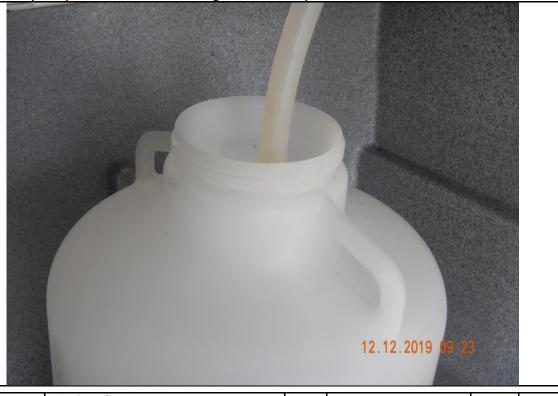
Description: Sample container and tubing for auto-sampler

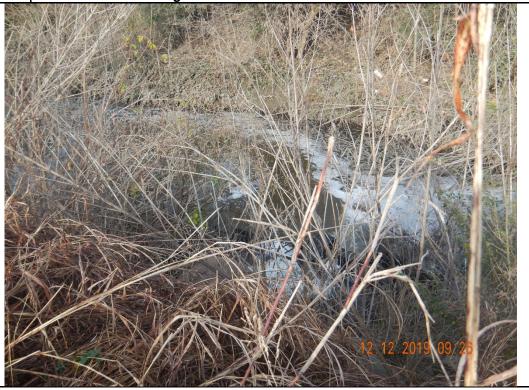
Description: Outfall 001 at receiving stream
