RE: Camden WWTP Inspection (Ouachita Co)

AFIN: 52-00073 NPDES Permit No.: AR0022365

OFFICE OF WATER QUALITY INSPECTION REPORT

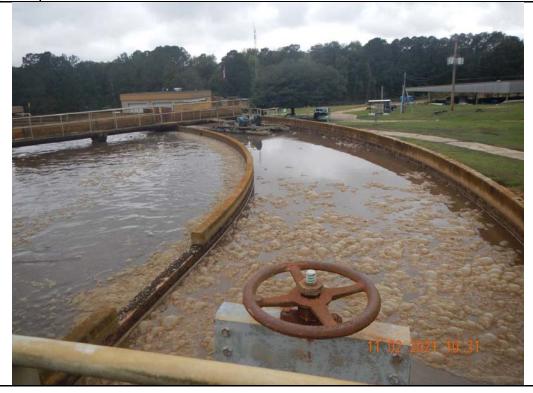
Coation: Camden WWTP Photographer: Michael Young Date: 11/02/2021 Time: 10:31 Witness: Photo #: 9

Description: Oxidation ditch with aeration.

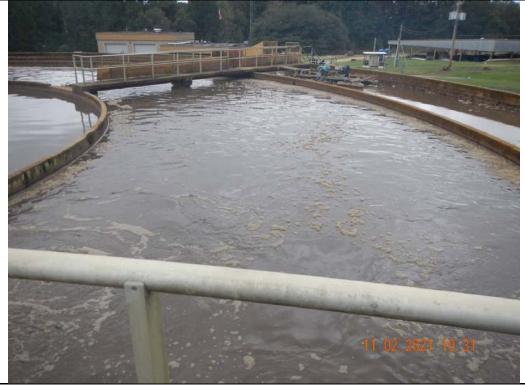
Photographer: Michael Young	Date: 11/02/2021	Time:	10:32
Witness:		Photo #	±: 10

Description: Aerator in oxidation ditch is a pontoon floating aerator.

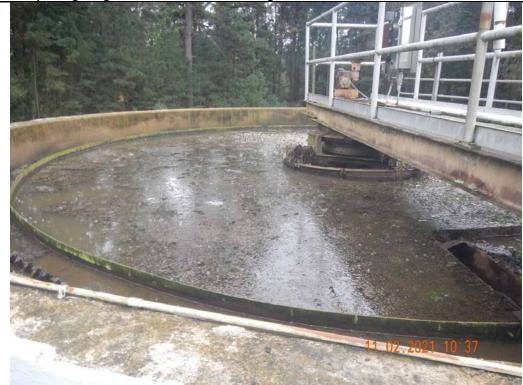
Photographer: Michael Young Date: 11/02/2021 Time: 10:37
Witness: Photo #: 20

Description: Sludge digester with materials being dewatered.

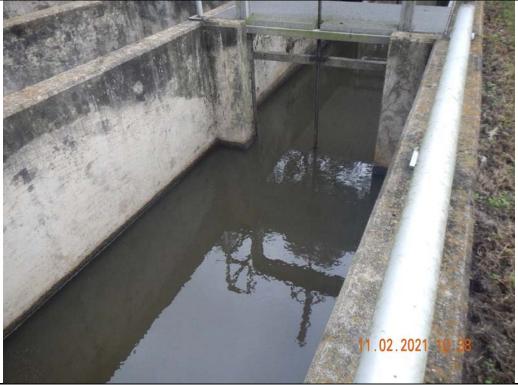
Camden WWTP Photographer: Michael Young Date: 11/02/2021 Time: 10:38 Witness: Photo #: 21

Description: Chlorine contact chamber following clarifiers.

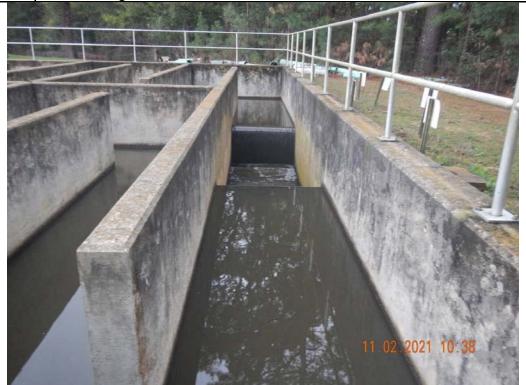
Photographer: Michael Young	Date: 11/02/2021	Time:	10:38
Witness:		Photo #	‡ : 22

Description: Water leaving the chlorine contact chamber.

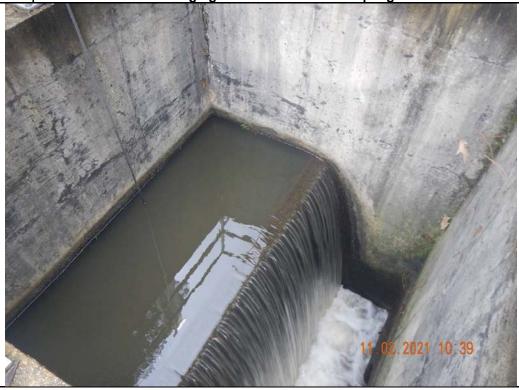
Office of Water Quality Photographic Evidence Sheet Location: Camden WWTP Photographer: Michael Young Date: 11/02/2021 Time: 10:39 Witness: Photo #: 23

Description: Treated effluent discharging to Outfall 002 and sampling location.

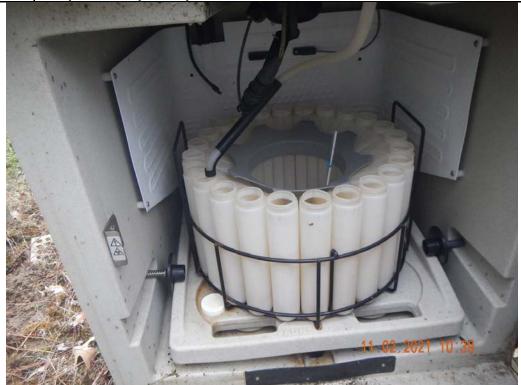
Photographer: Michael Young Date: 11/02/2021 Time: 10:39
Witness: Photo #: 24

Description: Composite sampler aliquots and thermometer.

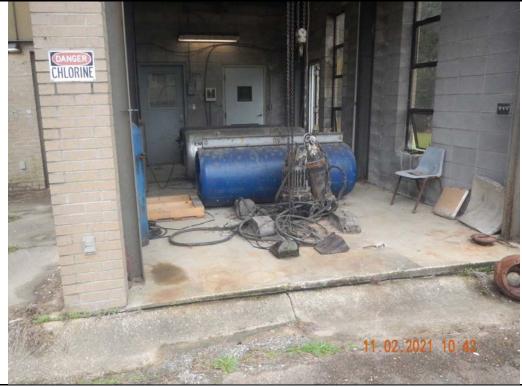
Coation: Camden WWTP Photographer: Michael Young Date: 11/02/2021 Time: 10:42 Witness: Photo #: 27

Description: Chlorine canisters for disinfection.

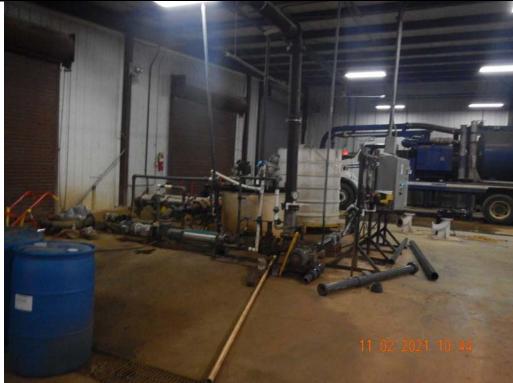
Photographer: Michael Young Date: 11/02/2021 Time: 10:44
Witness: Photo #: 28

Description: Chemical dosing for thickening and drying sludge.

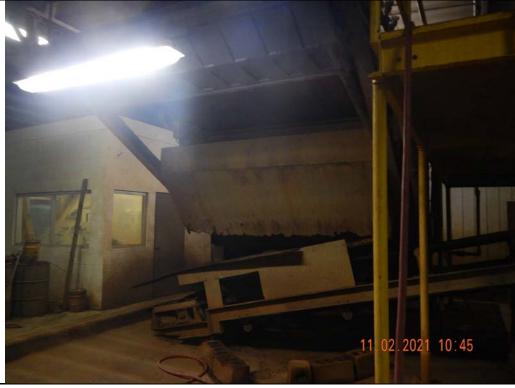
Coation: Camden WWTP Photographer: Michael Young Witness: Date: 11/02/2021 Date: 11/02/2021 Photo #: 29

Description: Sludge press used to dewater sludge prior to landfilling.

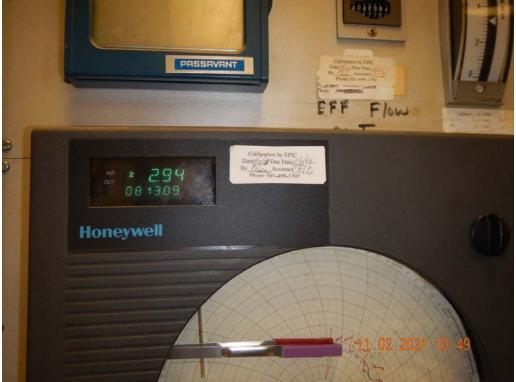
Office of Water Quality Photographic Evidence Sheet Location: Camden WWTP Photographer: Michael Young Date: 11/02/2021 Time: 10:49 Photo #: Witness: 31

Description: Totalizer readout and paper chart.
