RE: Stuttgart Municipal Water Works Inspection (Arkansas Co)

AFIN: 01-00214 NPDES Permit No.: AR0034380

OFFICE OF WATER QUALITY INSPECTION REPORT

AFIN: 01-00214 | PERMIT #: AR0034380 | DATE: 11/17/2021

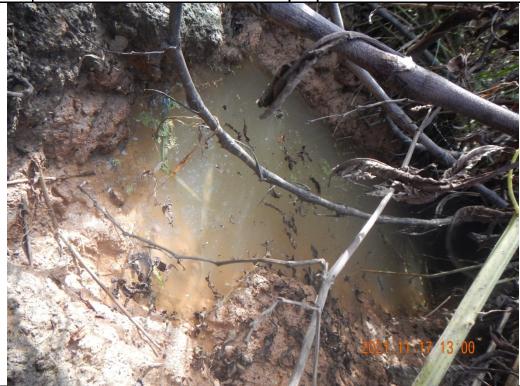
Photographer: Aaron Baggett Date: 11/17/2021 Time: 1256
Witness: Kerri McCabe Photo #: 18

Description: Water of uncertain origin pooling at northeast end of EQ basin; hose shown runs between sludge pump in EQ basin pump pit and sludge drying pad; facing west.

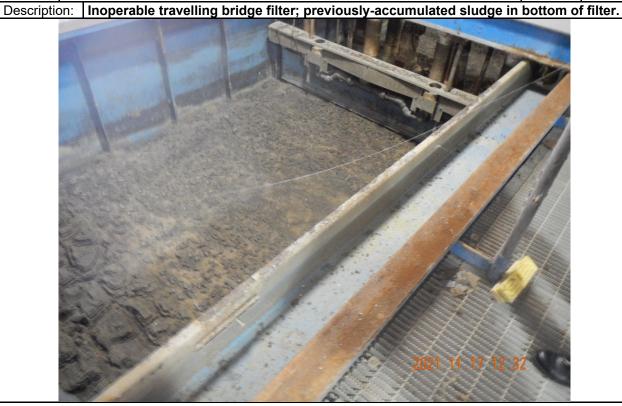
Photographer: Aaron Baggett Date: 11/17/2021 Time: 1231
Witness: Kerri McCabe Photo #: 22

- One of the two Travelling Bridge Filters was inoperable at the time of inspection.
- 4.) The sample data for the composite sampling are incomplete. The contract lab is conducting a 6-hr composite; however, there is no aliquot information to demonstrate the sample was collected per the definition of composite (see Part IV). Additionally, the POTW has two Industrial Users (IU) and the timeframe selected by the contract lab may not capture representative discharges from these IU. This is a violation of Part III, Section C, 1 of the permit. Aliquot information must include exact time, flow, and sample volume.

Description: Operable travelling bridge filter.

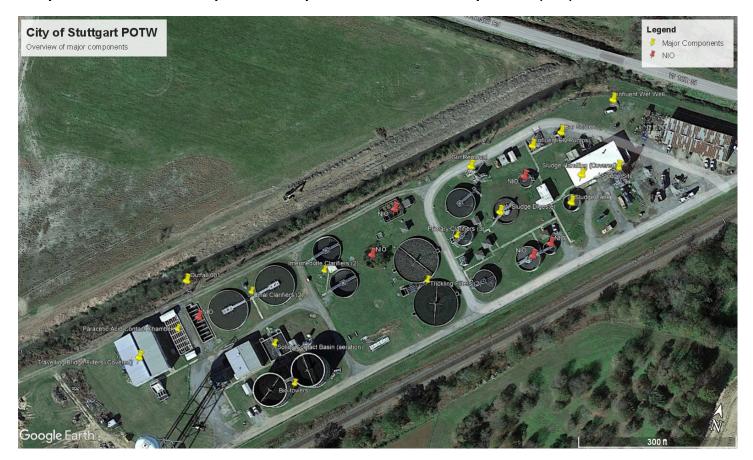
Figure 3. Google Earth image dated November 2020 depicting the City of Stuttgart EQ basin with major components identified.
