RE: Boyd Point WWTF Inspection

AFIN: 35-00149 Permit No.: AR0033316

OFFICE OF WATER QUALITY INSPECTION REPORT

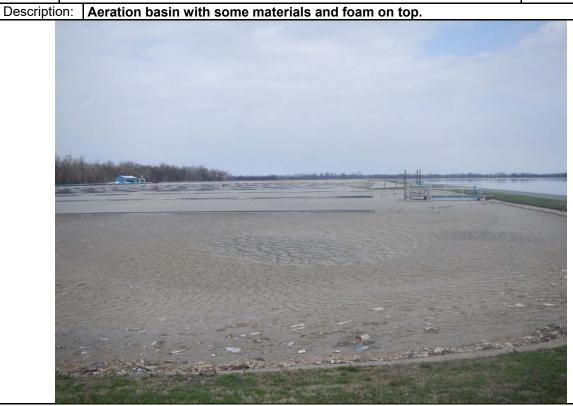
Photographer: Michael Young	Date: 02/23/2023	Time:	11:31
Witness: Robert Diaz		Photo #:	8

Description: Aeration basin with some materials and foam on top.
