**Re: City Corporation-CAO**  
**Final Report SSES Phase II (Basins RV13, RV16, RV26)**  
**NPDES Permit No. AR0021768**  
**CAO LIS No. 09-146**  
**AFIN 58-00105**

Russellville City Corporation  
Wastewater Collection System

SSES Phase 2 2015-2016

(Basins RV13, RV16, & RV26)

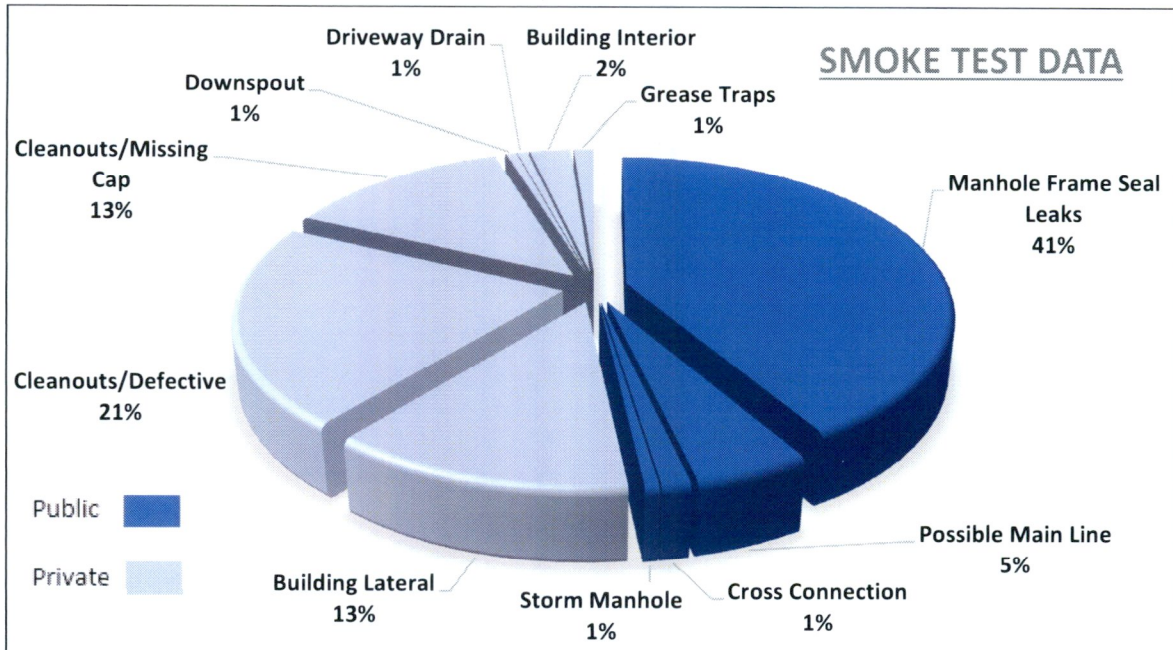
Table 2-E  
**SMOKE TEST DATA**

Smoke testing was performed in each of the basins selected for additional SSES investigation. A total of 166 potential sources of I/I were identified from the 114,975 linear feet of sewer line that was smoke tested in the selected basins. A total of 80 I/I sources identified are from the private sector and 86 in the public sector. These sources are represented in the following pie chart and a summary of all sources is given in Table 2-E. A computer output report listing the findings of the smoke testing program is given in Appendix C.

Type of Source	Quantity
<b>Public Sector</b>	
Possible Main Line	8
Cross Connection	2
Storm Manhole	1
Manhole Frame Seal Leaks	<u>69</u>
Subtotal	80
<b>Private Sector</b>	
Building Lateral	21
Cleanouts/Defective	35
Cleanouts/Missing Cap	22
Downspout	1
Area Drain	1
Building Interior	4
Grease Traps	<u>2</u>
Subtotal	<u>86</u>
<b>Total</b>	<b>166</b>
