Plastic  
Failure  
LABS

January 17, 2017

## Failure Analysis of 14" JM Eagle PVC C-905 Buried Force Main Pipe

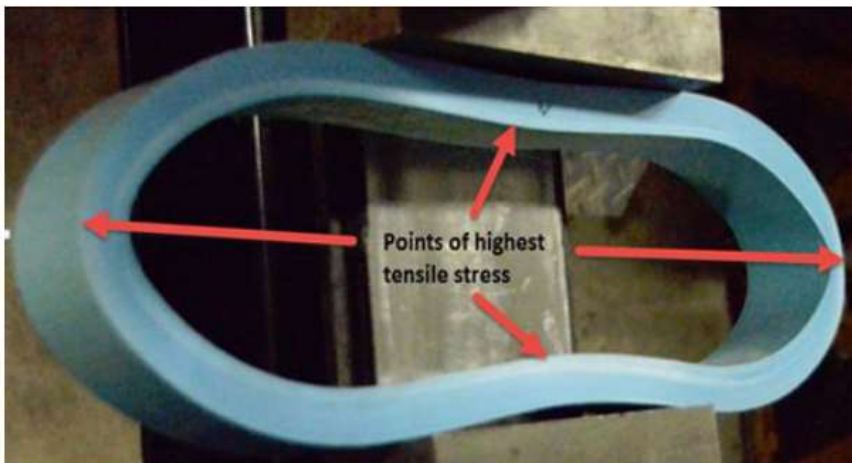
Three test rings were machined from the pipe near the bell. Two test rings passed the test demonstrating high ductility. However, one ring fractured during the test (Figure 6). Figure 7 shows the flattening test being run on a test ring of PVC pipe. Notice that the points of highest stress are on four locations in the ring. The test ring that fractured, broke where the top of the ring contacts the compression plate. Computer modeling reveals that the contact points of the ring with the parallel plates are the highest stress points and predicts that, if failure occurs, it would occur at these locations. Note that the test was only used for diagnostics purposes as the pipe is not required to pass the test once it has been installed. The main utility of the test is to

Figure 7. Photograph of a PVC test ring undergoing the ASTM D2412 ring compression test.

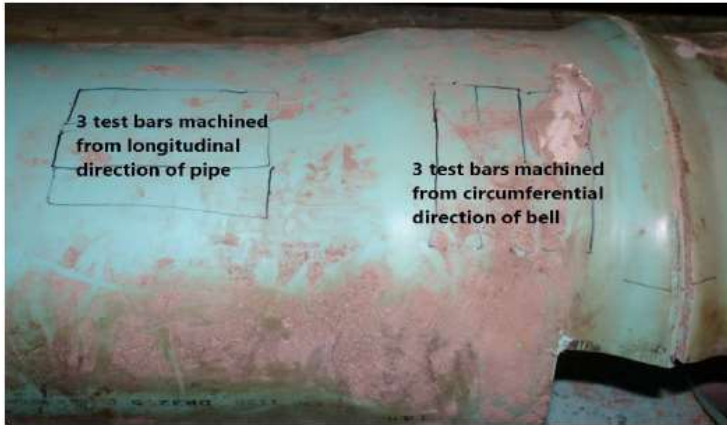
Figure 8. A marker was used to indicate the locations where test specimens were removed for mechanical strength testing.

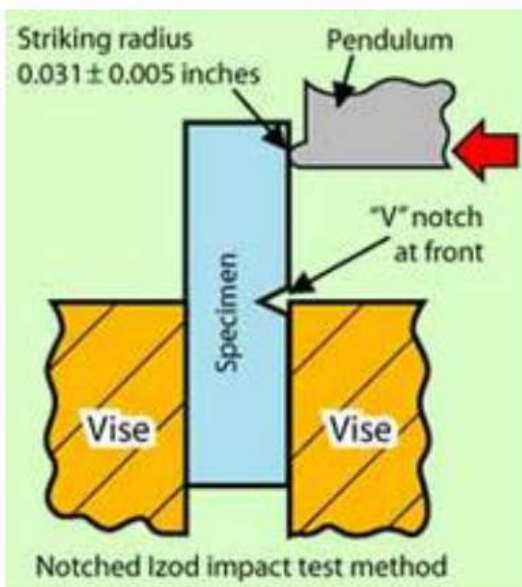
Most of the time, pipes are exposed to constant water pressure which places a hoop stress on the pipe wall. However, the pipes also are occasionally exposed to sudden rapid pressure changes; e.g., when valves are opened and closed. Really fast changes in pressure (water hammer) can create high speed shock waves inside the pipe line. Therefore it is important that the pipe be able to tolerate both high speed stress (impact) as well as long term hoop stress. Some materials may respond in a very ductile manner to slow speed stress but fail catastrophically in when exposed to high speed stress. The IZOD impact test (ASTM D256) was used to assess the high speed impact strength of the pipe. Again, the IZOD impact test specimens were machined in the weakest (hoop) direction of the pipe. The standard calls for the test bars to be notched. A swinging pendulum is used to break the bars (Figure 10). The amount of energy absorbed by the test bar provides the impact strength of the material. All test specimens significantly exceeded the impact strength requirements as shown in Table 1.

**Figure 10. IZOD impact strength test.**

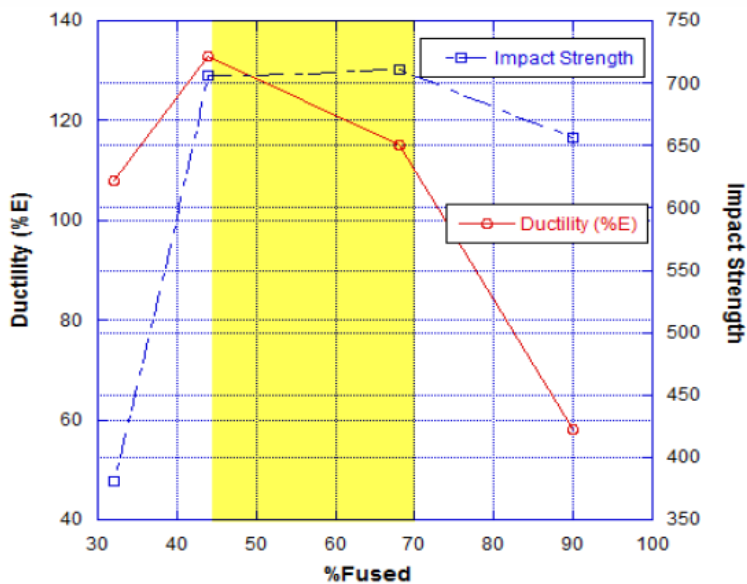
**Figure 11.** Data from Benjamin<sup>13</sup> was graphed. The data revealed that optimum balance of impact strength and ductility are achieved when the PVC is about half to two thirds fused.

When the degree of fusion is very low, the chemical and creep resistance of the pipe are poor. When the degree of fusion is very high, the ductility and impact strength of the pipe is poor. It is theorized that separation of incompletely fused PVC particles during a stress event is an energy absorption mechanism which explains why highly fused pipes have reduced strength.
