PROJECT REPORT

REPORT NUMBER: GBM-120816-1-RP1

DATE: April 11, 2017

GBMc and Associates
219 Brown Lane
Bryant, AR 72022
Attn: Chuck Campbell

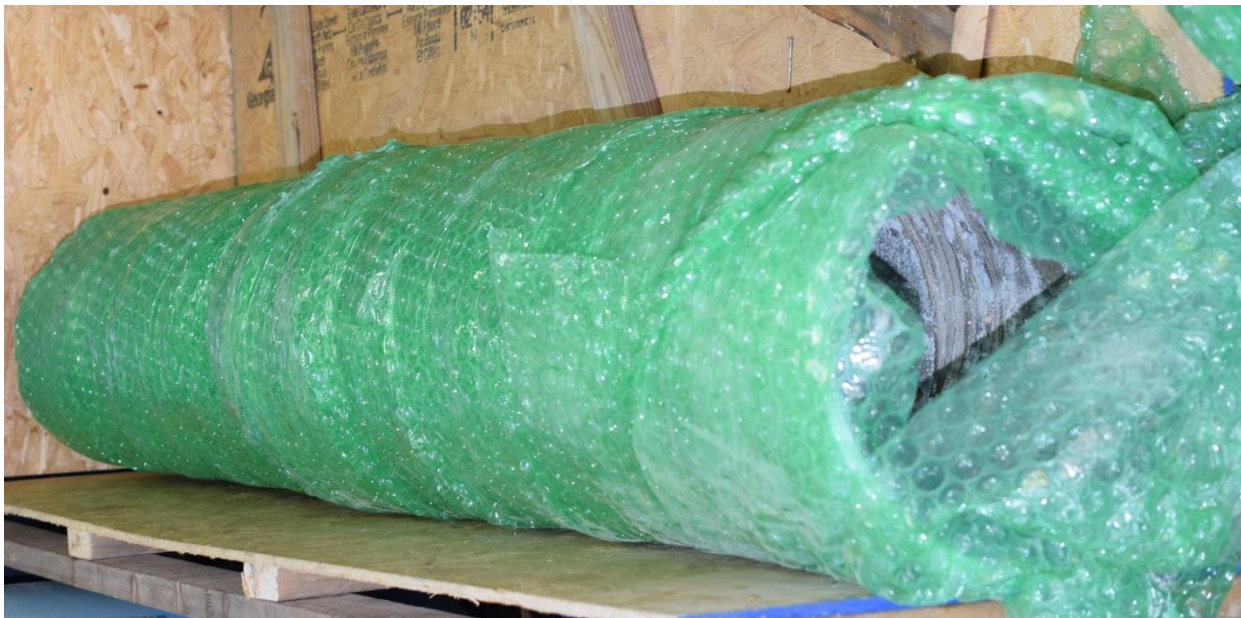
Figure 1. Digital image of one sample during uncrating.

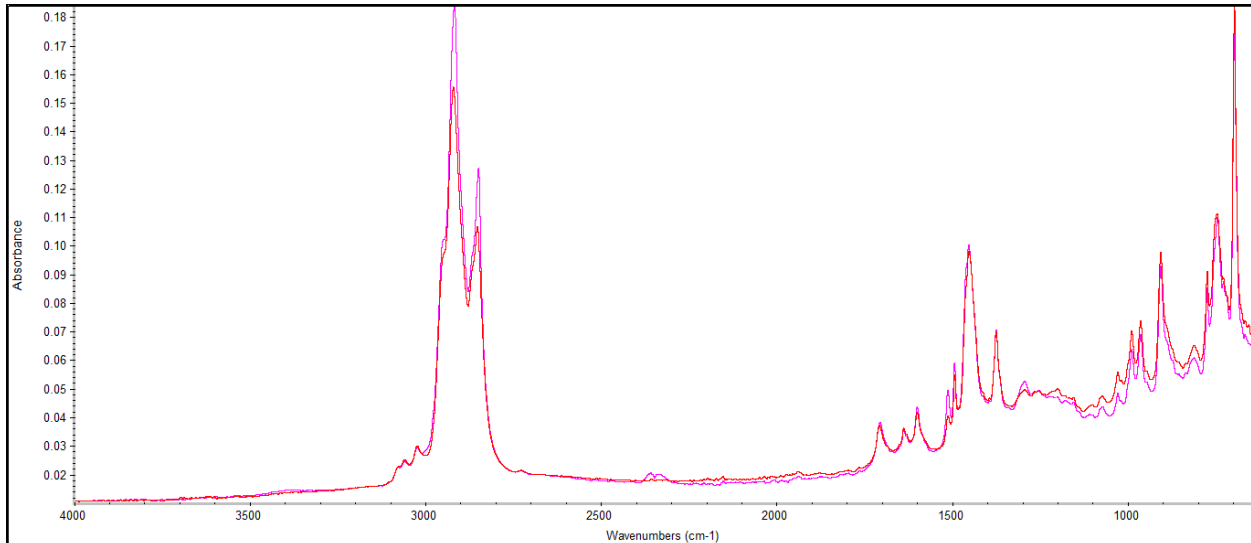
The elastomeric (rubber) material of the gasket was determined via pyrolysis FTIR. A small sample of the Sample E2 gasket was pyrolyzed and the condensate was then analyzed by FTIR. The gasket material was identified as a styrene butadiene rubber (SBR) material. Figure 14 displays the pyrolysis FTIR test results from the pressure and non-pressure sides of the Sample E2 gasket. Figure 15 displays the pyrolysis FTIR test results from the pressure side of the Sample E2 gasket stacked with a new exemplar gasket sample prepared in identical fashion. Figure 16 displays the new exemplar gasket sample pyrolysis FTIR spectrum matched to a library reference spectrum for styrene butadiene rubber (SBR).

Figure 14. Sample E2 gasket pyrolysis FTIR test results from the pressure and non-pressure sides of the gasket. Note the identical chemical makeup based on the presence of identical peaks within each spectrum.

Interpreting the complete body of gasket pyrolysis FTIR test results, the gasket material from Sample E2 was identical on the pressure and non-pressure sides of the gasket. The Sample E2 gasket material was also identical to a new exemplar gasket material provided by the pipe manufacturer. The Sample E2 gasket is identified as an SBR material, which was later confirmed via discussion with the gasket manufacturer.

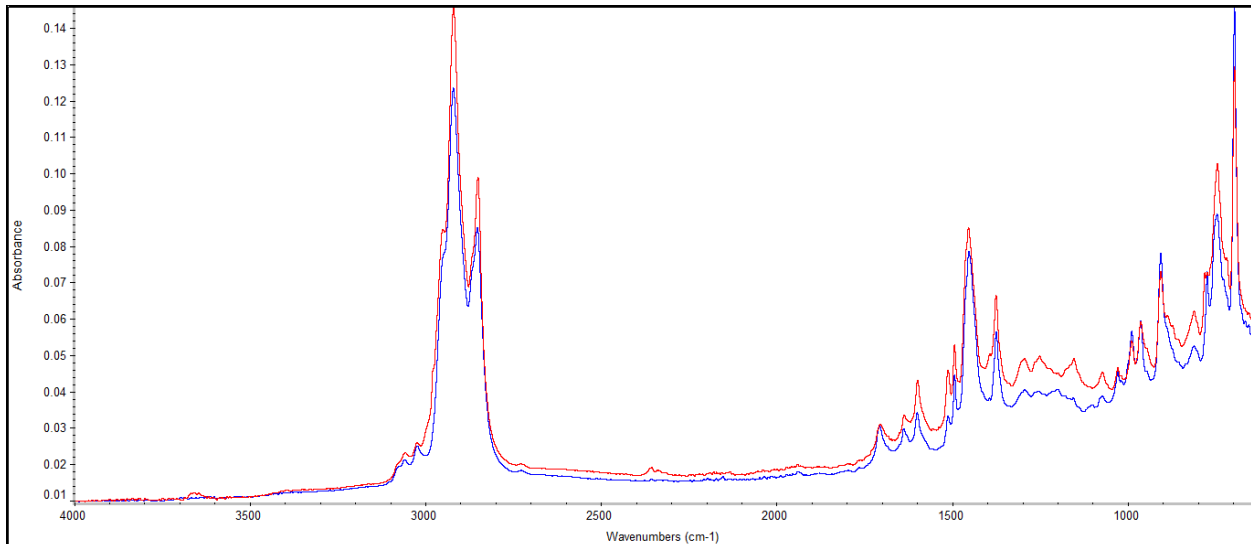
Figure 15. Sample E2 gasket pyrolysis FTIR test results from the pressure side of the gasket stacked with the pyrolysis FTIR spectrum of the new exemplar gasket sample prepared in identical fashion. Note the identical chemical makeup based on the presence of identical peaks within each spectrum.

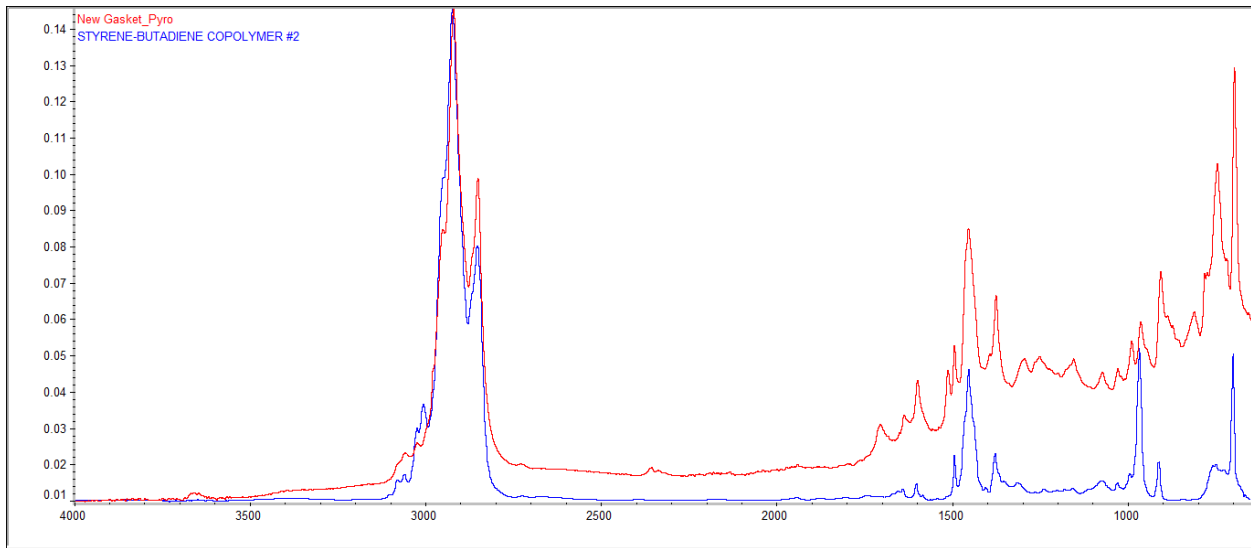
Figure 16. New exemplar gasket sample pyrolysis FTIR spectrum matched to a library reference spectrum for styrene butadiene rubber (SBR).

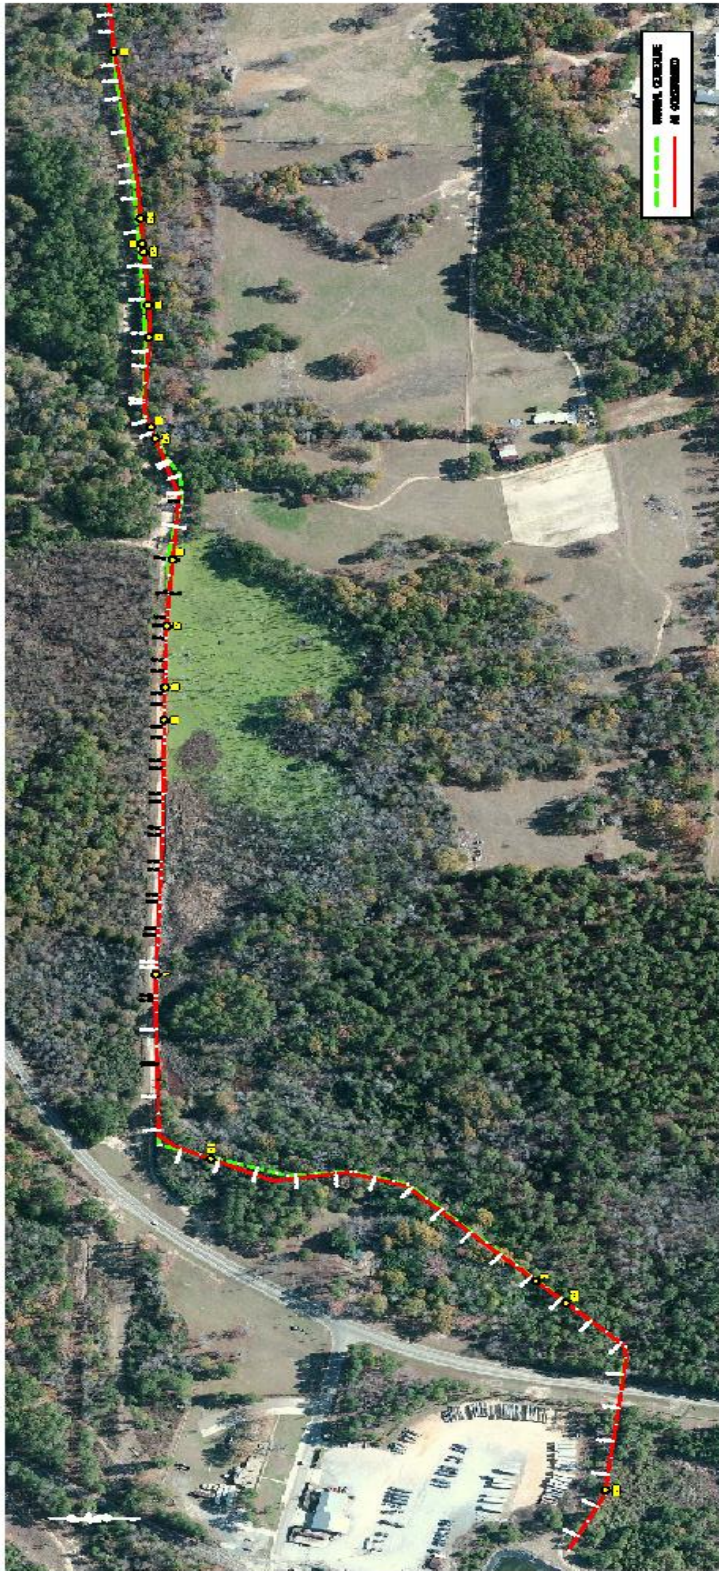
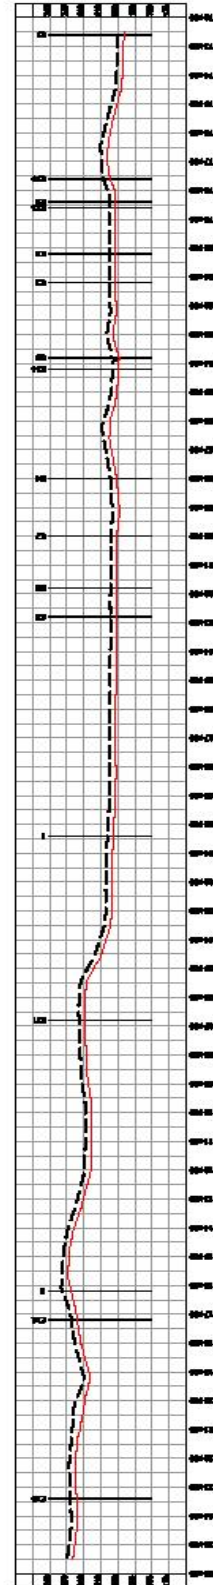
Figure 20.

Two items are attached at the end of this report: Figure 20 displays a client-provided view of the first approximately 5400 feet of the pipeline with failure locations and pipeline elevations marked thereon. Table 2 displays a rollup of information pertinent to the failure population.
