SEWER SYSTEM EVALUATION STUDY (SSES)

BENTON PUBLIC UTILITY COMMISSION,
BENTON, ARKANSAS

August 12, 2013

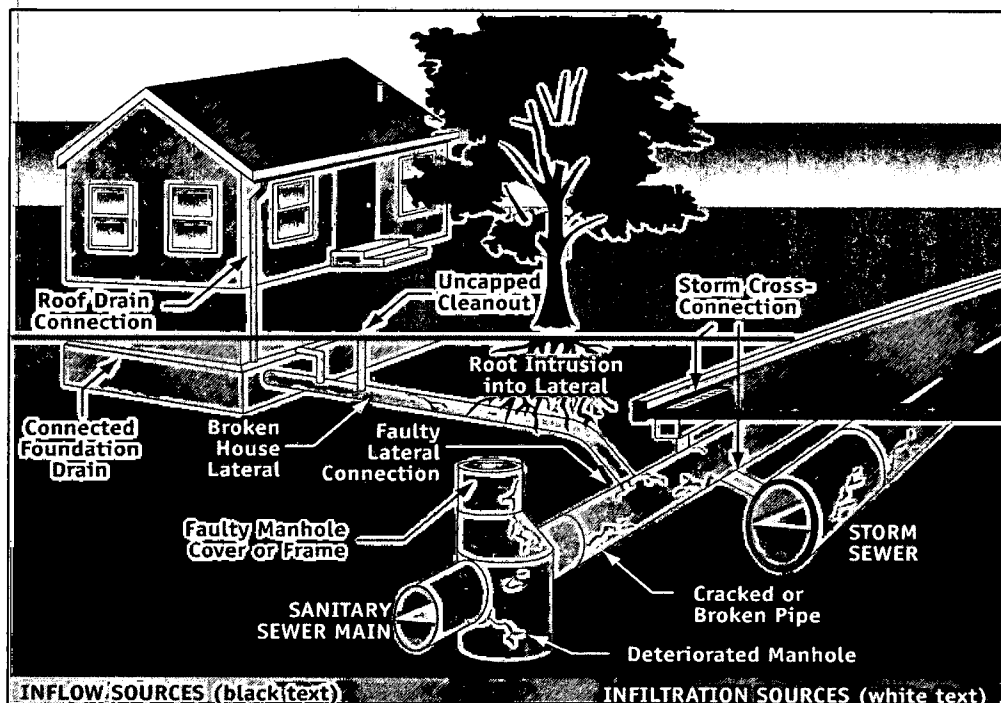
The Sewer System Evaluation Study (SSES) was performed to inspect the Benton Utilities Gravity Sanitary Sewer System to locate areas of inflow and infiltration (I & I) in order to prevent Sanitary Sewer Overflows (SSOs). Figure 1 shows examples of I & I that are to be corrected in the sanitary sewer system. The study consists of first dividing the entire system into drainage basins. The basins were then prioritized based on location and concentration of identified SSOs. Smoke testing was performed in all basins, beginning with the highest priority basin. Closed Circuit Television (CCTV) Inspections were performed on sewer lines deemed necessary based on the results of the smoke testing and/ or reoccurring maintenance issues. Manhole inspections were performed in all basins. A method of repair and cost was developed for the deficiencies found in the sewer system. The improvements were then prioritized and a schedule of long and short term goals for correcting the deficiencies in the sewer system was developed. Many repairs, such as uncapped cleanouts, were made immediately and are explained in more detail within the study.

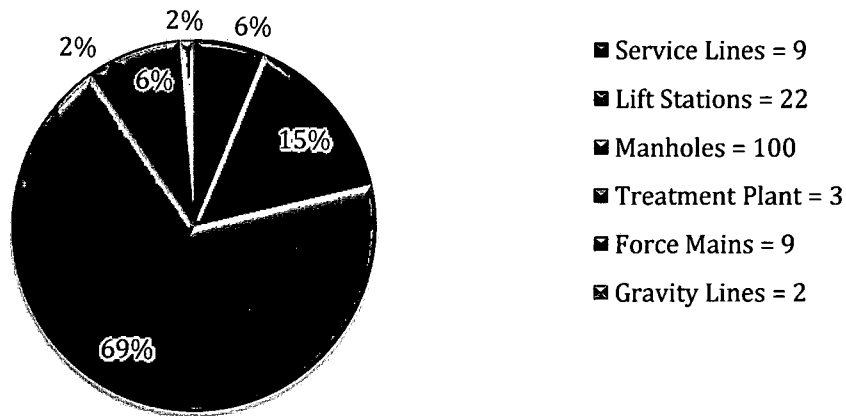
Graph 1

Sanitary Sewer Overflows Aug-2008 to July 2010

The graphs developed during the study show that manholes in the gravity sanitary sewer system make up the majority of the SSOs. Surface water infiltrates the wastewater collection system during rainfall events which result in hydraulic backups and cause the system to surcharge. The SSES examines each component of the gravity sewer system to pinpoint the exact causes in order to minimize the number of SSOs.

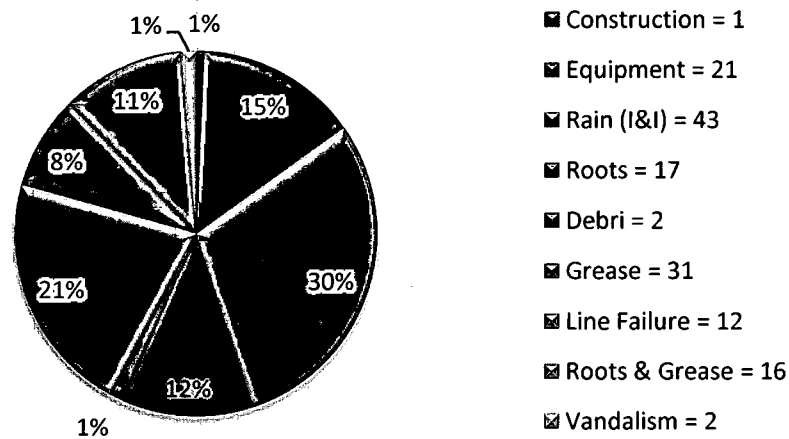
Graph 2

Sanitary Sewer Overflows Aug-2008 to July-2010 by Causes

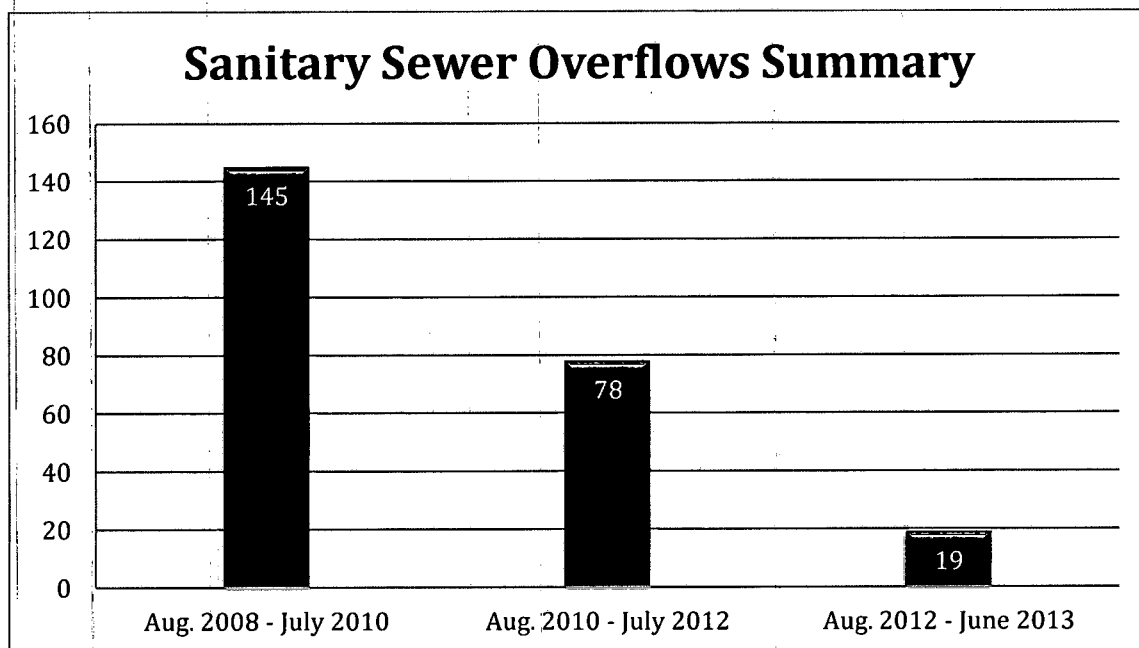
Since the beginning of the SSES investigation, Benton Utilities has been able to substantially reduce the number of SSOs recorded from August 2008 to June 2013. Graph 3 shows the decline of SSOs recorded from the sanitary sewer collection system. Benton Utilities recorded zero (0) SSOs for the months of May and June 2013. Significant reductions in I & I have been achieved through the "Find and Fix" approach employed during the SSES investigation and the many sanitary sewer rehabilitation and construction projects that have been completed over the past eight years. It is unrealistic to remove all I & I from the system, however, Benton Utilities can continue to follow the rehabilitation plan and schedule to improve and maintain the sanitary sewer collection system to prevent SSOs.
