RE: Corrective Action Plan for City of Hope, AR  
 Bois D'Arc WWTP, NPDES Permit No. AR0038466, AFIN 29-00034  
 Pate Creek WWTP, NPDES Permit No. AR0038458, AFIN 29-00512

# Sanitary Sewer Evaluation Survey Final Report

**City of Hope, Arkansas**

**June 2015**

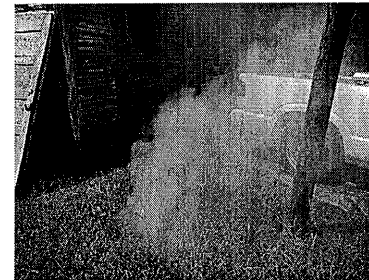
Figure III-1  
Photograph Nomenclature

Smoke Photo = Manhole ID, S, Photo No.  
Example: B11AS0012.jpg  
Manhole: B11A  
S=Smoke Photo  
Photo No. 0012
