RE: City of Minturn Waste Water Collection System

Satellite Collection System of Hoxie (AR0020141)

On September 15, 2010, Brent Walker and I performed an inspection of the waste water collection system in accordance with the provisions of the Federal Clean Water Act, the Arkansas Water and Air Pollution Control Act, and the regulations promulgated thereunder. This inspection revealed the following violations:

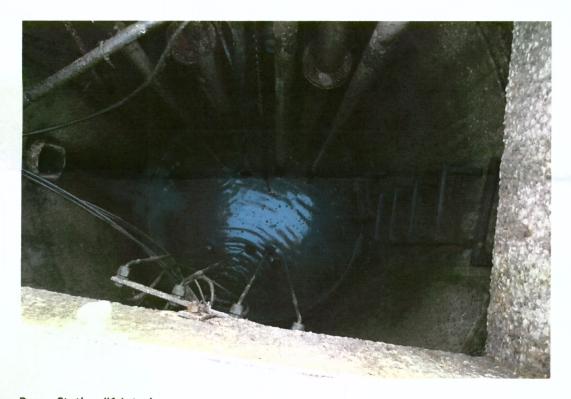
Pump Station #1 Interior

a. As per your admission the control box blows fuses at an alarming rate, indicating possible problems within the electrical system.

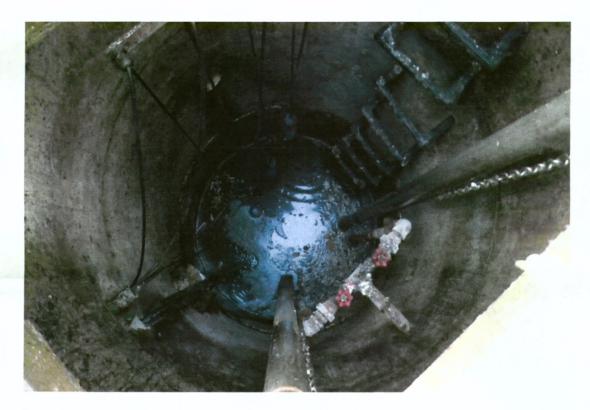
Pump Station #2 Interior

- a. The Auto System was not operational and the pumps had to be started manually.
- b. Only one of two pumps at the station was operational at the time of the inspection.
- c. The cover over the sewer line running parallel with County Road #712 was not sealed properly. The grout around the cover was missing in one section, thus allowing inflow and outflow of liquid. This line is located approximately 20-25 feet south of this pump station.

- a. In regards to the automatic function of this pump station not functioning, Instrument Supply of Hot Springs has made the necessary repairs and the station is now functioning correctly in the automatic position. A bill has not been issued by Instrument Supply at this time for repairs made.
- b. In regard to only one of the pumps in this duplex station being operational, this problem has been addressed and is now functioning properly. This problem was solved with the removal of a frog from the control panel.
- c. In regards to the missing section of grout, a new seal has been obtained and has been installed. The city of Hoxie donated a used grout ring, so no cost was associated with this repair.

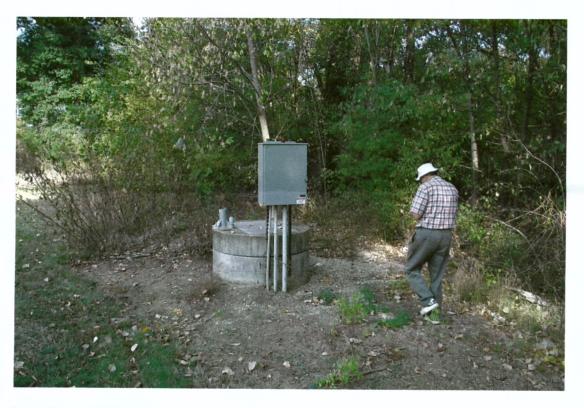
Pump Station #3 Exterior

a. There was an excessive accumulation of grease in the wet well.

a. In regard to the excess grease accumulation in the wet well, the grease has been removed from the wet well. The grease was removed via a dip net and was disposed of properly and the wet well has been pressure washed to remove any build up in the wet well. No cost associated with this repair.
