ARKANSAS
Department of Environmental Quality

October 15, 2012

RE: AFIN: 04-00175

NO DISCHARGE INDUSTRIAL PERMIT INSPECTION FORM

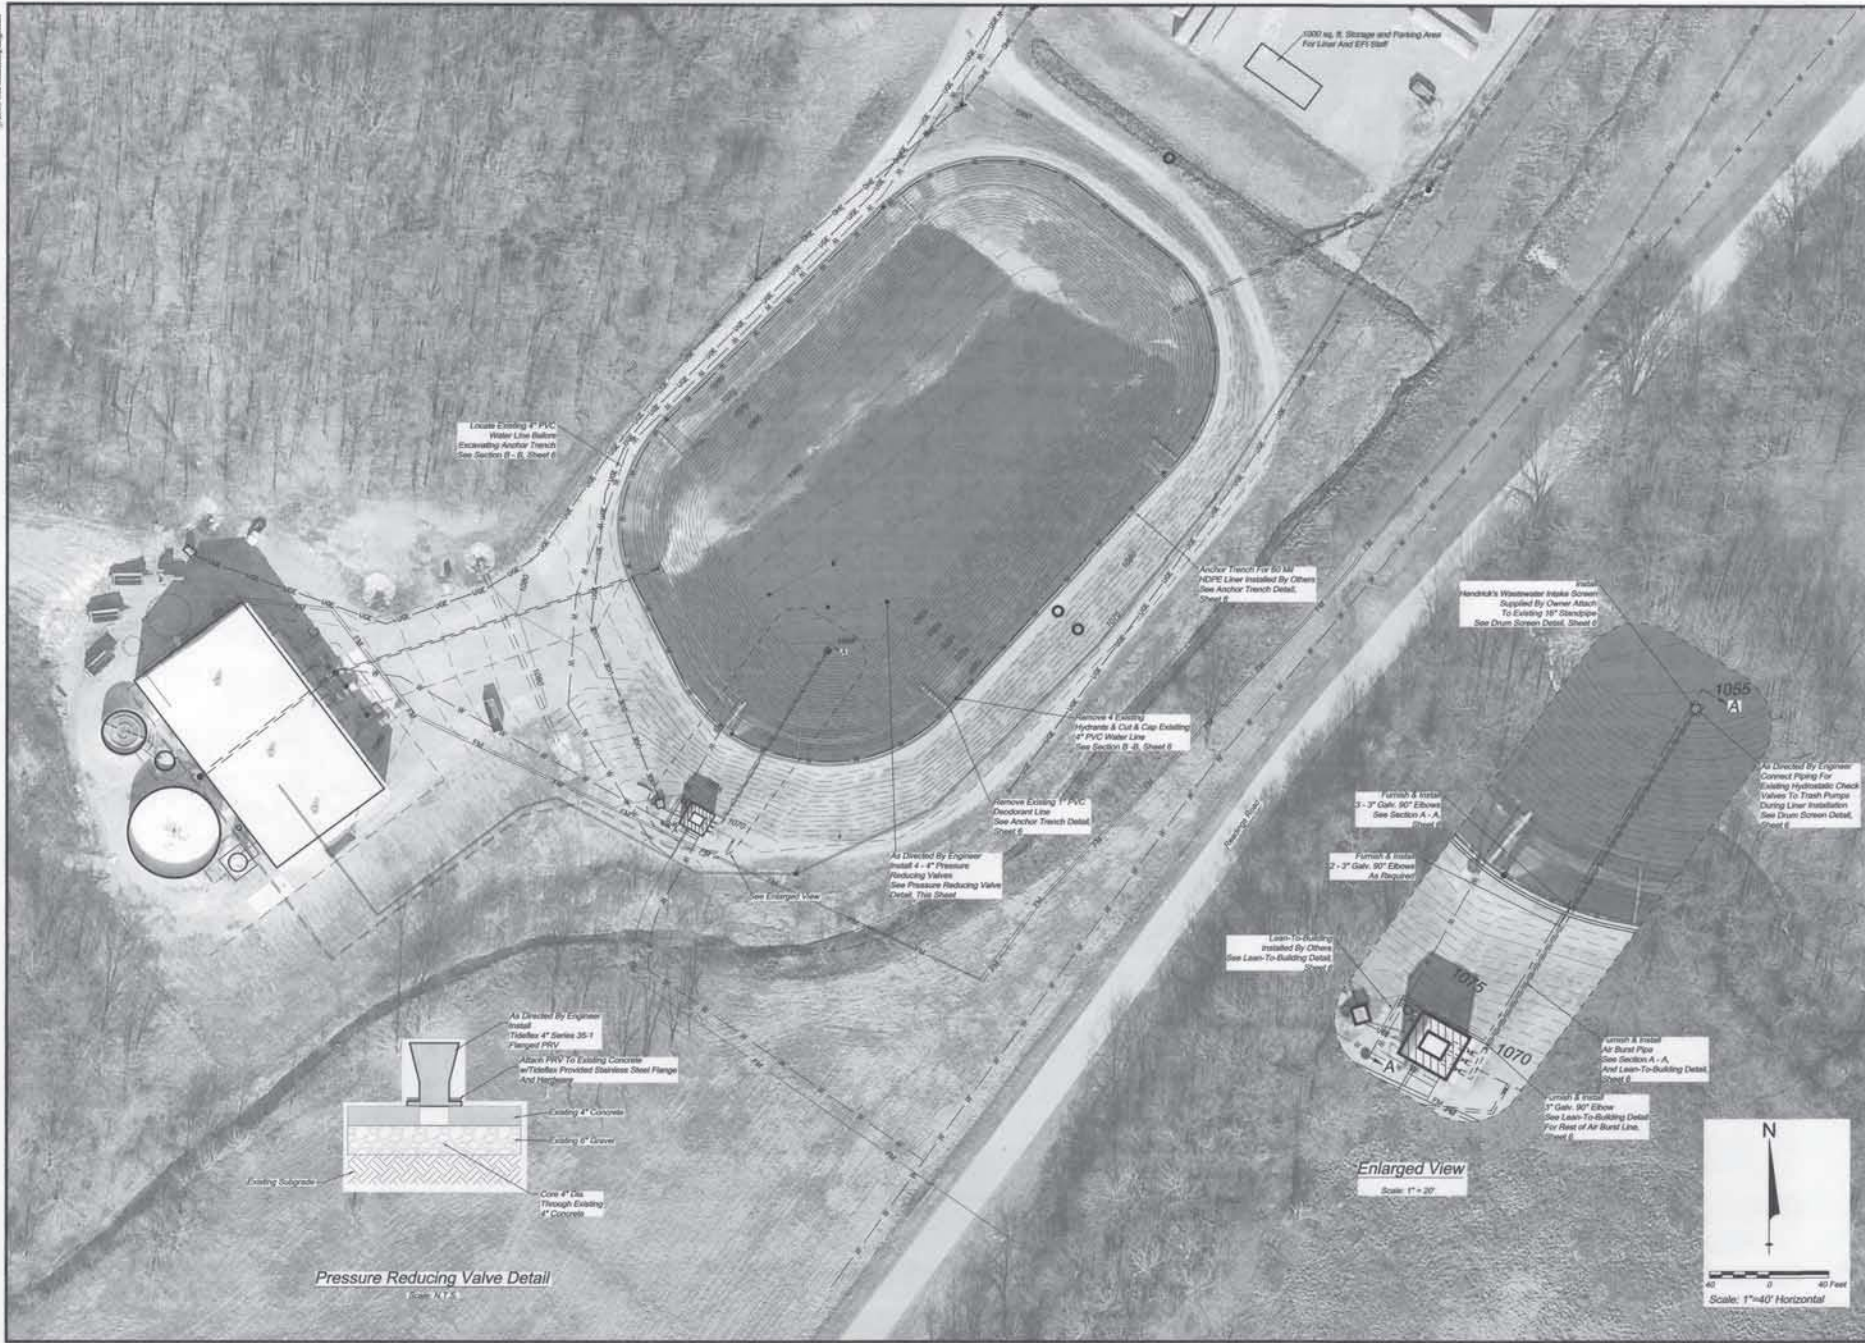
Pressure Reducing Valve Detail
Scale: N.T.S.

In response to the complaint, Allens contacted USI for input about the nature of construction of the pressure relief valves. USI has reiterated the need for hydrostatic relief, but did not provide a great deal of detail on their design, construction, or how they were attached. In fact, the valves do not appear on USI’s drawings (copy attached). As best as USI can recollect, they believe the pressure relief valves were installed by the lining contractor.

due to corrosion. PRV's are necessary, though, to prevent the heaving of the liners due to hydrostatic pressure caused by the surrounding ground water. The flap is found on page 25 of the attachment".

Based on the on-going groundwater monitoring results, Allens does not believe there is an immediate and significant concern about lagoon leakage. Because of the concerns raised in the alleged complaint, it is now recognized that there must have been much speculation amongst hourly staff about the potential source of the PVC pipes with caps found in the lagoon, and in contrast, the results of the groundwater monitoring were not really discussed with all employees. In any event, Allens plans on again emptying the lagoon with the new inlet screening project and inspecting the liner to confirm this and will make any corrective measures if necessary.
