**RE: Reconnaissance Inspection (Conway Co)**  
**AFIN: 15-00034**

**Permit No.: 3509-WR-5**

**NO DISCHARGE INDUSTRIAL PERMIT INSPECTION FORM**

<b>Water Division No Discharge Industrial Photographic Evidence Sheet</b>
---

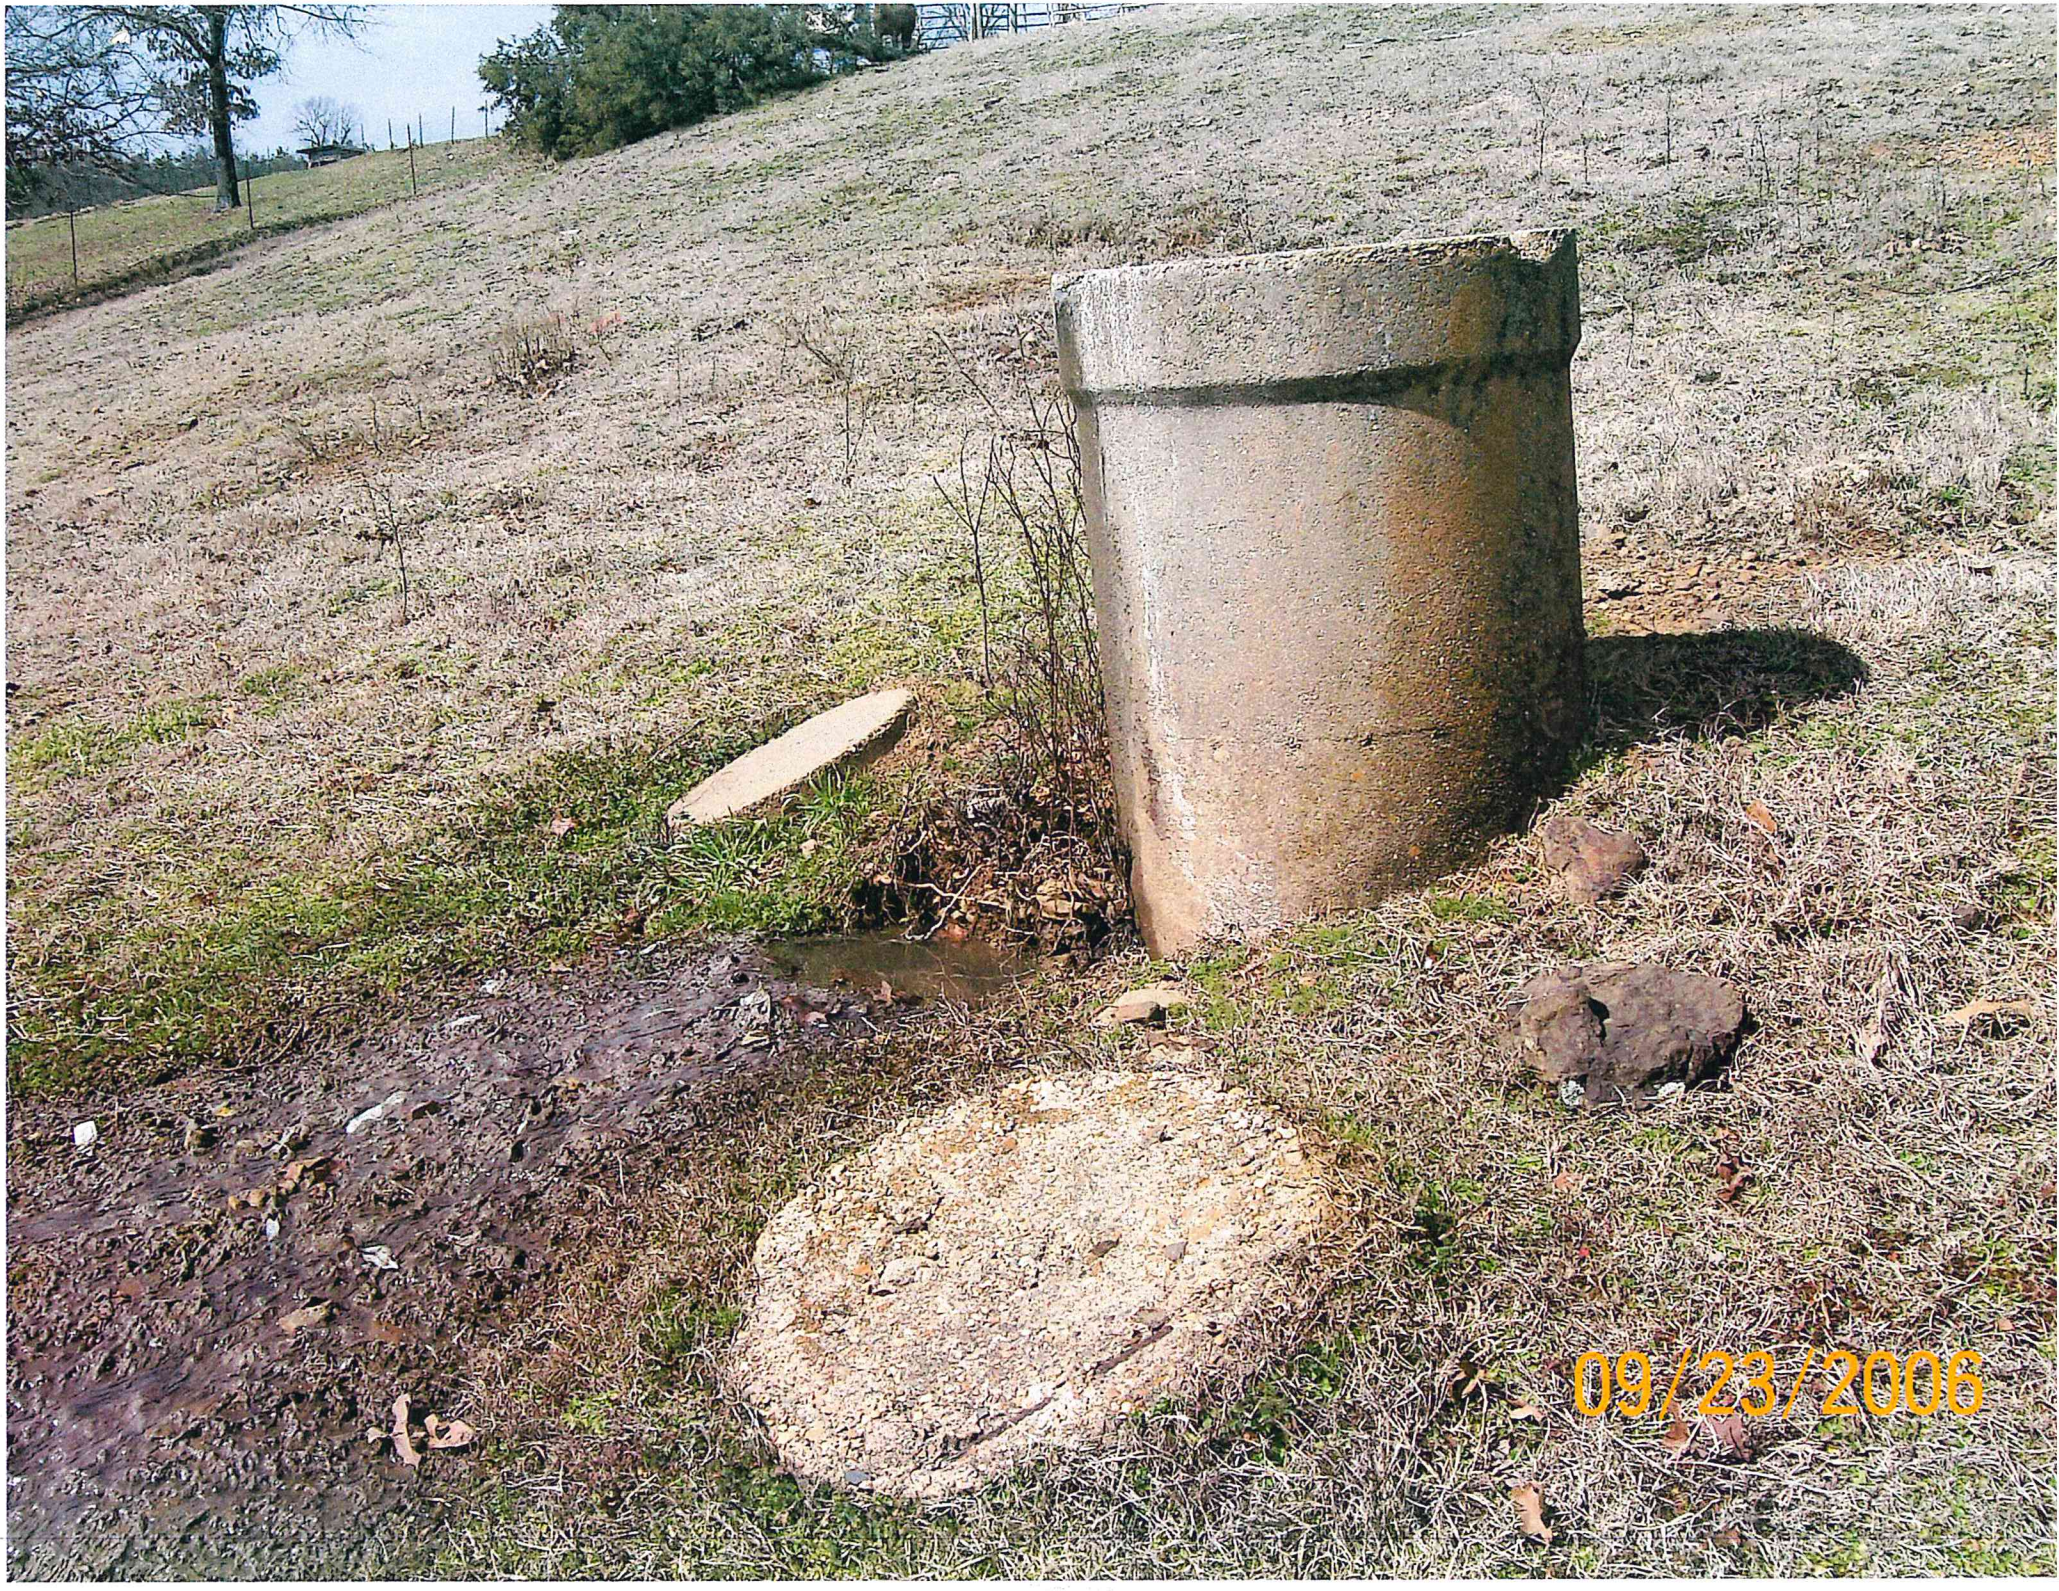
An additional 7 pages of photos taken by David York (operator) are attached. Hard copies were provided to me at the time of inspection. Note: the displayed date on these photos is incorrect.
