# Mayflower Pipeline Incident Update

June 28, 2013

## Northwoods Subdivision

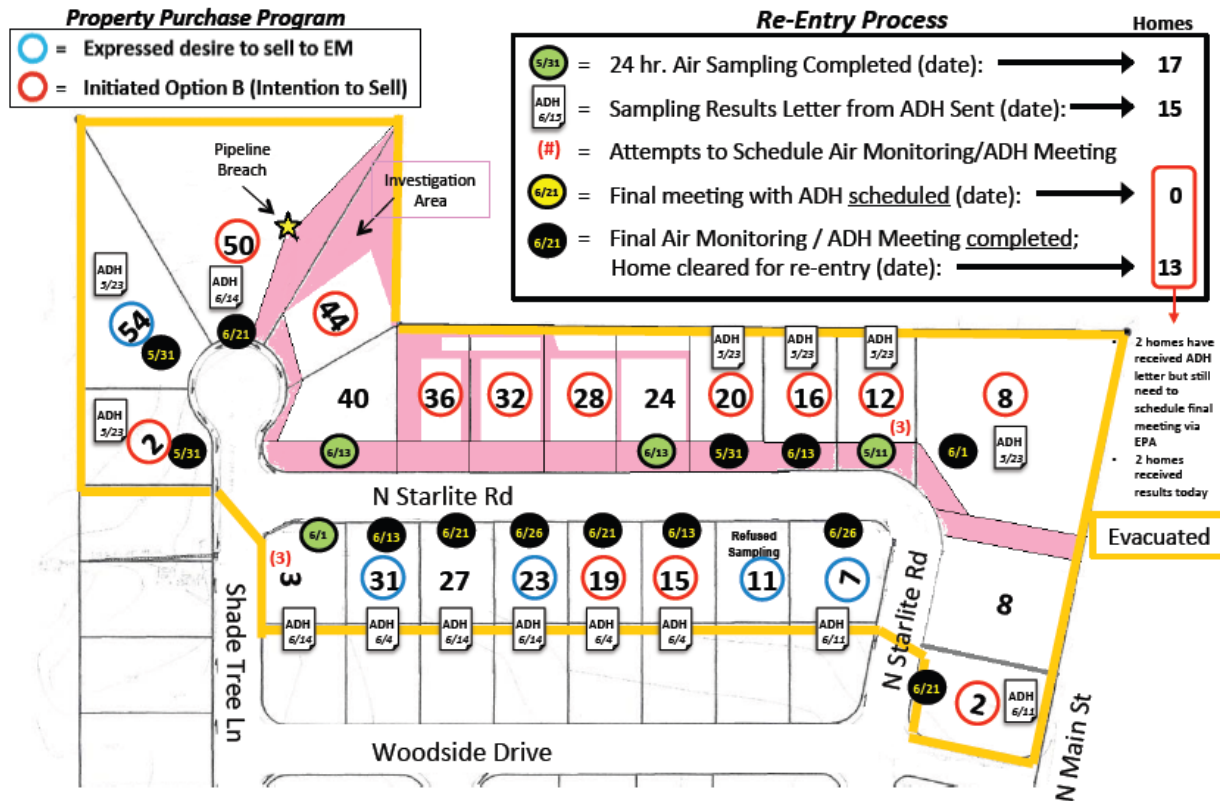
- Completed side/front yard sampling for 28 N. Starlite. Est'd grid for sampling at 32 N. Starlite.
- Performed excavation activities at 32 N. Starlite.
- Supported pot-holing and inspection of utilities east of 24 N. Starlite. No oil or sheen observed.
- Currently awaiting sampling results of additional potholing/excavation activity conducted at 24 and 50 N. Starlite.
