Appendix B

Sediment and Soil Photo Logs

MAYFLOWER PIPELINE INCIDENT RESPONSE

EXXONMOBIL ENVIRONMENTAL SERVICES COMPANY DOWNSTREAM AREAS DATA ASSESSMENT REPORT

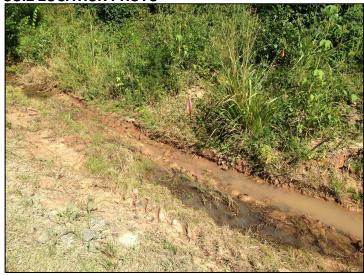
1.0 – 1.5 ft

CLAY (CL), stiff, low plasticity, dry, red, no odor

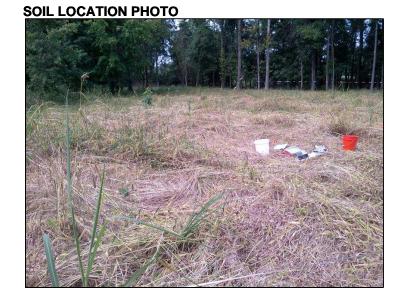
1.0 – 1.5 ft CLAY (CL), soft, medium plasticity, moist, light brown, no odor

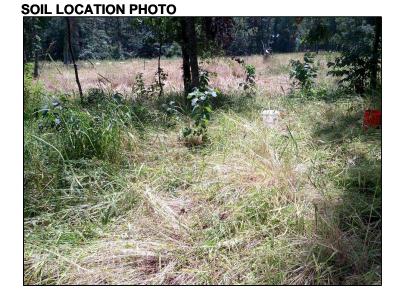
1.0 – 1.5 ft CLAY (CL), some silt, soft, dry, low plasticity, brown/gray, no odor

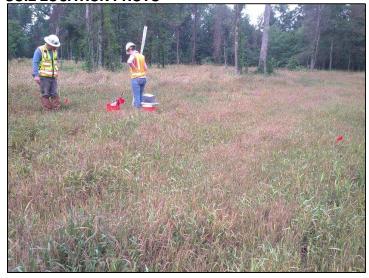
1.0 – 1.5 ft CLAY (CL), trace silt, stiff, no plasticity, dry, some organics, no odor

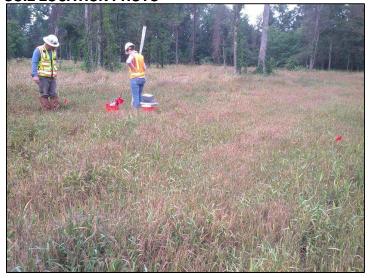
3.0 – 4.0 ft CLAY (CL), trace silt, stiff, low plasticity, slightly moist, some organics, no odor

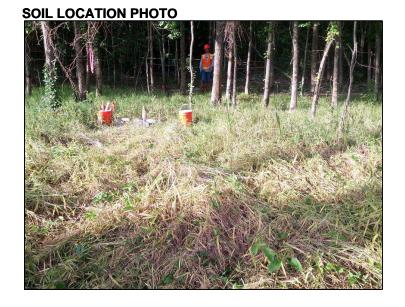
1.0 – 1.5 ft CLAY (CL), soft, dry, no plasticity, light brown, no odor

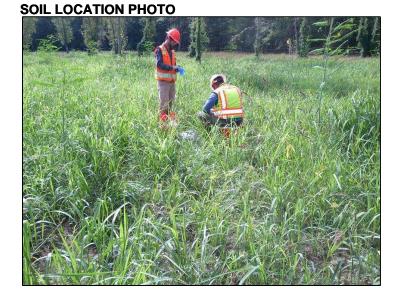
1.0 – 1.5 ft CLAY (CL), soft–medium stiff, low plasticity, brown, moist, no odor

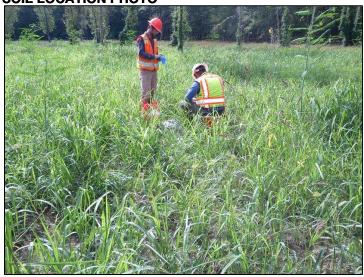
3.0 – 4.0 ft CLAY (CL), stiff, dry, no plasticity, grayish brown, no odor

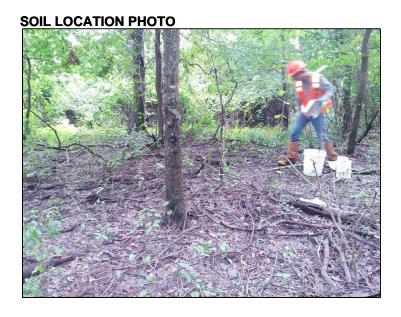
1.0 – 1.5 ft CLAY (CL), soft, dry, high plasticity, red, no odor, organics

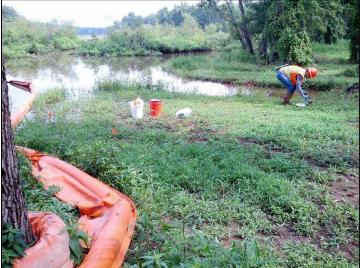
1.0 – 1.5 ft CLAY (CL), soft, high plasticity, moist, red, no odor

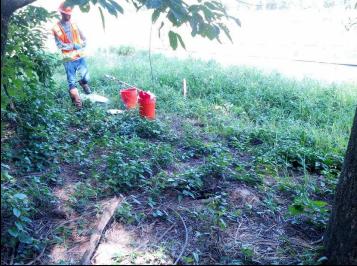
1.0 – 1.5 ft CLAY (CL), soft, wet, high plasticity, brown/reddish brown, no odor

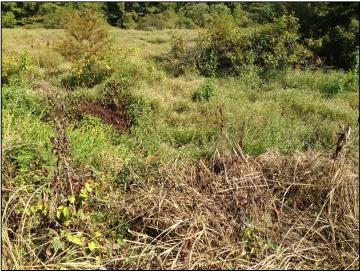
0.0 – 0.5 ft SILTY CLAY (CL), soft to medium stiff, low plasticity, dry, red, no odor, trace organics

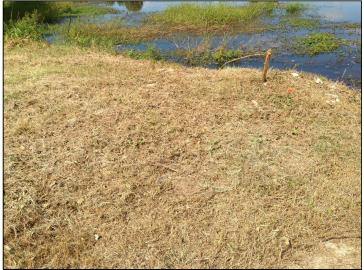
0.0 – 0.5 ft GRAVELLY SAND (SP), some fine sand, fine to medium grained sand, coarse subangular gravel, brown, moist, no odor

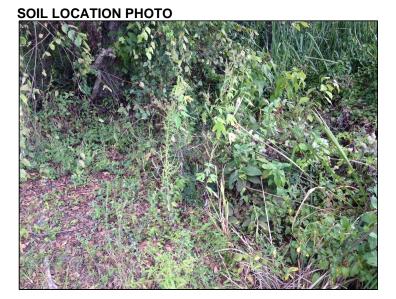
0.0 – 0.5 ft SILT (ML), some clay, soft, no plasticity, dry, reddish brown, no odor, organics

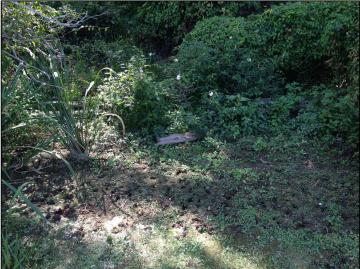
0.0 – 0.5 ft SILTY CLAY (CL), some silt, soft, high plasticity, brown, organics, dry, no odor

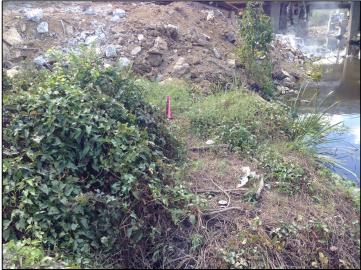
0.0 – 0.5 ft SILTY CLAY (ML/CL), medium stiff, low plasticity, some organics, dry, dark brown, no odor

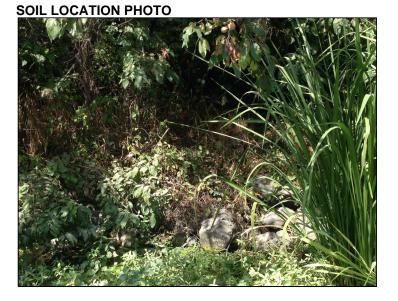
0.0 – 0.5 ft SILT (ML), some organics, trace clay, some gravel, 1" subangular, loose/soft, dry, dark brown, no odor

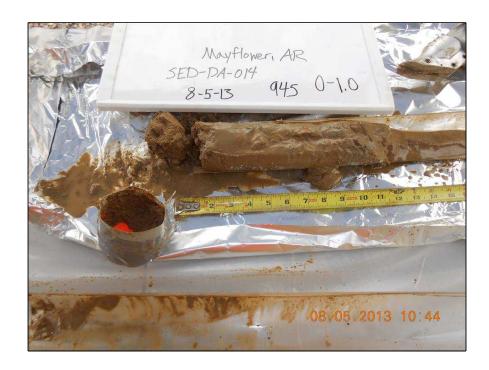
0 – 0.5	CLAYEY SAND, brown, fine grained, no odor
0.5 – 1.0	SANDY CLAY (CL), reddish brown, medium plasticity, no odor

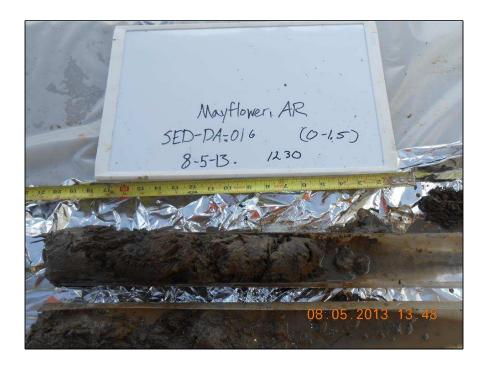
0 – 0.5	SANDY CLAY (CL), very soft, wet, low plasticity, brown, 50% organics
0.5 –1.0	SANDY CLAY (CL), very soft, wet, low plasticity, brown, 50% organics

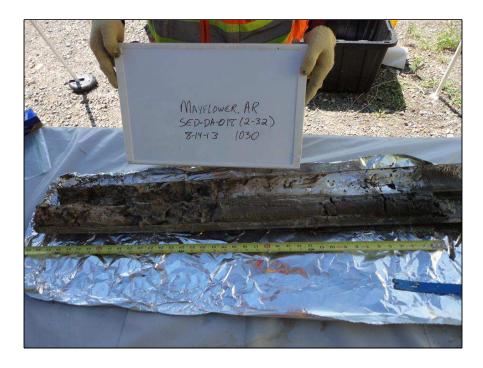
2.0 -3.0	CLAY (CL), soft, medium to high plasticity, wet, reddish gray, no odor
3.0 – 3.2	CLAY (CL), soft, medium to high plasticity, wet, reddish gray, no odor, trace organics

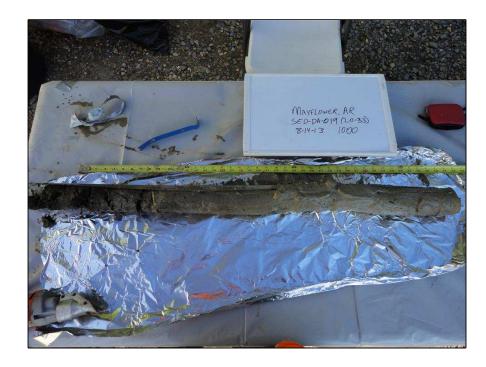
2.0 – 3.0	CLAY (CL), soft, low plasticity, wet, gray to 2.5 feet, no odor
3.0 – 3.3	CLAY (CL), stiff, moist, high plasticity, reddish gray, no odor

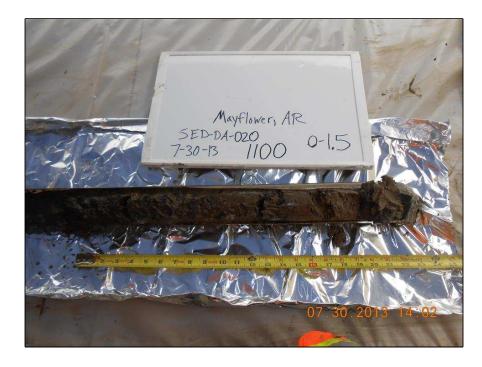
0 – 0.5	SILT (ML), brown, saturated, no odor
0.5 – 1.0	SILT (ML), brown, saturated, no odor
1.0 – 1.5	SILTY CLAY (CL), light brown, soft, wet, no odor

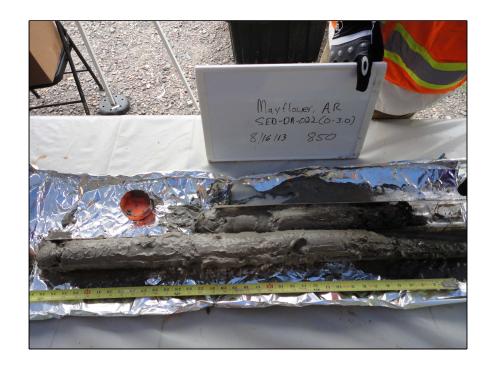
0.0 – 0.5	ORGANIC SILT (OL/PT), swamp soil, soft, organics, black, wet, organic odor
0.5 – 1.0	CLAY (CL), soft, low to medium plasticity, wet, gray, no odor
1.0 – 1.5	CLAY (CL), soft, low to medium plasticity, wet, gray, no odor
1.5 – 2.0	CLAY (CL), soft, low to medium plasticity, wet, gray, no odor
2.0 - 3.0	CLAY (CL), medium stiff, medium plasticity, moist to wet, gray with some red, no odor

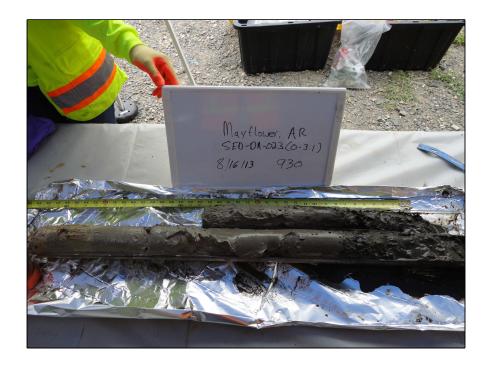
DEPTH INTERVAL (FT)	LITHOLOGY DESCRIPTION
0.0 – 0.5	ORGANIC SILT (OL), organics, soft, wet, black, some odor
0.5 – 1.0	ORGANIC SILT (OL–CL), organics, soft, wet, black, some odor, transitions to clay at 11 inches
1.0 – 1.5	CLAY (CL), some silt, soft, wet, no plasticity, gray, no odor
1.5 – 2.0	CLAY (CL), some silt, soft, wet, no plasticity, gray, no odor
2.0 - 3.0	CLAY (CL), some silt, soft, wet, no plasticity, gray, no odor, at 2 feet 10 inches transition to stiff, dry to moist clay, gray with red, no odor
3.0 – 3.1	CLAY (CL), some silt, soft, wet, no plasticity, gray, no odor

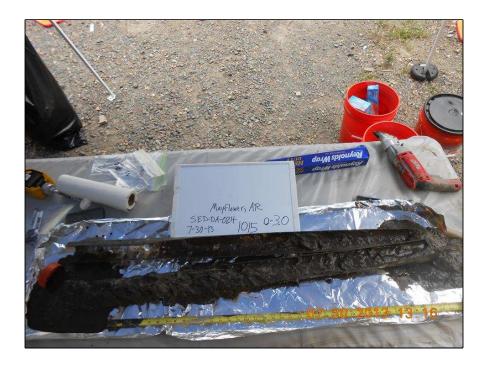
0 – 0.5	SILT (ML), brown, saturated, trace organics, slight odor (organic)
0.5 – 1.0	SILT (ML), brown, saturated, trace organics
1.0 – 1.5	SILT (ML), brown, saturated, trace organics
1.5 – 2.0	SILT (ML), brown, saturated, trace organics
2.0 - 3.0	SILT (ML), brown, saturated, trace organics

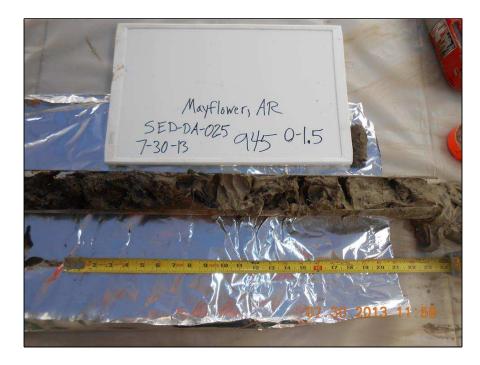
0 – 0.5	SILT (ML), brown, saturated, root mass, no odor
0.5 – 1.0	SILT (ML), some clay, light brown, saturated, no odor
1.0 – 1.5	SILTY CLAY (CL), light brown, wet, no odor

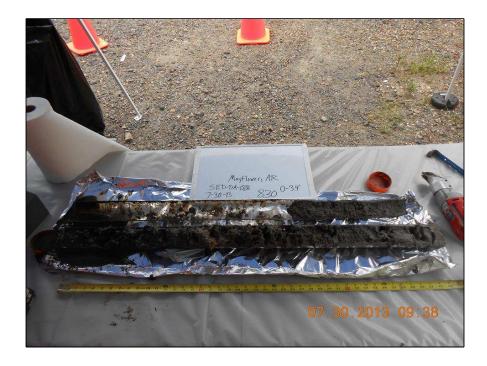
DEPTH INTERVAL (FT)	LITHOLOGY DESCRIPTION
0 – 0.5	SILT (ML), brown, no odor, root mass, saturated
0.5 –1.0	SILT (ML), brown, no odor, root mass, saturated
1.0 – 1.5	SILT (ML), light brown, saturated
1.5 – 2.0	SANDY CLAY (CL), light brown, wet, no odor, trace organics
2.0 - 3.0	SANDY CLAY (CL), light brown, wet, no odor, trace organics
3.0 - 3.4	SANDY CLAY (CL), light brown, wet, no odor, trace organics

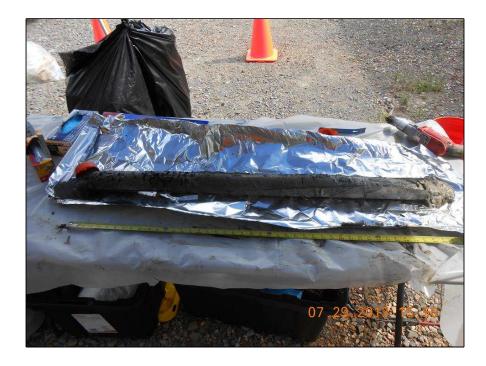
DEPTH INTERVAL (FT)	LITHOLOGY DESCRIPTION
0 – 0.5	SILT (ML), brown, saturated, root mass
0.5 – 1.0	SILT (ML), brown, saturated, root mass
1.0 – 1.5	SILTY CLAY (CL), gray, trace organics
1.5 – 2.0	SILTY CLAY (CL), gray, saturated
2.0 - 3.0	CLAY (CL), gray, trace organics, no odor, saturated
3.0 - 3.6	CLAY (CL), gray, trace organics, no odor, saturated

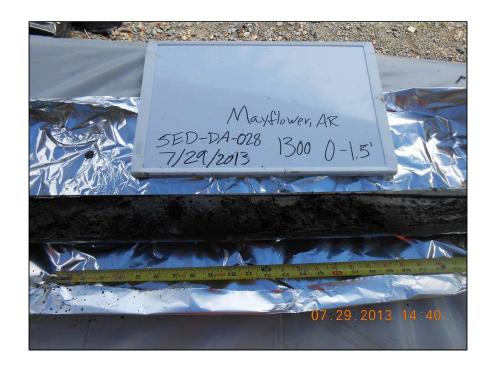
DEPTH INTERVAL (FT)	LITHOLOGY DESCRIPTION
0 – 0.5	SILT (ML), brown, no odor, root mass, saturated
0.5 – 1.0	SILT (ML), light brown, root mass, no odor, saturated
1.0 – 1.5	CLAY (CL), gray, trace organics, saturated

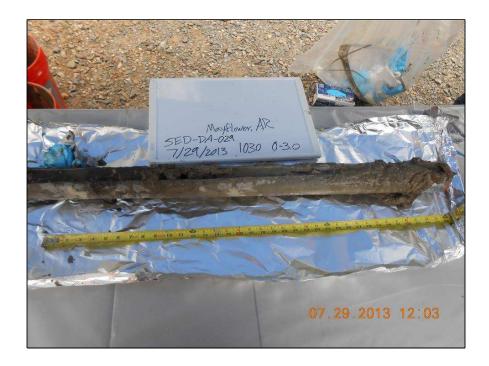
DEPTH INTERVAL (FT)	LITHOLOGY DESCRIPTION
0 – 0.5	SILT (ML), brown, no odor, saturated, trace organics, root mass
0.5 – 1.0	SILT (ML), brown, no odor, saturated, trace organics, root mass
1.0 – 1.5	SILT (ML), light brown, no odor, saturated, trace organics, and root mass
1.5 – 2.0	SILT (ML), light brown, no odor, saturated, trace organics, and root mass
2.0 – 3.0	SILT (ML), light brown, no odor, saturated, trace organics, and root mass

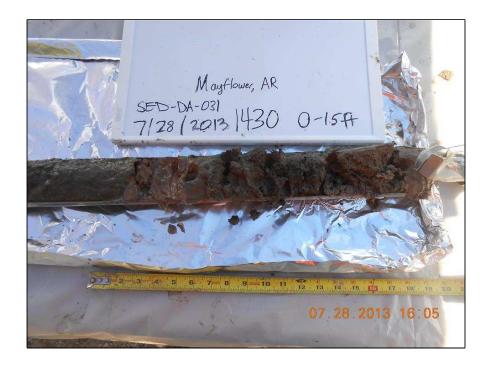
0 – 0.5	SILT (ML), brown, no odor, root mass
0.5 – 1.0	SILT (ML), brown, no odor, root mass
1.0 – 1.5	SILTY CLAY (CL), gray, root mass, no odor

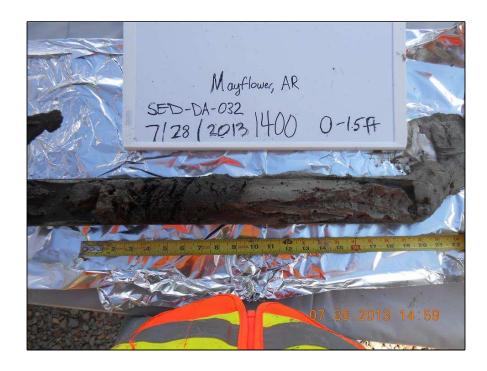
0 – 0.5	SILT (ML), brown, trace organics, mild odor, saturated
0.5 – 1.0	SILTY CLAY (CL), gray, no odor, saturated
1.0 – 1.5	CLAY (CL), gray, soft, no odor, saturated

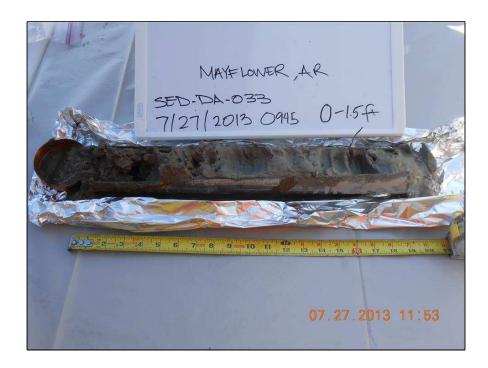
SEDIMENT SAMPLE FIELD PHOTOS: SED-DA-033

DEPTH INTERVAL (FT)	LITHOLOGY DESCRIPTION
0 – 0.5	SILT (ML), brown, trace organics, saturated
0.5 – 1.0	SILTY CLAY (CL), gray, trace organics, saturated
1.0 – 1.5	CLAY (CL), gray, trace organics, wet

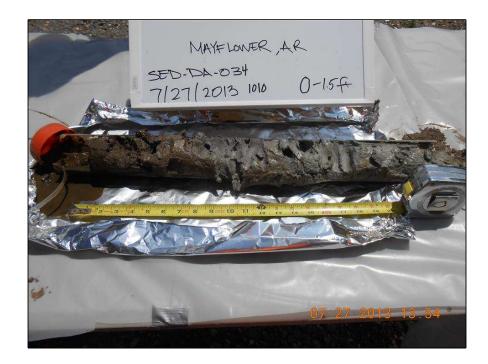
SEDIMENT SAMPLE FIELD PHOTOS: SED-DA-034

DEPTH INTERVAL (FT)	LITHOLOGY DESCRIPTION
0 – 0.5	CLAYEY SILT (ML), brown, trace organics, mild odor, saturated
0.5 – 1.0	SILTY CLAY (CL), gray, low plasticity, no odor
1.0 – 1.5	CLAY (CL), gray, low plasticity, no odor

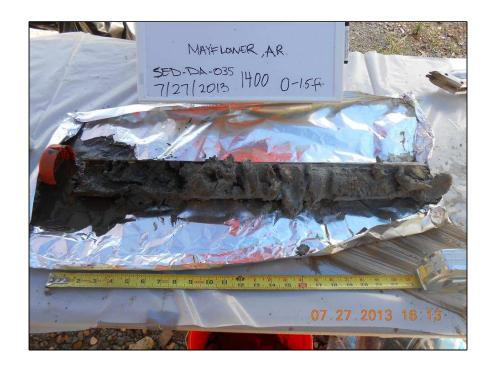
SEDIMENT SAMPLE FIELD PHOTOS: SED-DA-035

0 – 0.5	SILT (ML), brown, trace organics, mild odor, saturated
0.5 – 1.0	CLAYEY SILT (ML), brown to gray at 1 foot, saturated
1.0 – 1.5	SILTY CLAY (CL), gray, low plasticity, wet

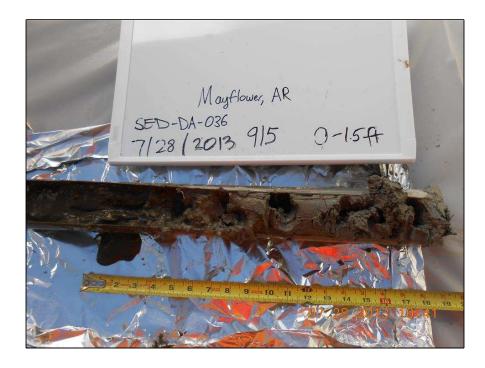
SEDIMENT SAMPLE FIELD PHOTOS: SED-DA-036

0 – 0.5	SILT (ML), brown saturated, trace organics, no odor
0.5 – 1.0	SILTY CLAY (CL), gray, trace organics, saturated, no odor
1.0 – 1.5	CLAY (CL), gray, trace organics, wet, no odor

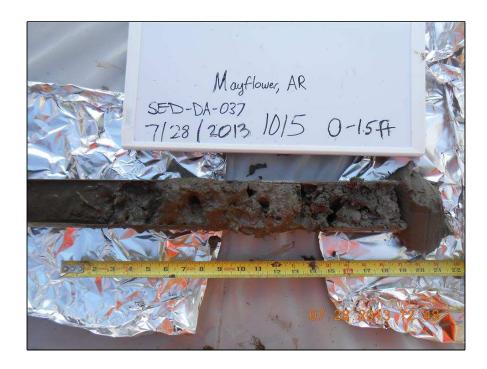
SEDIMENT SAMPLE FIELD PHOTOS: SED-DA-037

0 – 0.5	SILT (ML), brown, saturated, no odor
0.5 – 1.0	SILT (ML), dark gray, saturated, no odor
1.0 – 1.5	CLAY (CL), gray, soft, low plasticity, no odor

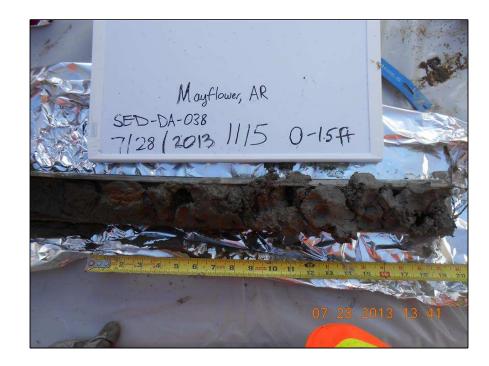
0 – 0.5	SILT (ML), brown, saturated, no odor, trace organics
0.5 – 1.0	SILT (ML), brown, saturated, no odor, trace organics
1.0 – 1.5	CLAY (CL), gray, soft, no odor, trace organics

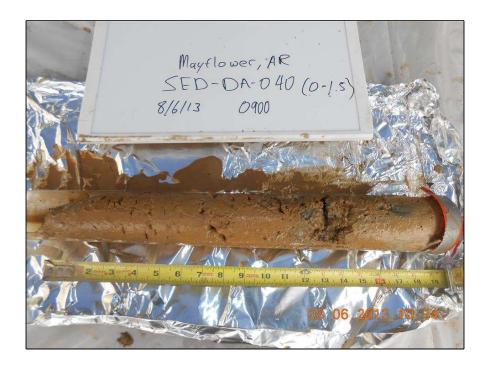
LITHOLOGY DESCRIPTION

0 – 0.5	CLAY (CL), trace silt, wet, medium-high plasticity, medium stiff
0.5 – 1.0	CLAY (CL), trace silt, wet, medium-high plasticity, medium stiff, light brown
1.0 – 1.5	CLAY (CL), trace silt, wet, medium-high plasticity, medium stiff, light brown

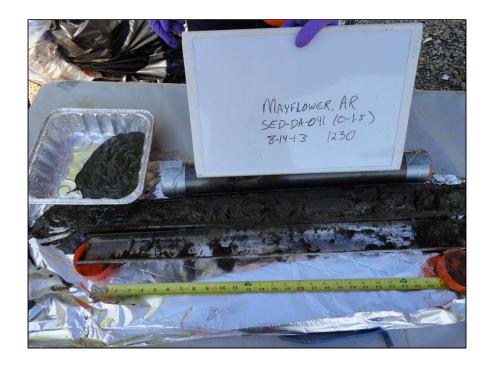
LITHOLOGY DESCRIPTION

0 – 0.5	SILT (ML/CL), soft, wet, black, very wet, slight odor, sheen
0.5 – 1.0	SILT (ML/CL), soft, wet, black, very wet
1.0 – 1.5	SILT (ML/CL), soft, wet, black, very wet

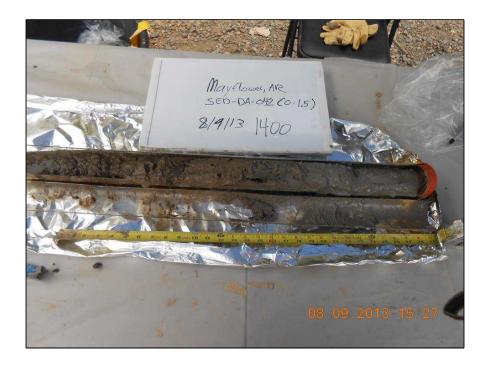
DEPTH INTERVAL (FT)	LITHOLOGY DESCRIPTION
0 – 0.5	MUD/SILT (ML), soft, trace clay, black, some organics, organic odor
0.5 – 1.0	SILTY CLAY (CL), soft, trace organics, low plasticity, organic odor, gray/black
1.0 – 1.5	CLAY (CL), soft-medium stiff, medium plasticity, gray, slight organic odor

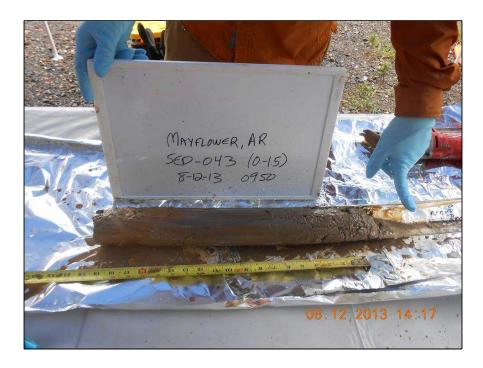
LITHOLOGY DESCRIPTION

0 – 0.5	SILTY CLAY (ML/CL), soft, wet, no plasticity, trace organics, no odor, black
0.5 – 1.0	CLAY (CL), soft, medium plasticity, wet, no odor, gray/brown
1.0 – 1.5	CLAY (CL), soft, medium plasticity, wet, no odor, gray/brown

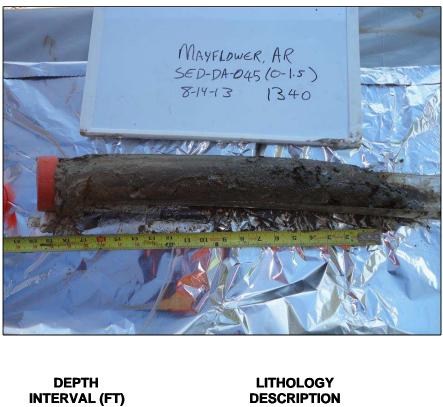
FIGURE **B-83**

1.0 – 1.5

CLAY (CL), trace coarse sand/gravel, soft, wet, light brown, no odor

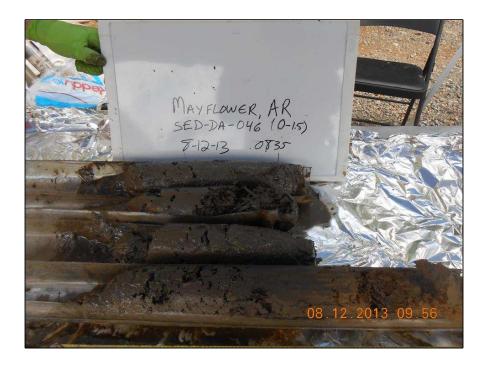
FIGURE **B-84**

LITHOLOGY DESCRIPTION

0 – 0.5	SILTY CLAY (CL), soft, medium plasticity, wet, some organics, slight odor, black
0.5 – 1.0	CLAY (CL), soft, high plasticity, wet, some organics, slight odor, gray
1.0 – 1.5	CLAY (CL), soft, high plasticity, wet, some organics, slight odor, gray

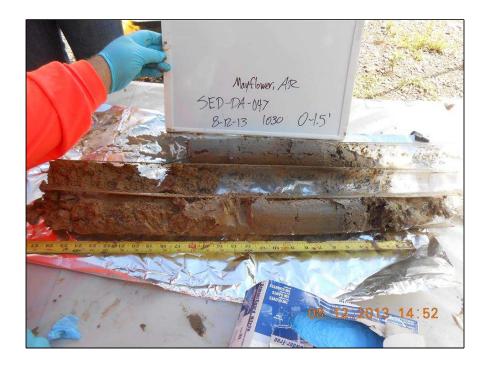
LITHOLOGY DESCRIPTION

0 – 0.5	SILT (ML), some clay, some organics, soft, wet, no plasticity, HCO, black
0.5 – 1.0	CLAY (CL), trace silt, organics, soft, wet, low plasticity, gray, no odor
1.0 – 1.5	CLAY (CL), trace silt, organics, soft, wet, low plasticity, gray, no odor

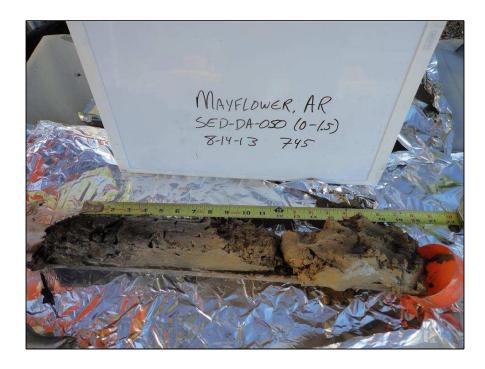
LITHOLOGY DESCRIPTION

0 – 0.5	ORGANIC SILT, PEAT (OL/PT), organics, wet, swamp soils, some clay, soft, black, slight odor
0.5 – 1.0	CLAY (CL), some silt, wet, soft, low plasticity, light brown, no odor
1.0 – 1.5	CLAY (CL), some silt, wet, soft, low plasticity, light brown, no odor

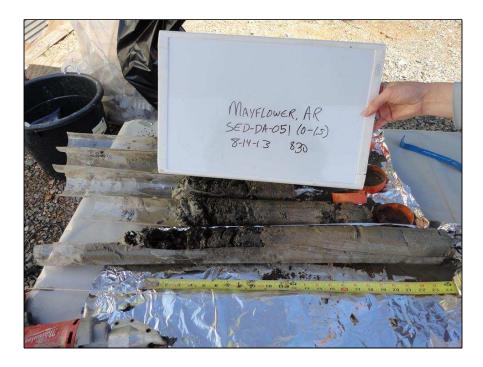
LITHOLOGY DESCRIPTION

0 – 0.5	ORGANIC SILT, PEAT (OL/PT), organics, peat/swamp soils, wet, soft, black, organic odor
0.5 – 1.0	CLAY (CL), trace silt, low to medium plasticity, soft, wet, gray, slight odor
1.0 – 1.5	CLAY (CL), trace silt, low to medium plasticity, soft, wet, gray, slight odor

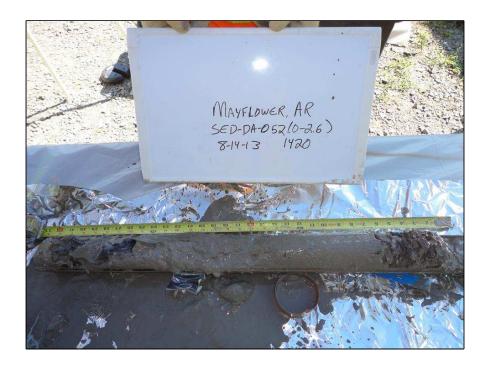
DEPTH INTERVAL (FT)	LITHOLOGY DESCRIPTION
1.5 – 2.0	CLAY/SILT (CL/ML), some organics, soft, wet, gray, no odor
2.0 – 2.6	CLAY/SILT (CL/ML), some organics, soft, wet, gray, no odor
