ARKANSAS  
Department of Environmental Quality

AFIN: 57-00042 NPDES Permit No.: AR0036692

## NPDES Compliance Inspection Report

**Subject:** 18 inch sewer main break at Polk 54 in Mena

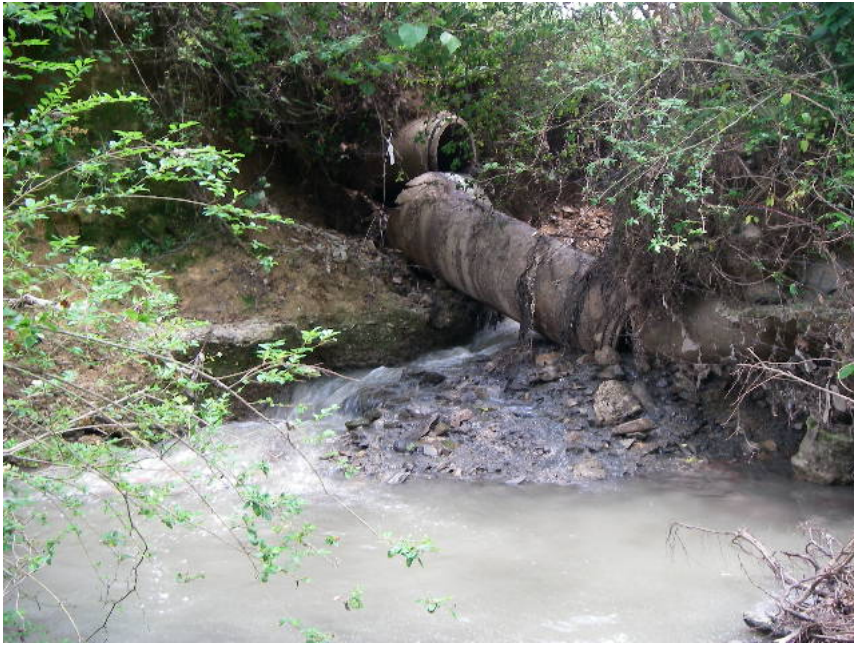
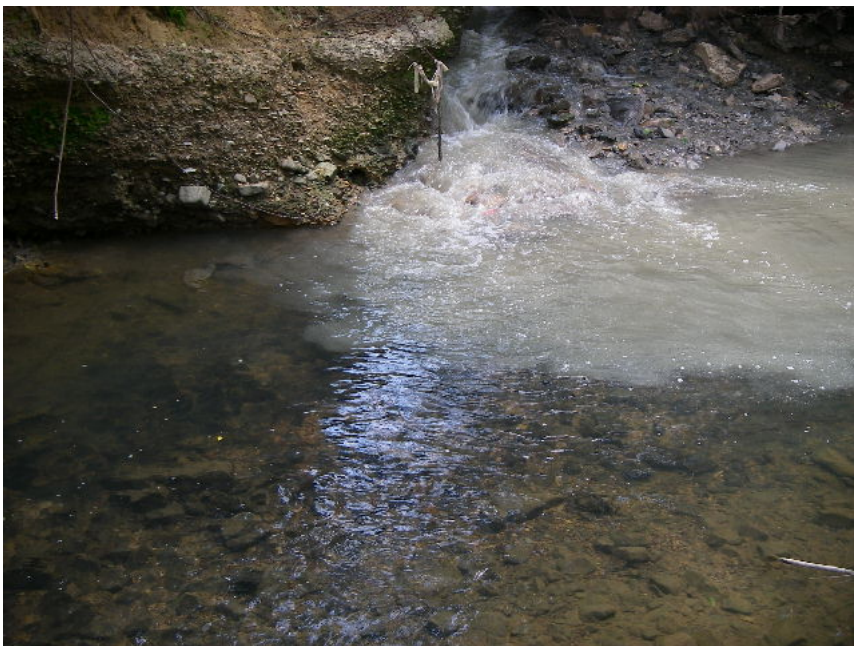
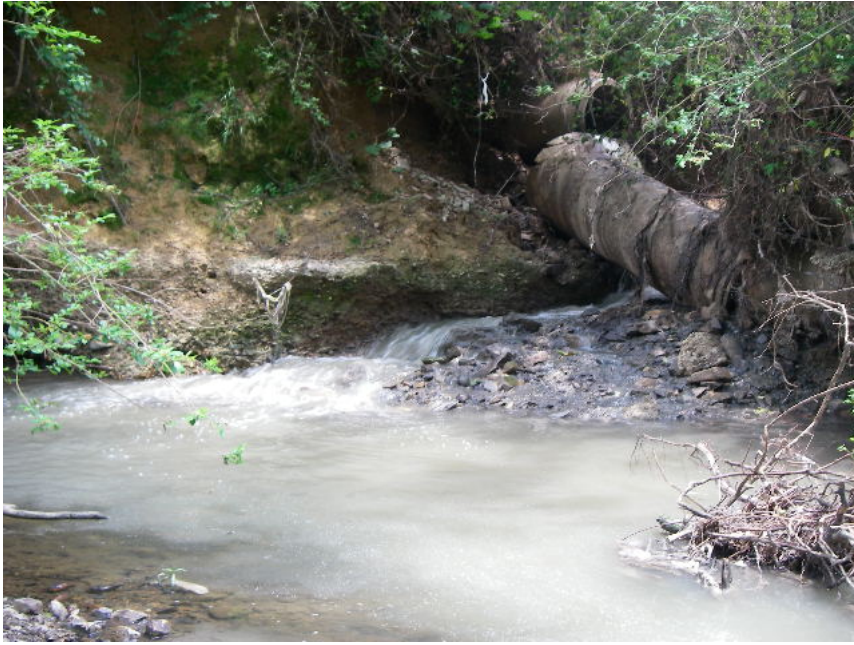
**The City of Mena collection system was discharging sewage via a broken sewer main. This unpermitted discharge was occurring into Ward Creek.**

As per your request, here is a time line of our progress. On June 2, Shan Lynch notified Mena Water Utilities regarding the sewer main break at Ward Creek. According to our observation, erosion of the creek bank caused the sewer main to shift and break. That afternoon we performed the preparatory work for the sewer main repair. We ordered materials, moved trees and brush, and removed the damaged pipe.

On June 3 we built a pier to support the new section of pipe and repaired the pipe using the following materials: twenty feet of eighteen inch ductile iron, fourteen feet of eighteen inch PVC sewer pipe, a solid 24 x 18 coupling, twenty-four inch PVC pipe for pier construction, twenty blocks and ten yards of concrete. The following day we added six more yards of concrete and ten loads of fill dirt to support the pipe and deter future erosion.
