RE: NPDES Sanitary Sewer Overflow Inspection, West Memphis WWTP

AFIN: 18-00879 NPDES Permit No.: AR0022039

NPDES Compliance Evaluation Inspection Wastewater Treatment Plant NPDES Sanitary Sewer Overflow Inspection Pretreatment Compliance Inspection

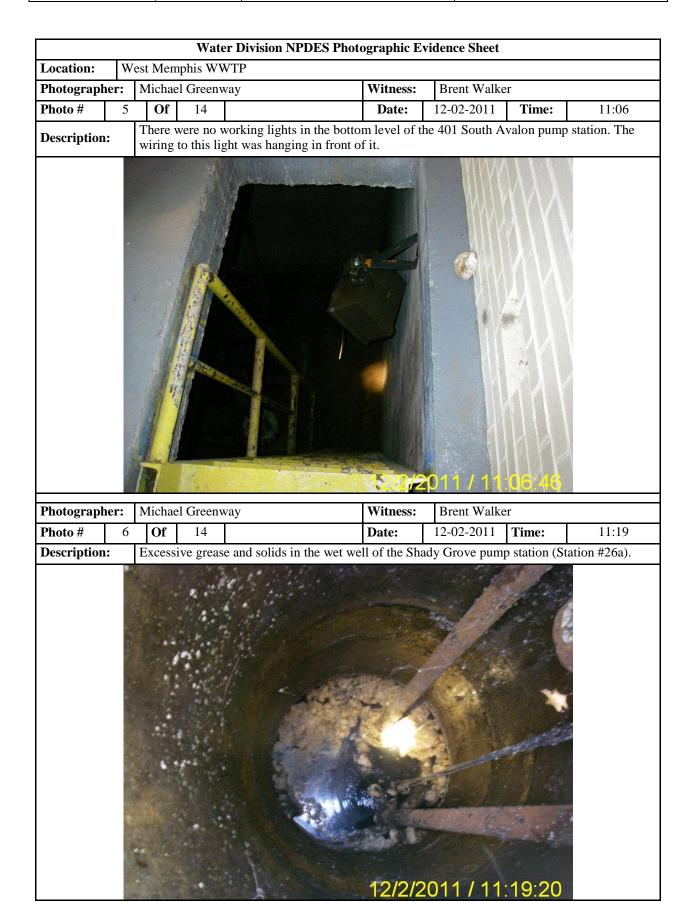
- 1. Station #8 (610 East Jefferson)
  - a. There was an uncovered hole in the floor where a pump had been removed.
- 2. Station #9 (1620 South Avalon)
  - a. There was excessive grease and solids in the wet well.
  - b. There were uncovered holes in the floor.
- 3. Station #6 (401 South Avalon)
  - a. One of the three pumps was not operational.
  - b. There was excessive grease and solids in the wet well.
  - c. One of the pumps did not have a driveshaft guard in place.
  - d. The lights for the lower level were inoperative.
- 4. Station #26a (Shady Grove)
  - a. There was excessive grease and solids in the wet well
  - b. The pumps were not alternating; both ran at the same time.
- 5. Station #13a (Park Plaza)
- a. A manhole behind station was damaged and partially uncovered.

Water Division NPDES Photographic Evidence Sheet										
<b>Location:</b> West Memphis WWTP										
Photograph	er: N	Aichae	el Greenv	vay	Witness:	Brent Walker				
Photo #	7	Of	14		Date:	12-02-2011	Time:	11:44		
<b>Description:</b>		Damaged and partially uncovered manhole behind the Park Plaza pump station (Station #13a).

- a) This has been repaired. (See picture-Pump Station #13A (Park Plaza)-Outside-1 & 2).
- 6. Station #29 (Lalman Mobile Home Park)
