ARKANSAS
Department of Environmental Quality

RE: Valley Ridge Subdivision Inspection
AFIN: 63-00820 Permit No.: ARR151435

A R K A N S A S Department of Environmental Quality		WATER DIVISION INSPECTION REPORT						
		AFIN: 63-00820		PERMIT #: ARR151435		DATE: 7/9/2015		
		COUNTY: 63 Saline			PDS #: 085802		MEDIA: WN	
		GPS LAT: 34.611232 LONG: -92.436733 LOCATION: General Area						
FACILITY INFORMATION				INSPECTION INFORMATION				
NAME: Valley Ridge Subdivision LOCATION: Valley Ridge Drive CITY: Alexander, AR				FACILITY TYPE: 1 - Municipal		INSPECTOR ID#: 107625 S - State		
				FACILITY EVALUATION RATING: ***		INSPECTION TYPE: Compliance Evaluation		
				DATE(S): 7/9/2015	ENTRY TIME: 09:45	EXIT TIME: 11:50	PERMIT EFFECTIVE DATE: 12/29/2011	
				PERMIT EXPIRATION DATE: 10/31/2016				
RESPONSIBLE OFFICIAL				FAYETTEVILLE SHALE RELATED: N FAYETTEVILLE SHALE VIOLATIONS: N INSPECTION PARTICIPANTS NAME/TITLE/PHONE/FAX/EMAIL/ETC.: Chris Naus/ADEQ District 9 Water Inspector/ 501-682-0658/naus@adeq.state.ar.us				
NAME / TITLE Greg Holman / Reg. Agents COMPANY: Boto AR Properties, LLC MAILING ADDRESS: 17901 Chenal Parkway CITY, STATE, ZIP: Little Rock AR 72223 PHONE & EXT: / FAX: 501-33

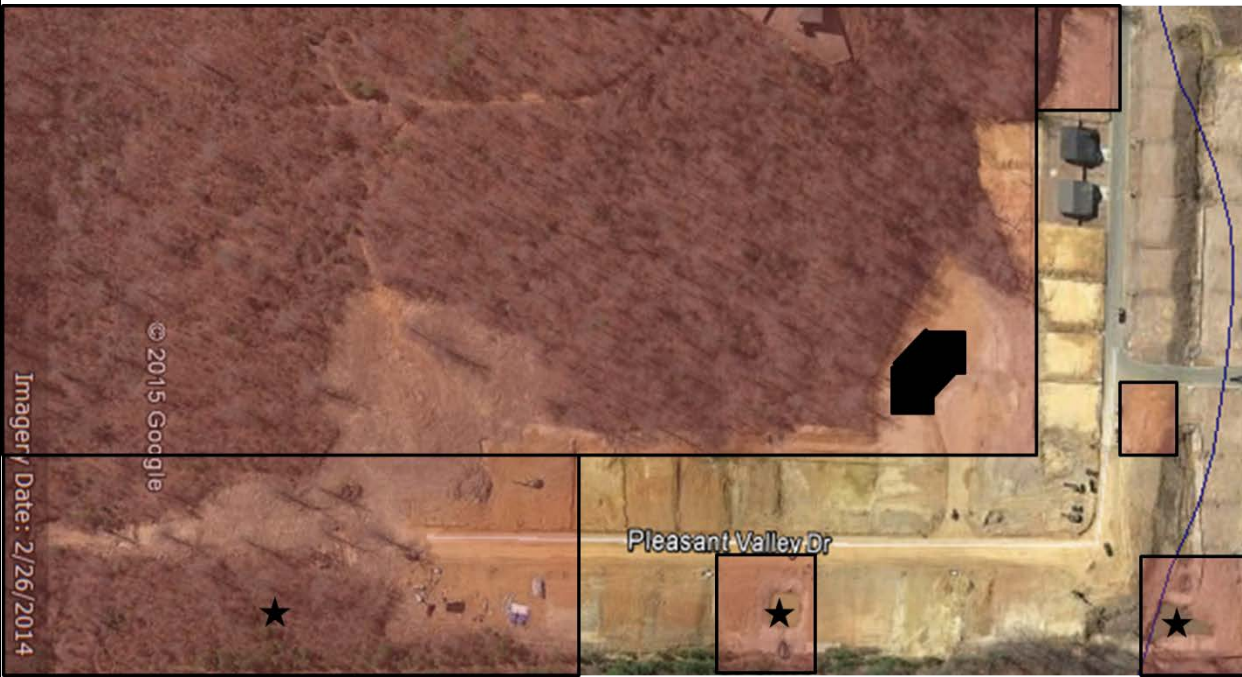
Water Division Photographic Evidence Sheet					
Location:	Valley Ridge Subdivision				
Photographer:	Google Earth Modified by Chris Naus	Date:	7/20/2015	Time:	
Witness:				Photo #:	1
Description:	Aerial photograph with Boto AR Properties, LLC properties outlined. Stars represent approximate locations of detention ponds owned by Boto AR Properties.
