ARKANSAS
Department of Environmental Quality

RE: James Olive Salvage Yard Inspection
AFIN: 56-00000 Permit No.: ARR000000 - Unpermitted

WATER DIVISION INSPECTION REPORT				
	AFIN: 56-00000	PERMIT #: ARR000000	DATE: 10/20/2015		
	COUNTY: 56 Poinsett	PDS #: 088062	MEDIA: WN		
	GPS LAT: 35.484233 LONG: -90.338308 LOCATION: Entrance				
FACILITY INFORMATION		INSPECTION INFORMATION			
NAME: James Olive Salvage Yard LOCATION: Steel Bridge Rd. CITY: Tyronza		FACILITY TYPE: 2 - Industrial INSPECTOR ID#: 52138 S - State FACILITY EVALUATION RATING: N INSPECTION TYPE: Industrial Stormwater DATE(S): 10/20/2015 ENTRY TIME: EXIT TIME: PERMIT EFFECTIVE DATE: PERMIT EXPIRATION DATE:			
RESPONSIBLE OFFICIAL		INSPECTION PARTICIPANTS			
NAME / TITLE: James Olive / Owner COMPANY: James Olive Salvage Yard MAILING ADDRESS: 39143 Steel Bridge Rd. CITY, STATE, ZIP: Tyronza AR 72386 PHONE & EXT. / FAX: 901-359-0995 / EMAIL:		NAME/TITLE/PHONE/FAX/EMAIL/ETC.: None			
CONTACTED DURING INSPECTION: No					
AREA EVALUATIONS (S=Satisfactory, M=Marginal, U=Unsatisfactory, N=Not Applicable/Evaluated)

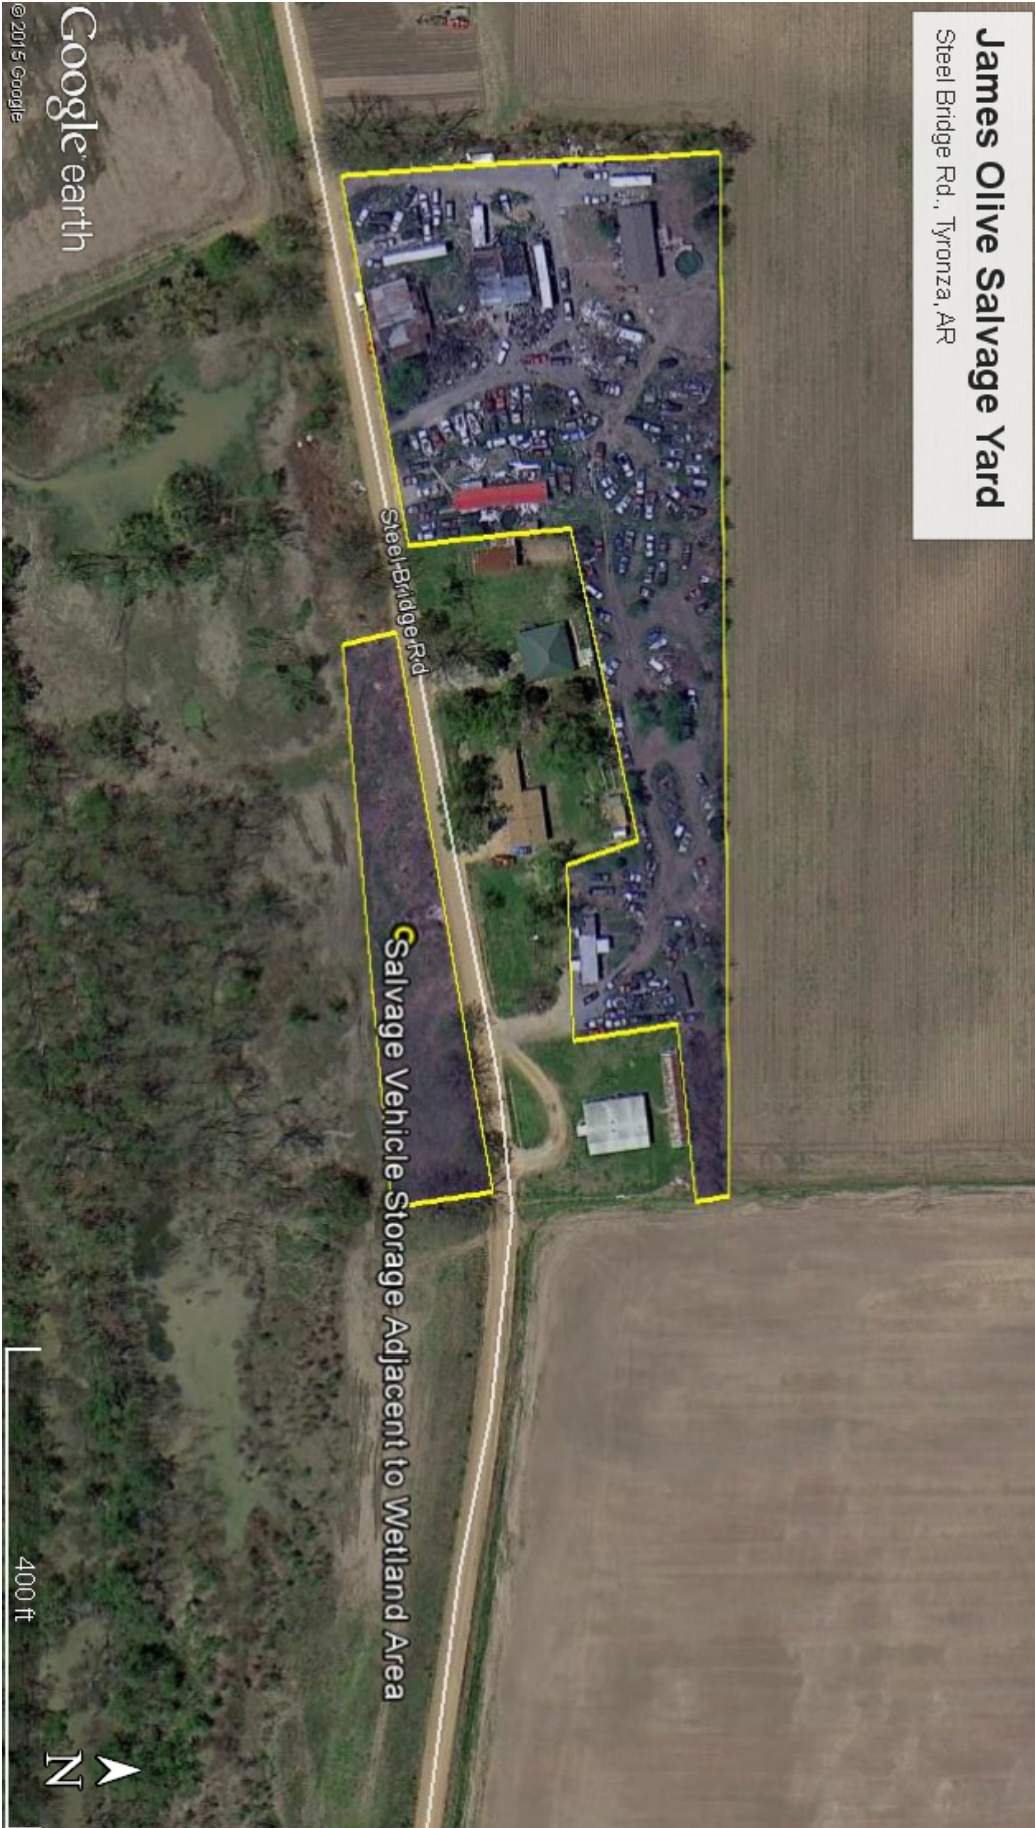
Location:	James Olive Salvage Yard, Steel Bridge Rd., Tyronza, AR				
Photographer:	Brent Walker	Date:	10/20/2015	Time:	1130
Witness:	Sarah Frasher	Photo #:	1		
Description:	Salvage vehicles stored adjacent to wetland area on south side of Steel Bridge Rd.
