<u>VDEO</u>	AFIN: 33-000 COUNTY: 33 GPS LAT: FACILITY INFORMATION Melbourne Spur Irne, AR RESPONSIBLE OFFICIAL AHalbrook / Mayor Melbourne RESS: AVERAGE AND	WATER I	DIVISION INSPECTION REPORT				
	ADLQ	AF	IN: 33-00026 PE	ERMIT #: AR002 0	0036		DATE: 1	1/26/2016
Δ	RKANSAS	CC	UNTY: 33 Izard		PDS #	#: 089189		MEDIA: WN
Dep	partment of Environmental Quality	GP	S LAT: LO	ONG: LOC	ATION	l: ******		
	FACILITY INFORMAT	ION		IN	SPECT	TION INFO	RMATIO	N
Cit	y of Melbourne			FACILITY TYPE: 1 - Municipal		or id#: 162 S - Stat	е	
	y 9 Spur			FACILITY EVALUATION RATING 2 - Marginal	2 - Marginal SSO/Collection Sy		ion System	
Ме	lbourne, AR			(-)	1:32	EXIT TIME: 12:45		FECTIVE DATE:
	AME: / TITLE			172072010	1.02	12.40	11/1/2 PERMIT EX	(U15 (PIRATION DATE:
	IAME: / TITLE					10/31	/2020	
COM				FAYETTEVILLE SHALE RELATED: N				
Cit	y of Melbourne			FAYETTEVILLE SHALE VIOLATIONS: N				
MAILING ADDRESS:		INSPECTION PARTICIPANTS

SUMMARY OF FINDINGS

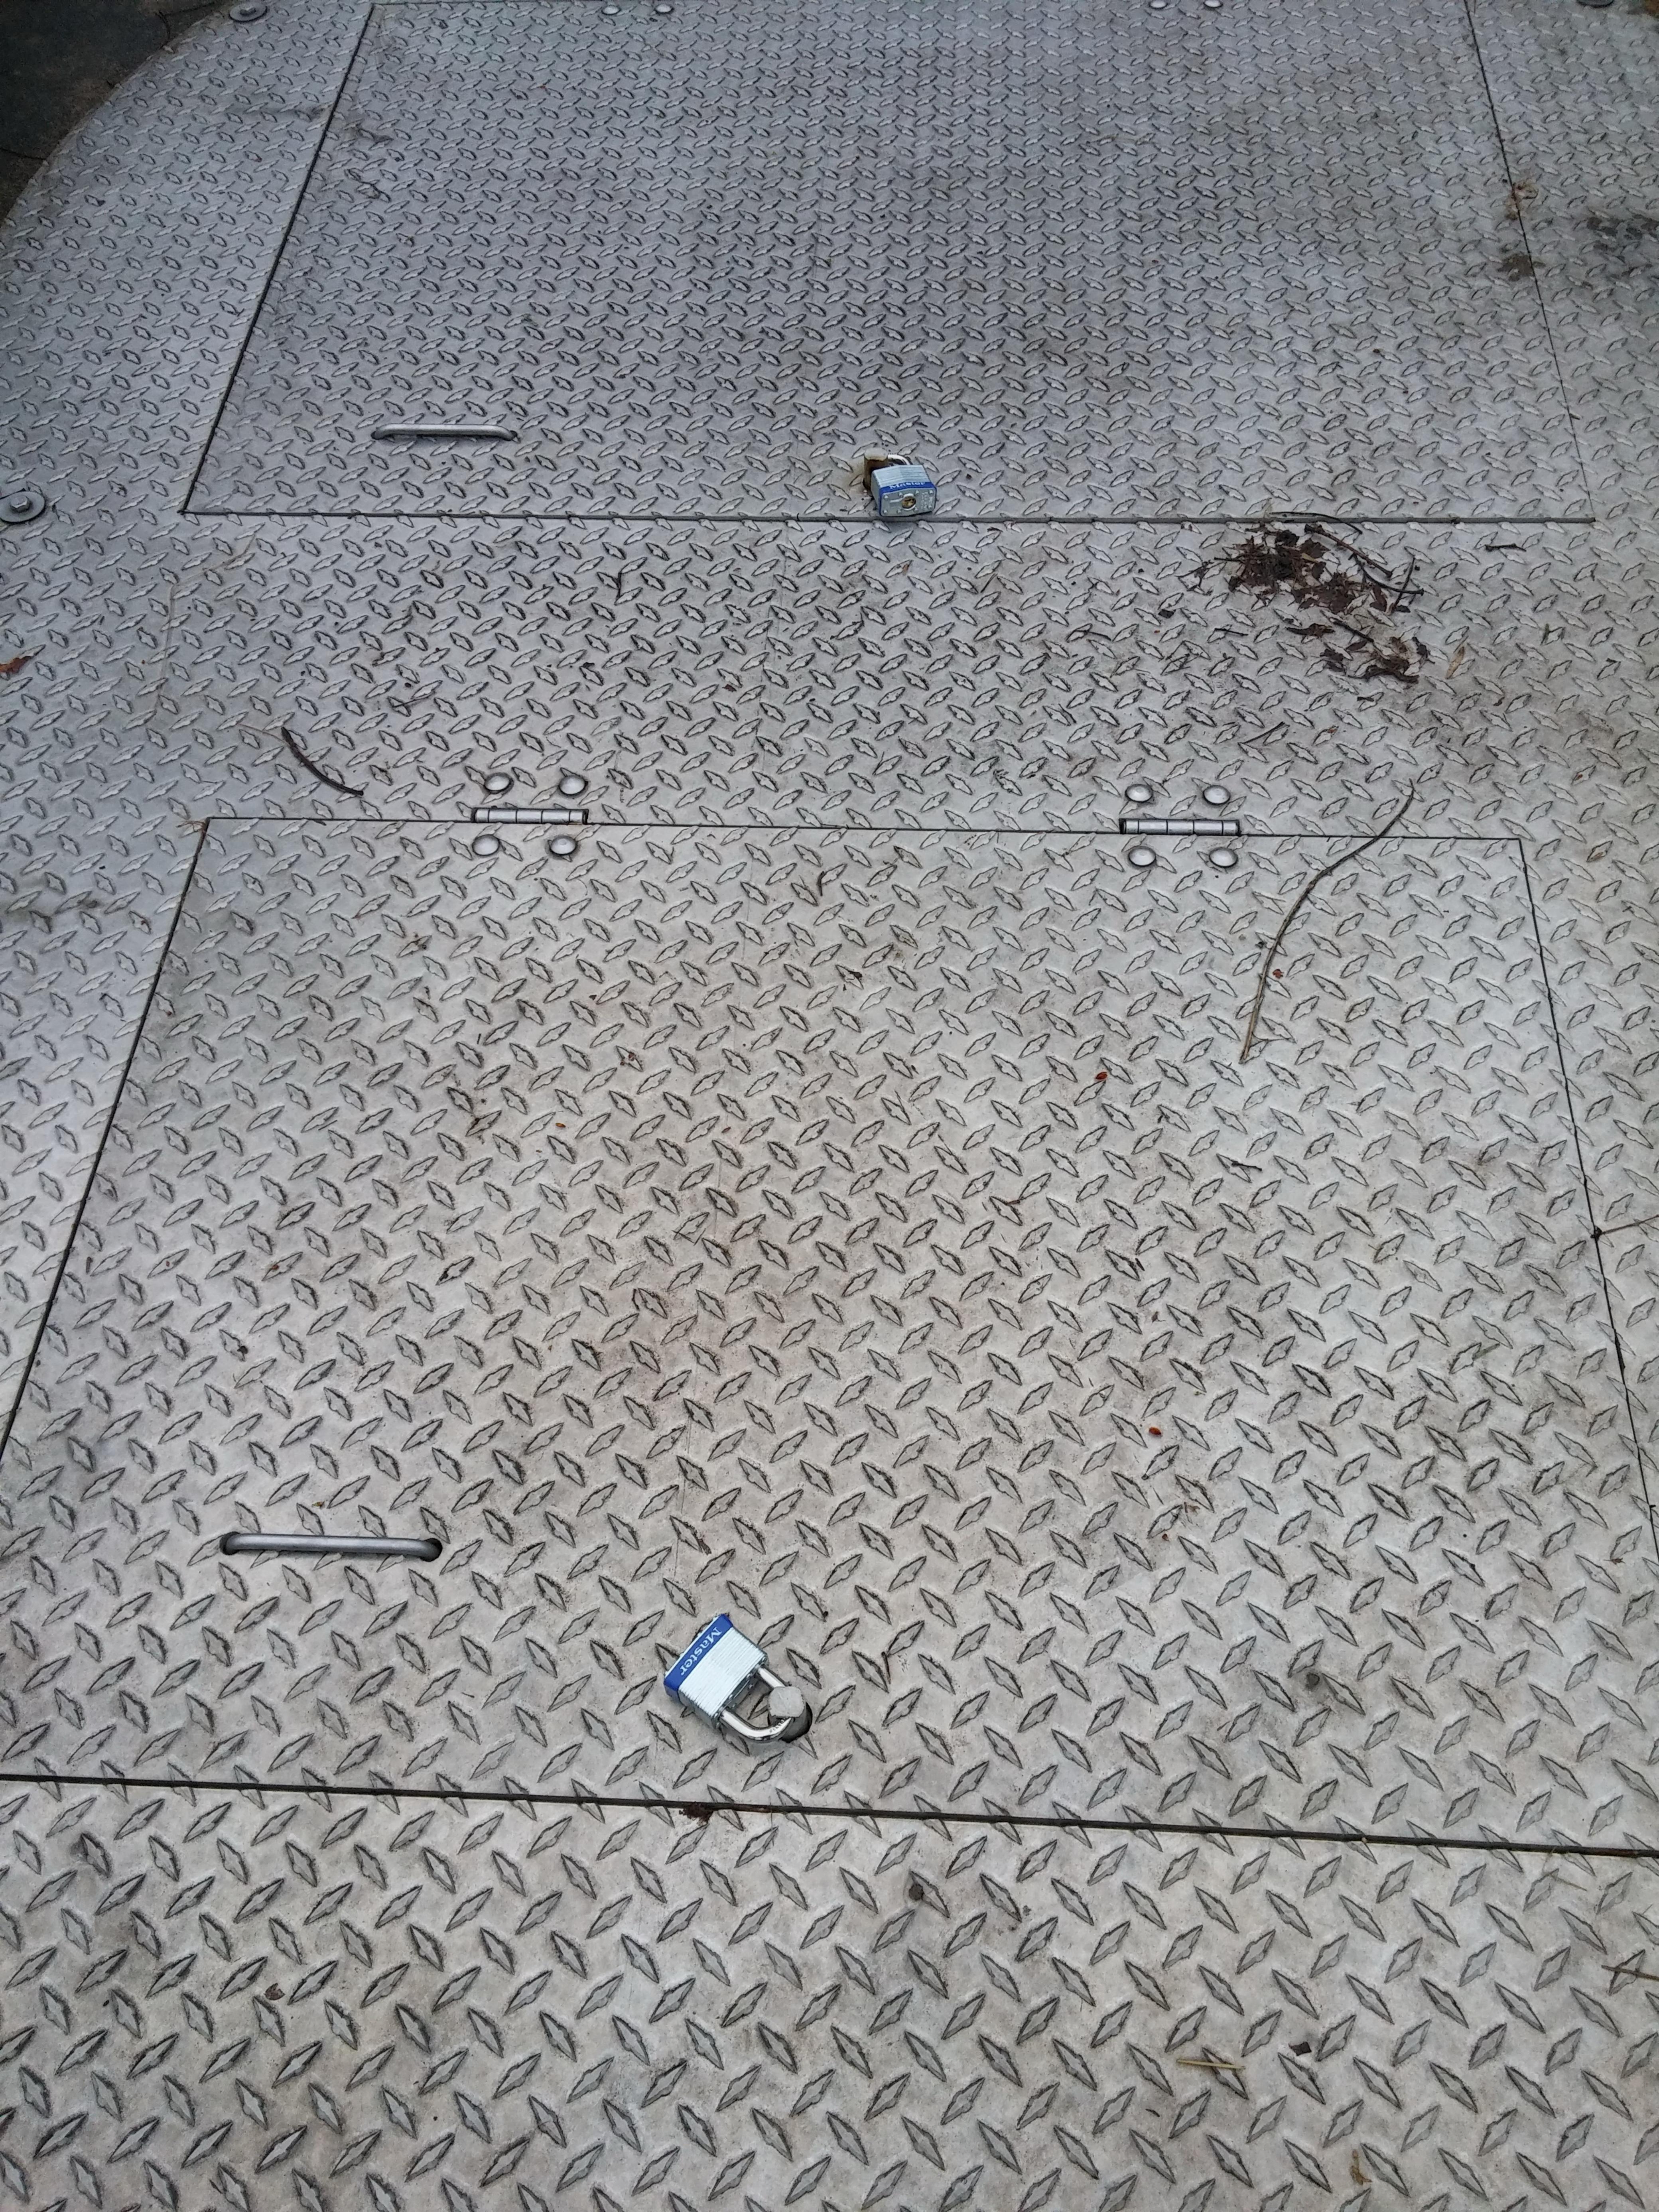
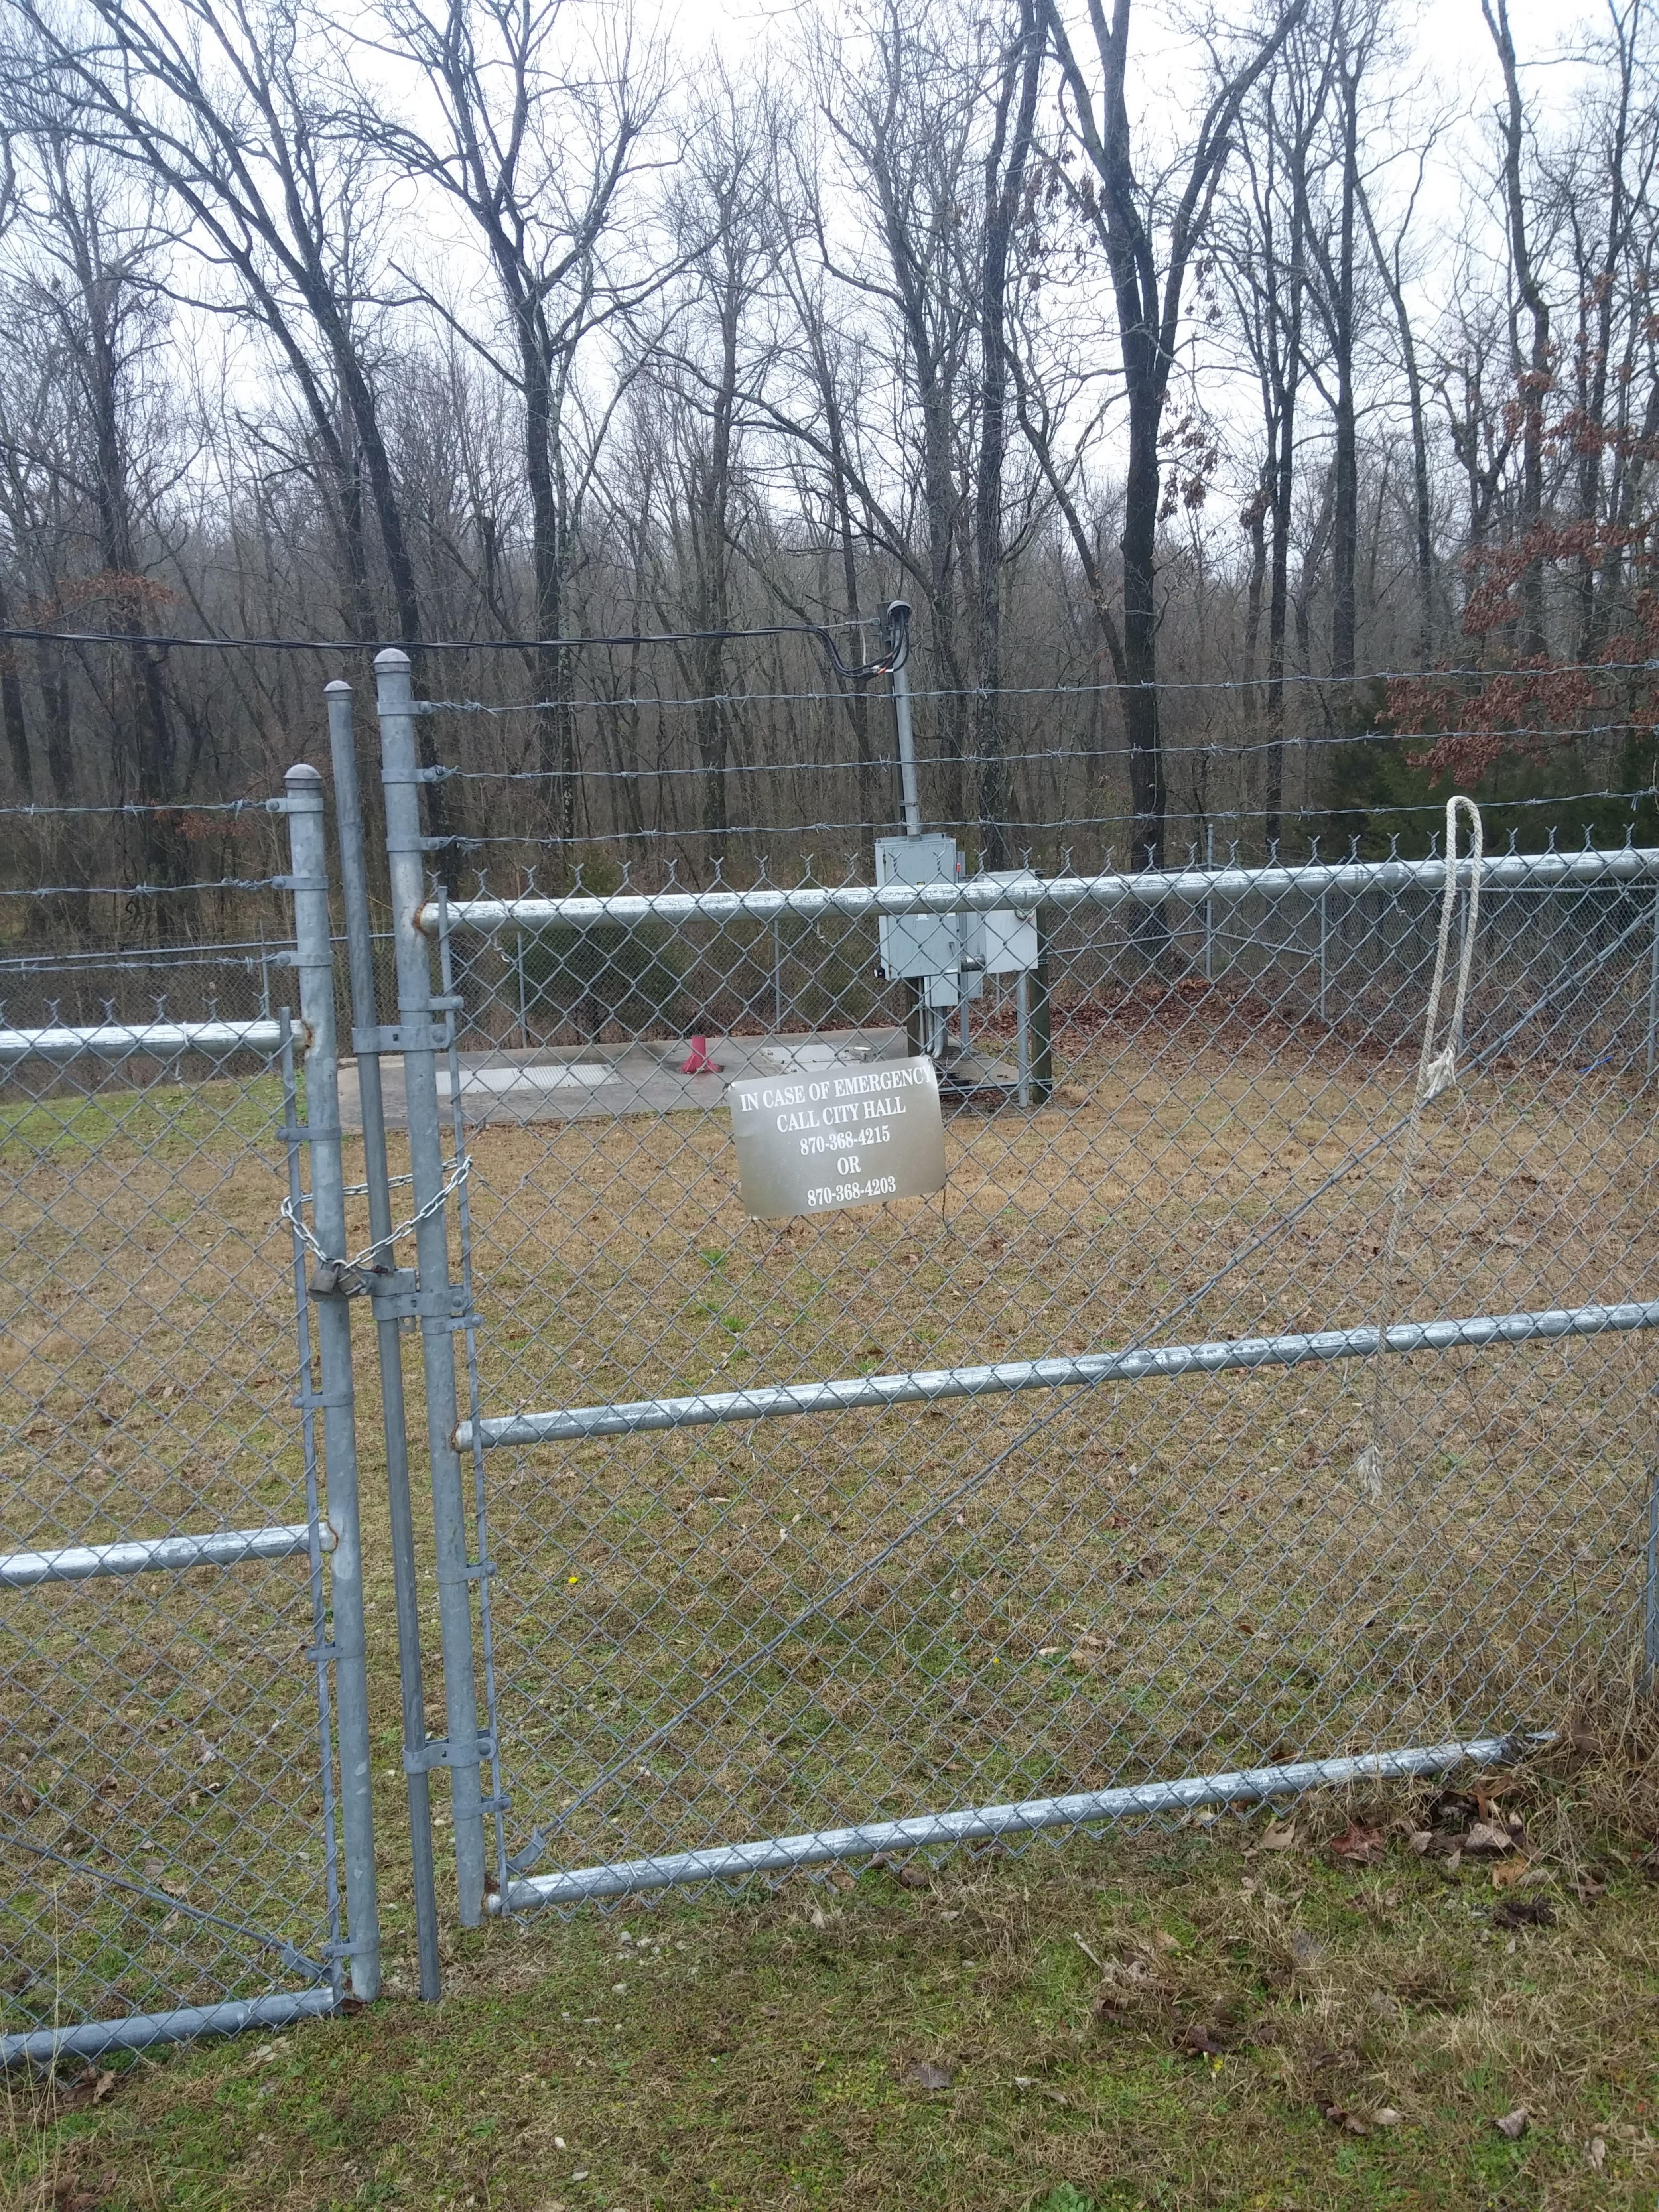
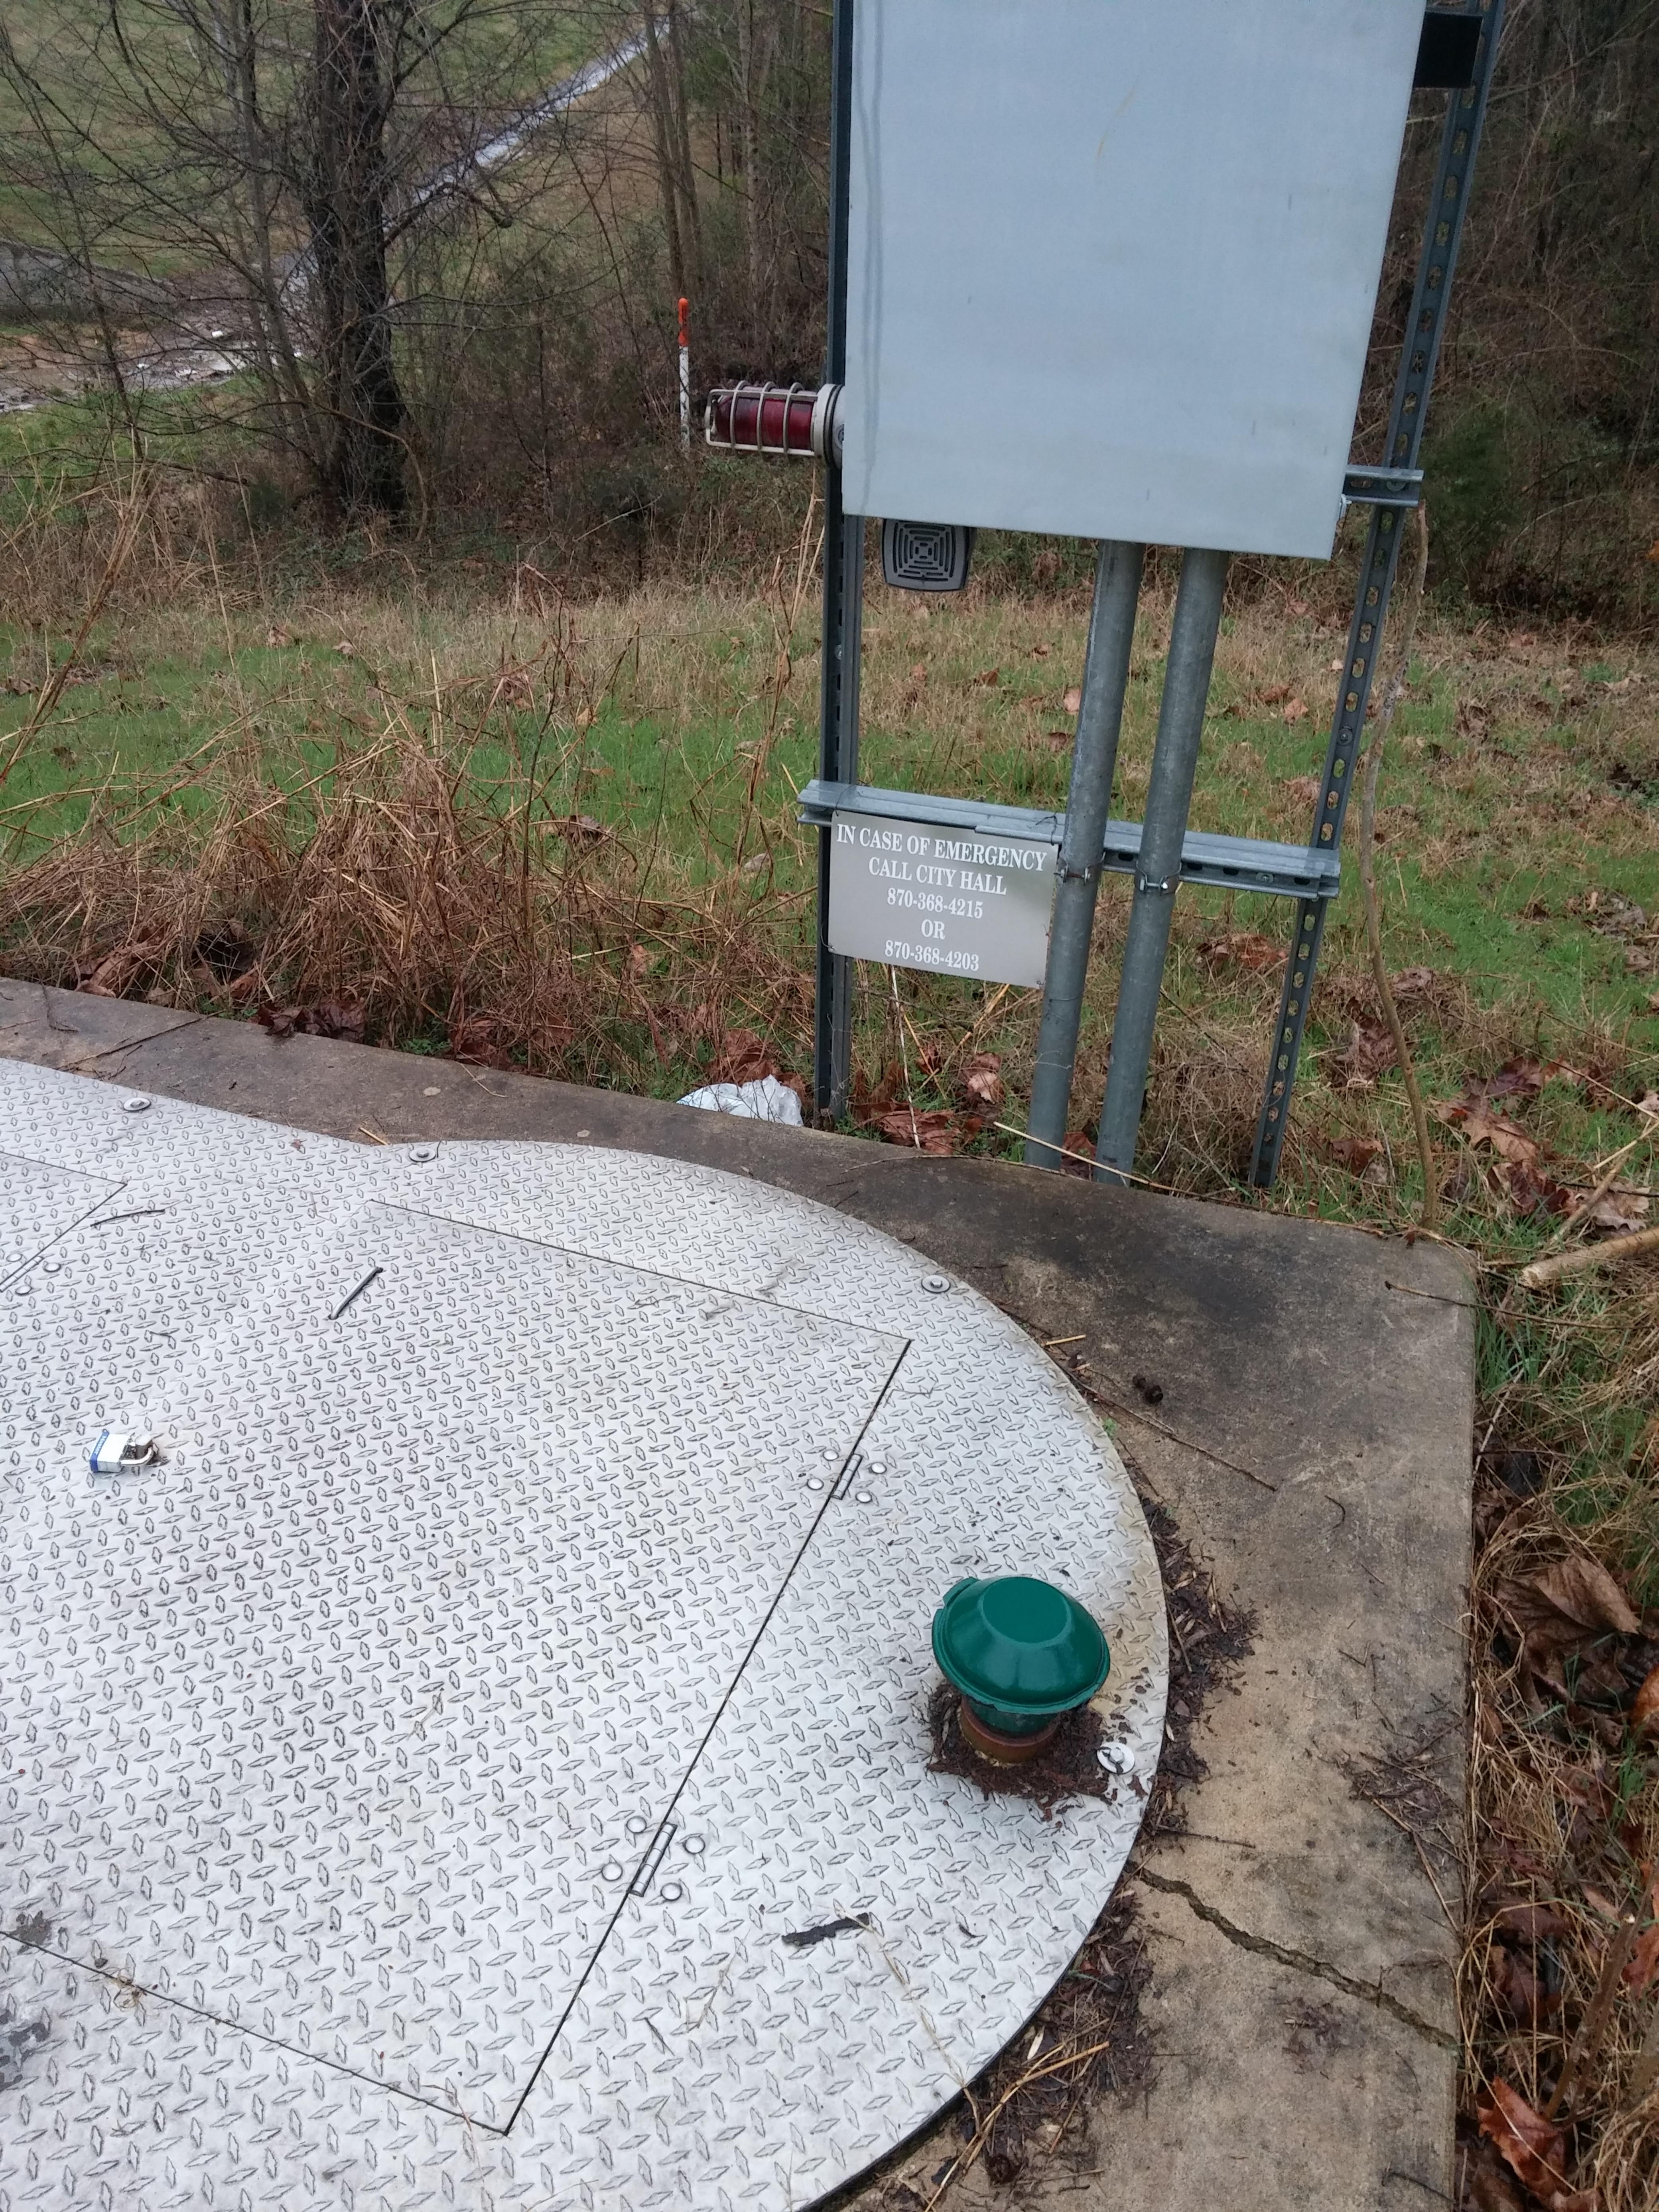
- e. waiting on funds to be available to repair teeth on clarifier weirs
 - f. sludge was wasted and water quality was improved in clarifiers
 - g. partial flume and staff gage were cleaned thoroughly

- h. dry sludge was placed back in drying bed
- Outfall 001 was thoroughly cleaned of visible solids and algae
- 3. repairs were done to secondary clarifier and is back operation
