-						
			WATER	<b>DIVISION IN</b>	NSP	ECTIC	)N	REPORT
		ERMIT #: <b>ARR000</b>				ATE: 2/6/2017		
_	R K A N S A S	СС	DUNTY: 70 Union		PDS #	#: 095668		MEDIA: WN
Dep	R K A N S A S partment of Environmental Quality	GF	S LAT: 33.15961	4 LONG: -92.4438	849 L	OCATION	: Ent	trance
	FACILITY INFORMAT	ION		INS	SPEC	TION INFC	RM	ATION
	thony Forest Products Compan			FACILITY TYPE: 2 - Industrial		<sup>TOR ID#:</sup>	te	
	36 Urbana Road			FACILITY EVALUATION RATING <b>1 - Unsatisfacto</b>	ry	Inc	ECTION	rial Stormwater

On February 6, 2017, I performed an inspection at Anthony Forest Products Company – Urbana Sawmill. The inspection was completed with Randy Evans, EHS Manager, and Amanda Gallagher, Environmental Engineer with GBMc. GBMc is contracted to perform inspections, sampling, and SWPPP updates. Training is completed by Mr. Evans. The SWPPP and site map was up to date and all Stormwater Annual Reports (SWARs) were completed with associated sampling COCs, laboratory bench sheets, and information. Outfalls 003 and 008 have had some benchmark parameters exceeded in the past three years, but corrective action reports were included with the exceedances. Outfalls 002-012 are indicated as S

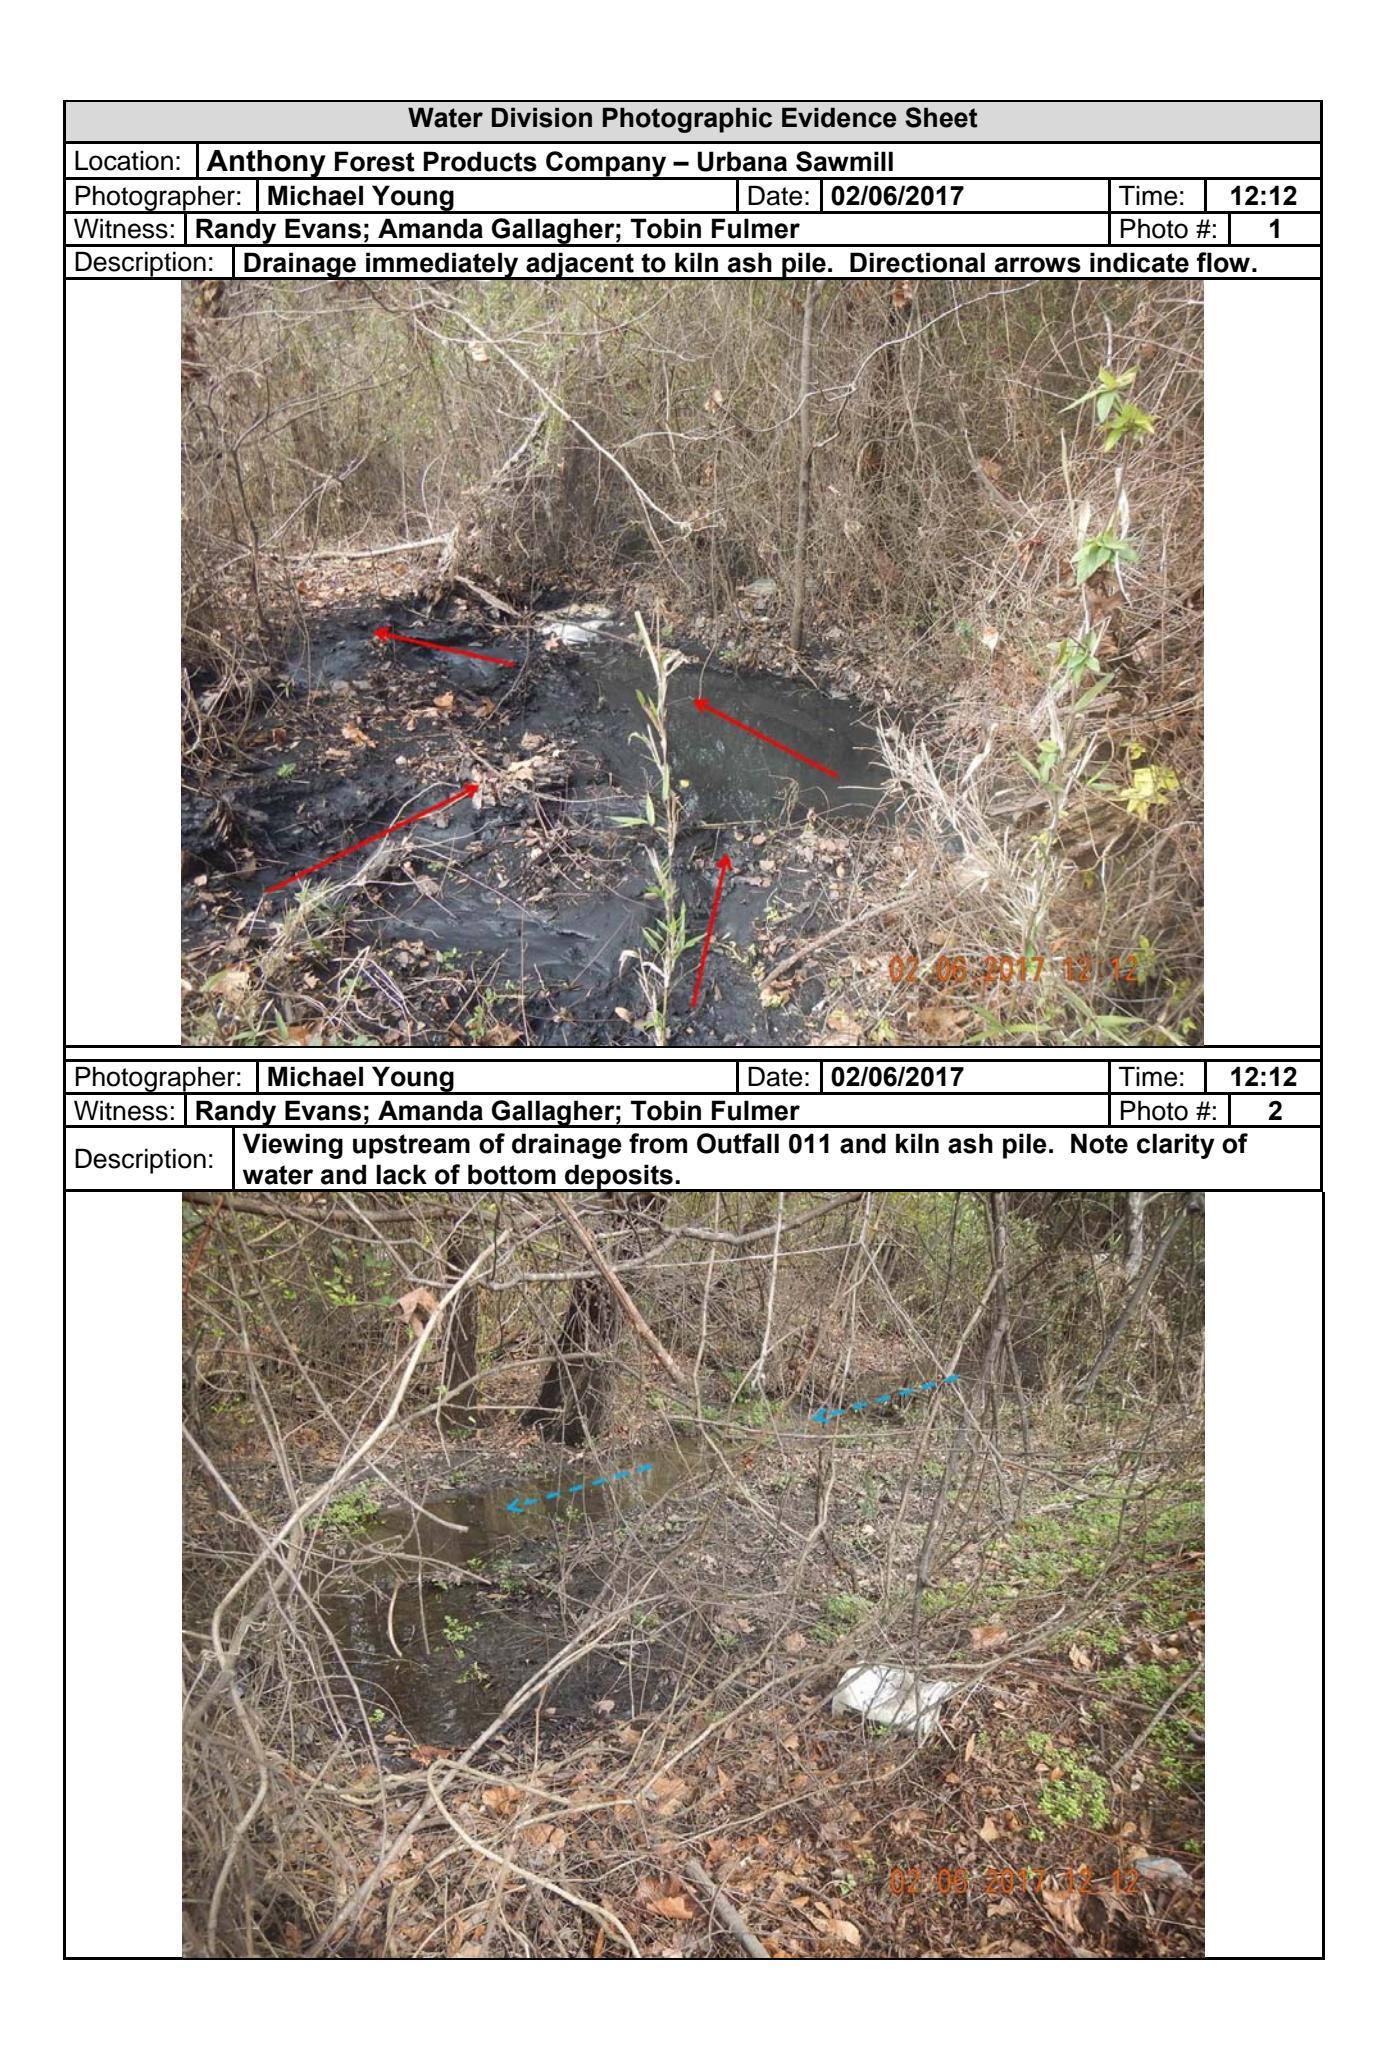
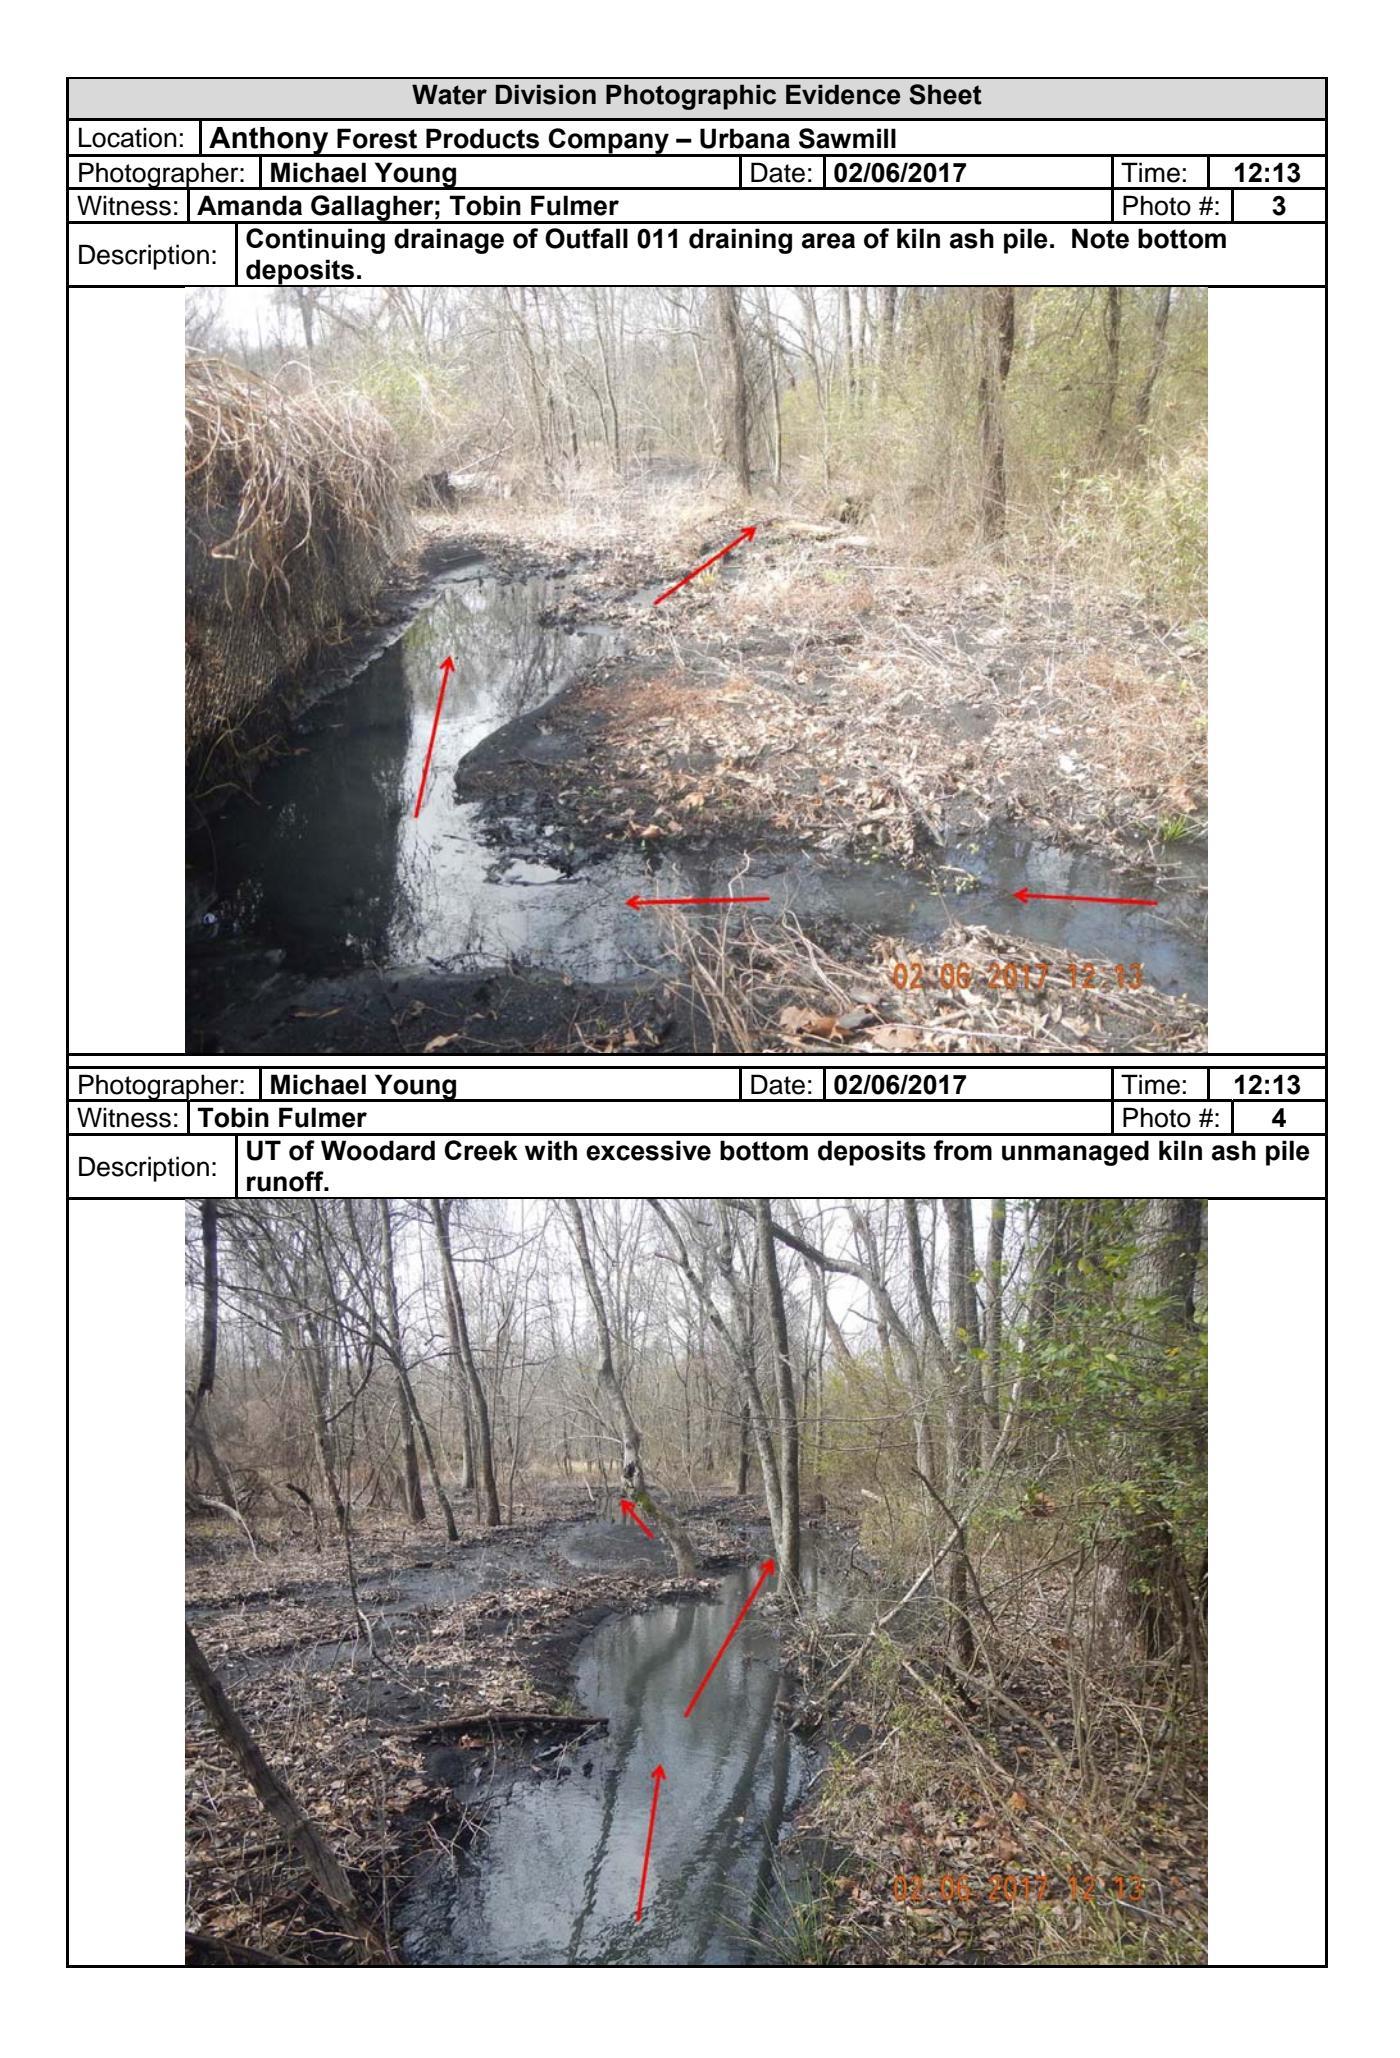
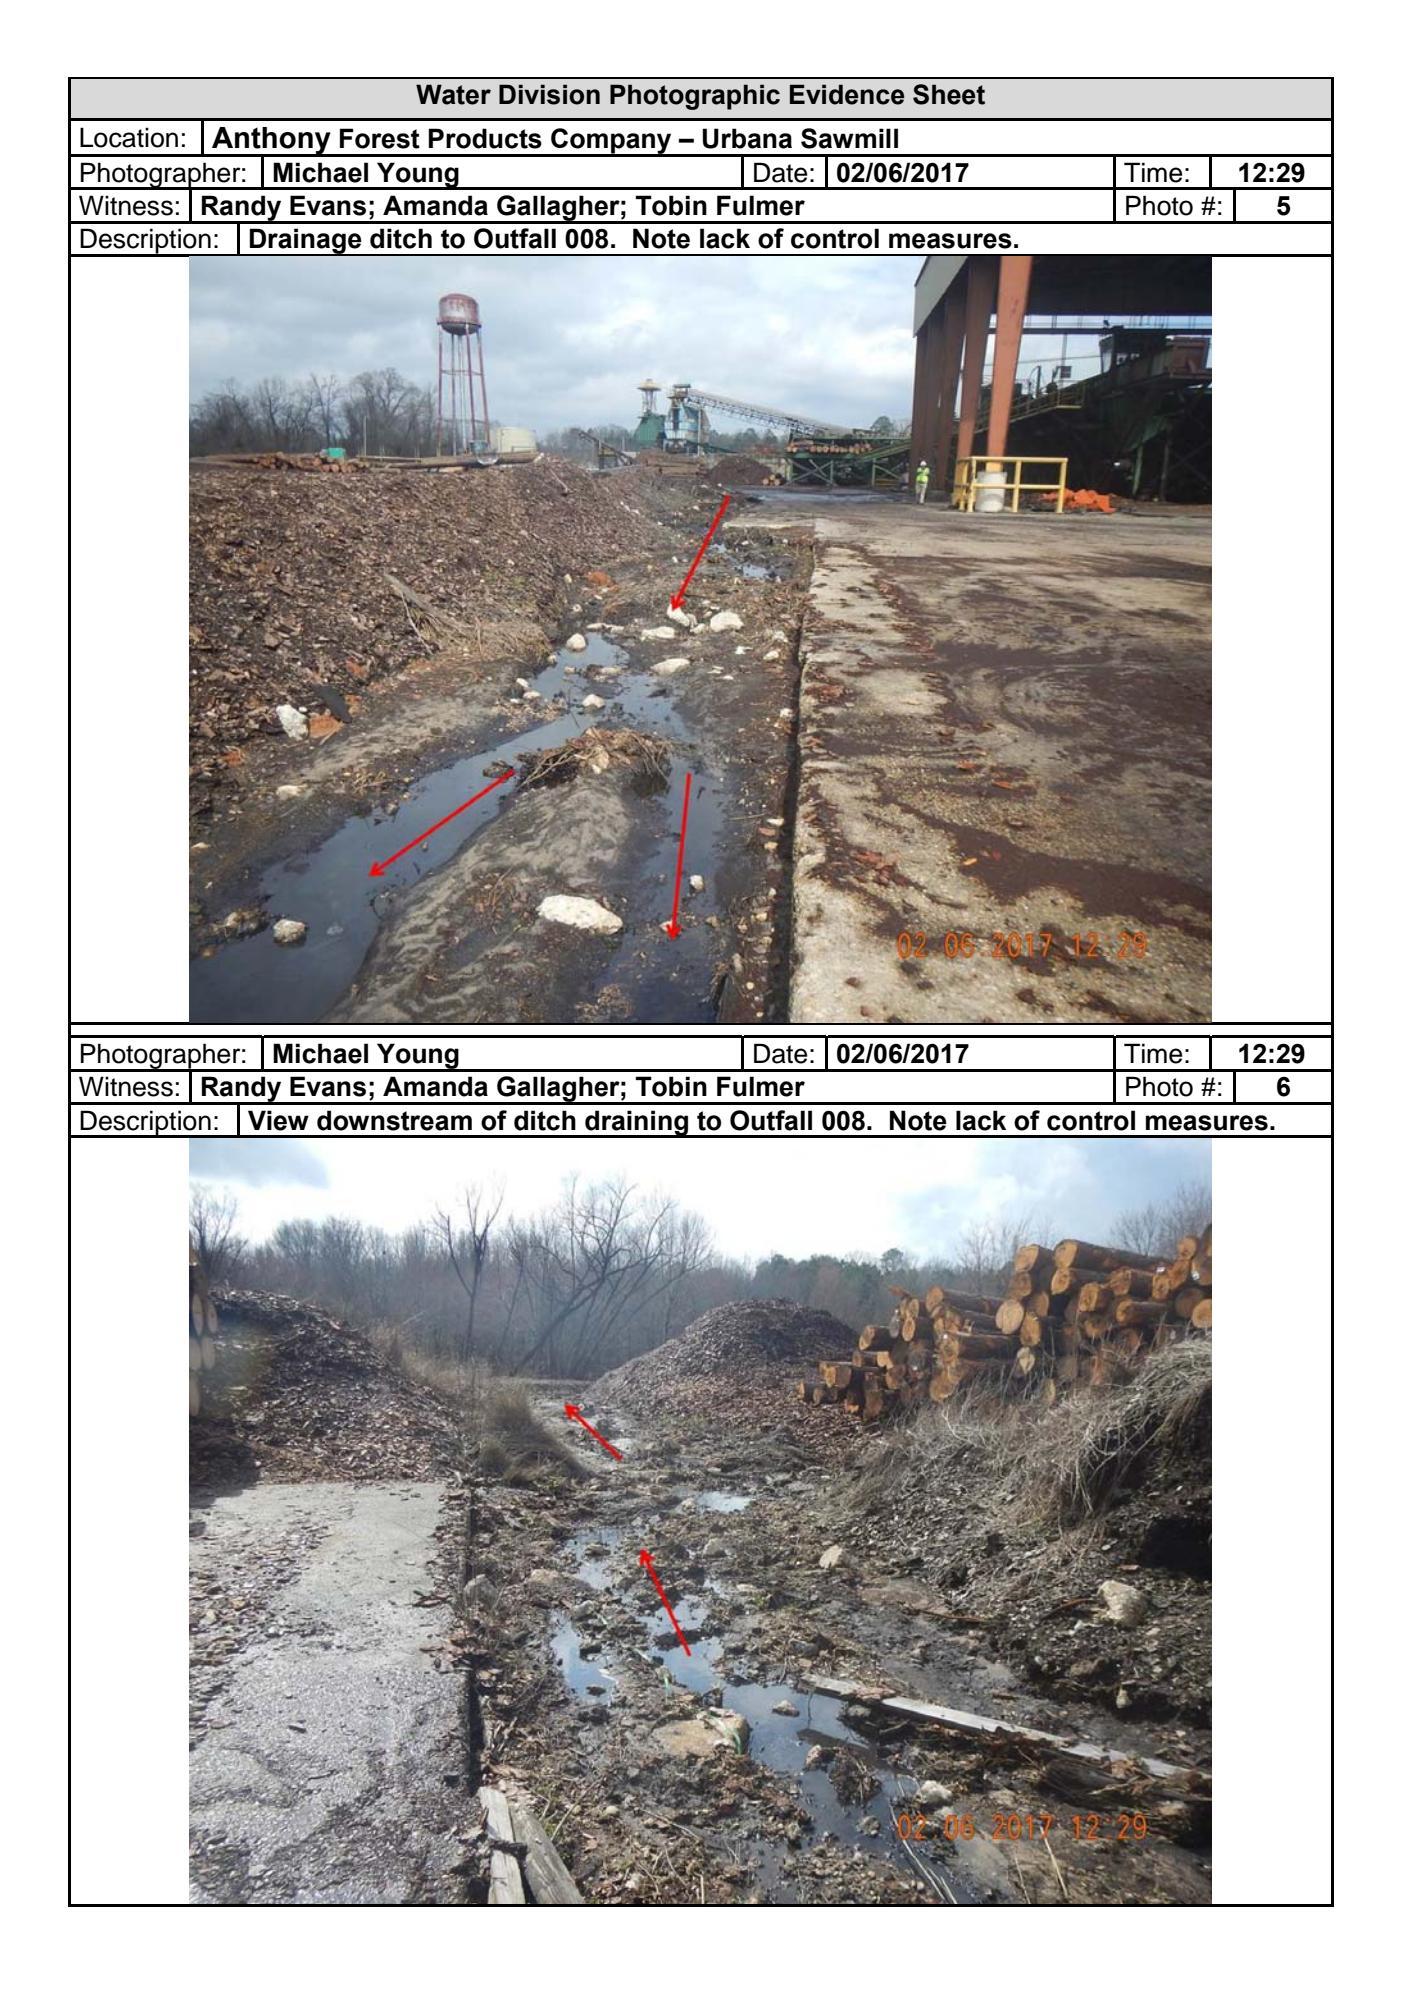
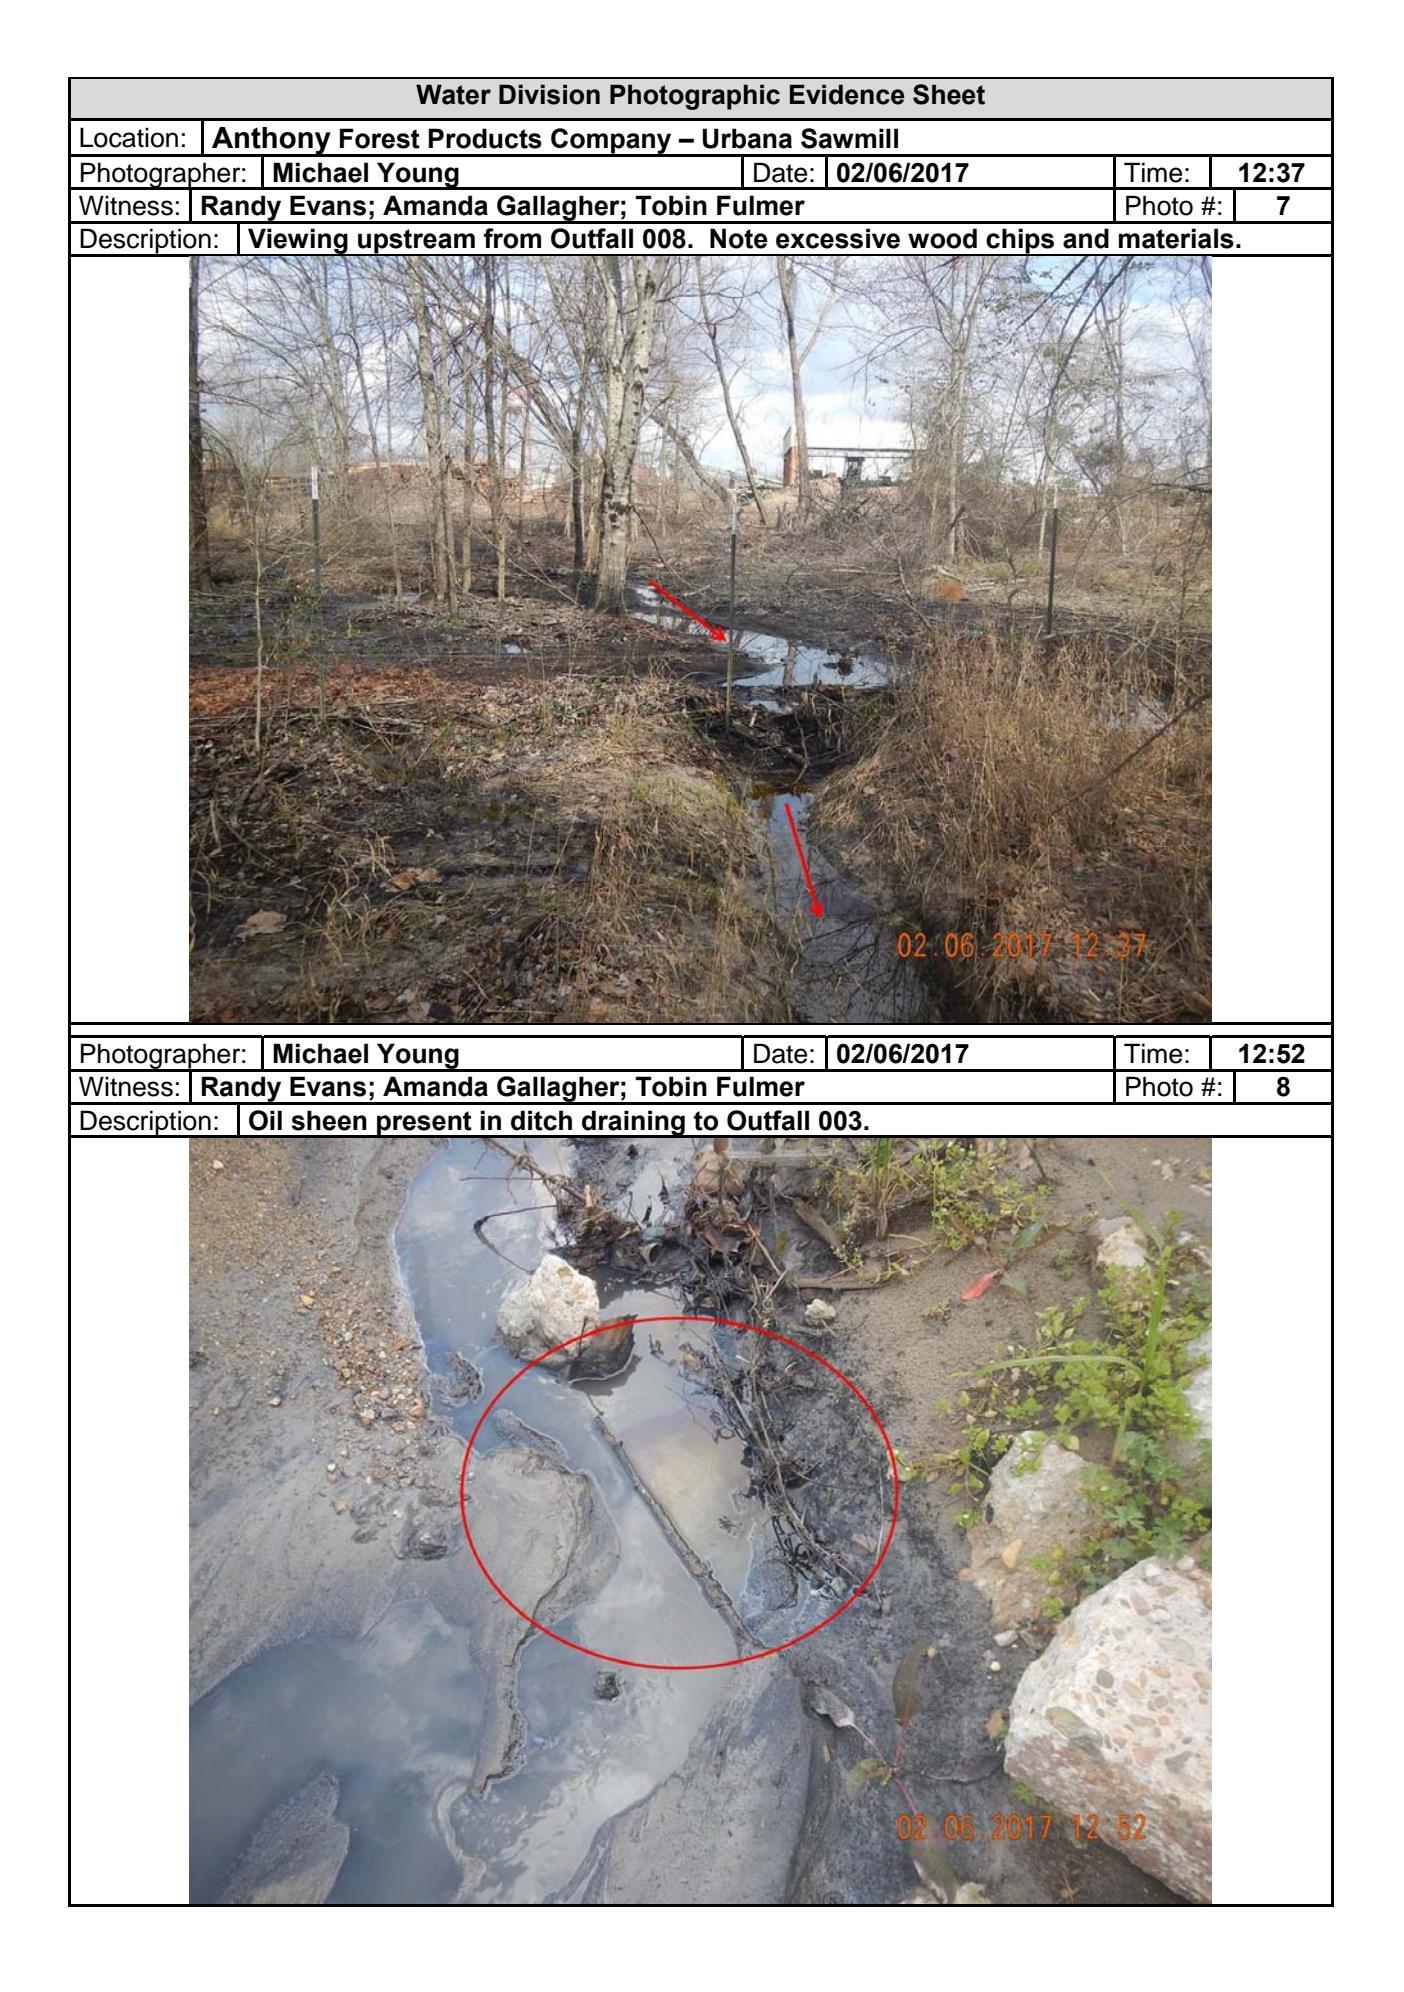
1.)	The facility has a kiln ash pile w	ith r			buting	g to polluti	ion d	of UT of Woodard
Cre	eek (see Photos 1-4; Figure 1). Ti	nis i	s a violation of A	Arkansas Water a	nd Air	Pollution	Act	472 A.C.A. § 8-4-
217	7 (a)(2), which states, "It shall be	unla	wful for any per	son to place or ca	ause t	o be place	ed a	ny sewage,
ind	lustrial waste, or other wastes in	a lo	cation where it is	s likely to cause p	olluti	on of any	wate	ers of this state."
SE	E KILN ASH COMMENTS

During the inspection, I observed runoff at Outfall 011 from a pile of kiln ash that lacked control measures (see Photo 1; Figure 1). The contributing industrial waste material and associated pollutants were observed in UT of Woodard Creek creating excessive bottom deposits (see Photos 3-4). This area needs to have control measures added and photos need to be submitted as a response to the violation.

Silt fence has been added to the downstream side of the kiln ash pile as a temporary control measure. Pictures showing the above described corrective action can be found in Attachment 2.
