October 25, 2017

RE: Reconnaissance Inspection (Newton County) AFIN: 51-00000 NPDES Permit No.:

ADEO			OFFICE OF WATER QUALITY INSPECTION REPORT						
ADEQ		AFIN: 51-00000 PERMIT #:			[DATE: 8/17/2017			
A R K A N S A S		COUNTY: 51 Newto		on	PDS #: 099746			MEDIA: W	
Department of Environmental Quality			GPS LAT: 36.10192 LONG: -93.01016 LOCATION: General Area						
	FACILITY INFORMAT	INSPECTION INFORMATION							
NAME: Pat Sanders LOCATION:				FACILITY TYPE:	104111 5 - State				
Pat Sanders Farm, Newton County Rd 50				FACILITY EVALUATION RATING: INSPECTION TYPE: *** Reconnaissance					
CITY:									
Western Grove, AR					11:14	12:30	PERMIT EF	FECTIVE DATE:	
RESPONSIBLE OFFICIAL				10/04/2017 1	6:40	16:50	PERMIT EX	PIRATION DATE:	
NAME: / TITLE Ret Sandara / Branarty Owner									
Pat Sanders / Property Owner COMPANY:				FAYETTEVILLE SHALE RELATED: N					
				FAYETTEVILLE SHALE VIOLATIONS: N					
Mailing address: Route 1 Box 238				INSPECTION PARTICIPANTS					
CITY, STATE, ZIP:				NAME/TITLE/PHONE/FAX/EMAIL/ETC.:

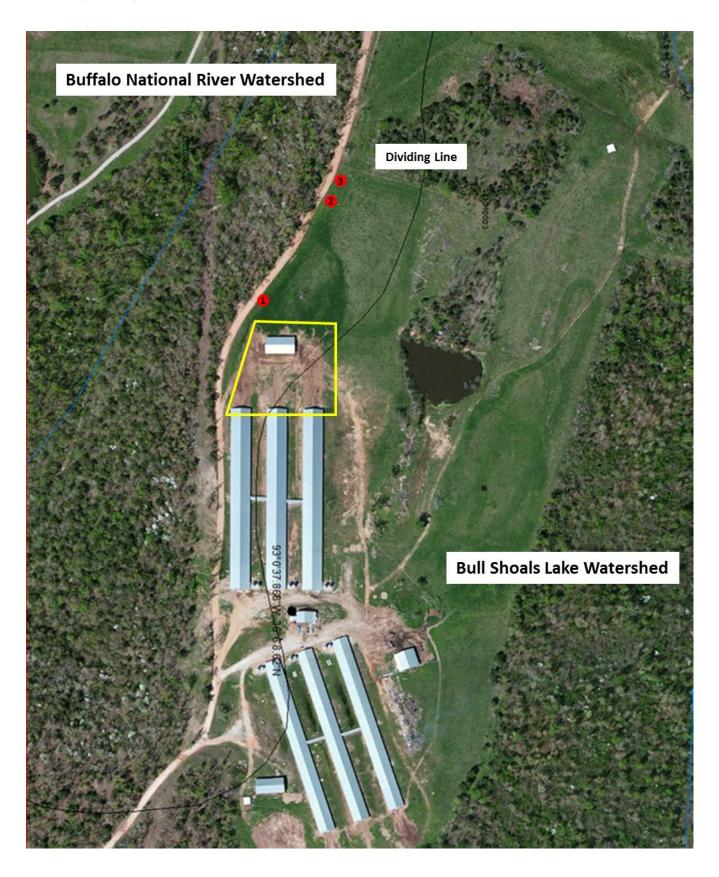
throughout the property (Photos #1 - #3). Water was observed flowing across the property, onto County Road 50, and south towards Cedar Creek (Photos #4 - #9, Figure 1). Water accumulated on the property was observed running off through an area where swine as well as piles of animal waste were located (Photos #2 #10 & #11).

Figure 5: Map showing approximate runoff locations (red dots 1-3) from Photos #4 - #9 onto County Road 50. Area inside of the yellow box outlines pig and animal waste locations in Photos #2 & #10. All runoff observed was flowing towards Cedar Creek (blue line) in the Buffalo National River Watershed.
