RE: City of Decatur WWTP Inspection

AFIN: 04-00052 Permit No.: AR0022292

## OFFICE OF WATER QUALITY INSPECTION REPORT

AFIN: **04-00052** | PERMIT #: **AR0022292** | DATE: **2/2/2018**

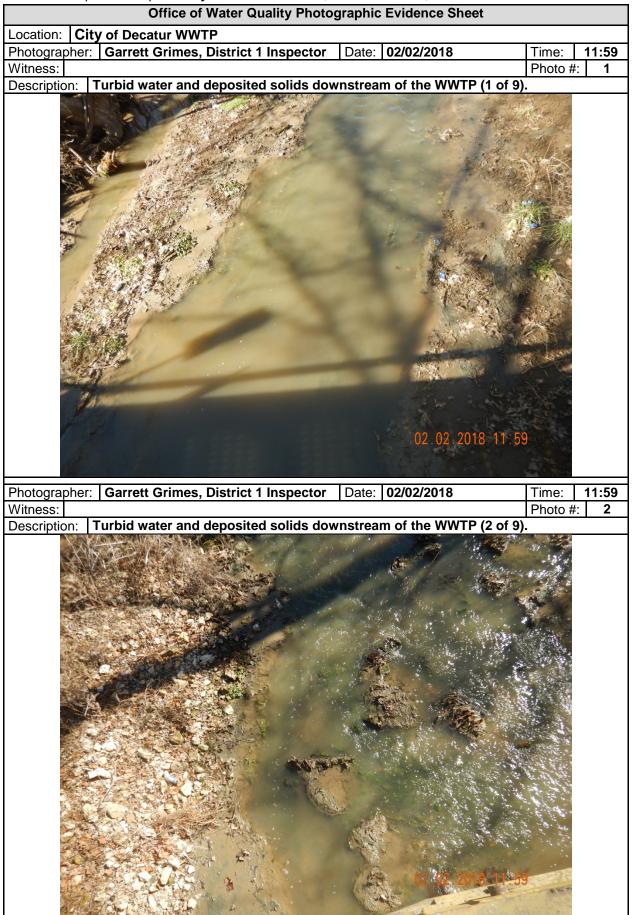
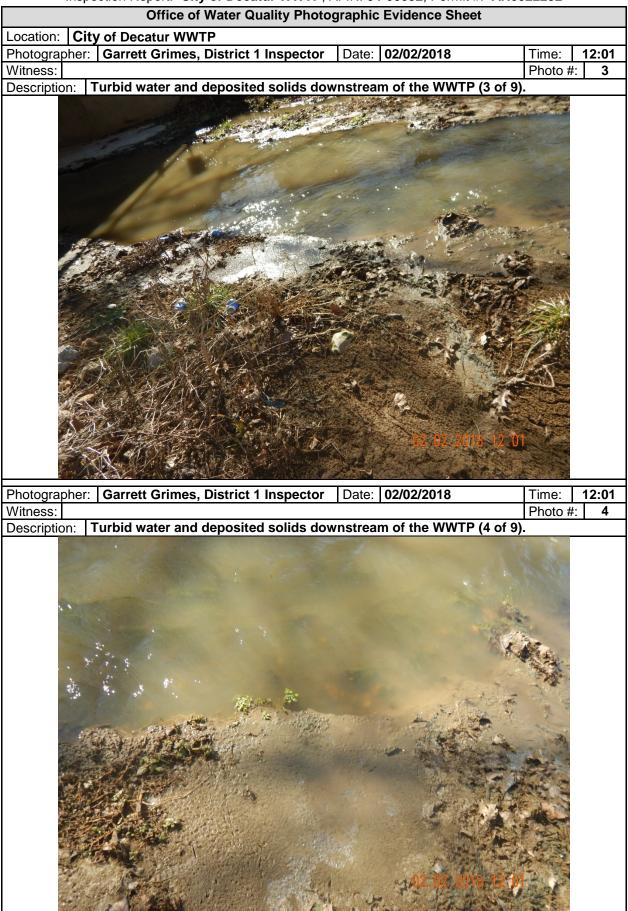
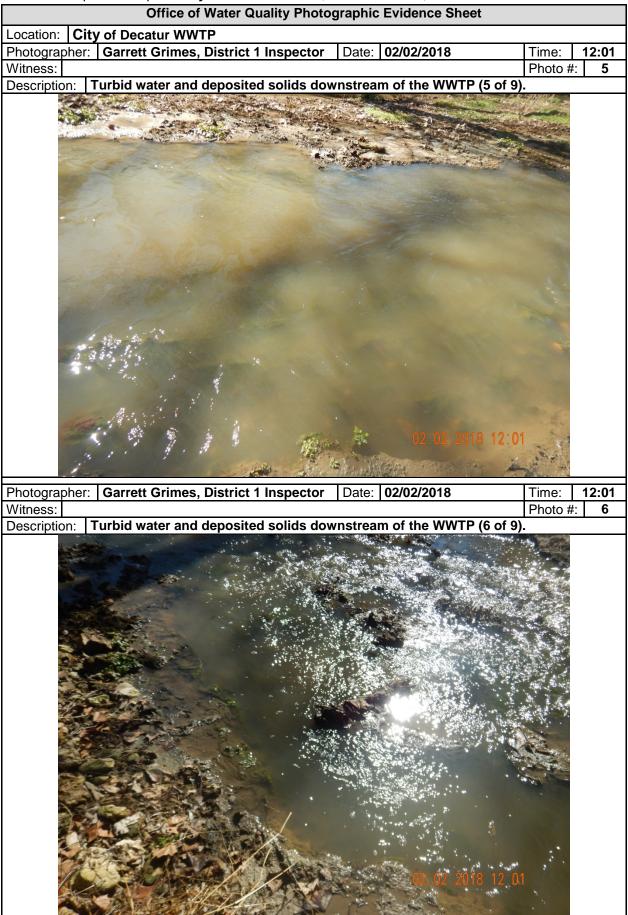
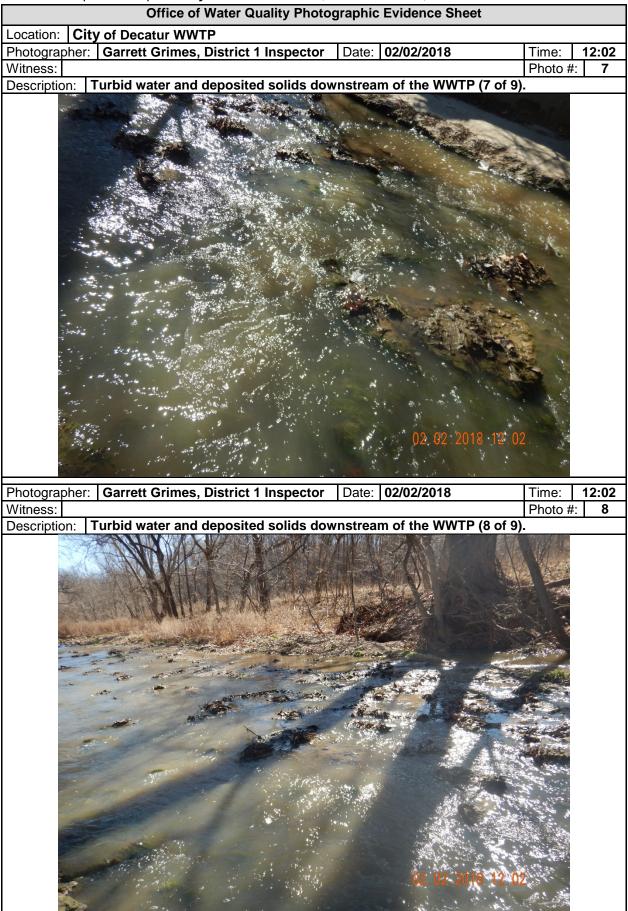
Turbid water and deposited solids were observed near the Mt. Zion Road bridge approximately 1.5 miles downstream from the WWTP (Photos #1 - #9, Attachment 1). The area also had a strong aroma similar to that of a WWTP aeration basin. Upstream of the WWTP, Columbia Hollow Creek appeared noticeably less turbid and solids were not observed deposited in the creek (Photos #10 - #13, Attachment). Water was collected in glass vials from both the previously mentioned downstream and upstream areas for visual comparison (Photos #14 - #15, Attachment 1). The water from downstream of the WWTP visually appeared to contain a greater amount of suspended solids than the water upstream of the WWTP (Photo #16).

# Inspection Report: City of Decatur WWTP, AFIN: 04-00052, Permit #: AR0022292 Office of Water Quality Photographic Evidence Sheet City of Decatur WWTP Location: Photographer: Garrett Grimes, District 1 Inspector Date: 02/02/2018 12:02 Time: Witness: Photo #: Description: Turbid water and deposited solids downstream of the WWTP (9 of 9). Date: 02/02/2018 Photographer: Garrett Grimes, District 1 Inspector 12:32 Time: Witness: Photo #: Upstream of the WWTP showing the water is not turbid and the previously Description: observed solids are not present (1 of 4).
