RE: City of Dumas Inspections (Desha Co)

AFIN: 21-00045 NPDES Permit No.: AR0033987

OFFICE OF WATER QUALITY INSPECTION REPORT

AFIN: **21-00045** | PERMIT #: **AR0033987** | DATE: **5/20/2021**

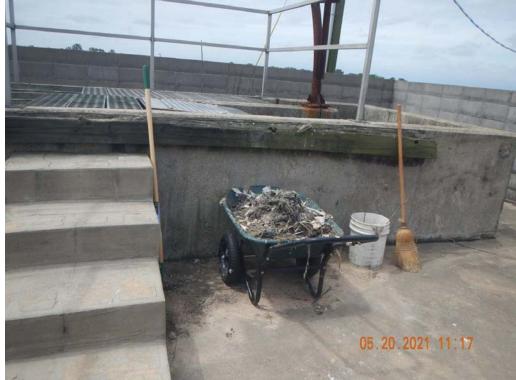
City of Dumas Photographer: Michael Young Witness: Date: 05/20/2021 Time: 11:17 Photo #: 3

- 1.) At the time of the inspection, solid waste materials removed from the bar screen are being placed in a wheelbarrow that is uncovered and exposed to rainfall. Stormwater runoff is not directed back to the treatment system. This is a violation of permit condition Part II. (6.).
- 2.) There is rust and other materials on the staff gauge causing it to be illegible. This is a violation of permit condition Part III. (C.) (2.). To perform flow checks on the totalizer, the staff gauge needs to be cleaned and legible.

Description: Open wheelbarrow with removed materials.

The staff gauge was replaced after the 1-10-19 inspection was performed, the operator has cleaned the staff gauge to make legible for readings. The city is currently changing means of operation when dealing with the solid waste materials off of the bar screen to prevent stormwater runoff. Currently a tarp is being utilized to cover the wheel barrow. McClelland Consulting Engineers, Inc. Is designing a new headworks with a cover for the future. This is a part current project connecting the Mitchellville system to Dumas. If you have any question please do not hesitate to call or email me at atriche@mce.us.com

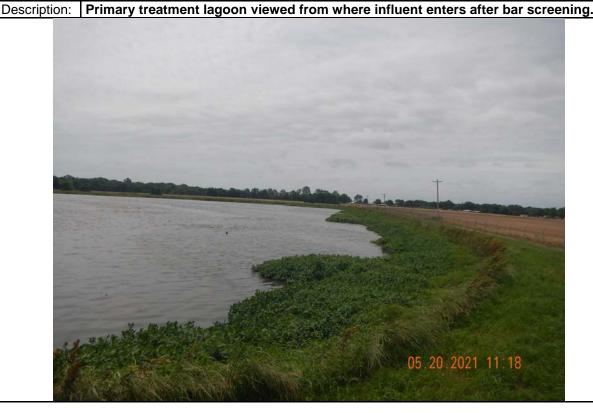
Photographer:Michael YoungDate:05/20/2021Time:11:18Witness:Photo #:4

At the headworks, influent enters from the main lift station in the city (see Photo 1) and passes through a bar screen (see Photos 2-3). Solids and materials are being collected by physically raking the bar screen and the materials are being placed in an open-top wheelbarrow (see Photo 4). There is no drain and the solids are not being managed in a container or by other methods, and there were materials scattered around on the ground around the wheelbarrow. I observed the primary lagoon to be well-managed and the aeration was occurring from air lines across the lagoon (see Photos 4-5). Levees between the primary and secondary lagoon were well-maintained and at the required width (see Photo 6). I observed that the second, third, and final treatment lagoon were all being aerated and well-maintained (see Photo 7-10). Chlorine gas is used to disinfect in the chlorine contact chamber and sulphur dioxide is used at the end of the contact chamber to dechlorinate (see Photos 11-13). I observed the primary flow device to be a 9" Parshall flume and the staff gauge was corroded and covered with material causing it to be illegible (see Photo 14). Flow is monitored daily using a totalizer that had been recently calibrated, but no flow checks are performed between calibrations (see Photo 15). Discharge is after final treatment and Outfall 001 discharges directly to a ditch and thence to the receiving stream, thence to Bayou Macon (see Photo 16).

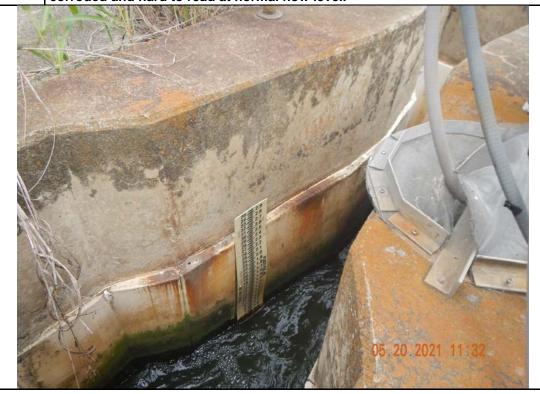
Photographer: Michael Young	Date: 05/20/2021	Time:	11:32
Witness:		Photo #	: 14

Description: Parshall flume used as primary flow device. Note that measuring device is corroded and hard to read at normal flow level.
