OFFICE OF WATER QUALITY INSPECTION REPORT

AFIN: 04-00052	PERMIT #: AR0022292	DATE: 3/16/2022
COUNTY: 04 Benton	PDS #: 123356	MEDIA: WN
GPS LAT: 36.34417 LONG: -94.47271 LOCATION: General Area

FACILITY INFORMATION	INSPECTION INFORMATION
NAME: City of Decatur WWTP LOCATION: 985 Austin Avenue CITY: Decatur	FACILITY TYPE: 1 - Municipal INSPECTOR ID#: 104111 S - State FACILITY EVALUATION RATING: N INSPECTION TYPE: Reconnaissance DATE(S): 3/16/2022 ENTRY TIME: 11:50 EXIT TIME: 13:45 PERMIT EFFECTIVE DATE: 12/1/2020 PERMIT EXPIRATION DATE: 11/30/2025
RESPONSIBLE OFFICIAL	FAYETTEVILLE SHALE RELATED: N FAYETTEVILLE SHALE VIOLATIONS: N
NAME / TITLE: Robert Tharp / Mayor COMPANY: City of Decatur MAILING ADDRESS: PO Box 247 CITY, STATE, ZIP: Decatur AR 72722 PHONE & EXT. / FAX: 479-752-3912 / EMAIL: james.boston@decaturarkansas.us	INSPECTION PARTICIPANTS
CONTACTED DURING INSPECTION: No	NAME/TITLE/PHONE/FAX/EMAIL/ETC.: James Boston, Public Works Director, City of Decatur; Garrett Grimes, District 1 Inspector, DEQ

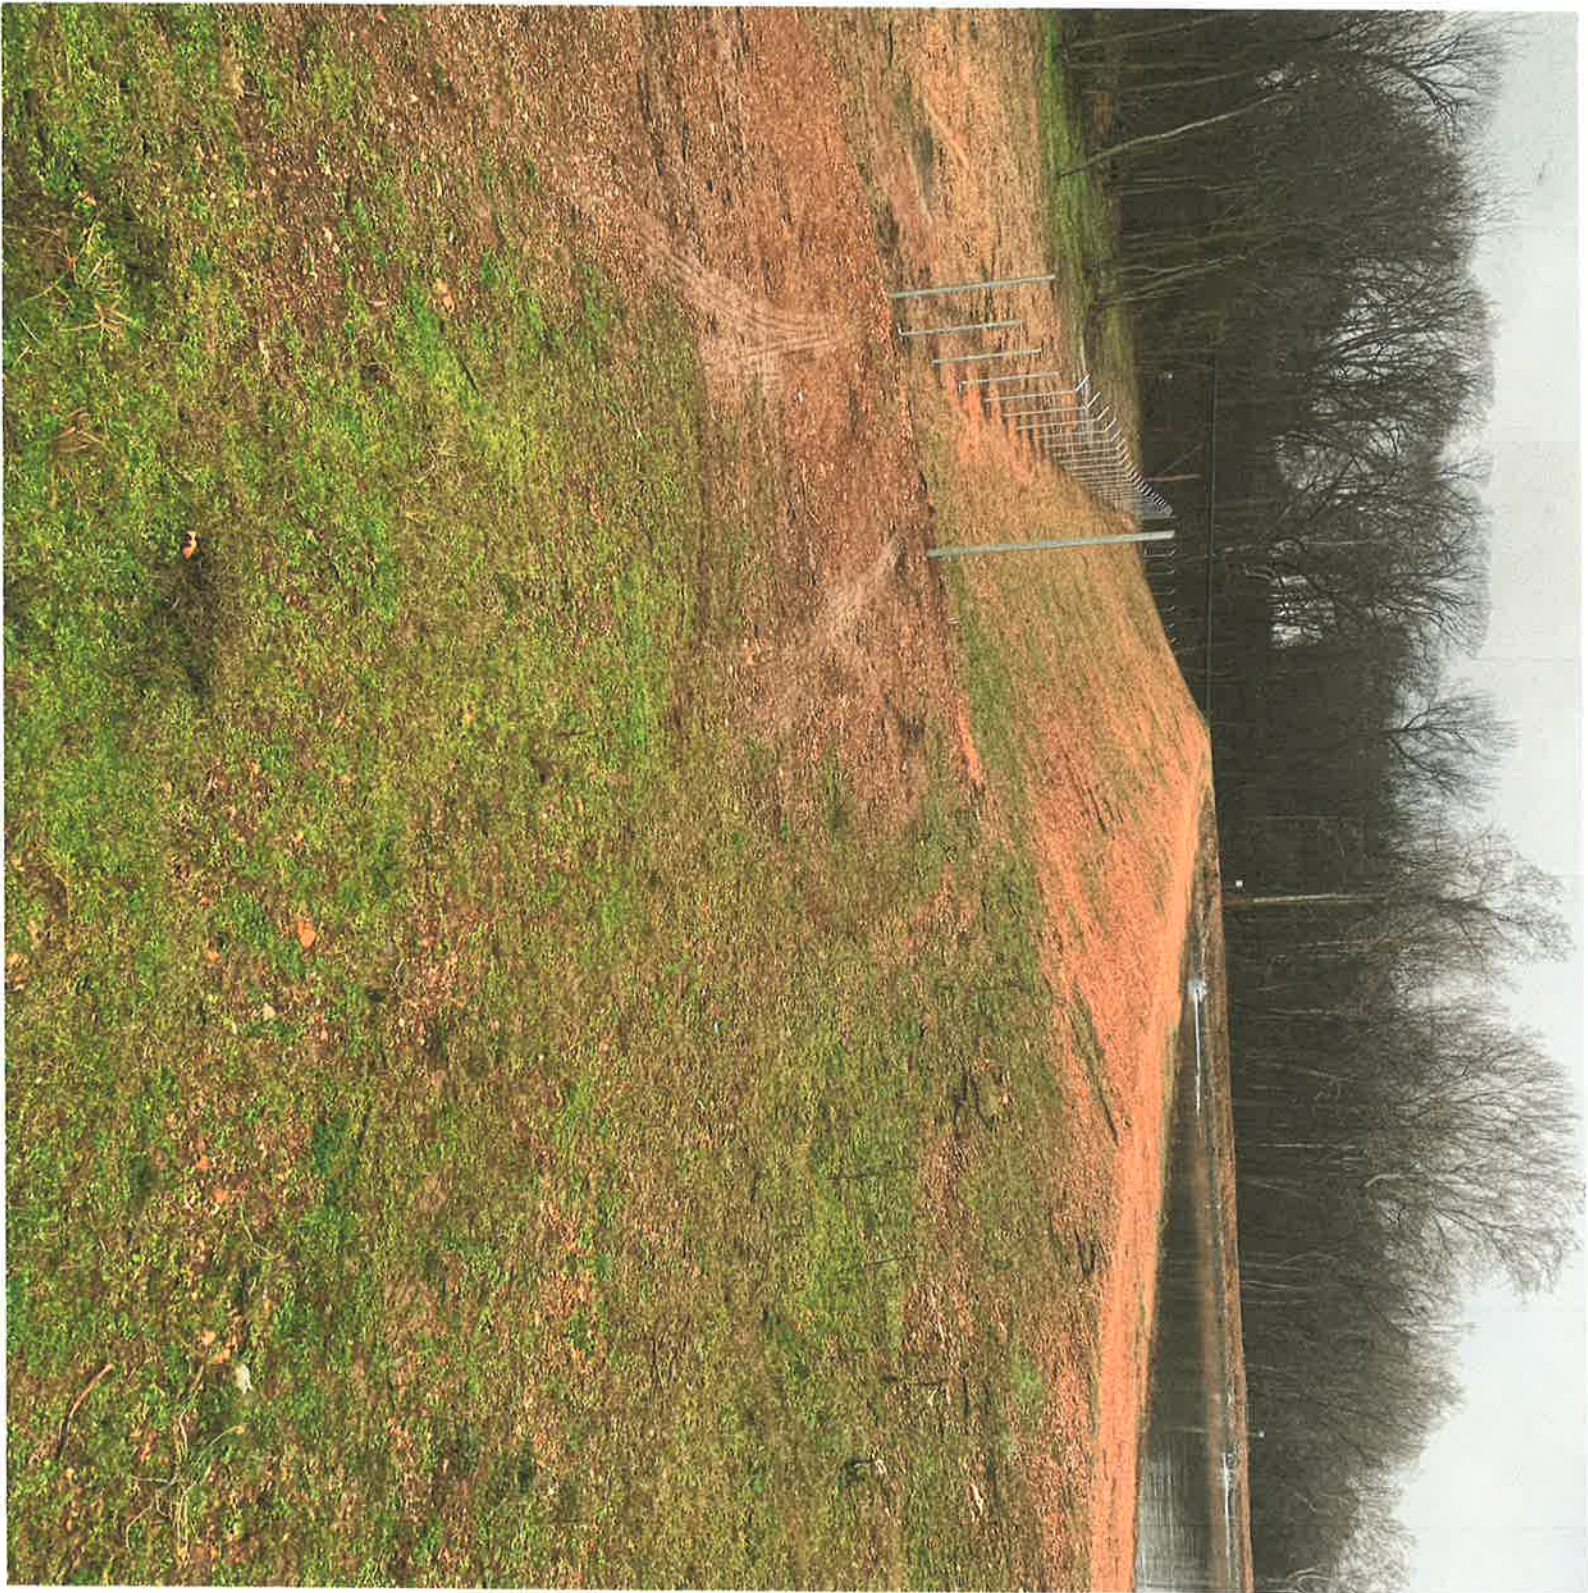
Part two of this response is about the follow you sent from the inspection report. This dealt with the grounds of the plant area and the fence and trees that were growing on the equalization ponds south bank. Since your visit it has been cleaned up, grass was immediately planted and even though it was winter, some grass is now established on the area of concern. I have enclosed a photo of the area and the new fence that has been installed to replace the old one that was overgrown. By placing the fence at the toe of the pond, maintenance should be much easier to do.
