RE: City of Decatur WWTP Inspection (Benton Co)
AFIN: 04-00052 **NPDES Permit No.: AR0022292**

ENVIRONMENTAL QUALITY	OFFICE OF WATER QUALITY		
	INSPECTION REPORT		
	AFIN: 04-00052	PERMIT #: AR0022292	DATE: 7/27/2023
	COUNTY: 04 Benton	PDS #: 126876	MEDIA: WN
GPS LAT: 36.343294 LONG: -94.471183 LOCATION: Entrance			
FACILITY INFORMATION		INSPECTION INFORMATION	
NAME: City of Decatur WWTP LOCATION: 985 Austin Ave. CITY: Decatur		FACILITY TYPE: 1 - Municipal INSPECTOR ID#: 142257 S - State FACILITY EVALUATION RATING: 1 - Unsatisfactory INSPECTION TYPE: Reconnaissance	
RESPONSIBLE OFFICIAL		DATE(S): 7/27/2023 ENTRY TIME: 22:06 EXIT TIME: 22:12 PERMIT EFFECTIVE DATE: 11/30/2020 7/27/2023 23:20 23:26 PERMIT EXPIRATION DATE: 11/30/2025	
NAME: / TITLE Robert Tharp / Mayor COMPANY: City of Decatur MAILING ADDRESS: P.O. Box 247 CITY, STATE, ZIP: Decatur AR 72722 PHONE & EXT: / FAX: 479-752-3912 / EMAIL: james.boston@decaturarkansas.com		FAYETTEVILLE SHALE RELATED: N FAYETTEVILLE SHALE VIOLATIONS: N INSPECTION PARTICIPANTS NAME/TITLE/PHONE/FAX/EMAIL/ETC.: James Boston, Public Works Director, 479-212-0726, james.boston@decaturarkansas.com William Cody, Area 1 Inspector, 501-944-2569, william.

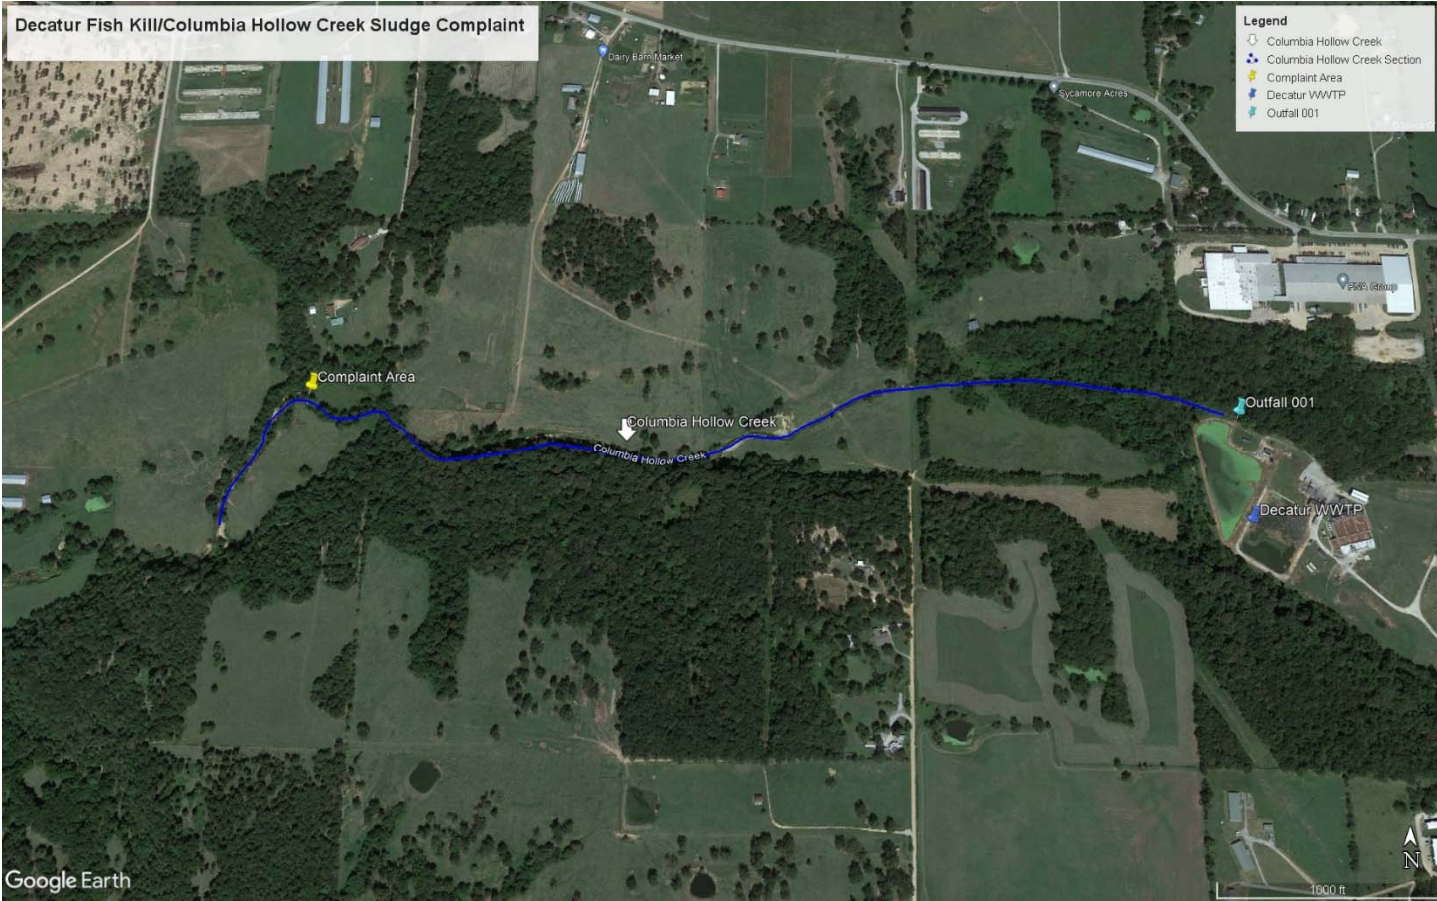
Attachment 1. Google Earth photo depicting the complaint/fish kill/sludge accumulation location, Columbia Hollow Creek, and the Decatur WWTP and associated outfall.
