NOTICE OF NON-COMPLIANCE

RE: Notice of Non-Compliance and Order to Cease Off-Site Tracking of Sediment NPDES Permit No.: ARR000231, AFIN 72-00144

OFFICE OF WATER QUALITY INSPECTION REPORT

AFIN: **72-00144** PERMIT #: **ARR000231** DATE: 2/21/2024

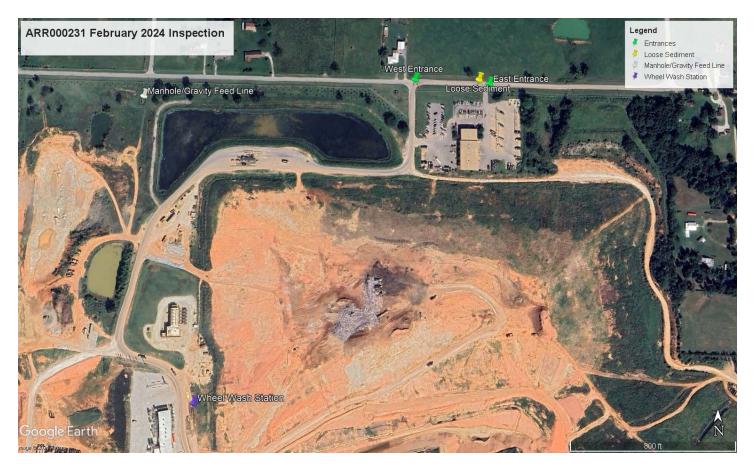
Attachment 1. Google Earth satellite imagery with locations of the wheel wash station, entrances, approximate location of loose sediment accumulation, and the manhole/gravity feed line where odors were expressed to have been located.
