# Memo

Re: Sewer line rupture at 2816 Albert Pike, Hot Springs (occurred August 20, 2015); PDS# 086146

## Water Division Photographic Evidence Sheet

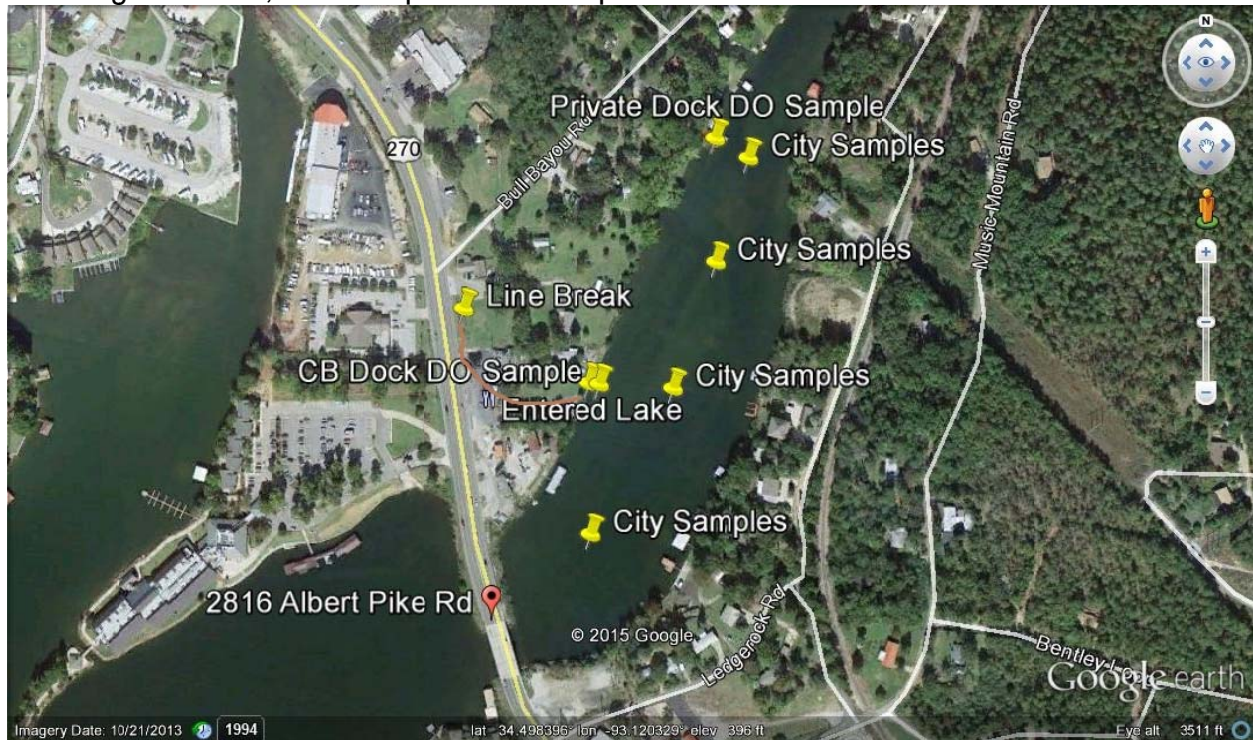
Google Earth image showing approximated locations of the line rupture, flow path, lake discharge location, and sample collection points:
