RE: City of Bryant  
LIS 16-057, AFIN 63-0005, Permit No. AR0034002  
CIP Update

Subject: City of Bryant – SECAP update with Future Development Capacity Analysis & Improvement Tech Memo

## Draft Report

City of Bryant, AR

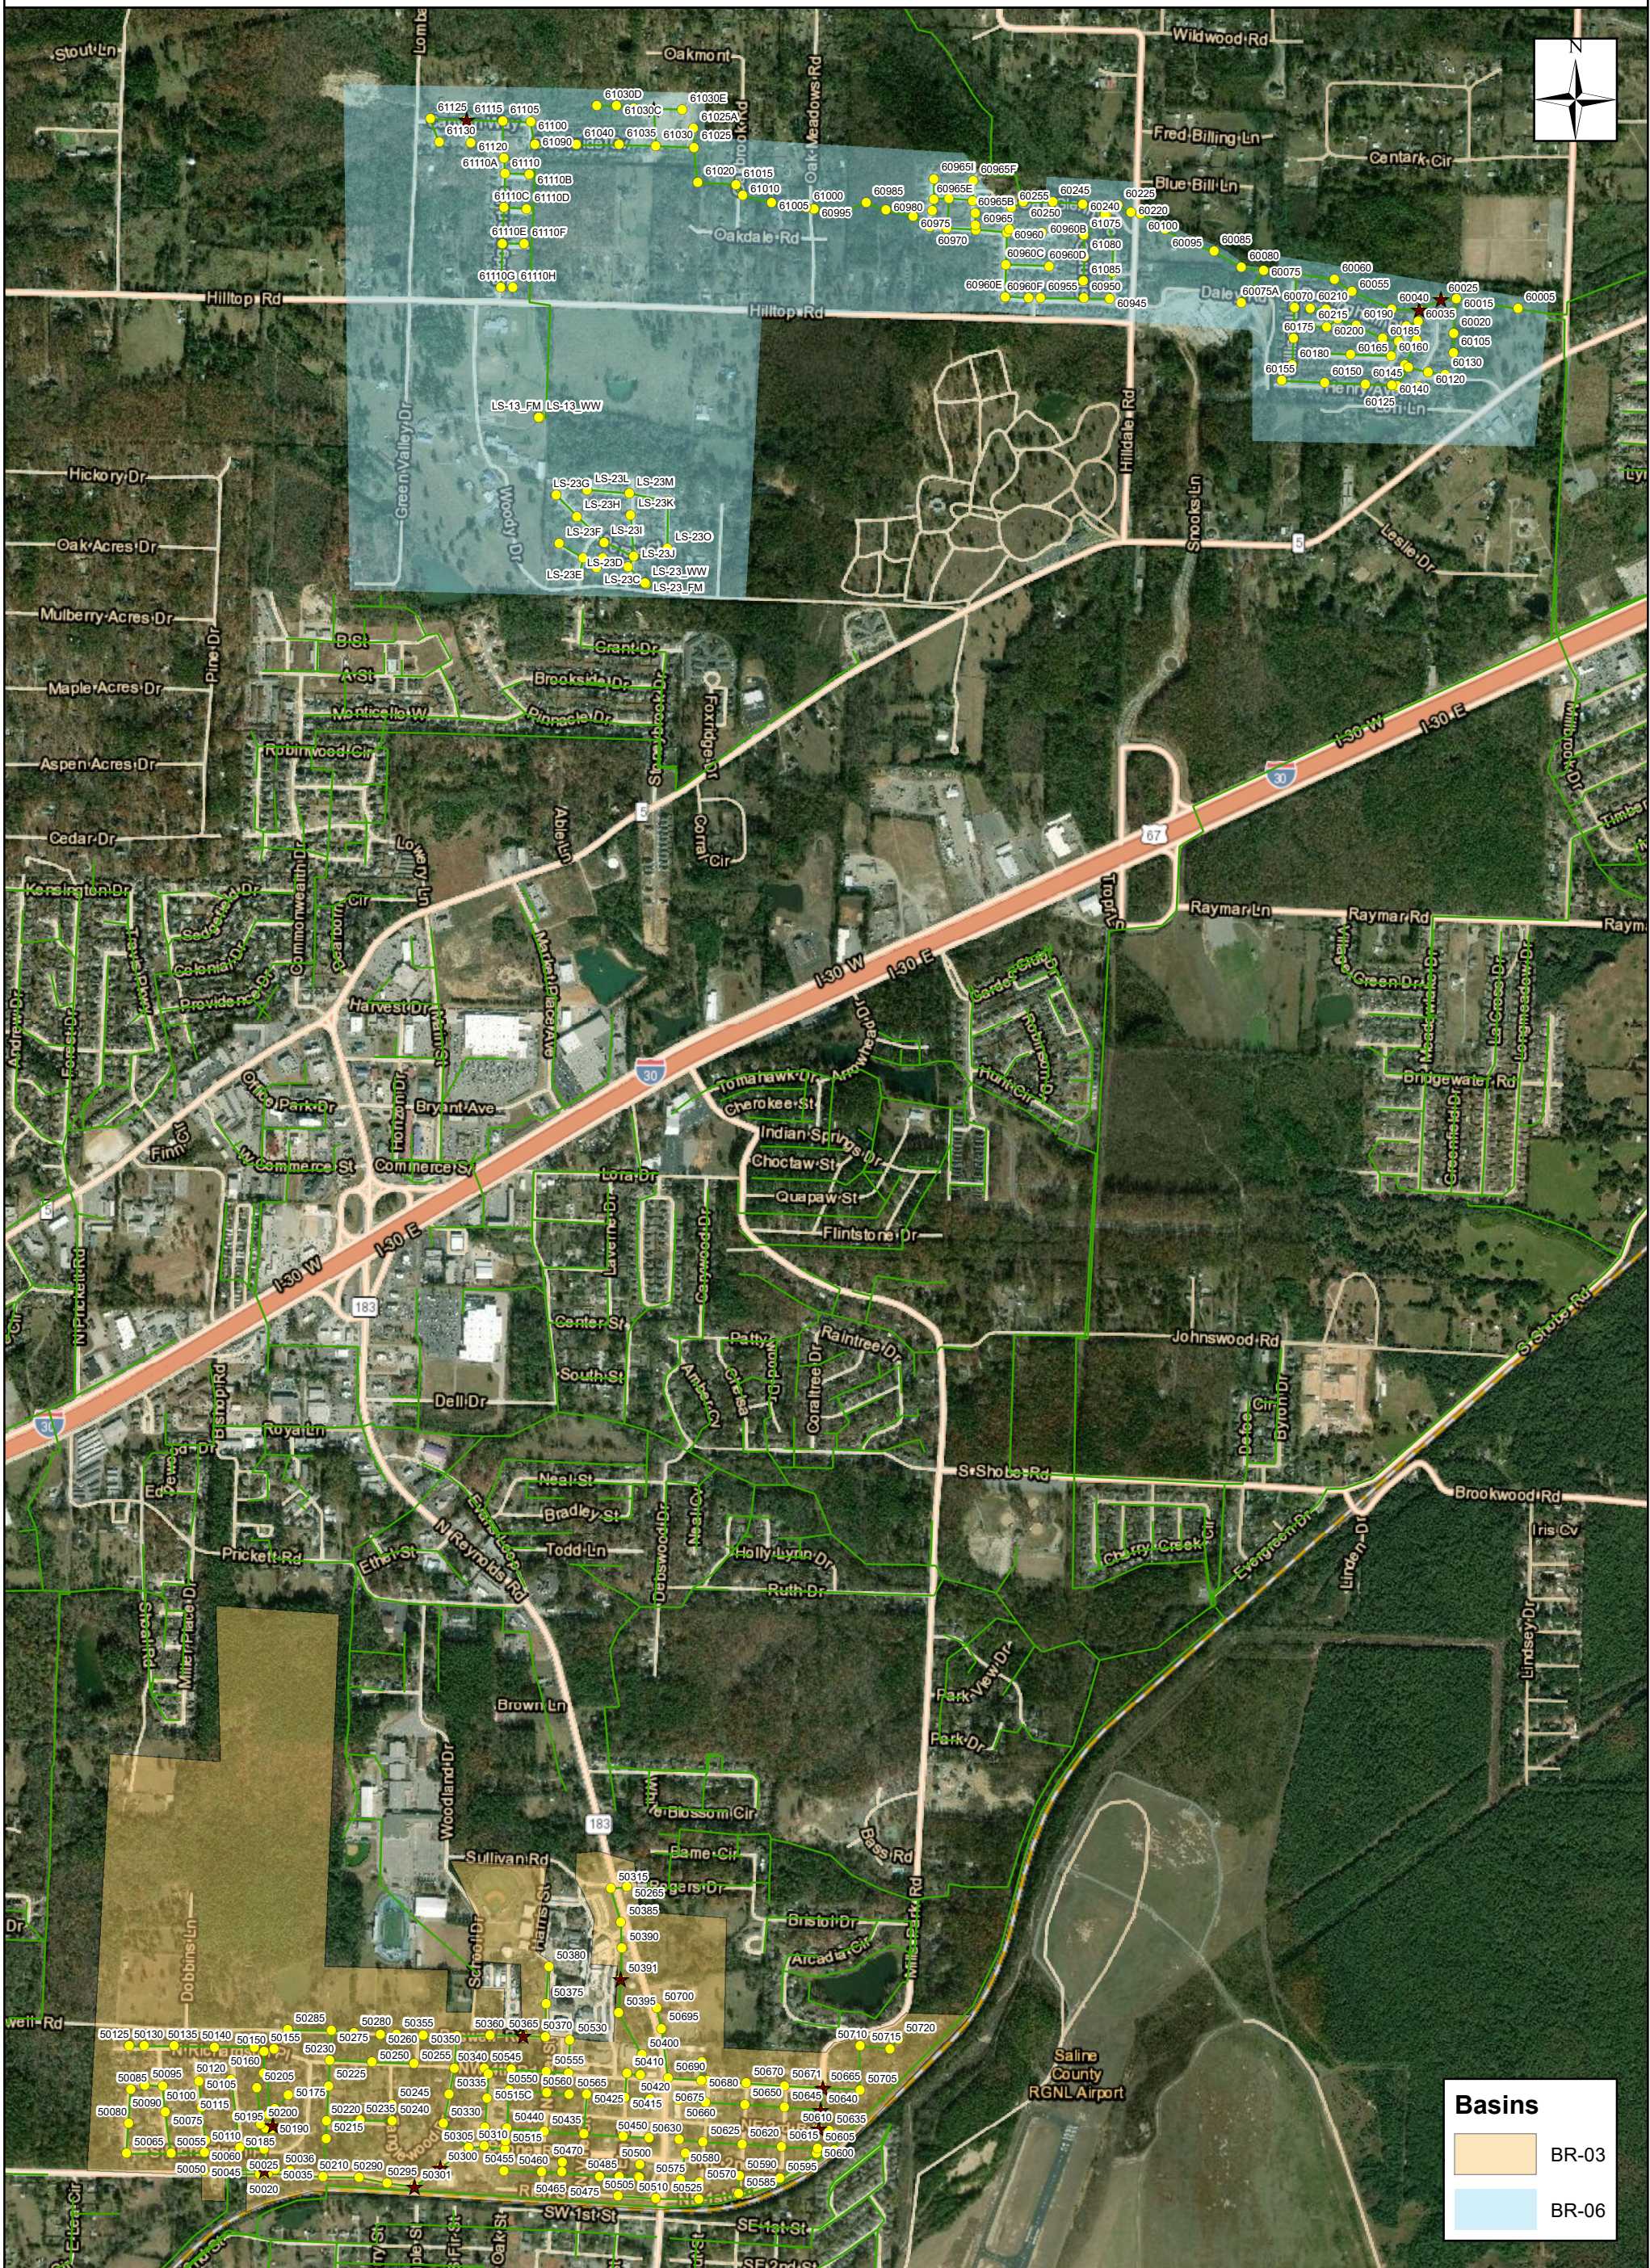
Defective pipe seals and manhole walls are the main sources of infiltration, totaling 75 defects which contributes approximately 0.038 mgd. A total of 13 manholes located throughout the study area indicated evidence of surcharging. These manholes are shown on Figure 2.1. A detailed manhole inspection report is included in Appendix A

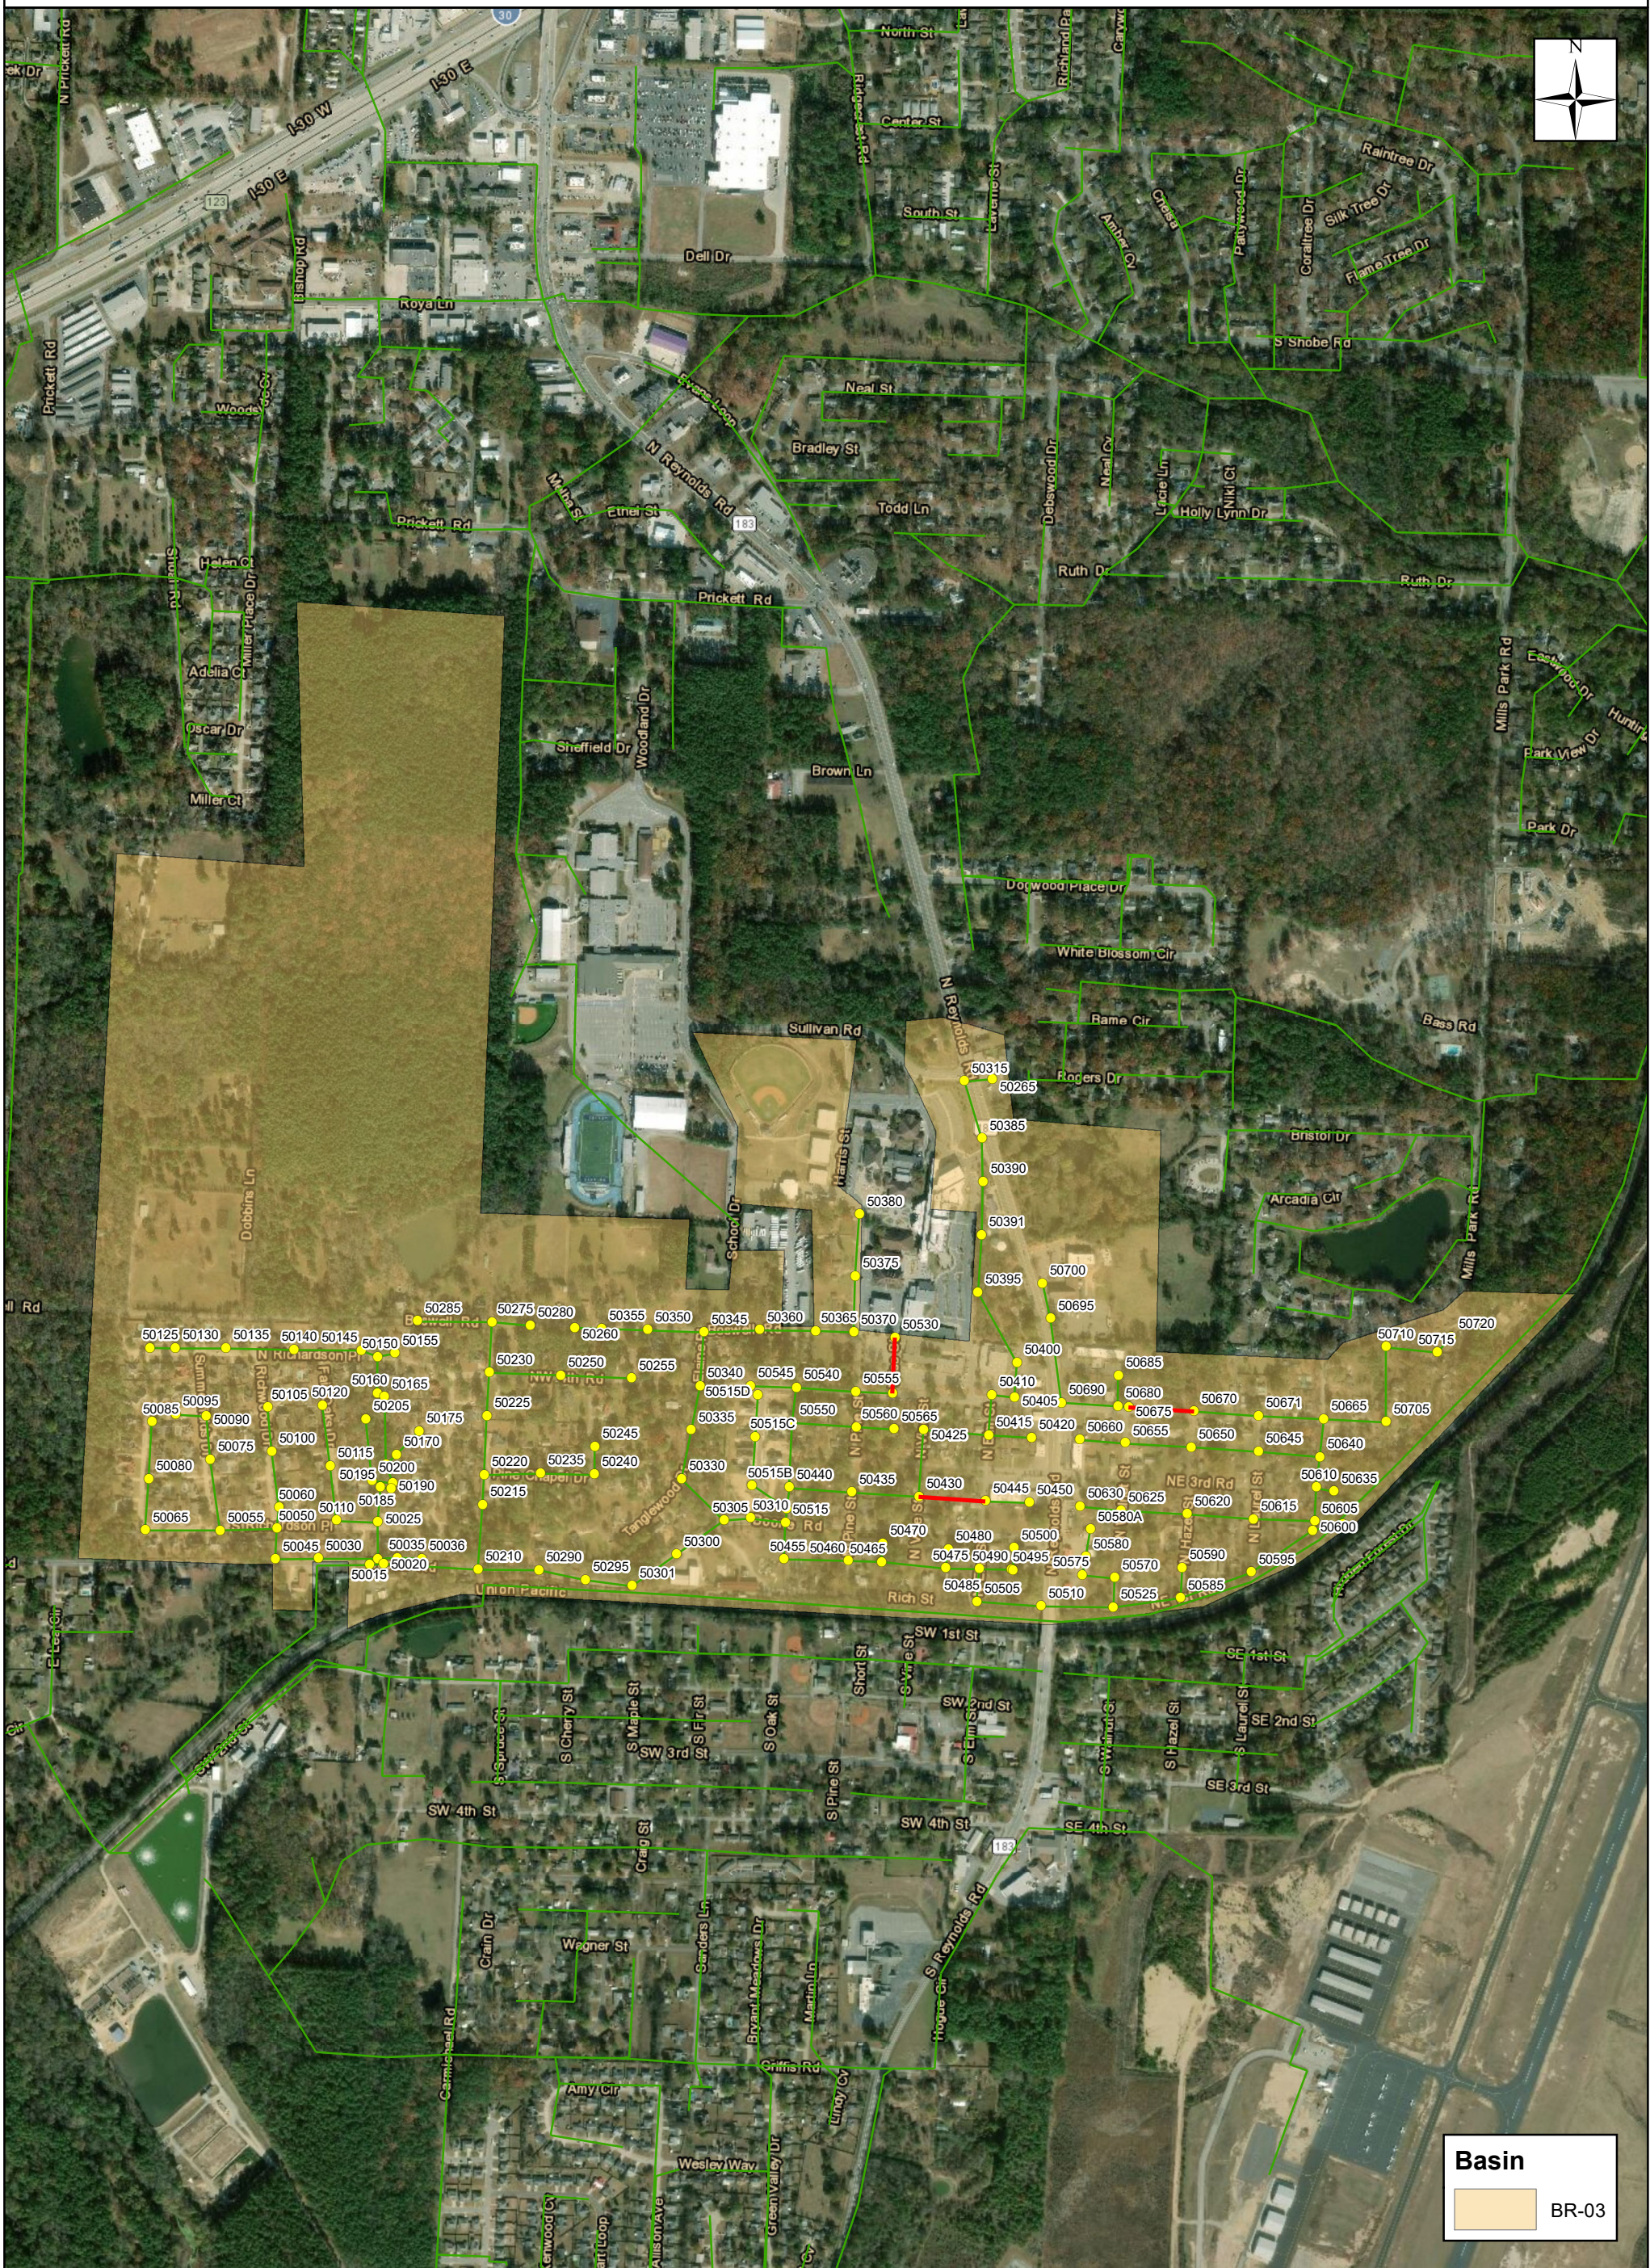
A total of 13,903 was attempted with 13,166 successfully televised and submitted to RJN for review. Due to defects or obstacles such as heavy roots, grease, broken or collapsed pipe not all segments were completely surveyed, many segments were inspected enough to make a recommendation. A summary of the line segments reviewed is provided in Appendix E. A total of three segments have voids visible; making the pipe susceptible to collapse and high I/I. A summary of these segments are given in Table 2.5 and shown in Figure 2.3. Two of the segments, 50445:50430 and 50530:50535, are shown in the photos below, and are recommended for immediate repair.

Table 2.5 Segments with Voids Visible				
USMH	DSMH	Observation	Diameter (in)	Linear Feet (lf)
50445	50430	Hole	6	357
50530	50535	Hole	8	304
50675	50670	Crack	6	<u>353</u>
<b>Total</b>				<b>1,014</b>

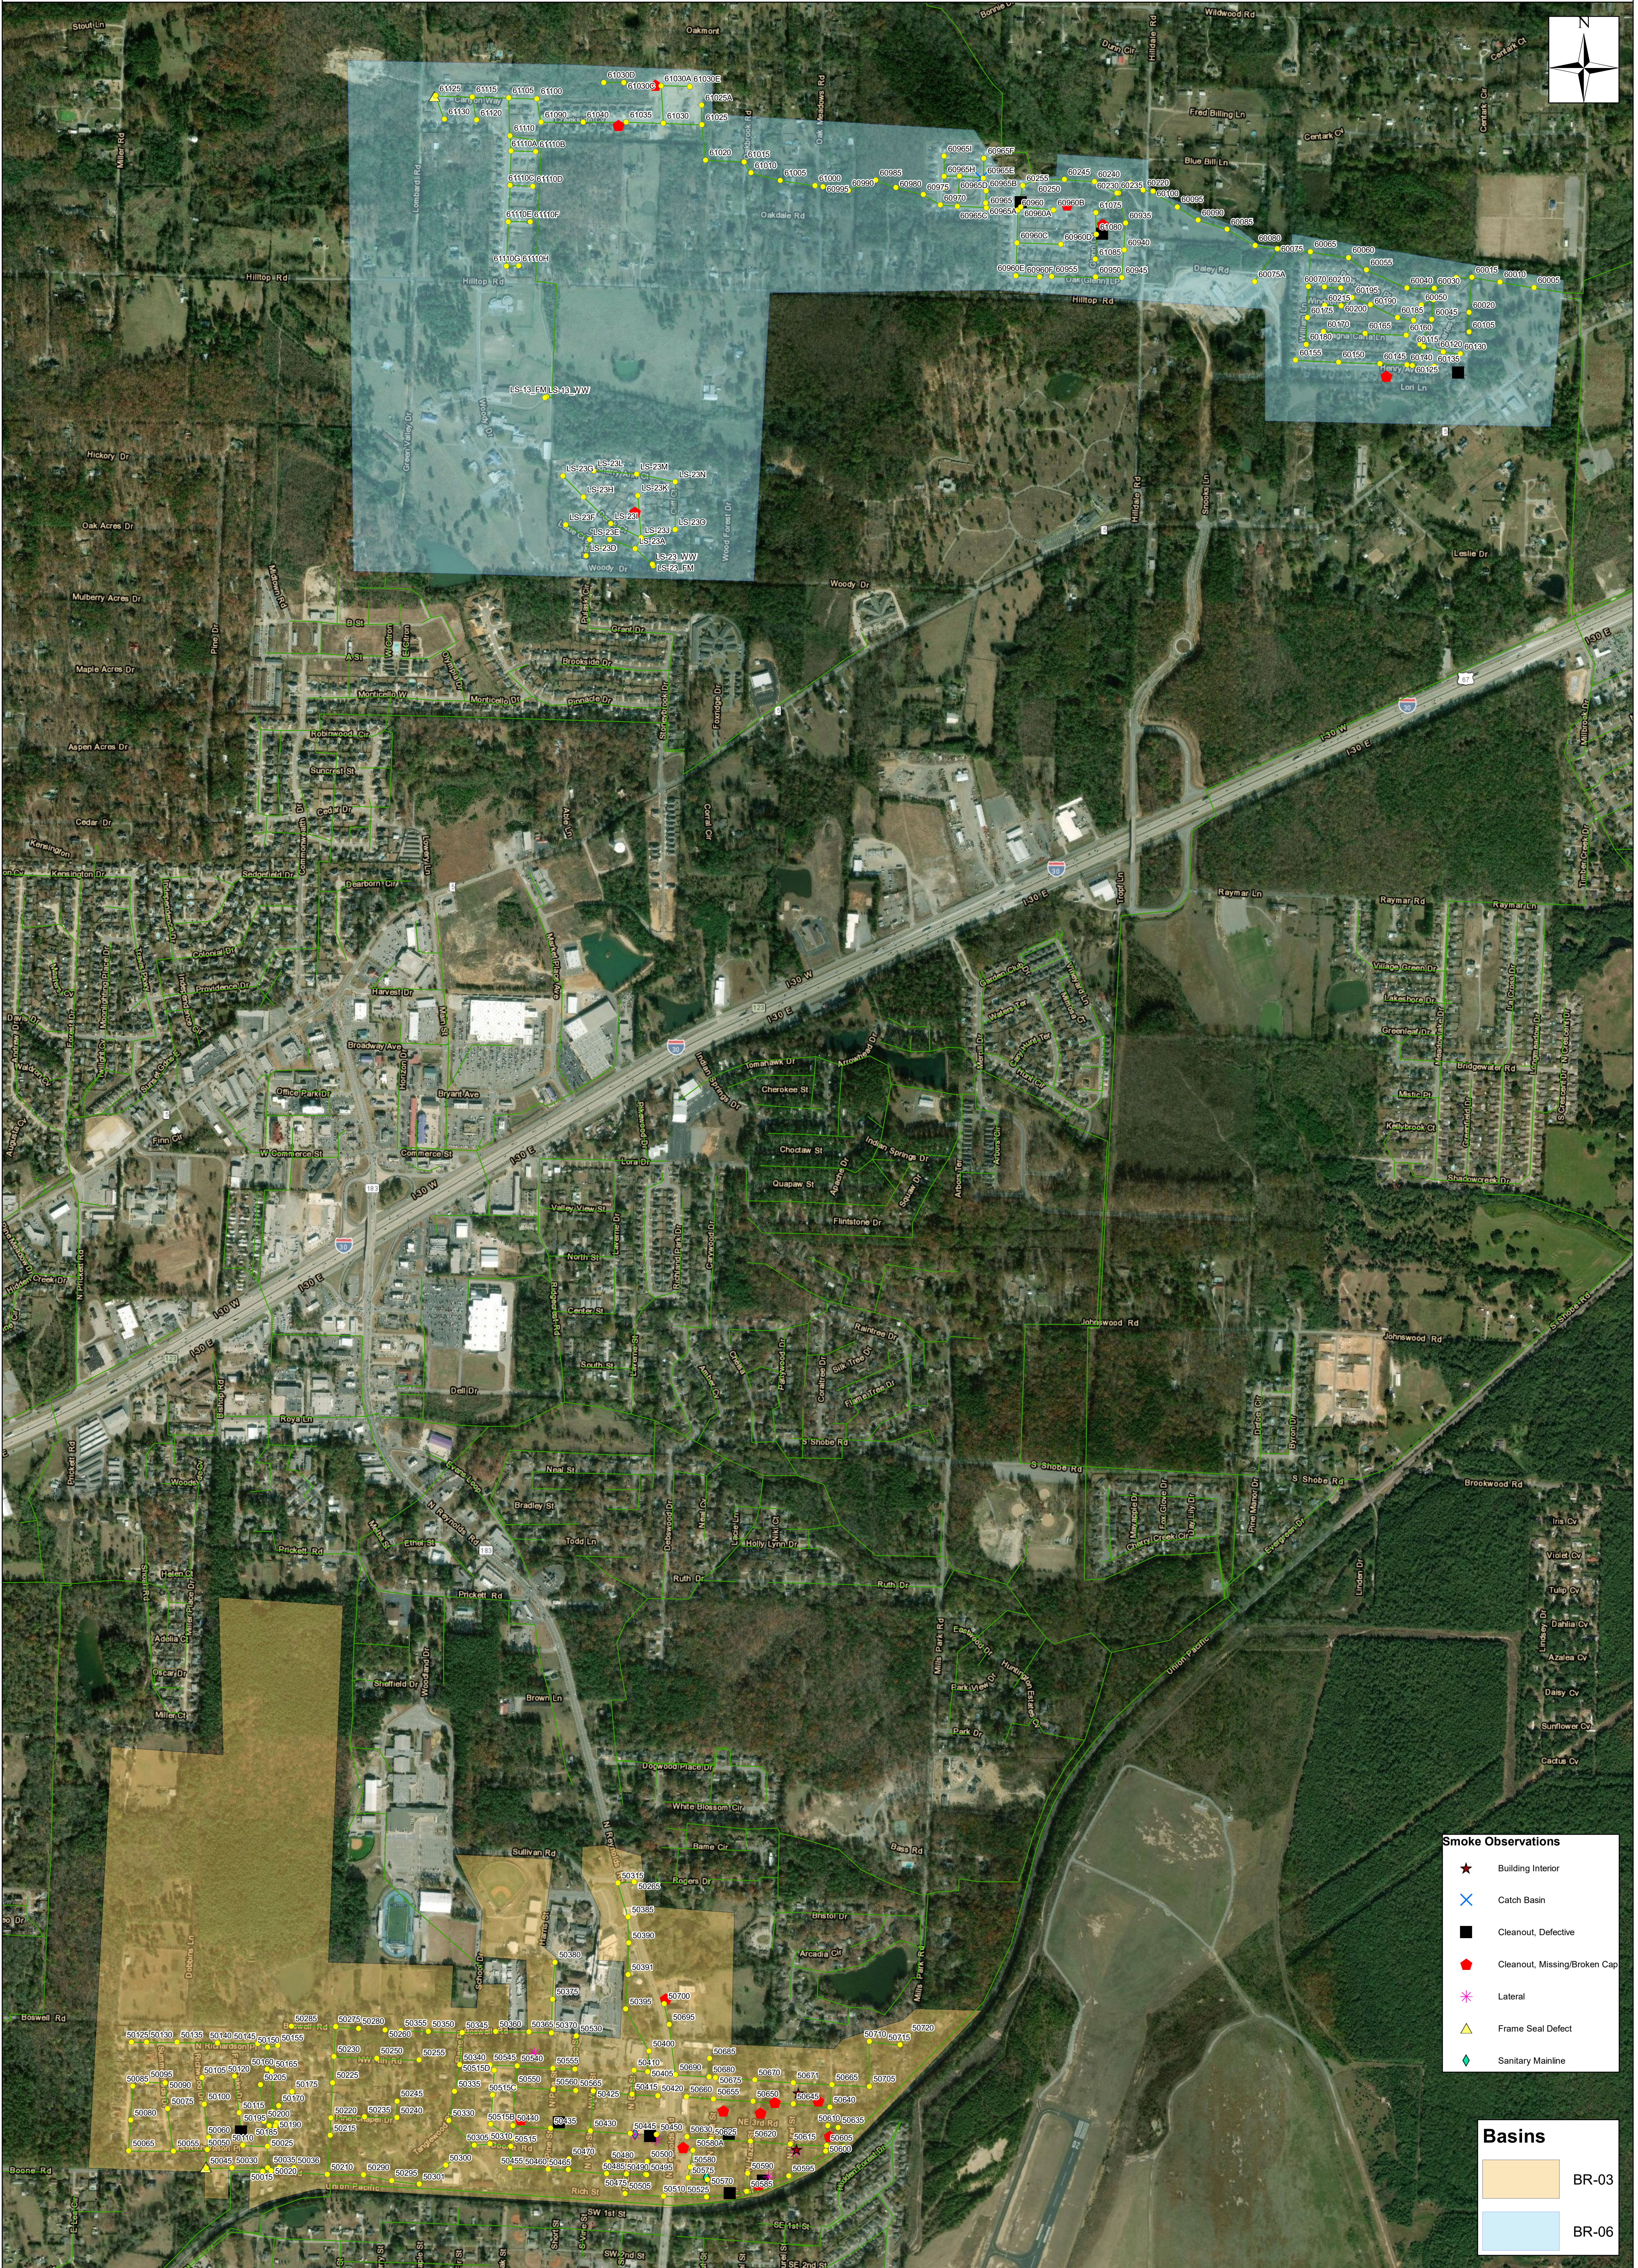
**Smoke Observations**

Table 2.3 Smoke Test Data	
Type of Source	Quantity
<b>Public Sector</b>	
Manhole	3
Mainline	2
Catch Basin	<u>1</u>
<i>Subtotal</i>	6
<b>Private Sector</b>	
Private Cleanout	24
Private Lateral	5
Building Interior	<u>2</u>
<i>Subtotal</i>	<u>31</u>
<b>Total</b>	<b>37</b>
