2019 Sanitary Sewer Evaluation Study

Final Report

Malvern Water Works

RJN Project No. 18-3337-00

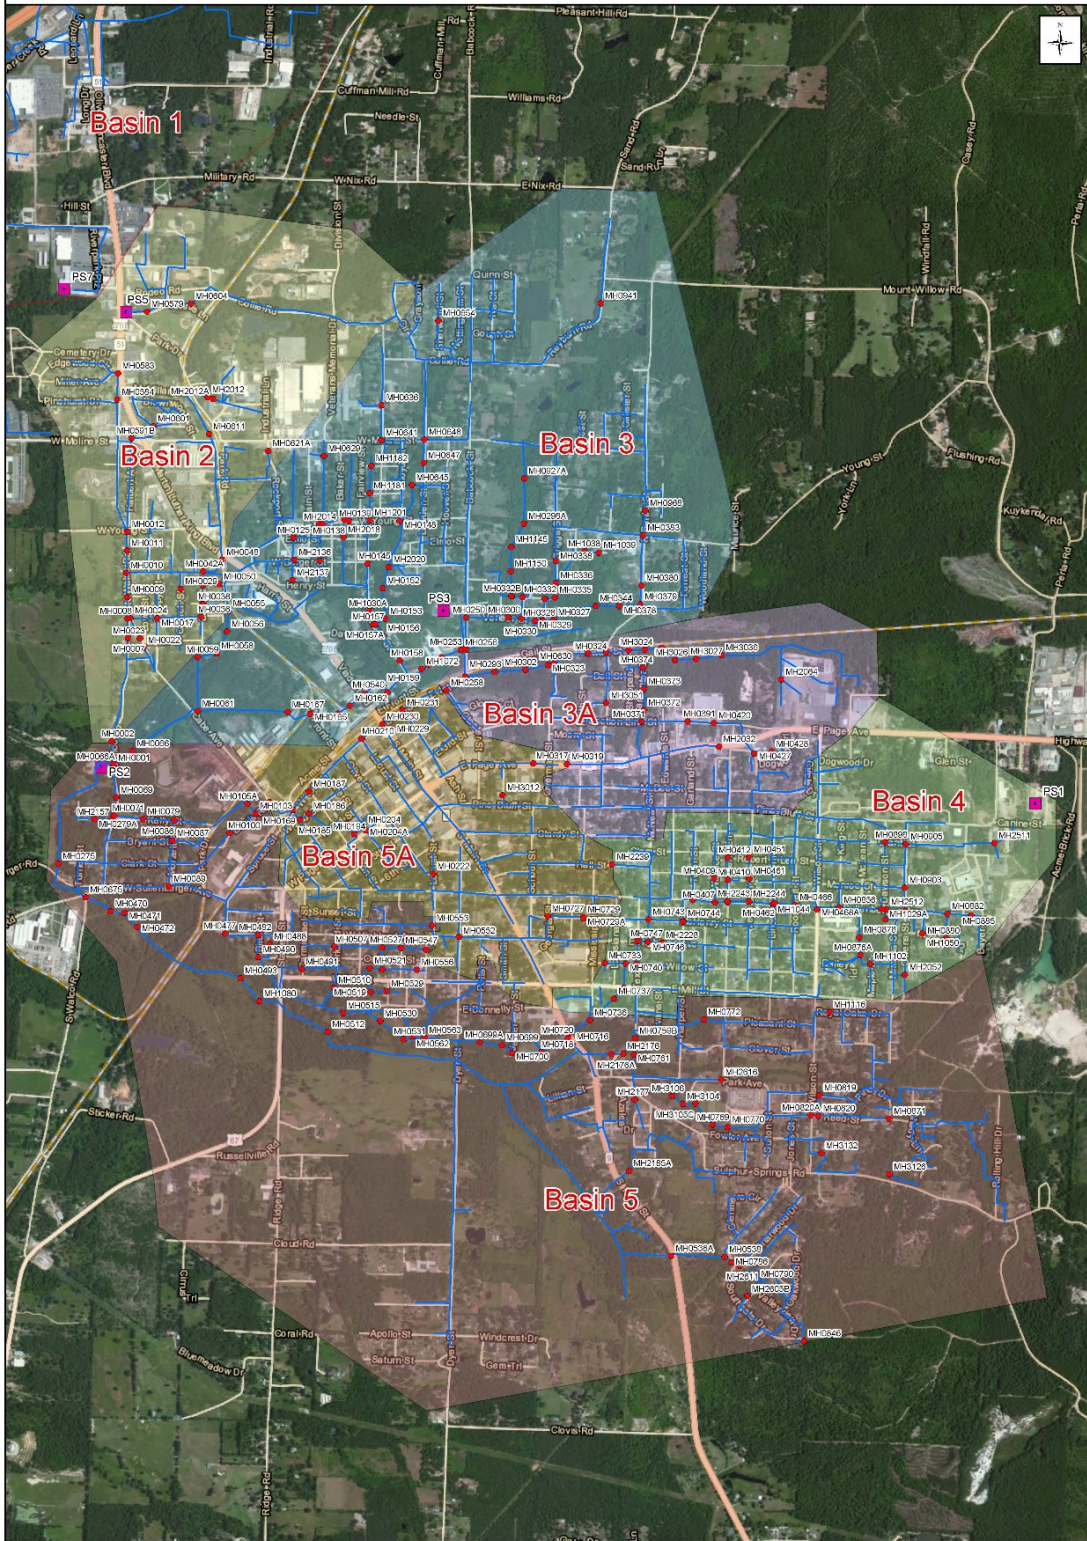
Defective benches and manhole walls are the main sources of infiltration, totaling 868 defects which contributes approximately 0.325 mgd. A total of 280 manholes located throughout the study area indicated evidence of surcharging. These manholes are shown on Figure 2.1.

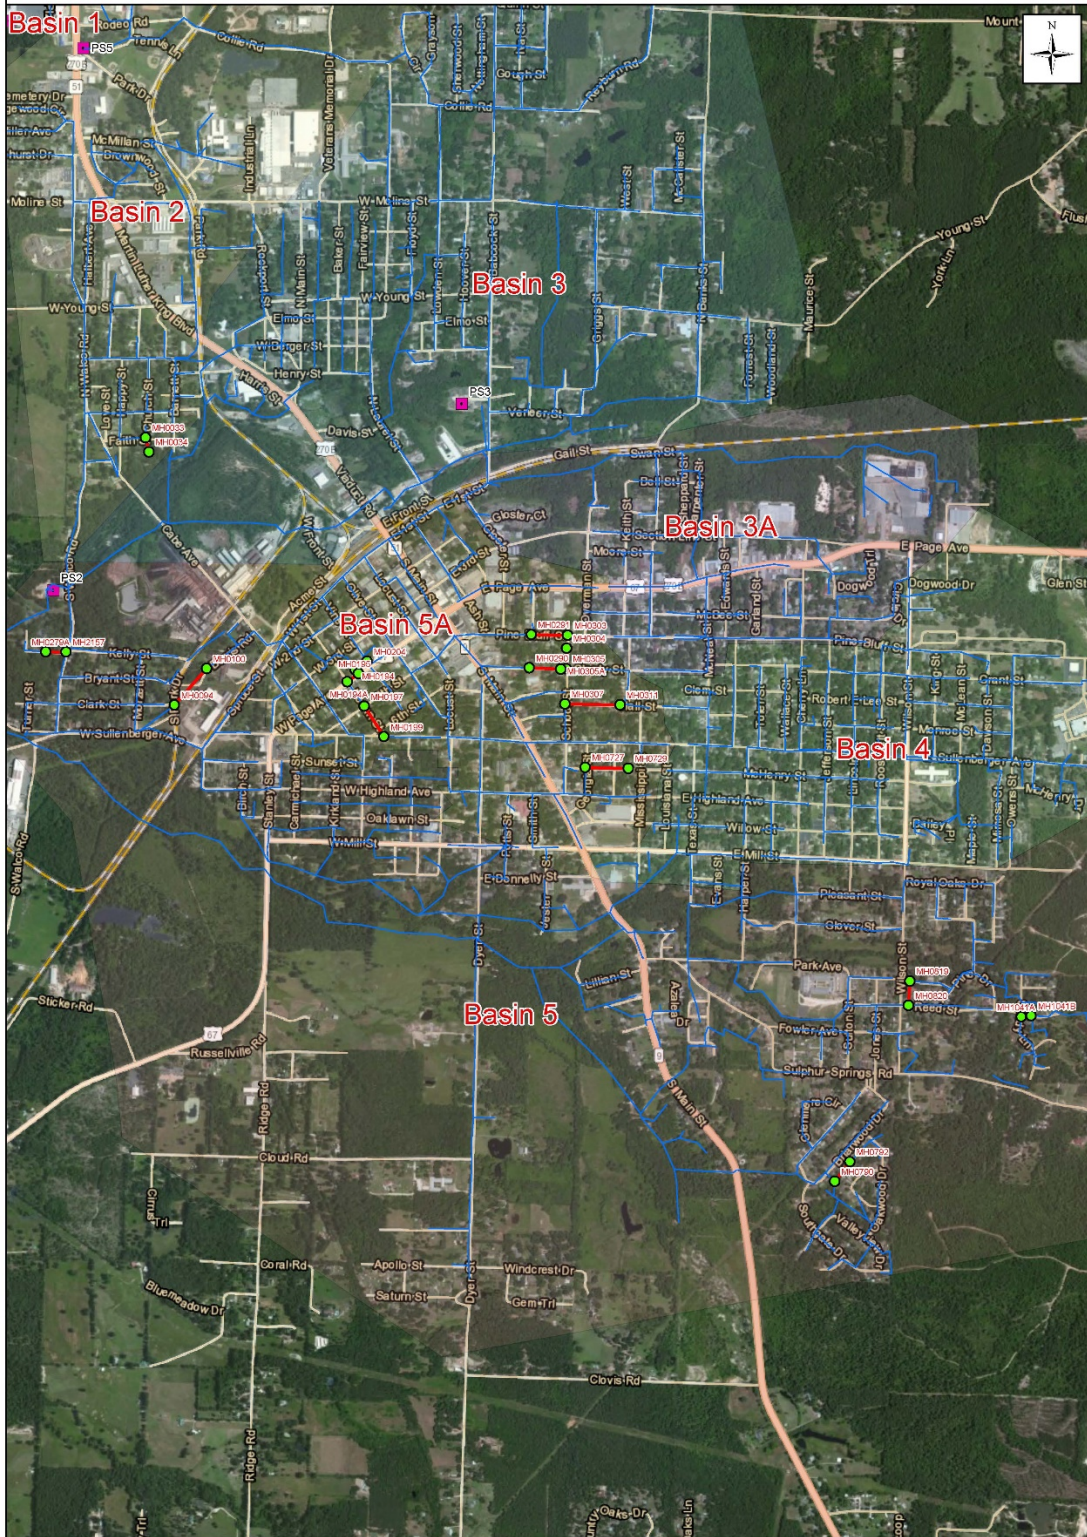
Figure 2.2
Dye Testing Locations

shown in Figure 2.2 and dye test data can be found in appendix D. Dye testing identified a total of 0.419 mgd of inflow; addressing these defects should make an immediate impact to the system.
