2023 City of Malvern Sanitary Sewer Evaluation Study

FINAL REPORT

Subject: City of Malvern – 2023 Sanitary Sewer Evaluation Study (SSES)

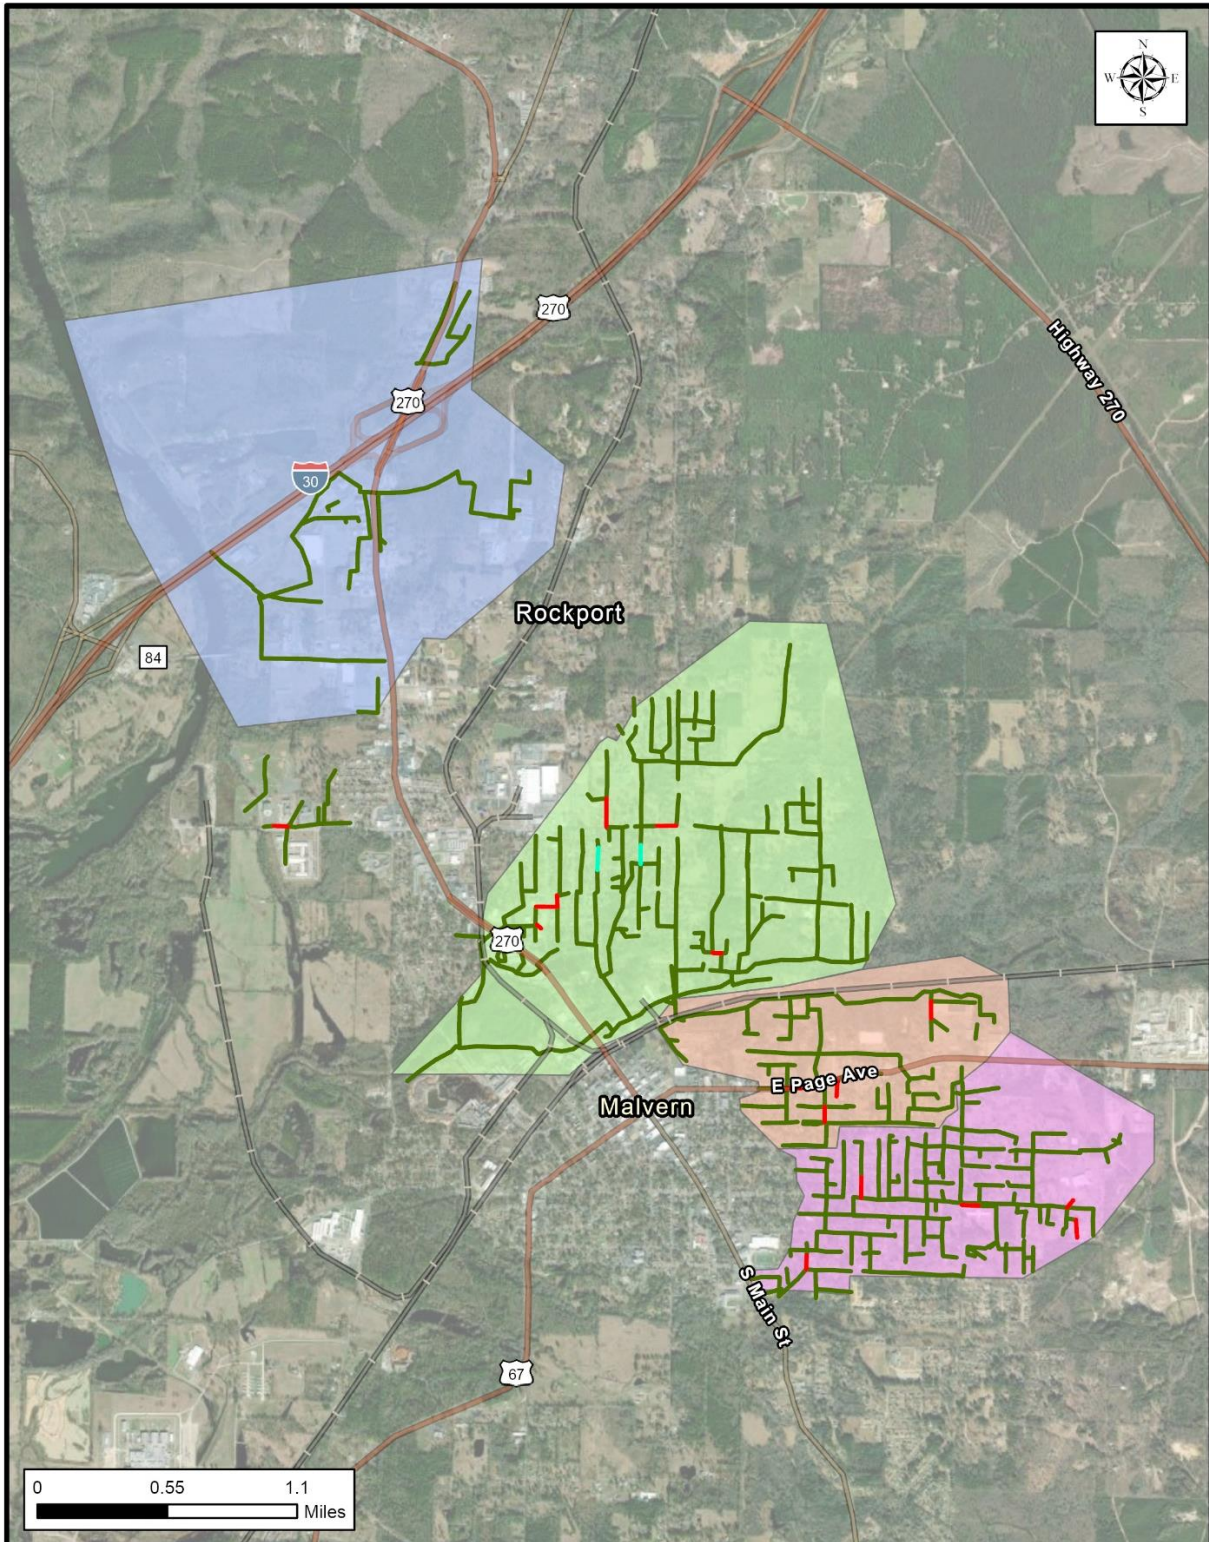
Figure 2.2
Dye Testing

The locations of the 21 dye tests are shown in Figure 2.2 on page 2-17 and dye test data can be found in Appendix D. Dye testing identified a total of 137,952 gpd of inflow; addressing these defects should make an immediate impact to the system. Table 2.4 summarizes the dye testing efforts.

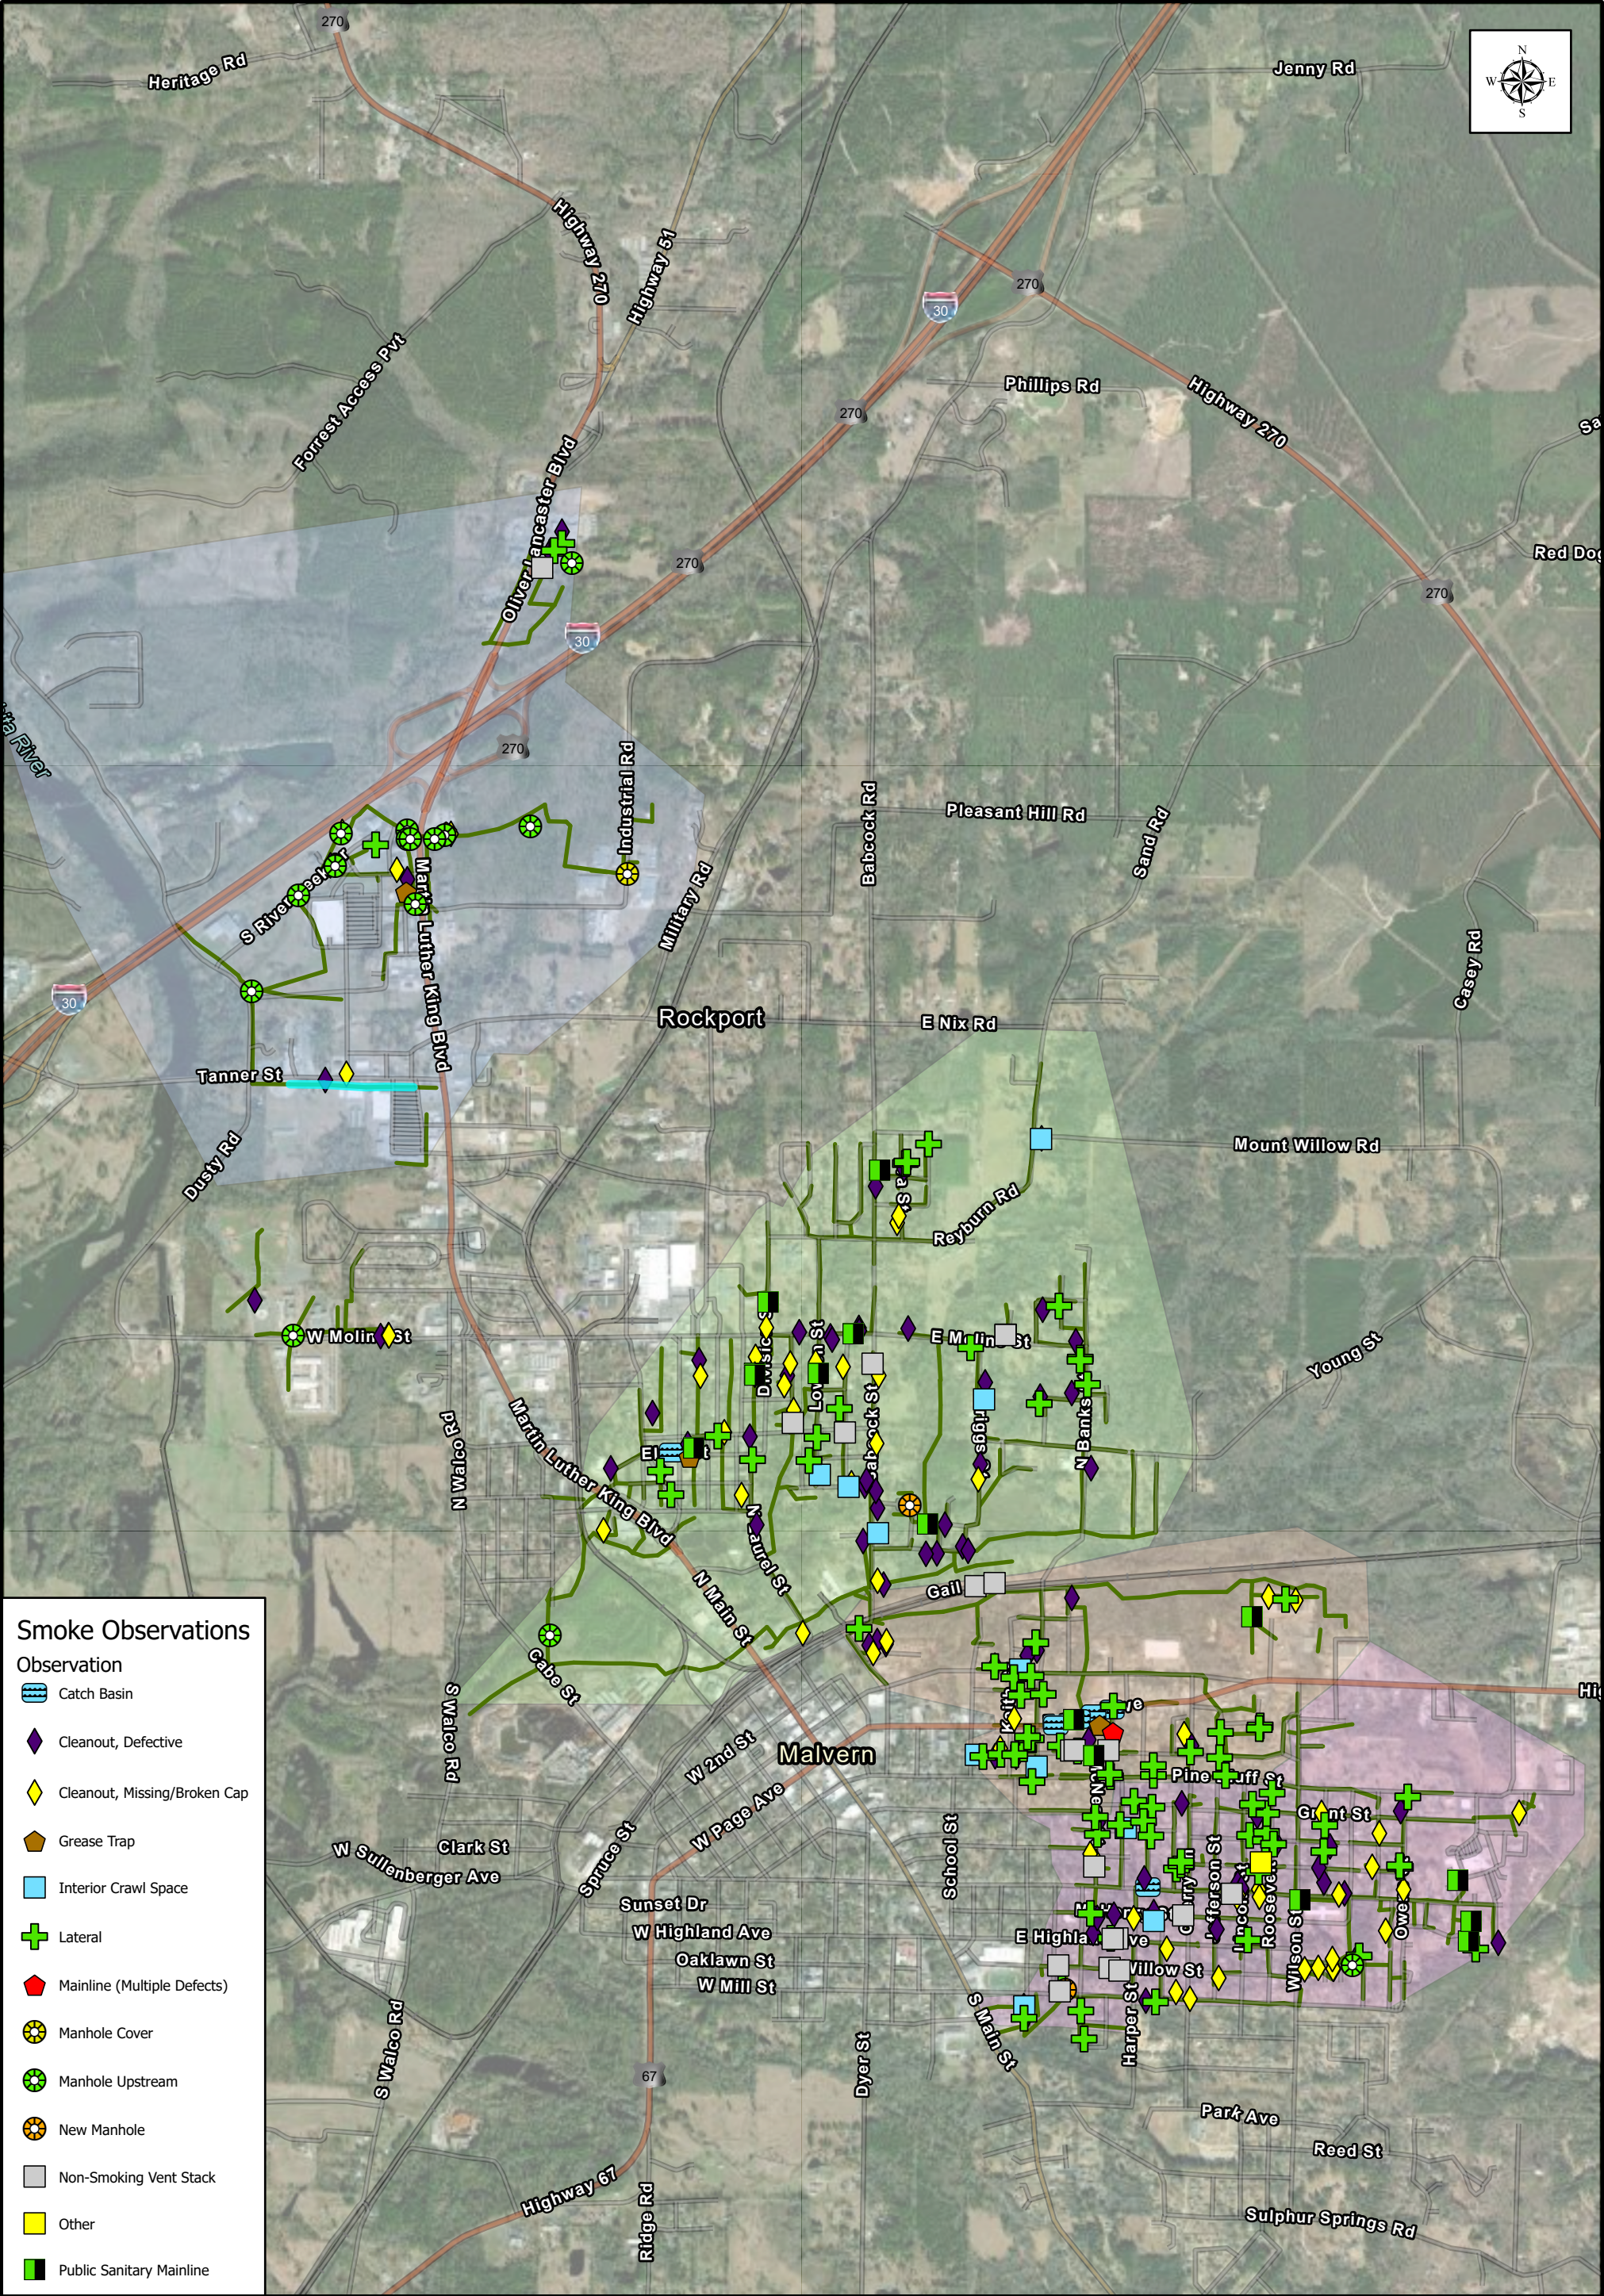
Exhibit B
Smoke
Observations

Sources are represented in the pie chart on page 2-8 and a summary is given in Table 2.3. Map Exhibit B shows the locations of defects found during smoke testing. A report listing the findings of the smoke testing program is given in Appendix C.
