2023 City of Malvern Sanitary Sewer Evaluation Study

FINAL REPORT

Subject: City of Malvern – 2023 Sanitary Sewer Evaluation Study (SSES)

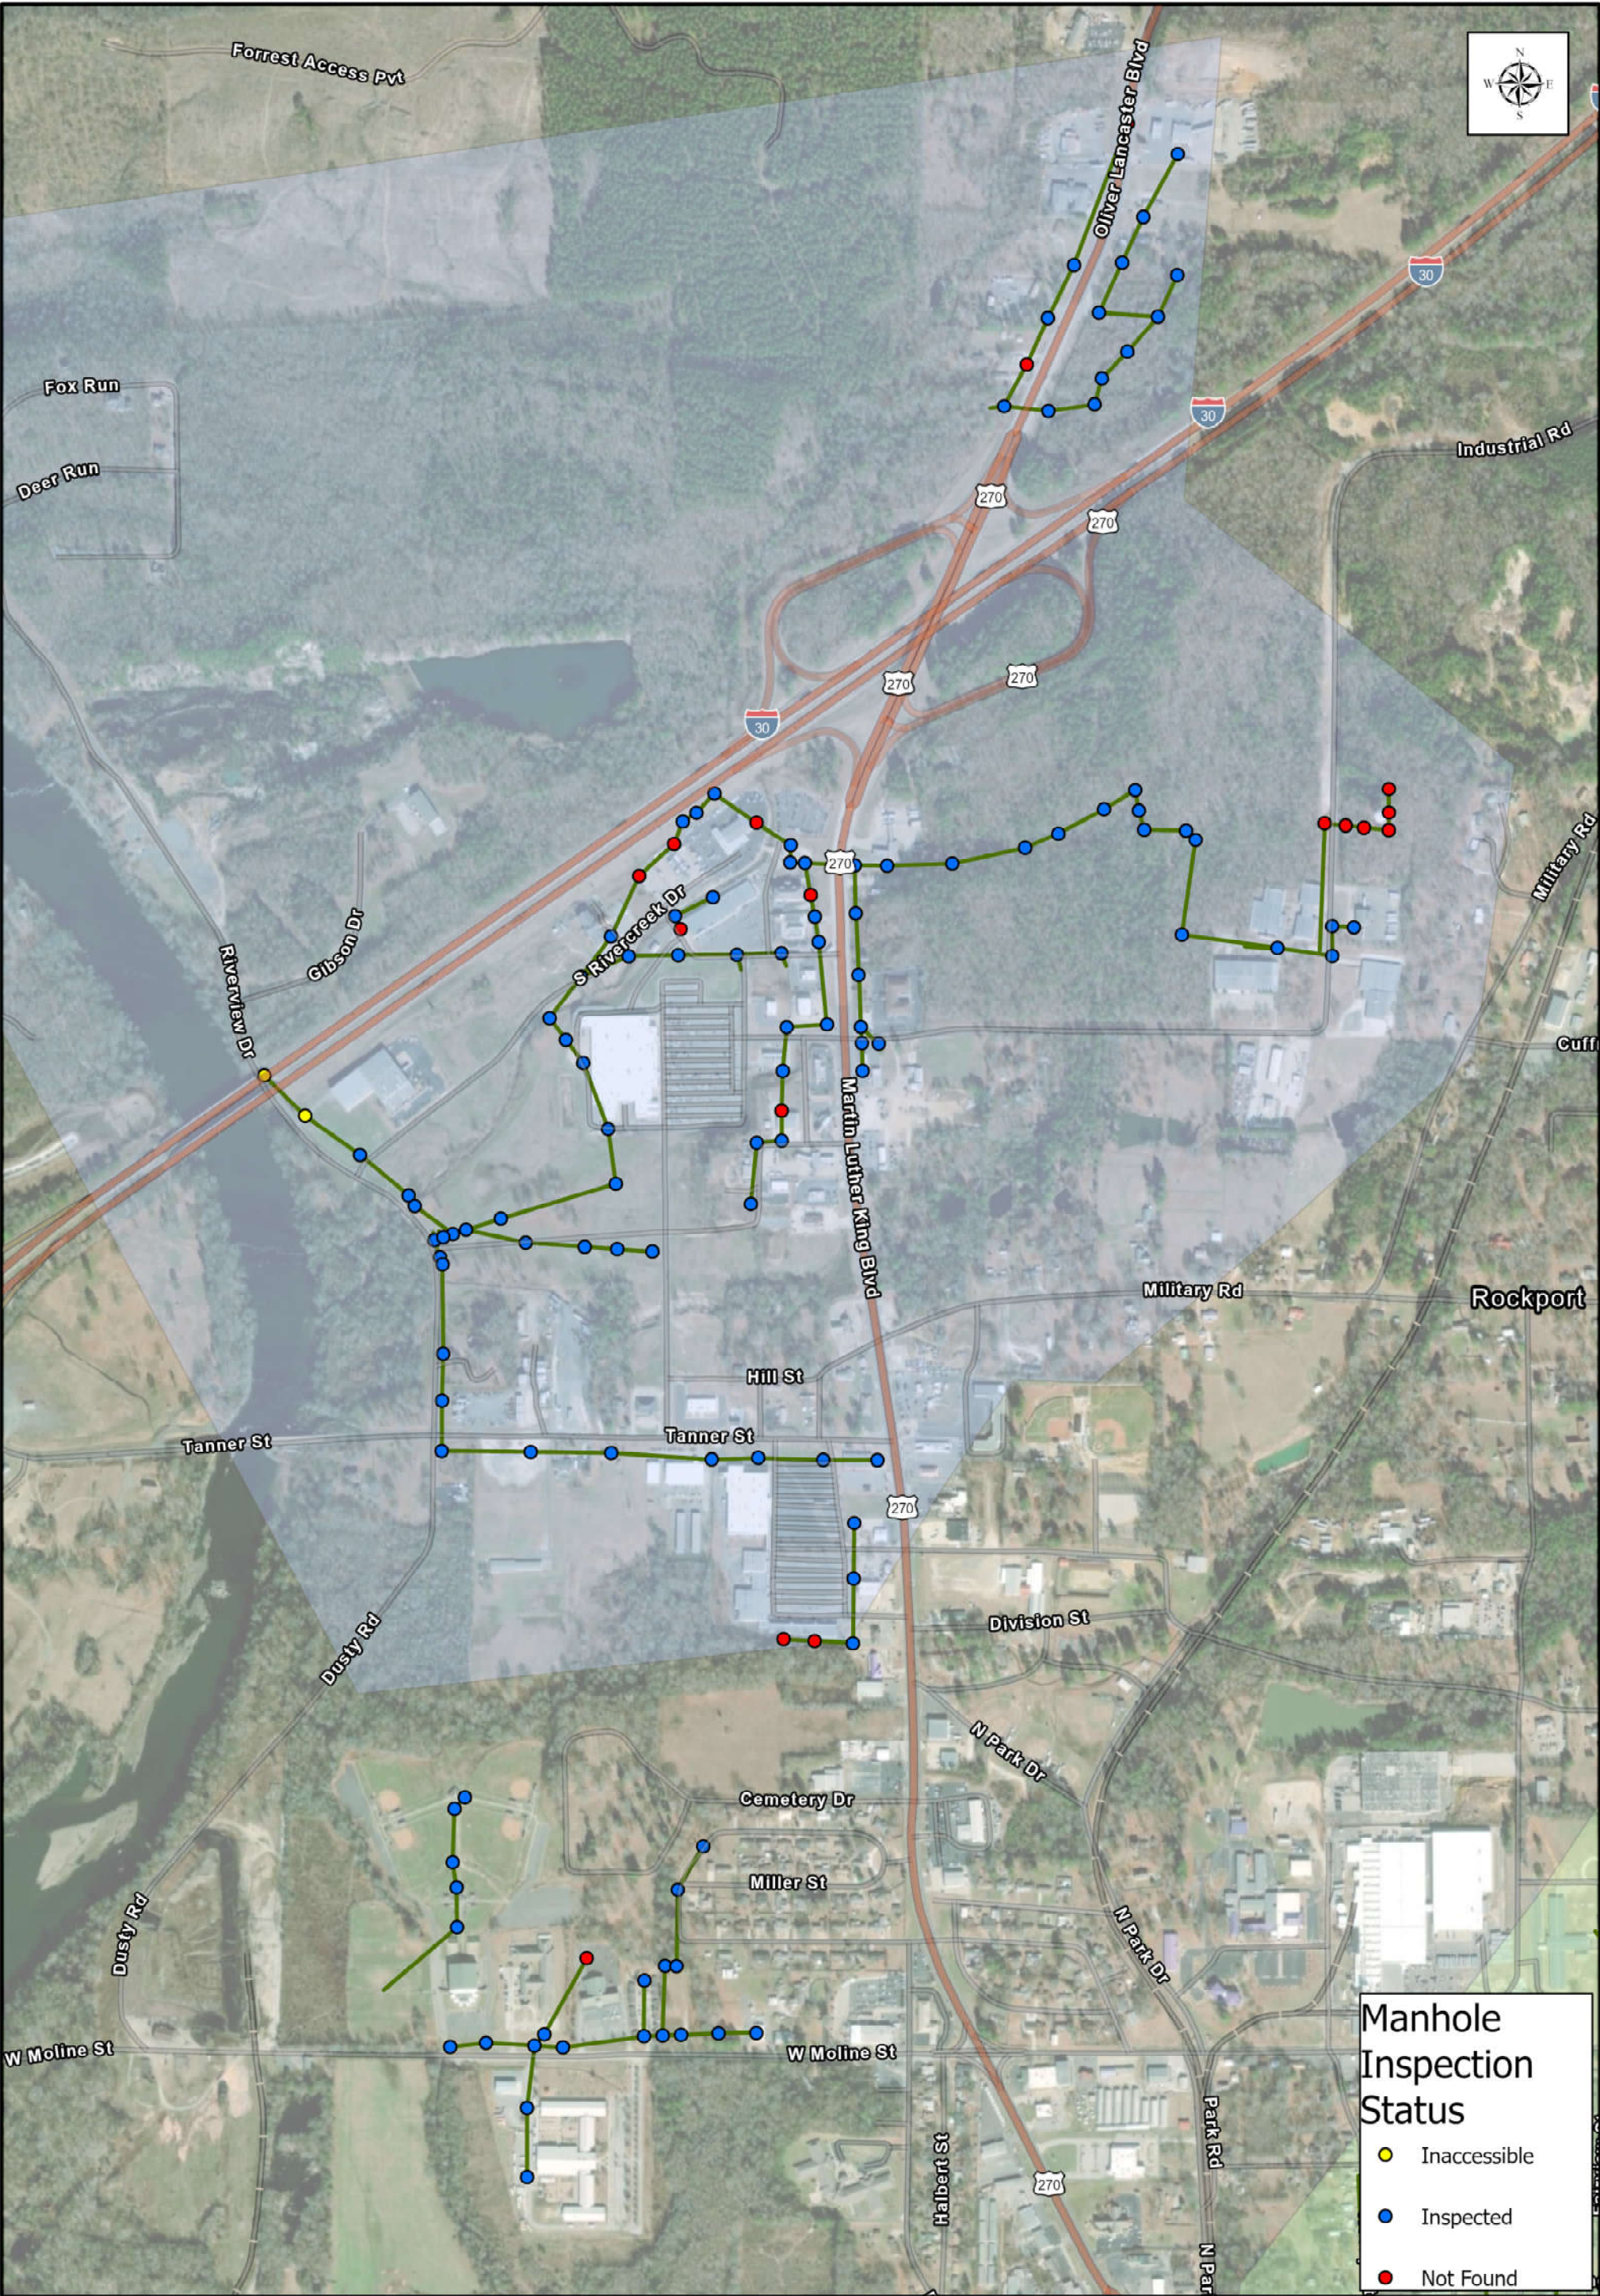
Exhibit A
Manhole
Inspection Status

Inspections were performed on 107 out of 131 manholes (82 percent) in and around Basin 1. Every effort was made to locate each structure, however 24 remained uninspected. These manholes consist of 19 that were unable to locate, and 5 that were inaccessible due to various reasons such as locked gates or dogs present in backyards. A list of these structures and corresponding status has been provided to the city. All manhole inspection information can be found within the report in Appendix A. An access structure inspection summary is given in Table 2.1, and a summary of manhole defects is given in Table 2.2. Map Exhibit A depicts manhole inspection status.

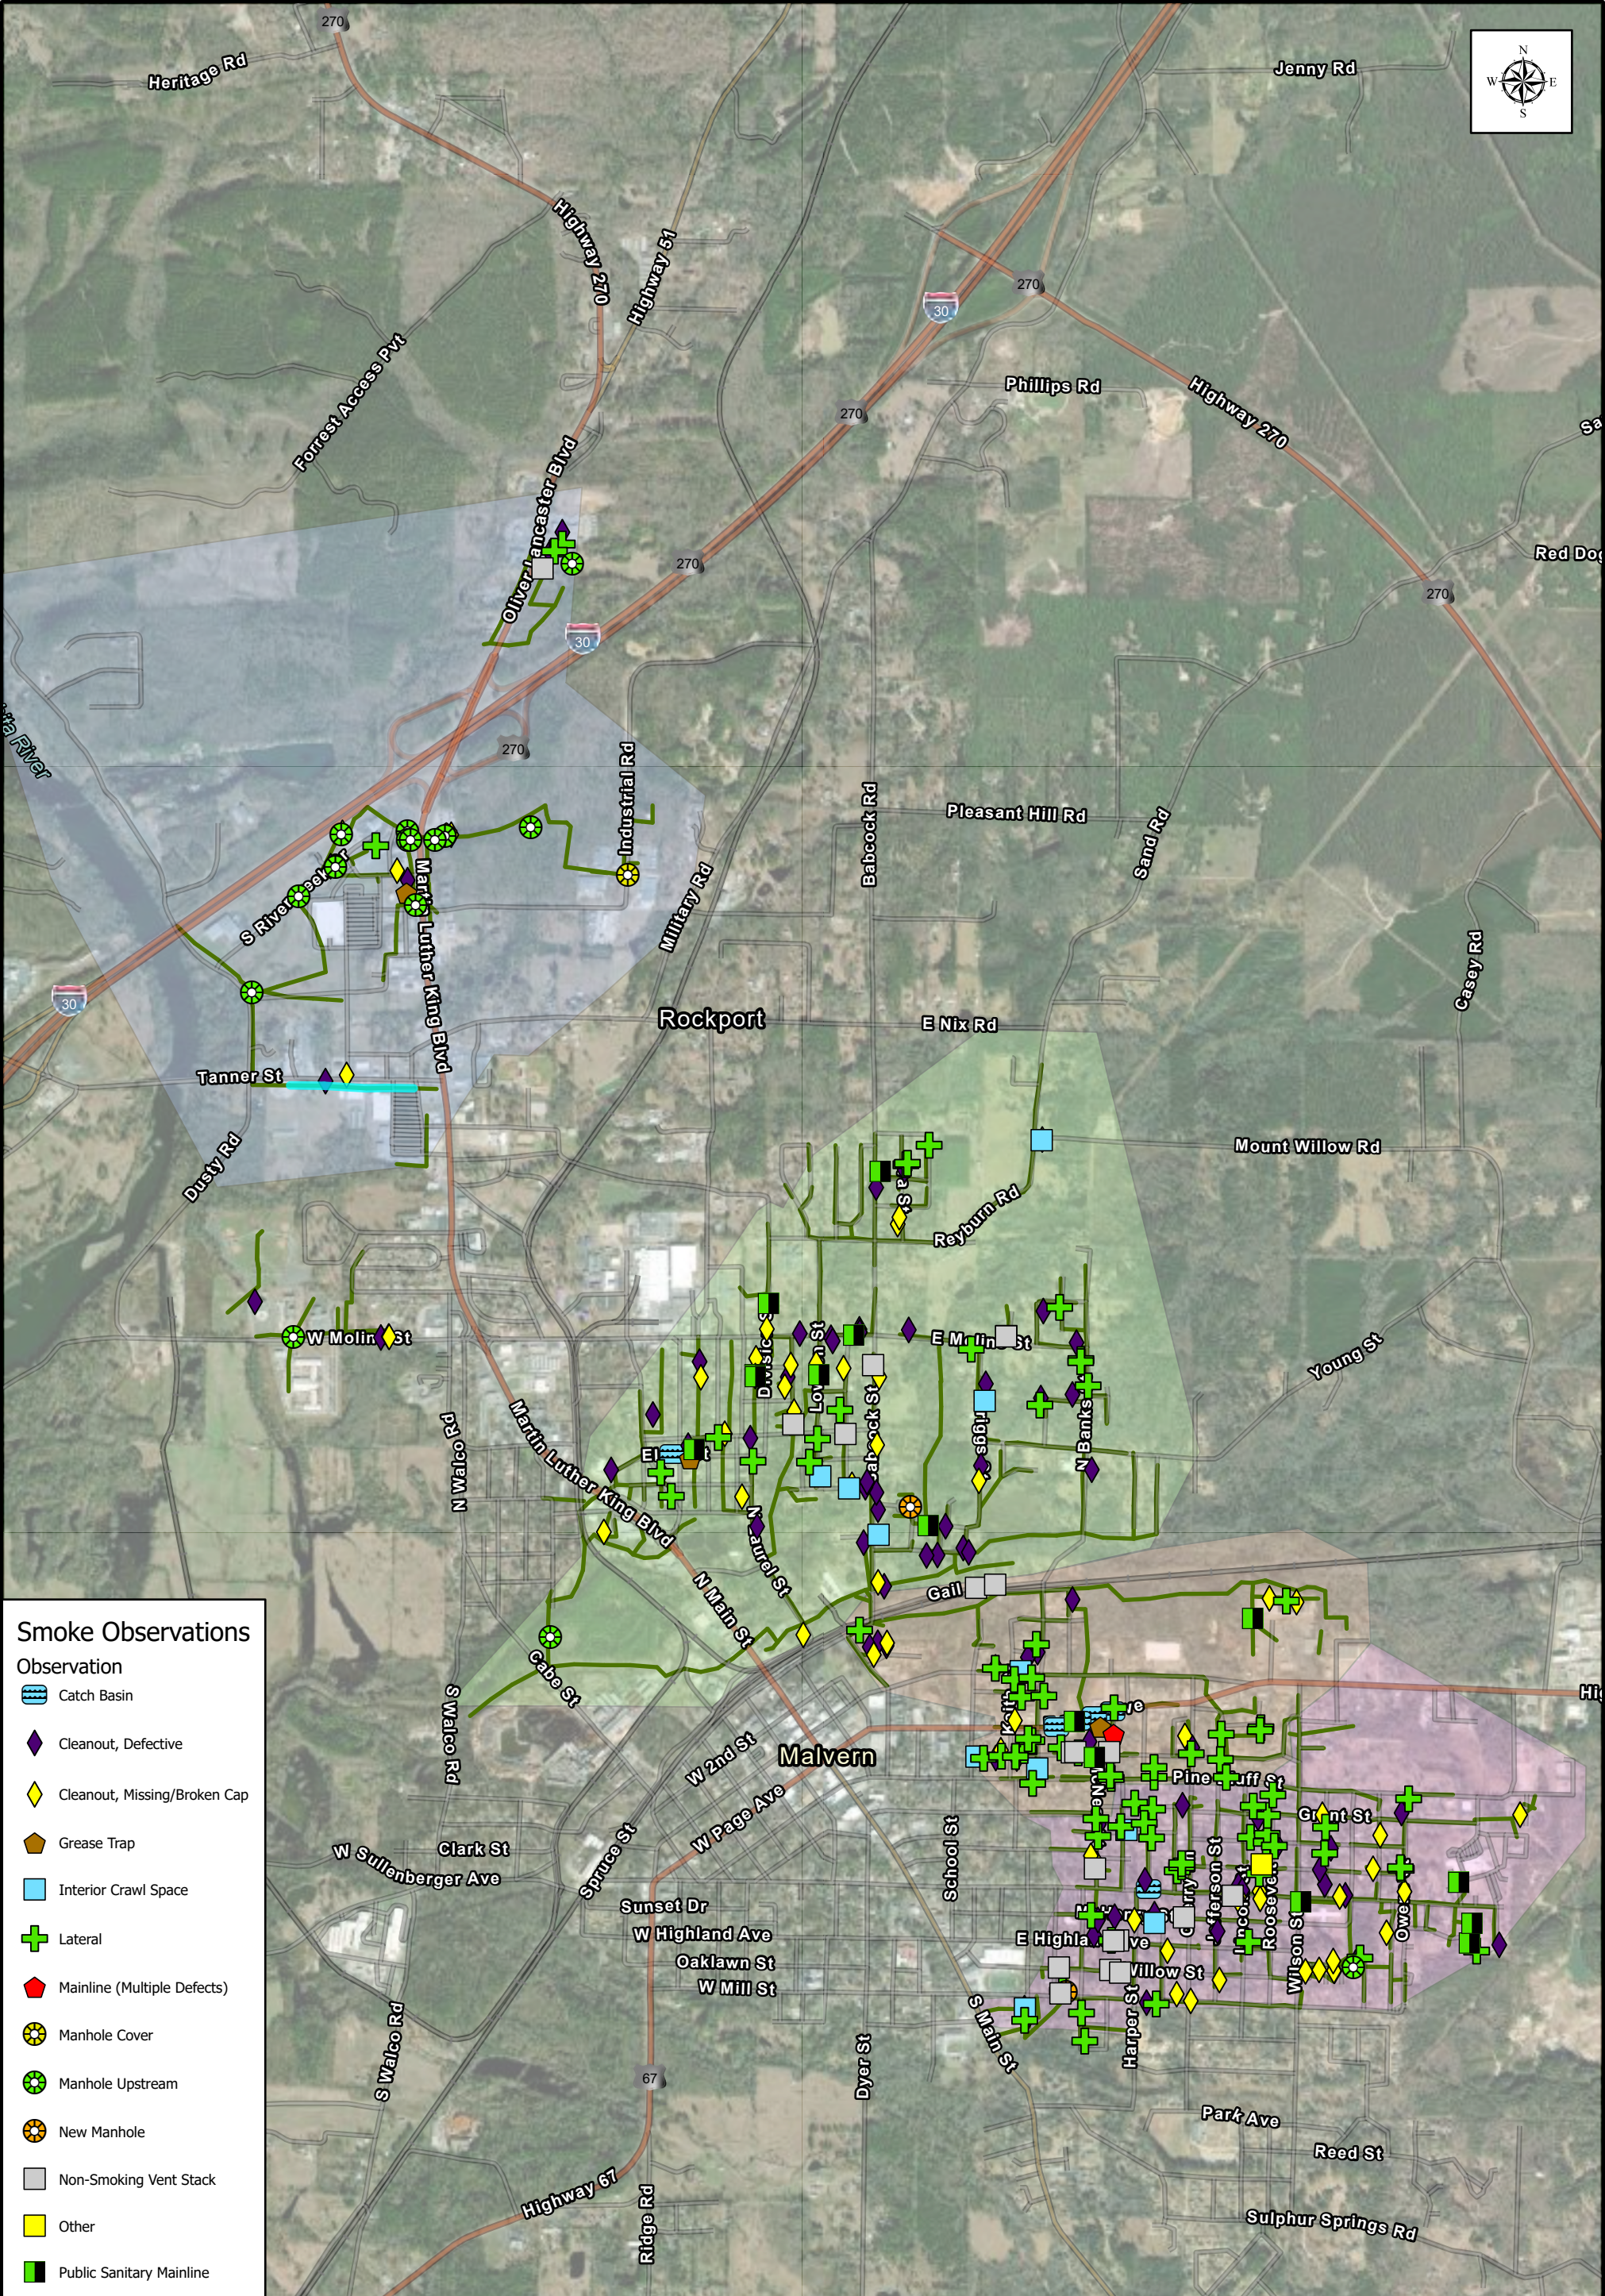
Exhibit B
Smoke
Observations

Sources are represented in the pie chart on page 2-8 and a summary is given in Table 2.3. Map Exhibit B shows the locations of defects found during smoke testing. A report listing the findings of the smoke testing program is given in Appendix C.
