SANITARY SEWER EVALUATION & SURVEY

***MENA WATER UTILITIES
MENA, ARKANSAS***

MAY 2012

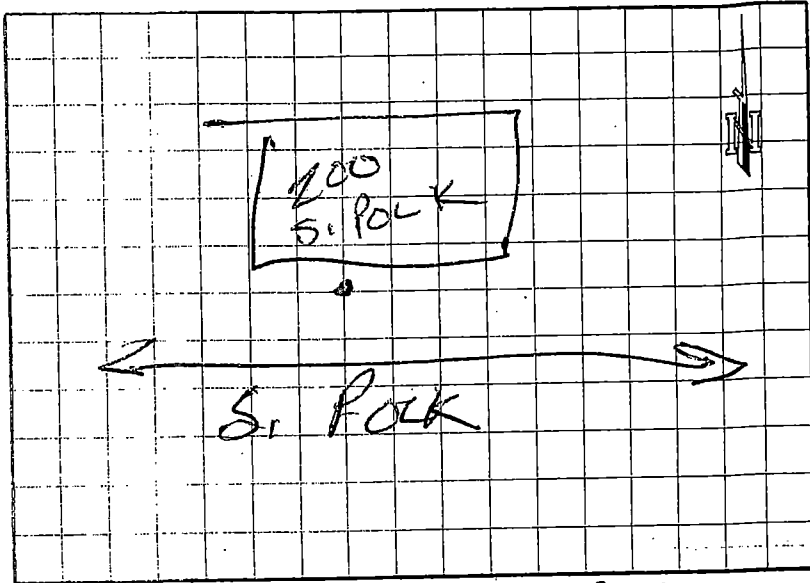
Subject: Mena Utilities SSES
 Location: 200 S. POLK
 Area: 5
 Line No. _____
 Leak No. _____
 Date: 8/10 Time: _____
 Inspector: (BB)

DESCRIPTION OF LEAK: MISSING CLEAN OUT CAP CATCHING ALL RAIN OFF EYE OF HOUSE

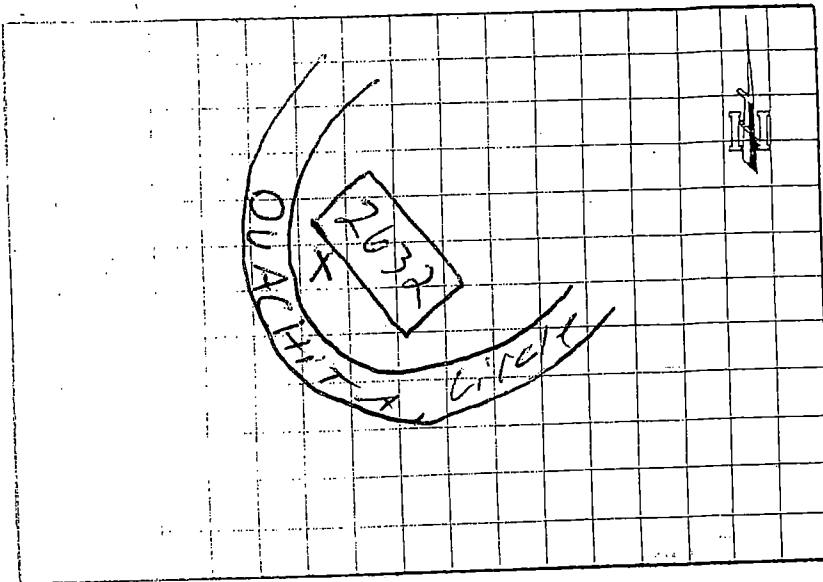
DESCRIPTION OF LEAK: Cap broke

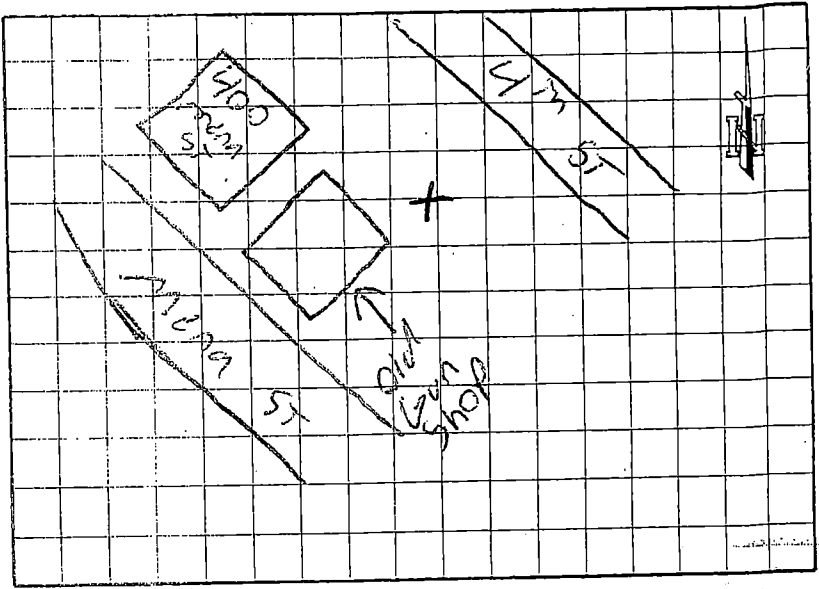
Subject: Mena Utilities SSES
 Location: Beh. by Old gunshop
next to Funel home
 Area: 6
 Line No. _____
 Leak No. _____
 Date: 7/21/10 Time: _____
 Inspector: Boyer

DESCRIPTION OF LEAK: Cap m. '55' long

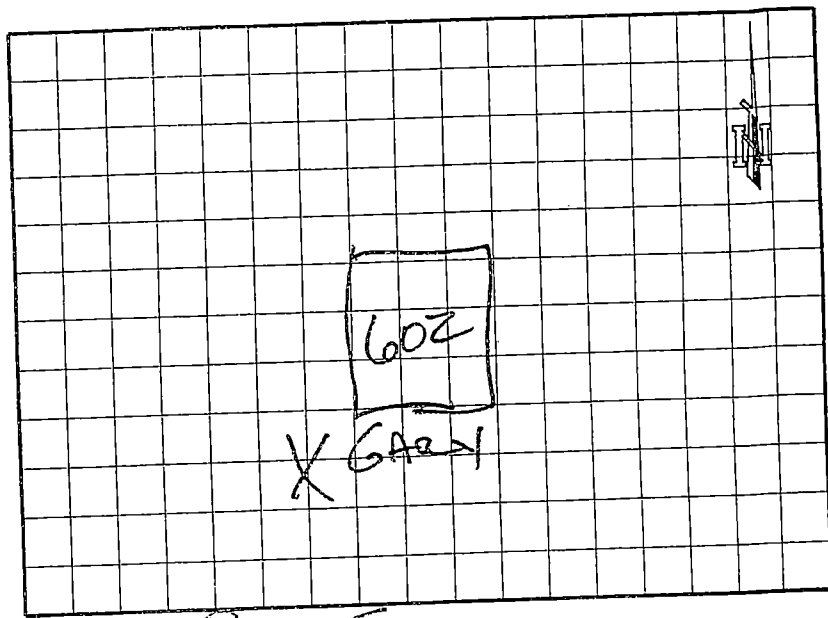
Subject: Mena Utilities SSES
 Location: 602 GARLY
 Area: SEC. 5
 Line No. _____
 Leak No. _____
 Date: _____ Time: _____
 Inspector: _____

DESCRIPTION OF LEAK: HOUSE EMPTY FOR SALE

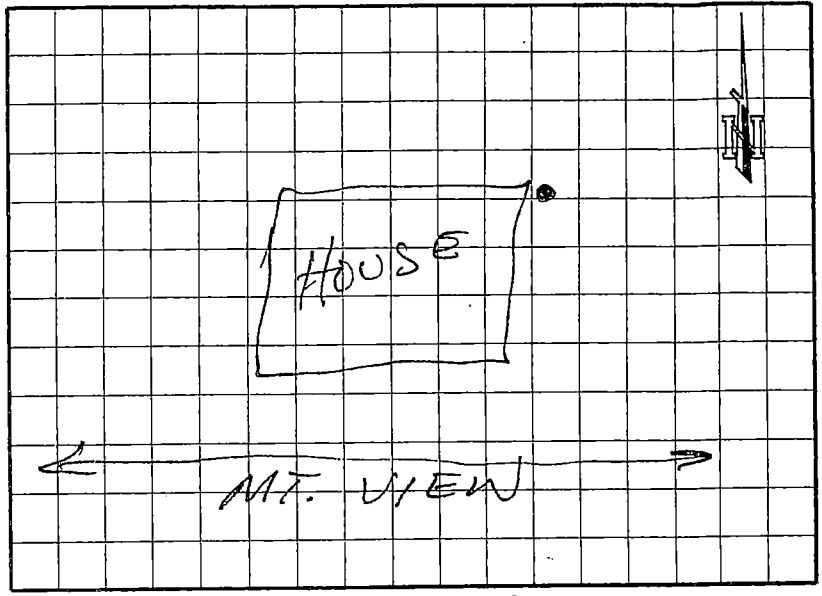
DESCRIPTION OF LEAK: CLEAN OUT @ BACK RT CORNER OF HOUSE WITH NO CAP.

<p><u>GREE OF LEAK</u></p> <input type="checkbox"/> Heavy <input checked="" type="checkbox"/> Moderate <input type="checkbox"/> Light	<p><u>LEAK CHARACTERISTICS</u></p> Ponding Area <u>4'</u> Size Of Hole <u>4"</u> Potential Head <u>3"</u>	<p><u>DRAINAGE AREA</u></p> <input type="checkbox"/> Pavement <input checked="" type="checkbox"/> Ground <input type="checkbox"/> Roof	<p><u>COVER OVER LEAK</u></p> <input type="checkbox"/> Conc.Pavement <input type="checkbox"/> Asph.Pavement <input type="checkbox"/> Gravel <input type="checkbox"/> Sidewalk <input checked="" type="checkbox"/> Yard/Field <input type="checkbox"/> Woods Other _____
<p><u>TYPE OF PROPERTY</u></p> <input checked="" type="checkbox"/> Residence <input type="checkbox"/> Apartment <input type="checkbox"/> Vacant Lot <input type="checkbox"/> Business <input type="checkbox"/> Trailer Park <input type="checkbox"/> Other _____

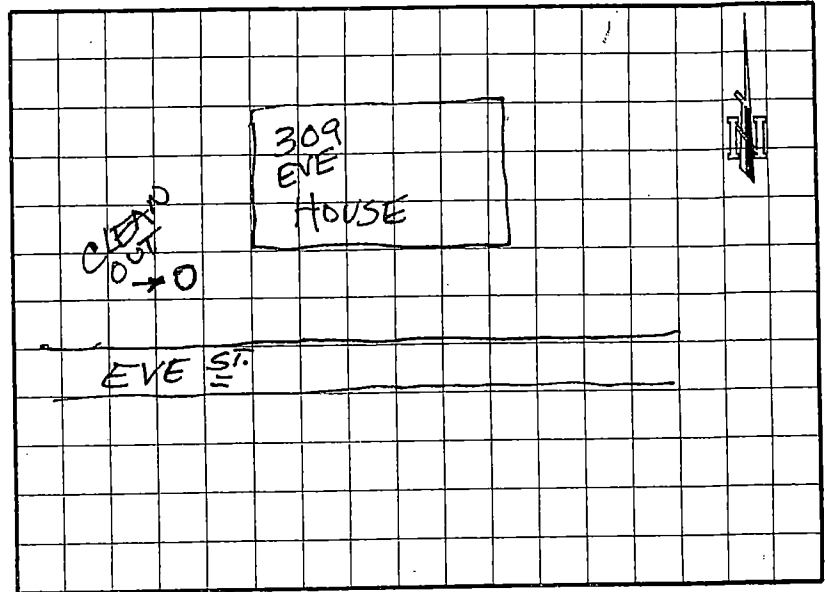
Leak No: 4

DESCRIPTION OF LEAK: SMOKE COMING FROM CUST. CLEAN OUT (CAP BROKE)

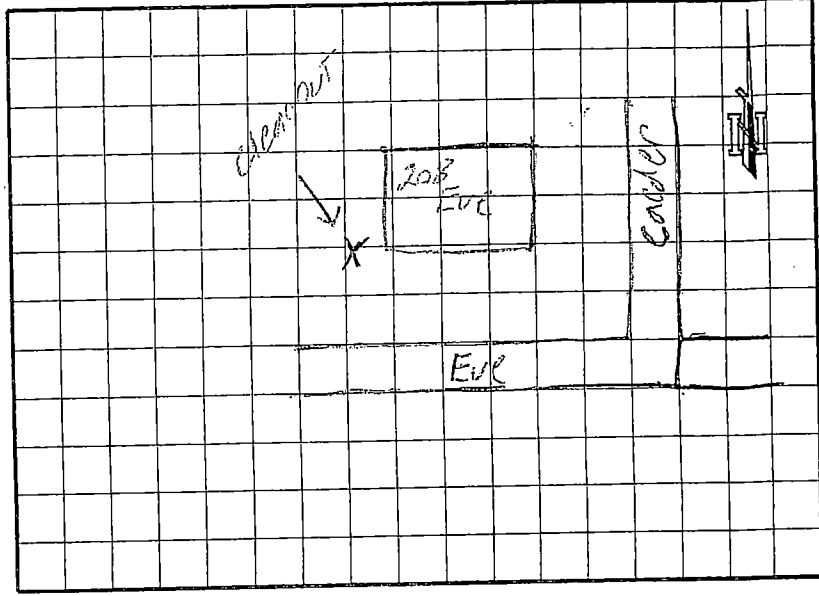
Leak No. 10

DESCRIPTION OF LEAK: NO CAP ON CLEANOUT

TYPE OF LEAK	LEAK CHARACTERISTICS	DRAINAGE AREA	COVER OVER LEAK
<input type="checkbox"/> Heavy <input checked="" type="checkbox"/> Moderate <input type="checkbox"/> Light	Ponding Area <u>6 sqm feet</u> Size Of Hole <u>4"</u> Potential Head <u>1"</u>	<input type="checkbox"/> Pavement <input checked="" type="checkbox"/> Ground <input type="checkbox"/> Roof	<input type="checkbox"/> Conc.Pavement <input type="checkbox"/> Asph.Pavement <input type="checkbox"/> Gravel <input type="checkbox"/> Sidewalk <input checked="" type="checkbox"/> Yard/Field <input type="checkbox"/> Woods Other _____
TYPE OF PROPERTY			
<input checked="" type="checkbox"/> Residence <input type="checkbox"/> Business	<input type="checkbox"/> Apartment <input type="checkbox"/> Trailer Park	<input type="checkbox"/> Vacant Lot <input type="checkbox"/> Other _____

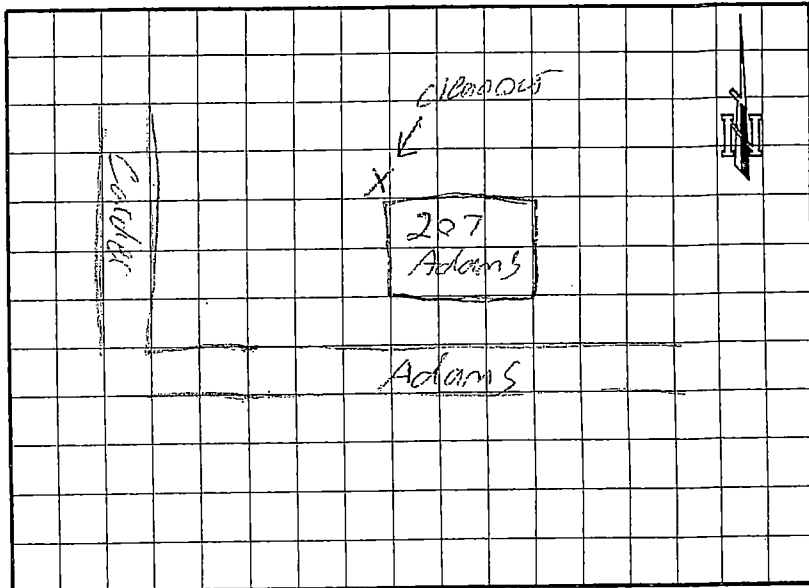
Leak No.: 11

DESCRIPTION OF LEAK: NO CAP ON CREST 100 CLEANOUT

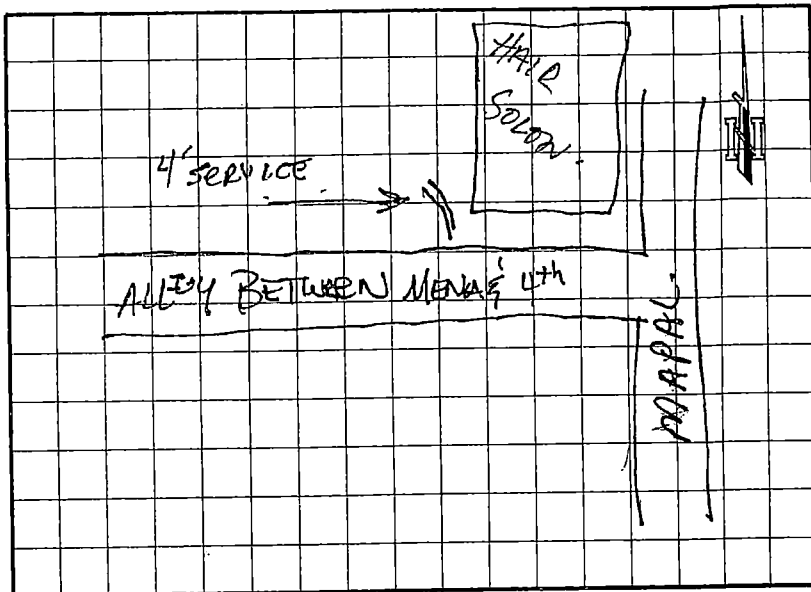
Leak No. 3

DESCRIPTION OF LEAK: COMING FROM OLD SERVICE LINE

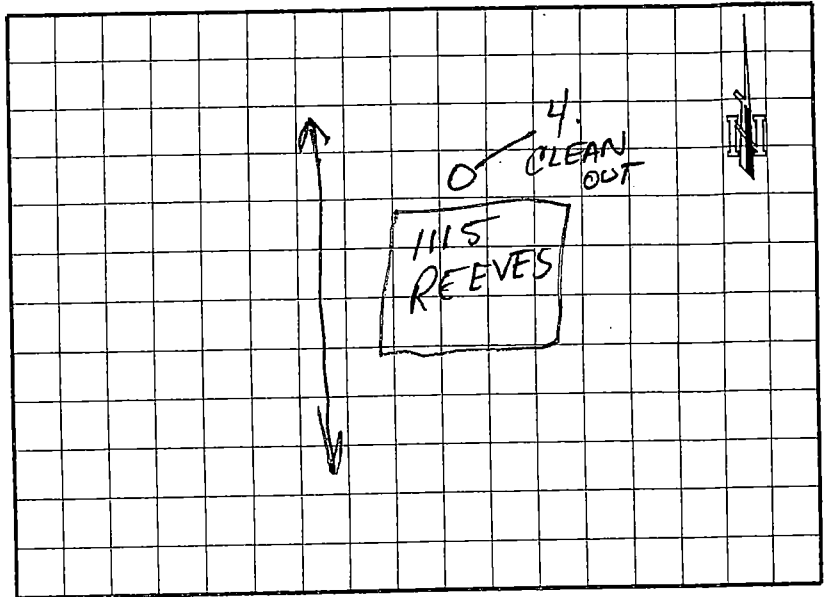
Project: Mena Utilities SSES
 Location: 1115 REEVES
SEC 11
 Area: BESIDE HOUSE
 Line No. _____
 Leak No. _____
 Date: 6-28-10 Time: _____
 Inspector: BAW

DESCRIPTION OF LEAK: BROKE CLEAN OUT CAP

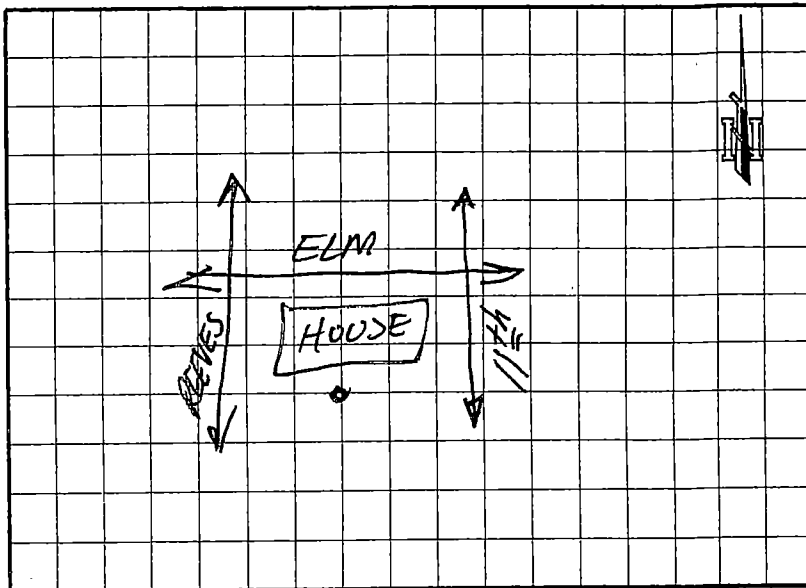
Project: Mena Utilities SSES
 Location: HOUSE BETWEEN REEVES
5811^{1/2} ON ELM-
 Area: BEHIND HOUSE
 Line No. _____
 Leak No. _____
 Date: 6-28-10 Time: _____
 Inspector: (Signature)

DESCRIPTION OF LEAK: BROKE CLEAN OUT CAP

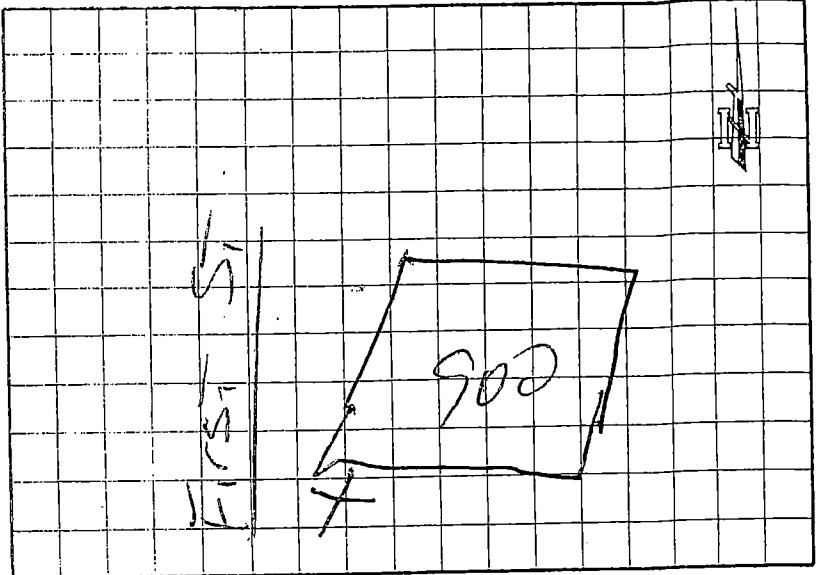
DESCRIPTION OF LEAK: 4" Clean out Broken

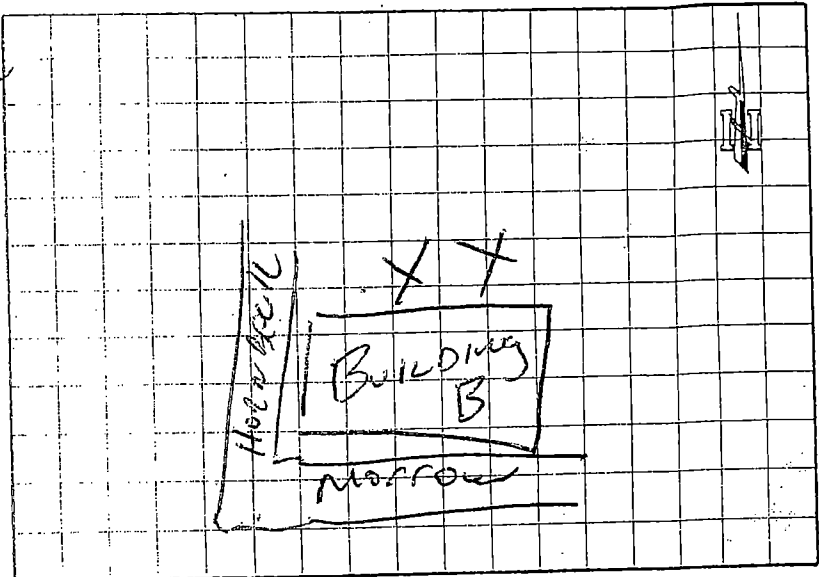
Subject: Mena Utilities SSES
 Location: Hornbeck + Morrow
 Area: 7
 Line No. _____
 Leak No. _____
 Date: _____ Time: _____
 Inspector: Mike

DESCRIPTION OF LEAK: 2 2 1/2" CLEAN OUTS BEHIND
APT BUILDING B
 MEASURED INFLOW (GPD) _____

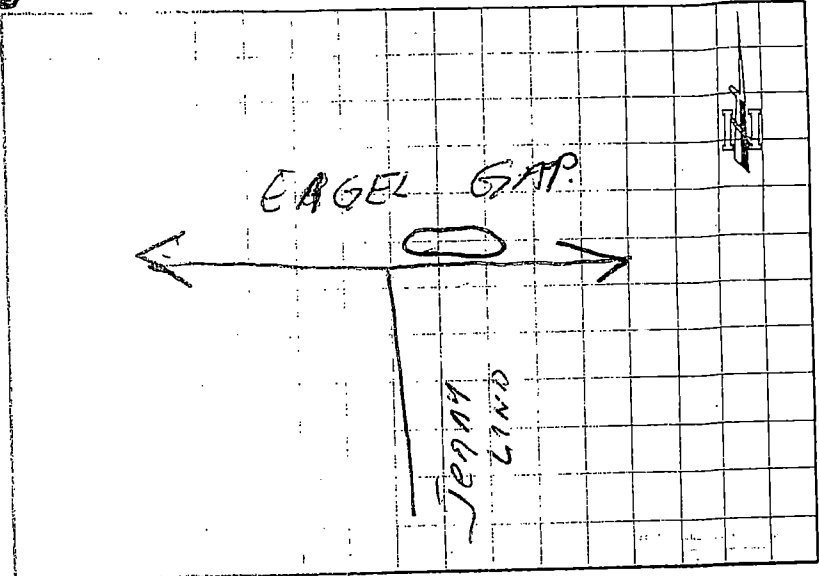
Subject: Mena Utilities SSES
 Location: EAGLE GAP & TENNA LIND

DESCRIPTION OF LEAK: IN DITCH

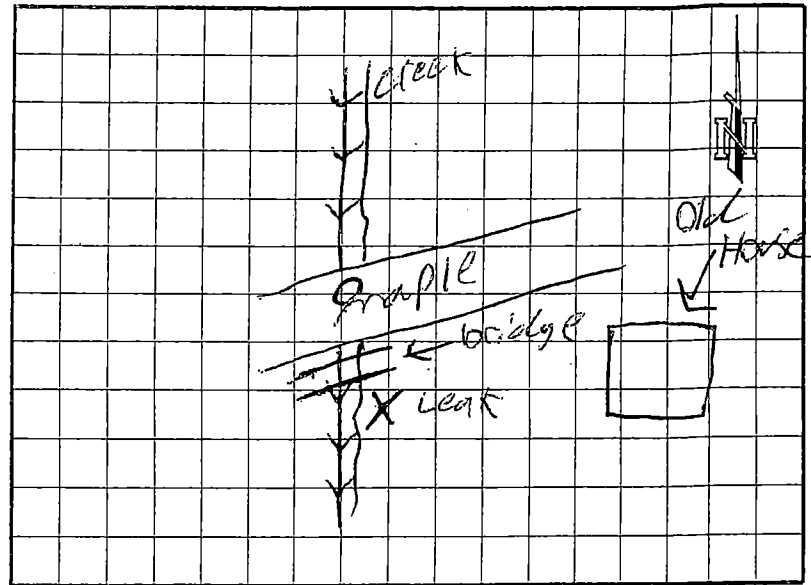
Project: Mena Utilities SSES
 Location: maple between 10th & 21st
 Area: SEC 11
 Line No. 3
 Leak No. 3
 Line Size: 10"
 Date: 6/22/10 Time: _____
 Inspector: Boley

DESCRIPTION OF LEAK: possible service line to old Joe down House,

Leak #3 ~~_____~~
MH 534 to MH 535
427 ft. of 10"

Replace 427 ft. of Line 10"
 Make _____ Point repair(s)
 Other _____

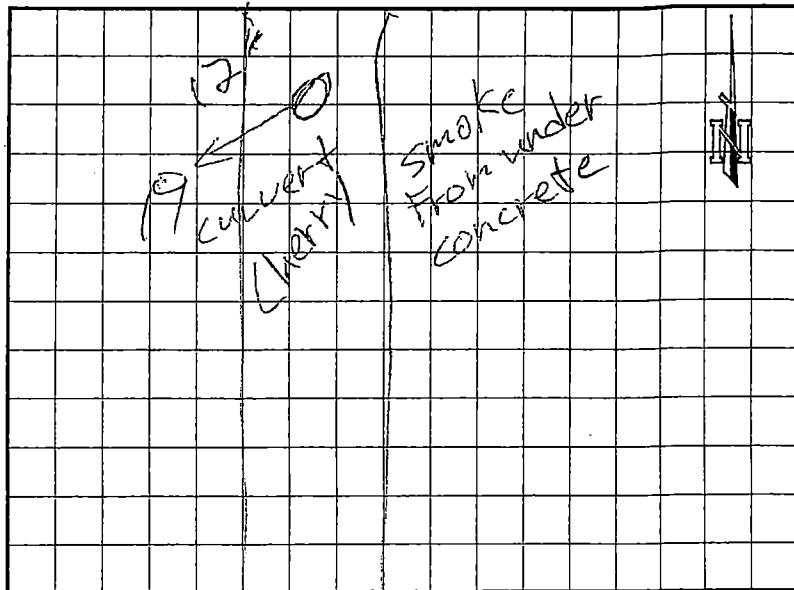
Project: Mena Utilities SSES
 Location: Cherry S. of Hornbeck
 Area: 12
 Line No. _____
 Leak No. 4
 Line Size: 8"
 Date: 2 JULY Time: 1300
 Inspector: JEFF/BRIAN

DESCRIPTION OF LEAK: smoke in ditch

Replace 328 ft. of Line 8"
 Make _____ Point repair(s)
 Other _____

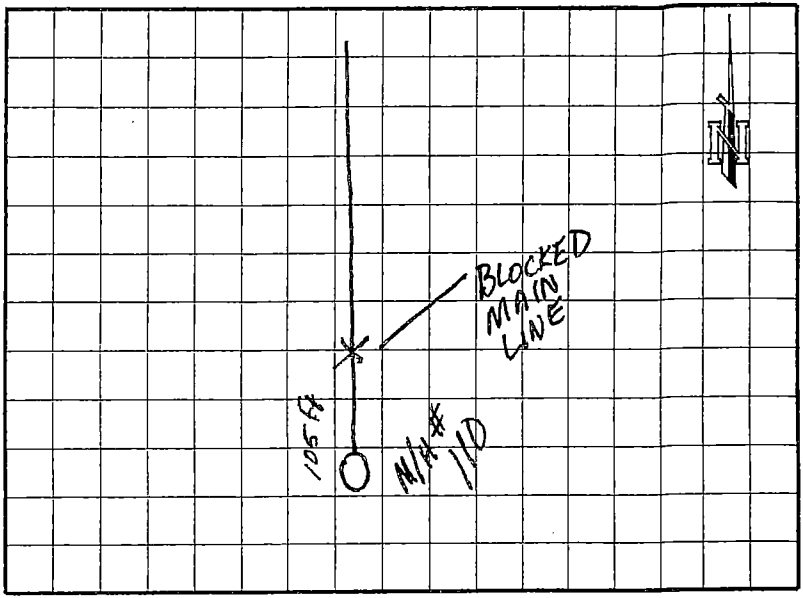
Leak No. 5

DESCRIPTION OF LEAK: BLOCKED MAIN LINE APPROX 105 FT FROM MAN HOLE #110 FLOW REDUCED TO APPROX 6 TO 8 IN. PIPE.

MEASURED INFLOW (GPD) _____ LEAK LOCATION: _____ Feet from MH# APPROX 105-FT.

Replace 301 ft. of Line 18"
Make _____ Point repair(s)
Other _____

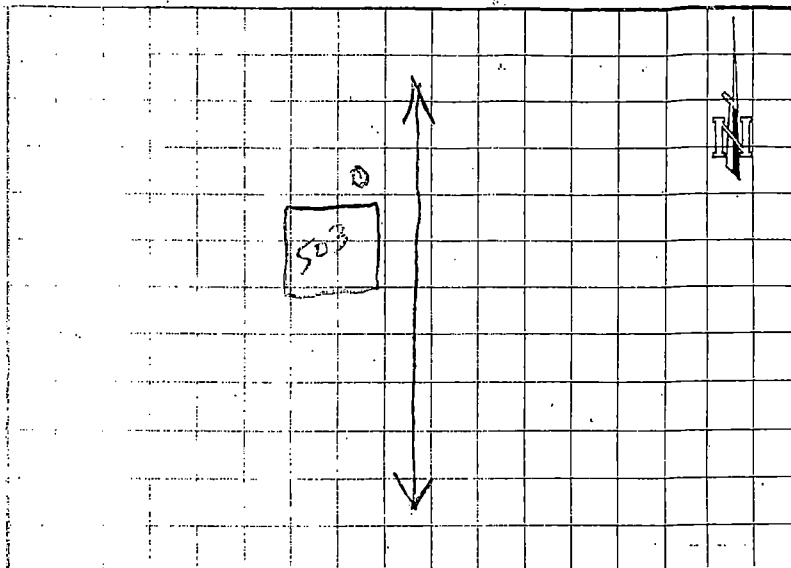
Leak No. 6

DESCRIPTION OF LEAK: CLEAN OUT BROKE OF @ SLAB.

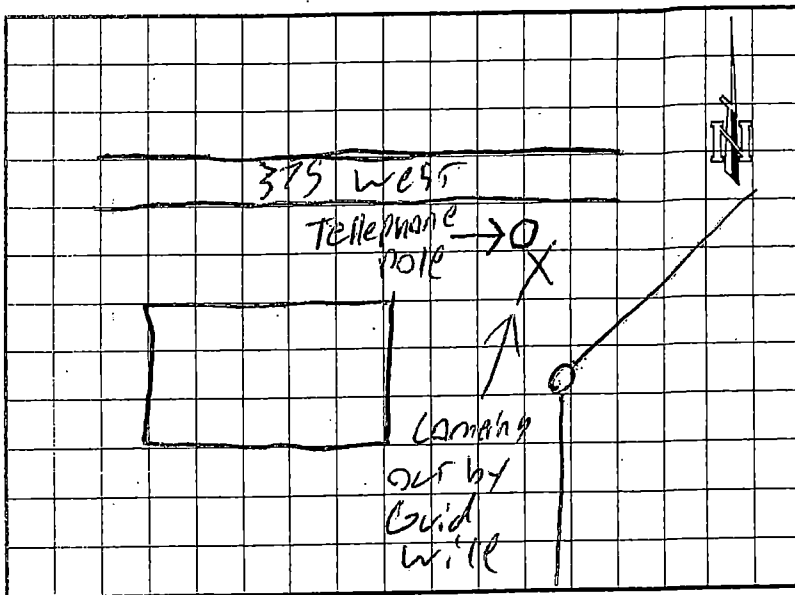
Leak No. 7

DESCRIPTION OF LEAK: Smoke coming up around Guid wire

Replace 145 ft. of Line 12"
Make _____ Point repair(s)
Other under N.G.

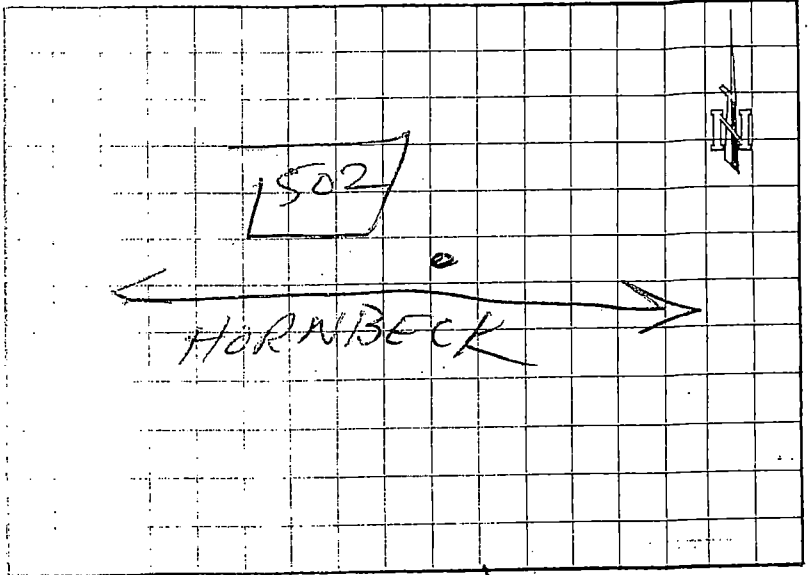
Area: 7
Line No. _____
Leak No. 10
Line Size: 18
Date: 8/10 Time: _____
Inspector: BD

DESCRIPTION OF LEAK: Smoke coming from Ditch.

Replace 255 ft. of Line 18"
Make _____ Point repair(s)
Other _____

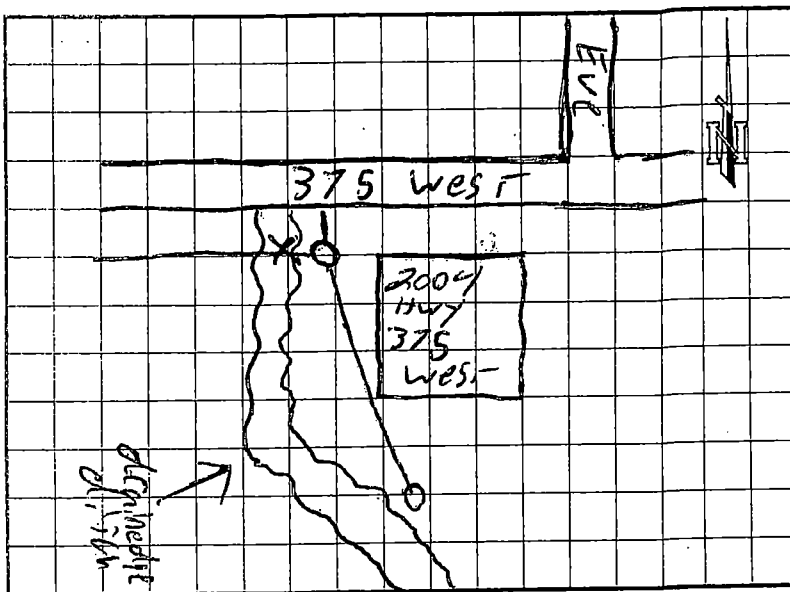
Leak No. 11

DESCRIPTION OF LEAK: Smoke coming up in ditch

Replace 520²⁴² ft. of Line 10"
Make _____ Point repair(s)
Other under M.G.

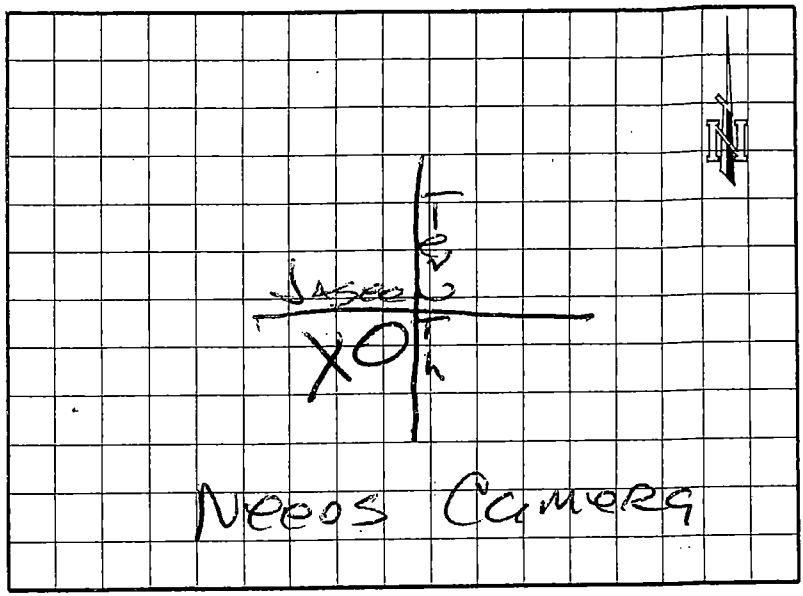
Leak No. 13

DESCRIPTION OF LEAK: Main Line leaking TO Storm Drain

MEASURED INFLOW (GPD) _____ LEAK LOCATION: _____ Feet from MH# 106

NEEDS CAMERA

Replace 343 ft. of Line 10"

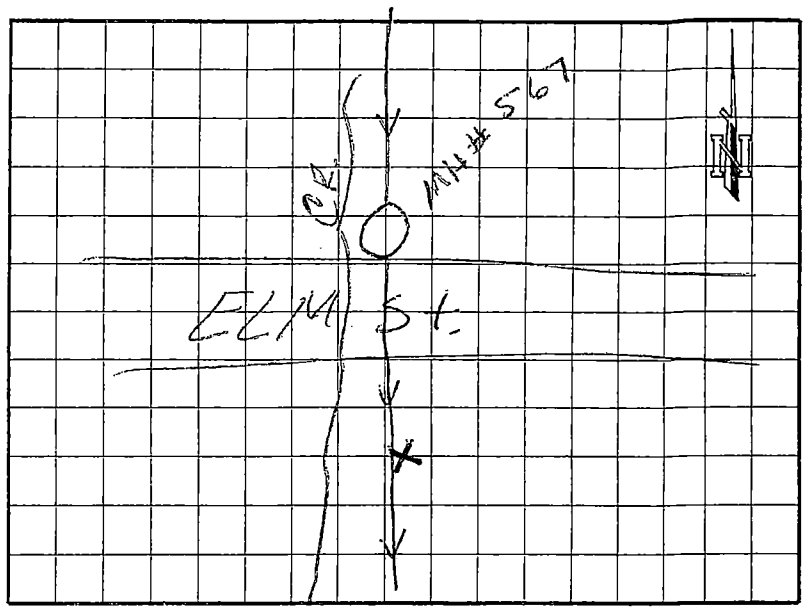
Project: Mena Utilities SSES
 Location: Just South of Elm in Creek E. Bank
 Area: SEC II
 Line No. _____
 Leak No. 14
 Line Size: 10"
 Date: _____ Time: _____
 Inspector: _____

DESCRIPTION OF LEAK: Hole in Creek Bank. (Major)

REHABILITATION METHOD (in office)
 Replace 315 ft. of Line 10"
 Make _____ Point repair(s)
 Other under alley

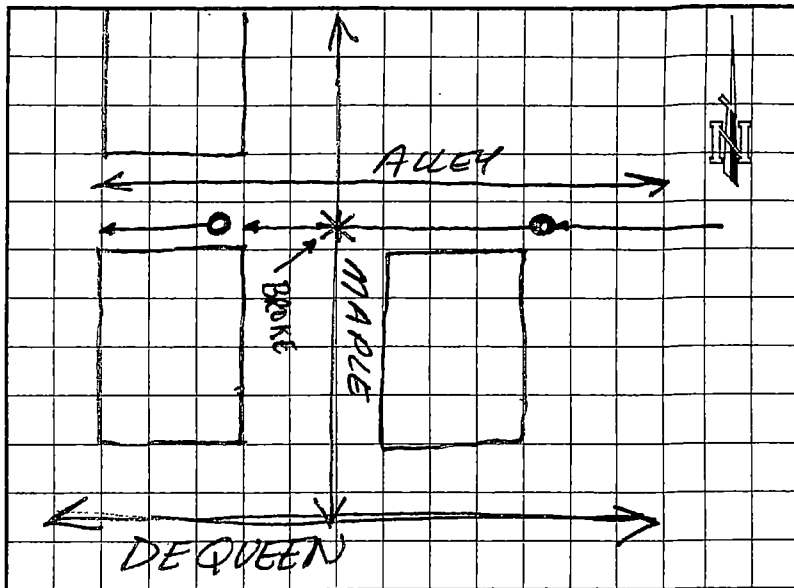
Project: Mena Utilities SSES
 Location: MAPLE & DeQueen
SEC 6
 Area: MAIN LINE IN AVEY
 Line No. _____
 Leak No. 15
 Line Size: 8 IN
 Date: 6-24-10 Time: _____
 Inspector: (Signature)

DESCRIPTION OF LEAK: 8" SEWER MAIN BROKE & FLOWING INTO STORM DRAIN

REHABILITATION METHOD (in office)	
Replace	<u>355</u> ft. of Line <u>8"</u>
Make	_____ Point repair(s)
Other	_____

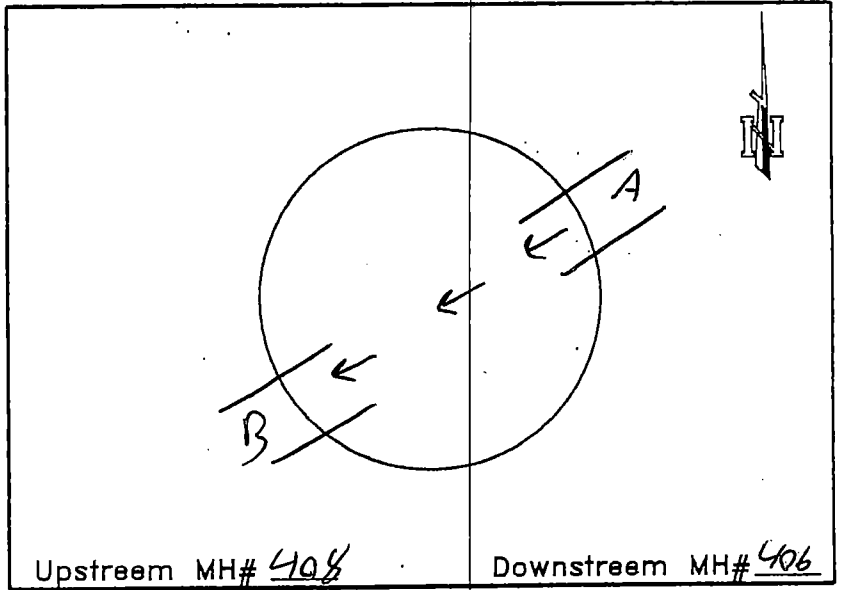
MANHOLE CONDITION
<input type="checkbox"/> Good
<input checked="" type="checkbox"/> Fair
<input type="checkbox"/> Poor
<input type="checkbox"/> Debris in Flowline
<input type="checkbox"/> Debris on Bench
<input type="checkbox"/> Evidence of Surcharge
<input type="checkbox"/> Evidence of Infiltration
<input type="checkbox"/> Other _____

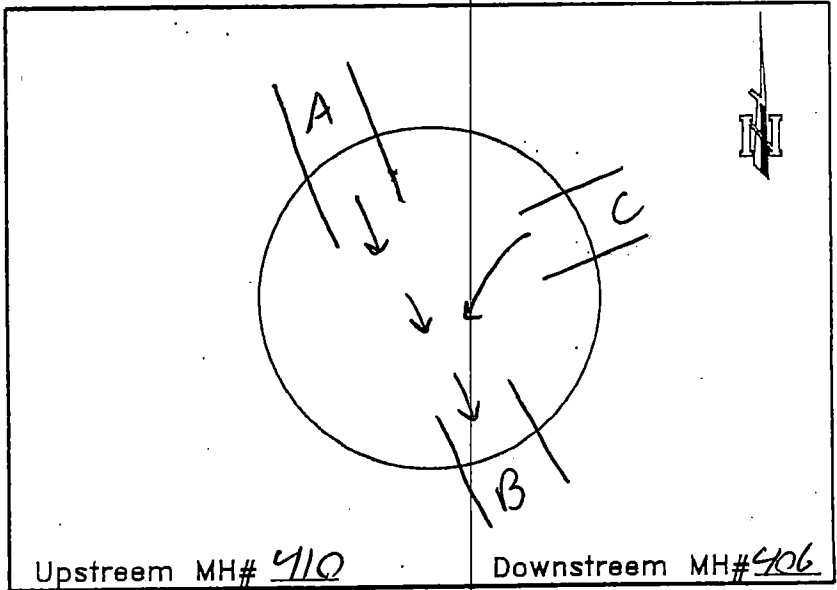
MANHOLE CONDITION
<input type="checkbox"/> Good
<input checked="" type="checkbox"/> Fair
<input type="checkbox"/> Poor
<input type="checkbox"/> Debris in Flowline
<input type="checkbox"/> Debris on Bench
<input type="checkbox"/> Evidence of Surcharge
<input type="checkbox"/> Evidence of Infiltration
<input type="checkbox"/> Other _____

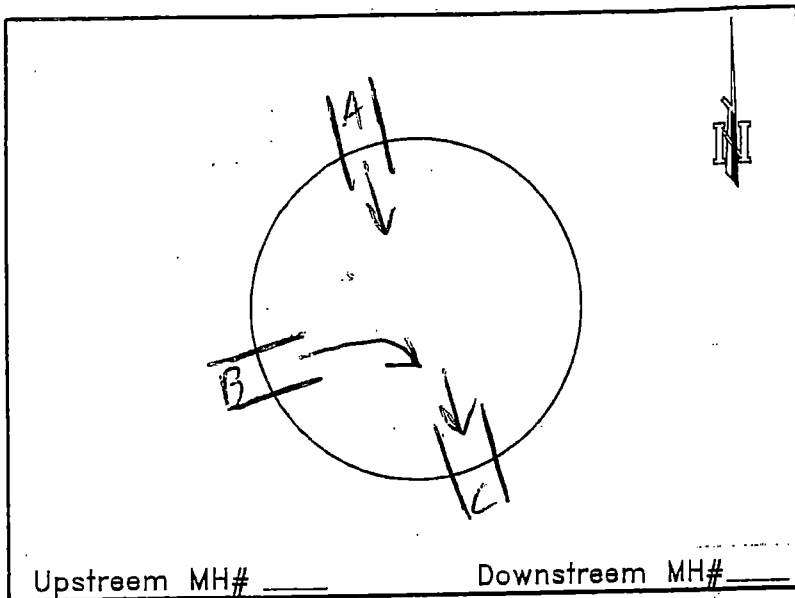
<input type="checkbox"/> Good
<input checked="" type="checkbox"/> Fair
<input type="checkbox"/> Poor
<input type="checkbox"/> Debris in Flowline
<input type="checkbox"/> Debris on Bench
<input type="checkbox"/> Evidence of Surcharge
<input type="checkbox"/> Evidence of Infiltration
<input type="checkbox"/> Other _____

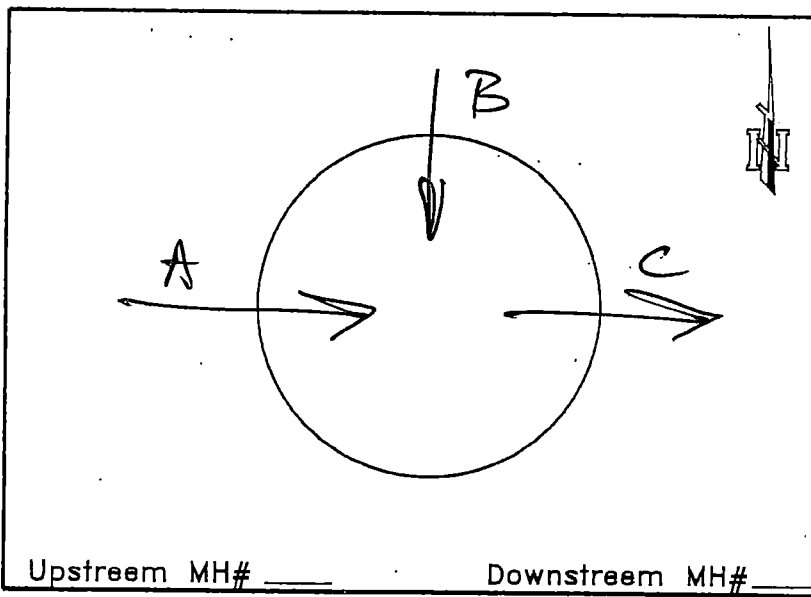
MANHOLE CONDITION	
<input type="checkbox"/> Good	
<input checked="" type="checkbox"/> Fair	
<input type="checkbox"/> Poor	
<input type="checkbox"/> Debris in Flowline	
<input type="checkbox"/> Debris on Bench	
<input type="checkbox"/> Evidence of Surcharge	
<input type="checkbox"/> Evidence of Infiltration	
<input type="checkbox"/> Other _____

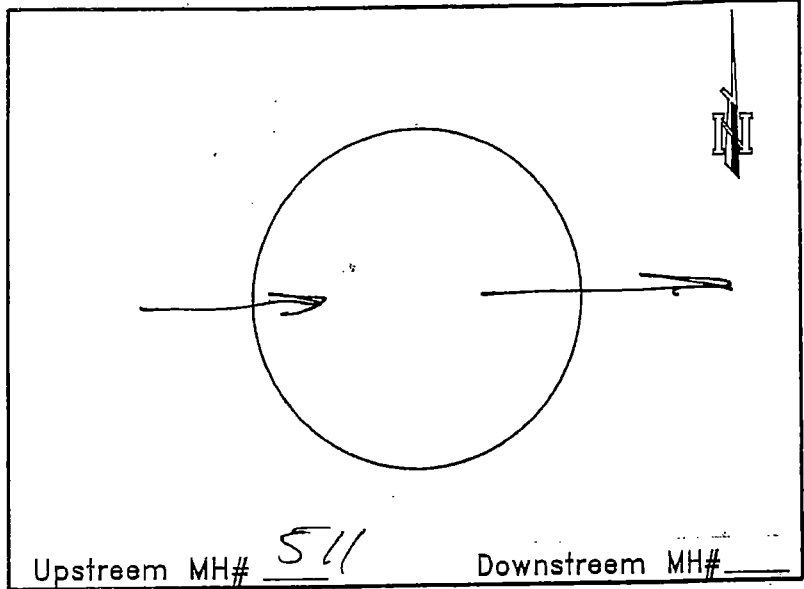
MANHOLE CONDITION	
<input checked="" type="checkbox"/> Good	
<input type="checkbox"/> Fair	
<input type="checkbox"/> Poor	
<input type="checkbox"/> Debris in Flowline	
<input type="checkbox"/> Debris on Bench	
<input type="checkbox"/> Evidence of Surcharge	
<input type="checkbox"/> Evidence of Infiltration	
<input type="checkbox"/> Other _____

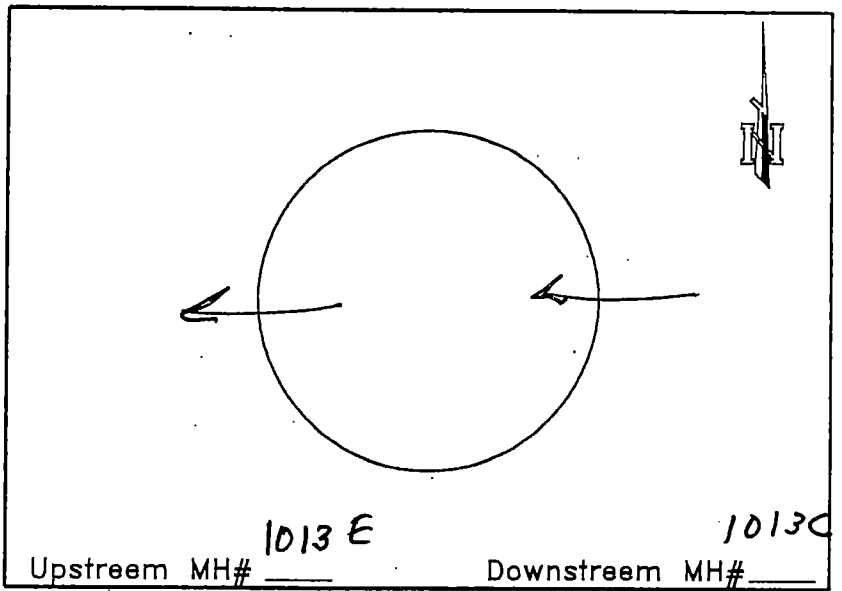
Project: Mena Utilities SSES
 Location: BEHIND 1210
MISSOURI.
 Basin: 5
 MH No. 1013 D
 Date: 2-28 Time: _____
 Inspector: (Signature)

Concrete 4 ft. Diameter
 Brick
 Fiberglass 4.1 ~~ft.~~ ft. Depth
 Other _____ Lid Size

Good
 Fair
 Poor
 Debris in Flowline
 Debris on Bench
 Evidence of Surcharge
 Evidence of Infiltration
 Other _____

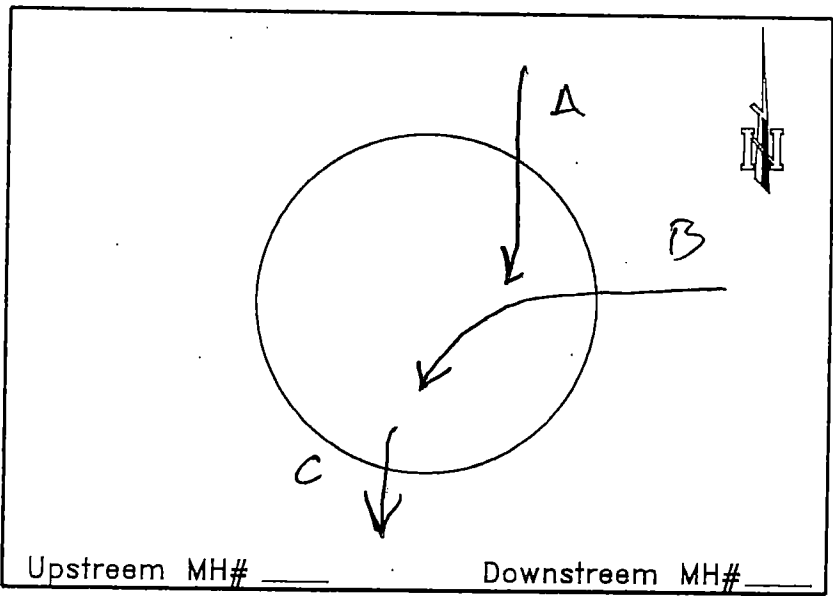
Object: Mena Utilities SSES
 Location: CORCHA - W. BOUNDARY.
 Basin: 5
 MH No. 1020
 Date: 2-23 Time: _____
 Inspector: (Signature)

MANHOLE CONDITION
 Good
 Fair
 Poor
 Debris in Flowline
 Debris on Bench
 Evidence of Surcharge
 Evidence of Infiltration
 Other _____

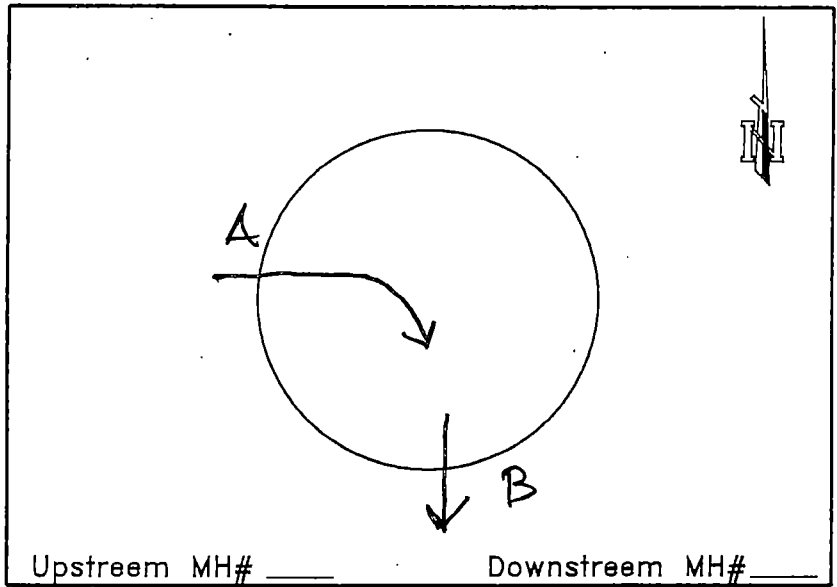
Object: Mena Utilities SSES
 Location: BACK YARD OF 2611
OSARK
 Basin: 5
 MH No. 1024
 Date: 2-23 Time: _____
 Inspector: (BR)

TYPE OF MH DESCRIPTION
 Concrete 4 ft. Diameter
 Brick 14.5 ft. Depth
 Fiberglass
 Other _____ Lid Size

MANHOLE CONDITION
 Good
 Fair
 Poor
 Debris in Flowline
 Debris on Bench
 Evidence of Surcharge
 Evidence of Infiltration
 Other _____

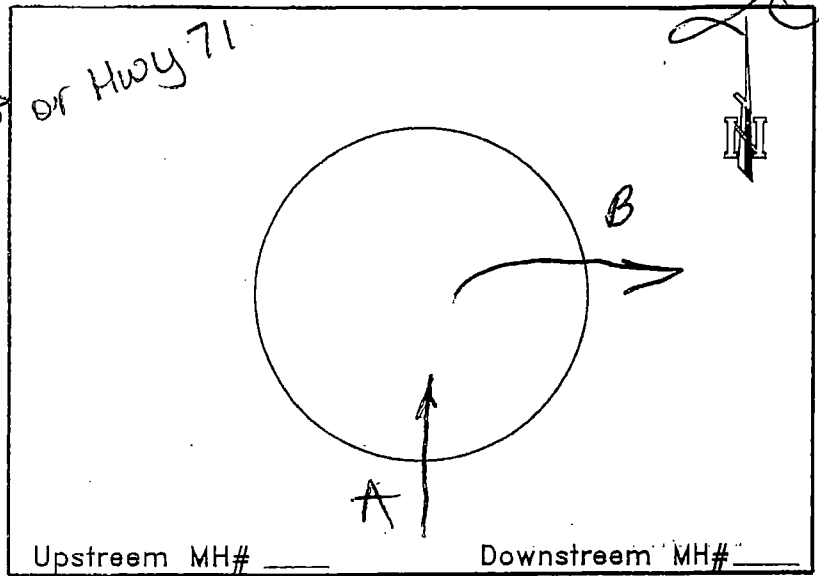
Project: Mena Utilities SSES
 Location: (20) CORNER OF GRIFFITH DRIVE & Hwy 71
 Basin: _____
 MH No. 1120
 Date: 8/10 Time: _____
 Inspector: (Signature)

<input checked="" type="checkbox"/>	Concrete	<u>4</u> ft. Diameter
<input type="checkbox"/>	Brick	<u>4'</u> ft. Depth
<input type="checkbox"/>	Fiberglass	
<input type="checkbox"/>	Other	<u>3 1/2</u> lid Size

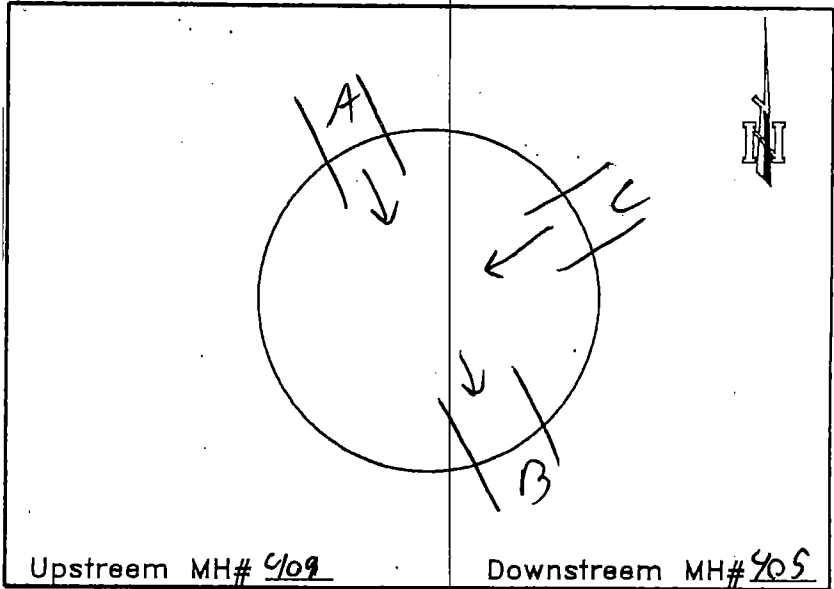
MANHOLE CONDITION	
<input type="checkbox"/> Good	
<input checked="" type="checkbox"/> Fair	
<input type="checkbox"/> Poor	
<input type="checkbox"/> Debris In Flowline	
<input type="checkbox"/> Debris on Bench	
<input type="checkbox"/> Evidence of Surcharge	
<input type="checkbox"/> Evidence of Infiltration	
<input type="checkbox"/> Other _____

REHABILITATION (in office)	
<input checked="" type="checkbox"/> Replace Manhole	
<input type="checkbox"/> Clean-out Manhole	
<input type="checkbox"/> Re-Build Bench	
<input type="checkbox"/> Replace Ring & Cover	
<input type="checkbox"/> Re-Grout Top Cone & Lid	
<input type="checkbox"/> Seal Inside of Manhole	
<input type="checkbox"/> Grout in Pipe Penetration	
<input type="checkbox"/> Other _____

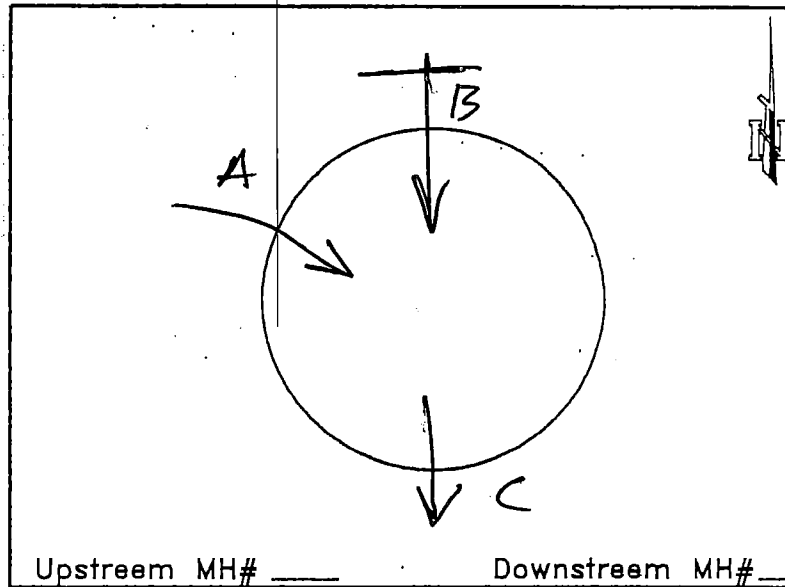
Project: Mena Utilities SSES
 Location: ALLEY BETWEEN 3 & 4 ON
CHURCH
 Basin: 6
 MH No. 451
 Date: 3-2 Time: _____
 Inspector: (BA)

MANHOLE CONDITION

- Good
- Fair
- Poor
- Debris in Flowline
- Debris on Bench
- Evidence of Surchage
- Evidence of Infiltration
- Other _____

- Replace Manhole
- Clean-out Manhole
- Re-Build Bench
- Replace Ring & Cover
- Re-Grout Top Cone & L
- Seal Inside of Manhole
- Grout In Pipe Penitrator
- Other _____

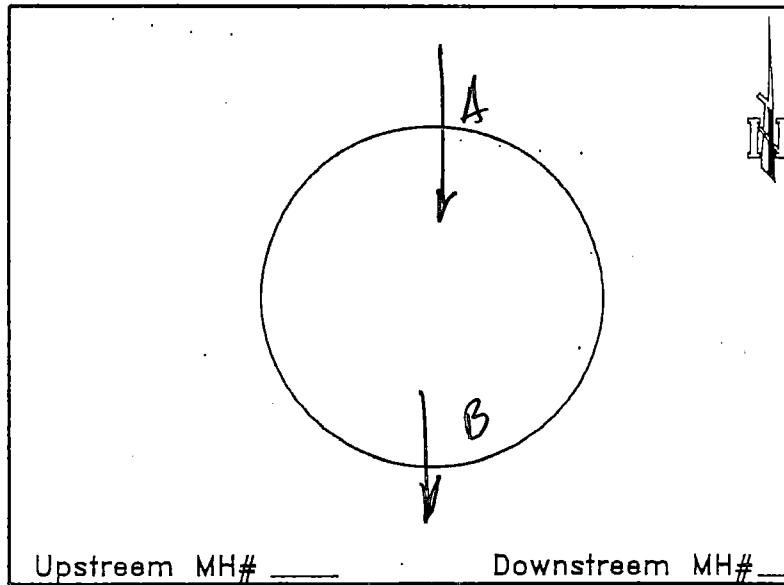
Project: Mena Utilities SSES
 Location: ALLEY BETWEEN MENA 54th
ON MAPLE
 Basin: 6
 MH No. 454
 Date: 3-2 Time: _____
 Inspector: (BFB)

MANHOLE CONDITION

Good
 Fair
 Poor
 Debris in Flowline
 Debris on Bench
 Evidence of Surcharge
 Evidence of Infiltration
 Other _____

Replace Manhole
 Clean-out Manhole
 Re-Build Bench
 Replace Ring & Cover
 Re-Grout Top Cone & I
 Seal Inside of Manhole
 Grout In Pipe Penitratio
 Other _____

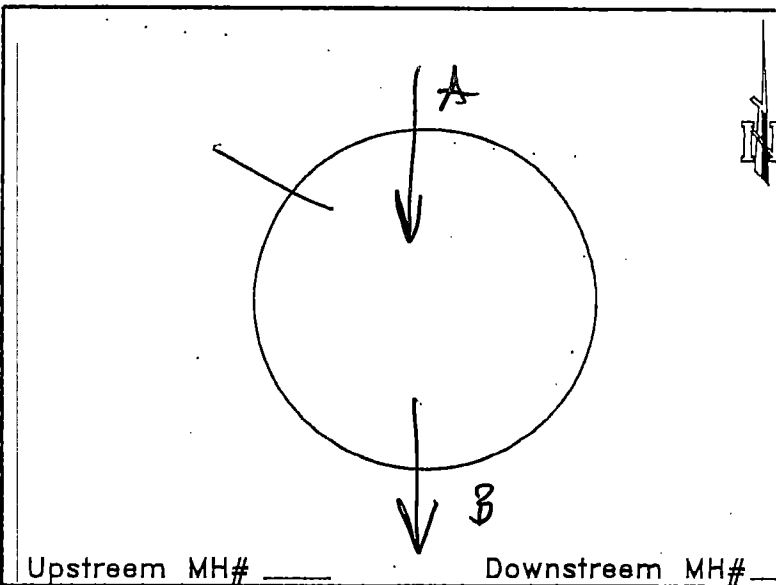
Project: Mena Utilities SSES
 Location: PORT ARTHUR ALLEY BETWEEN
4th & MENA.
 Basin: 6
 MH No. 455
 Date: 3-2 Time: _____
 Inspector: (BB)

MANHOLE CONDITION

Good
 Fair
 Poor
 Debris in Flowline
 Debris on Bench
 Evidence of Surcharge
 Evidence of Infiltration
 Other _____

Replace Manhole
 Clean-out Manhole
 Re-Build Bench
 Replace Ring & Cover
 Re-Grout Top Cone & I
 Seal Inside of Manhole
 Grout In Pipe Penitratio
 Other _____

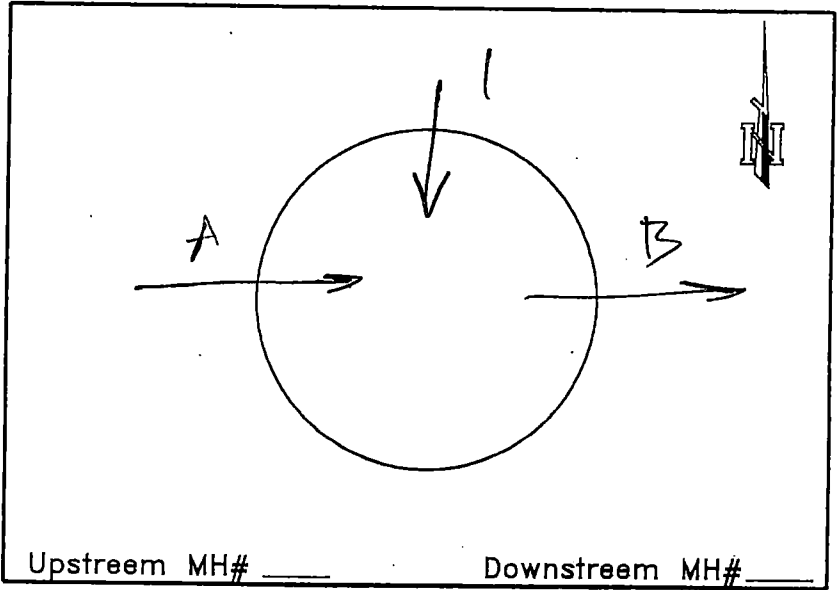
Object: Mena Utilities SSES
 Location: WIMBLEY - LENA
 Basin: 5
 MH No. 531
 Date: 2-23 Time: _____
 Inspector: BA

MANHOLE CONDITION
 Good
 Fair
 Poor
 Debris in Flowline
 Debris on Bench
 Evidence of Surcharge
 Evidence of Infiltration
 Other _____

SOURCE OF LEAK
 Main Line Pipe Penetrations
 Service Penetrations
 Manhole Joints
 Cone Broken
 Lid Broken
 Lid Missing
 Hole In Lid
 Other _____

REHABILITATION (in office)
 Replace Manhole
 Clean-out Manhole
 Re-Build Bench
 Replace Ring & Cover
 Re-Grout Top Cone & Lid
 Seal Inside of Manhole
 Grout in Pipe Penetration
 Other _____

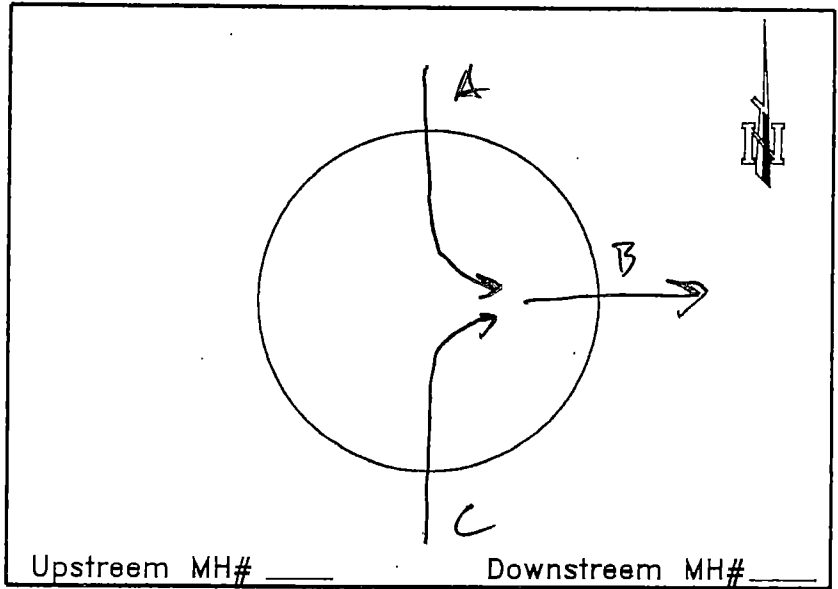
Object: Mena Utilities SSES
 Location: POLK - LENA.
 Basin: 5
 MH No. 532
 Date: 2-23 Time: _____
 Inspector: (BB)

MANHOLE CONDITION
 Good
 Fair
 Poor
 Debris in Flowline
 Debris on Bench
 Evidence of Surcharge
 Evidence of Infiltration
 Other _____

SOURCE OF LEAK
 Main Line Pipe Penitrations
 Service Penitrations
 Manhole Joints
 Cone Broken
 Lid Broken
 Lid Missing
 Hole In Lid
 Other _____

REHABILITATION (in office)
 Replace Manhole
 Clean-out Manhole
 Re-Build Bench
 Replace Ring & Cover
 Re-Grout Top Cone & Lid
 Seal Inside of Manhole
 Grout in Pipe Penetration
 Other _____

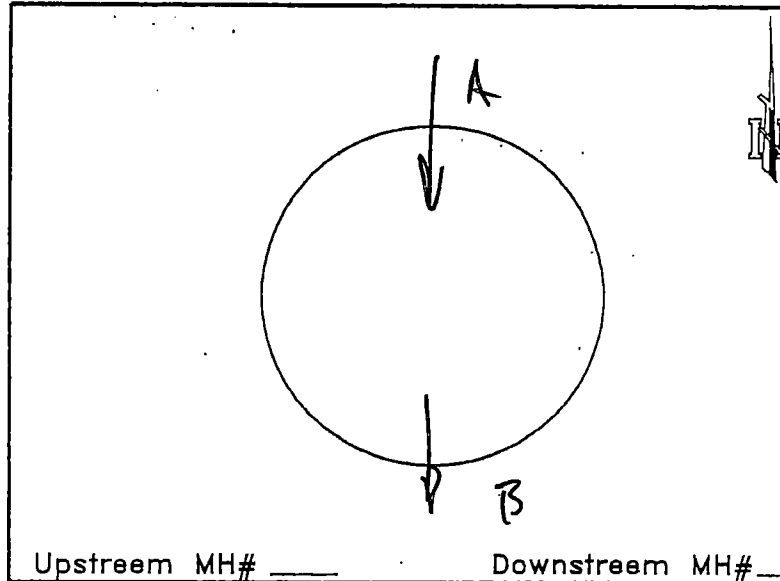
Project: Mena Utilities SSES
 Location: ALLEY BETWEEN 9510 ON CHURCH.
 Basin: 6
 MH No. 545
 Date: 3-7-11 Time: _____
 Inspector: (Signature)

Good
 Fair
 Poor
 Debris in Flowline
 Debris on Bench
 Evidence of Surcharge
 Evidence of Infiltration
 Other _____

Main Line Pipe Penitrations
 Service Penitrations
 Manhole Joints
 Cone Broken
 Lid Broken
 Lid Missing
 Hole In Lid
 Other _____

Replace Manhole
 Clean-out Manhole
 Re-Build Bench
 Replace Ring & Cover
 Re-Grout Top Cone & L
 Seal Inside of Manhole
 Grout In Pipe Penitrator
 Other _____
