SANITARY SEWER EVALUATION & SURVEY

***MENA WATER UTILITIES
MENA, ARKANSAS***

MAY 2012

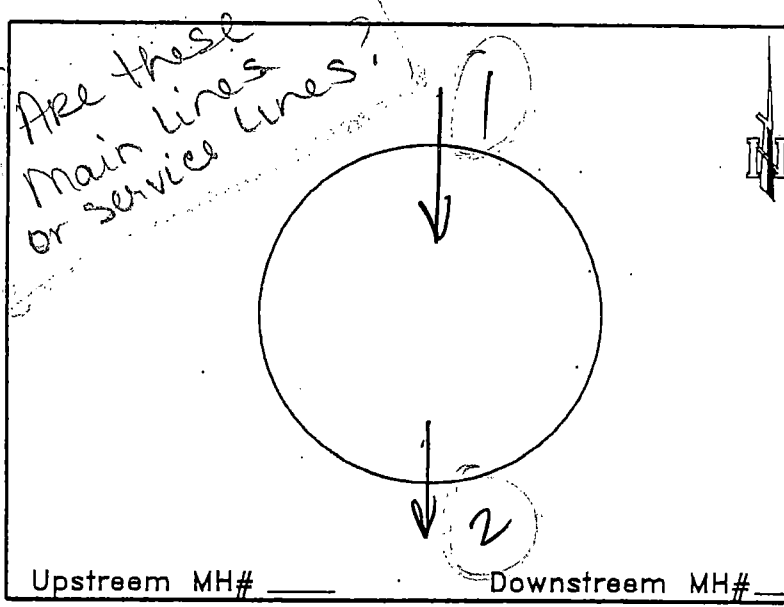
MANHOLE CONDITION	
<input type="checkbox"/> Good	
<input checked="" type="checkbox"/> Fair	
<input type="checkbox"/> Poor	
<input type="checkbox"/> Debris in Flowline	
<input type="checkbox"/> Debris on Bench	
<input type="checkbox"/> Evidence of Surcharge	
<input type="checkbox"/> Evidence of Infiltration	
<input type="checkbox"/> Other _____

SOURCE OF LEAK	
<input type="checkbox"/> Main Line Pipe Penitrations	
<input type="checkbox"/> Service Penitrations	
<input type="checkbox"/> Manhole Joints	
<input type="checkbox"/> Cone Broken	
<input type="checkbox"/> Lid Broken	
<input type="checkbox"/> Lid Missing	
<input type="checkbox"/> Hole in Lid	
<input type="checkbox"/> Other _____

REHABILITATION (in office)	
<input checked="" type="checkbox"/> Replace Manhole	
<input type="checkbox"/> Clean-out Manhole	
<input type="checkbox"/> Re-Build Bench	
<input type="checkbox"/> Replace Ring & Cover	
<input type="checkbox"/> Re-Grout Top Cone & L	
<input type="checkbox"/> Seal Inside of Manhole	
<input type="checkbox"/> Grout in Pipe Penitrator	
<input type="checkbox"/> Other _____

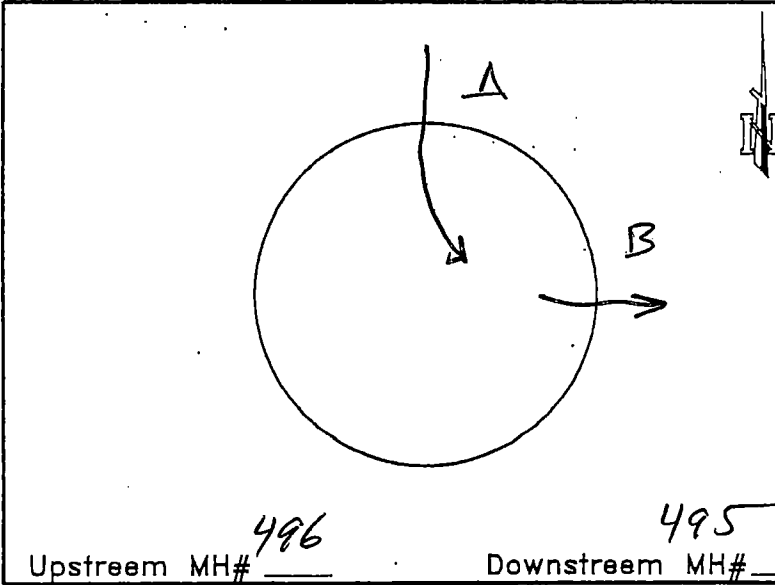
Basin: 6
 MH No. 548
 Date: 3-2 Time: _____
 Inspector: R12

Good
 Fair
 Poor
 Debris in Flowline
 Debris on Bench
 Evidence of Surcharge
 Evidence of Infiltration
 Other _____

Main Line Pipe Penitrations
 Service Penitrations
 Manhole Joints
 Cone Broken
 Lid Broken
 Lid Missing
 Hole In Lid
 Other _____

Replace Manhole
 Clean-out Manhole
 Re-Build Bench
 Replace Ring & Cover
 Re-Grout Top Cone &
 Seal Inside of Manhole
 Grout In Pipe Penitratio
 Other _____

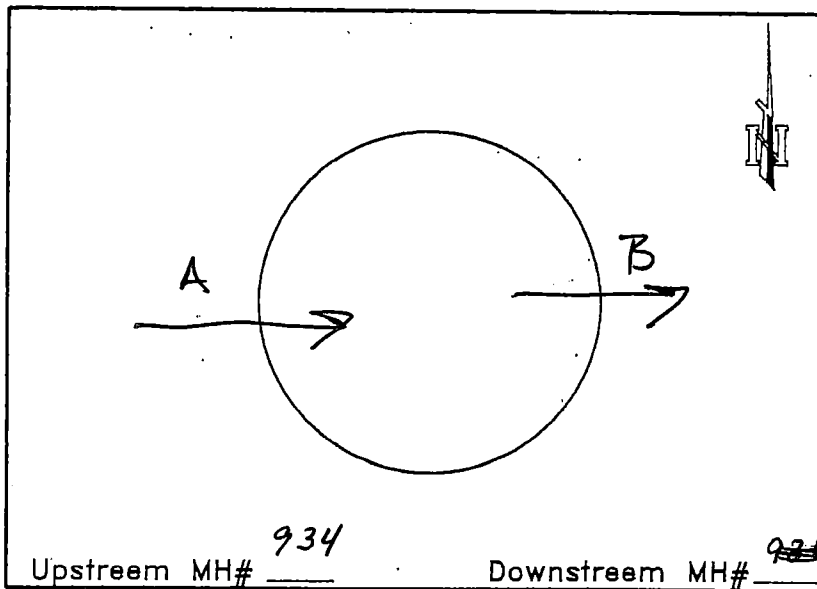
MANHOLE CONDITION	
<input type="checkbox"/> Good	
<input checked="" type="checkbox"/> Fair	
<input type="checkbox"/> Poor	
<input type="checkbox"/> Debris in Flowline	
<input type="checkbox"/> Debris on Bench	
<input type="checkbox"/> Evidence of Surcharge	
<input type="checkbox"/> Evidence of Infiltration	
<input type="checkbox"/> Other _____

SOURCE OF LEAK	
<input type="checkbox"/> Main Line Pipe Penetrations	
<input type="checkbox"/> Service Penetrations	
<input type="checkbox"/> Manhole Joints	
<input type="checkbox"/> Cone Broken	
<input type="checkbox"/> Lid Broken	
<input type="checkbox"/> Lid Missing	
<input type="checkbox"/> Hole in Lid	
<input type="checkbox"/> Other _____

REHABILITATION (in office)	
<input checked="" type="checkbox"/> Replace Manhole	
<input type="checkbox"/> Clean-out Manhole	
<input type="checkbox"/> Re-Build Bench	
<input type="checkbox"/> Replace Ring & Cover	
<input type="checkbox"/> Re-Grout Top Cone & Lid	
<input type="checkbox"/> Seal Inside of Manhole	
<input type="checkbox"/> Grout in Pipe Penetration	
<input type="checkbox"/> Other _____

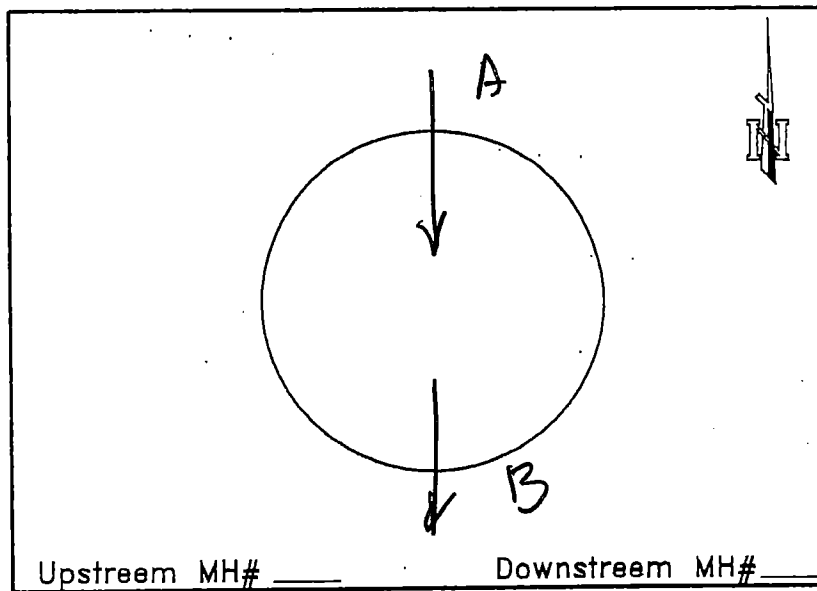
MANHOLE CONDITION
<input type="checkbox"/> Good
<input checked="" type="checkbox"/> Fair
<input type="checkbox"/> Poor
<input type="checkbox"/> Debris in Flowline
<input type="checkbox"/> Debris on Bench
<input type="checkbox"/> Evidence of Surcharge
<input type="checkbox"/> Evidence of Infiltration
<input type="checkbox"/> Other _____

SOURCE OF LEAK
<input type="checkbox"/> Main Line Pipe Penitrations
<input type="checkbox"/> Service Penitrations
<input type="checkbox"/> Manhole Joints
<input type="checkbox"/> Cone Broken
<input type="checkbox"/> Lid Broken
<input type="checkbox"/> Lid Missing
<input type="checkbox"/> Hole In Lid
<input type="checkbox"/> Other _____

REHABILITATION (in office)
<input checked="" type="checkbox"/> Replace Manhole
<input type="checkbox"/> Clean-out Manhole
<input type="checkbox"/> Re-Build Bench
<input type="checkbox"/> Replace Ring & Cover
<input type="checkbox"/> Re-Grout Top Cone & Lid
<input type="checkbox"/> Seal Inside of Manhole
<input type="checkbox"/> Grout in Pipe Penetration
<input type="checkbox"/> Other _____

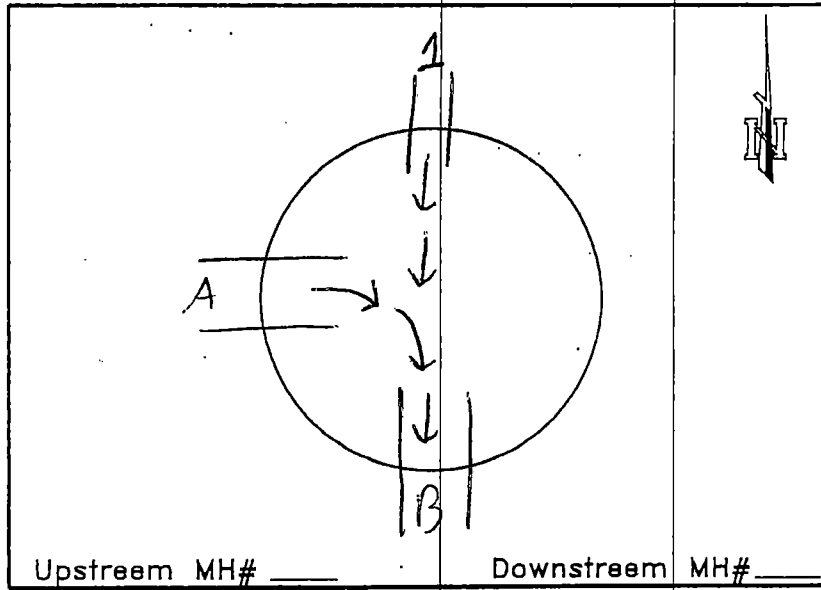
MANHOLE CONDITION
<input type="checkbox"/> Good
<input type="checkbox"/> Fair
<input checked="" type="checkbox"/> Poor
<input type="checkbox"/> Debris in Flowline
<input type="checkbox"/> Debris on Bench
<input type="checkbox"/> Evidence of Surcharge
<input type="checkbox"/> Evidence of Infiltration
<input type="checkbox"/> Other _____

SOURCE OF LEAK
<input type="checkbox"/> Main Line Pipe Penetrations
<input type="checkbox"/> Service Penetrations
<input type="checkbox"/> Manhole Joints
<input type="checkbox"/> Cone Broken
<input type="checkbox"/> Lid Broken
<input type="checkbox"/> Lid Missing
<input type="checkbox"/> Hole In Lid
<input type="checkbox"/> Other _____

ADDITIONAL COMMENTS Needs repair

REHABILITATION (in office)
<input checked="" type="checkbox"/> Replace Manhole
<input type="checkbox"/> Clean-out Manhole
<input type="checkbox"/> Re-Build Bench
<input type="checkbox"/> Replace Ring & Cover
<input type="checkbox"/> Re-Grout Top Cone & Lid
<input type="checkbox"/> Seal Inside of Manhole
<input type="checkbox"/> Grout In Pipe Penetration
<input type="checkbox"/> Other _____

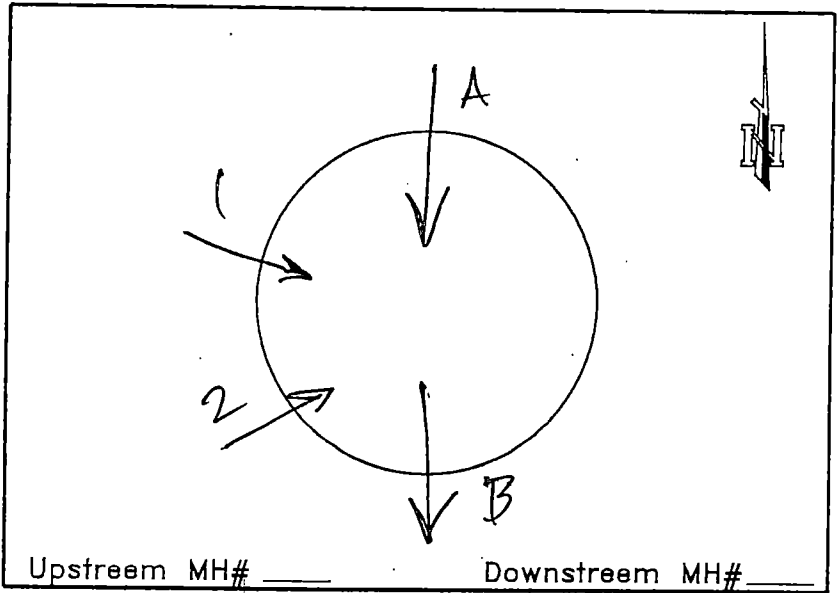
Object: Mena Utilities SSES
 Location: LENA - ADAMS
 Basin: 5
 MH No. 957
 Date: 2-23 Time: _____
 Inspector: BA

MANHOLE CONDITION
 Good
 Fair
 Poor
 Debris in Flowline
 Debris on Bench
 Evidence of Surcharge
 Evidence of Infiltration
 Other _____

SOURCE OF LEAK
 Main Line Pipe Penetrations
 Service Penetrations
 Manhole Joints
 Cone Broken
 Lid Broken
 Lid Missing
 Hole In Lid
 Other _____

REHABILITATION (in office)
 Replace Manhole
 Clean-out Manhole
 Re-Build Bench
 Replace Ring & Cover
 Re-Grout Top Cone & Lid
 Seal Inside of Manhole
 Grout In Pipe Penetration
 Other _____

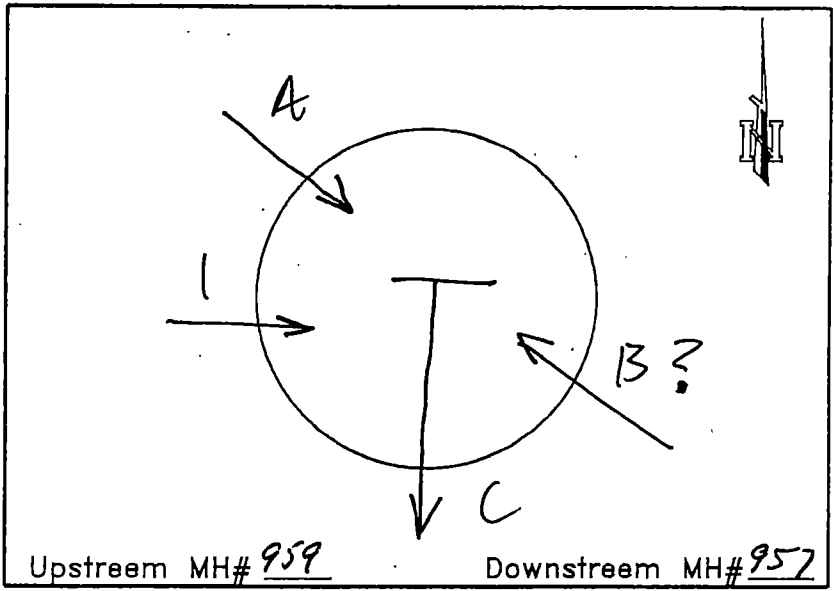
Project: Mena Utilities SSES
 Location: S. ADAMS & SOUTHERLAND.
 Basin: 5
 MH No. 958
 Date: 2-24 Time: _____
 Inspector: (Signature)

- Good
- Fair
- Poor
- Debris in Flowline
- Debris on Bench
- Evidence of Surcharge
- Evidence of Infiltration
- Other _____

- Main Line Pipe Penetrations
- Service Penetrations
- Manhole Joints
- Cone Broken
- Lid Broken
- Lid Missing
- Hole In Lid
- Other _____

- Replace Manhole
- Clean-out Manhole
- Re-Build Bench
- Replace Ring & Cover
- Re-Grout Top Cone & Lid
- Seal Inside of Manhole
- Grout In Pipe Penetration
- Other _____

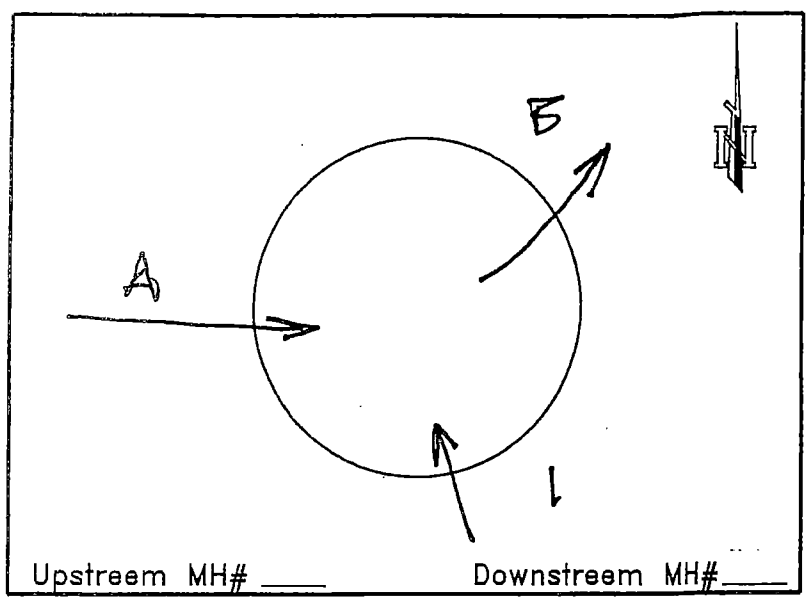
Project: Mena Utilities SSES
 Location: 805 DALLAS
 Basin: 12
 MH No. 290
 Date: 7.2.10 Time: _____
 Inspector: BB

* Previous SSES listed this manhole for complete replacement now suggested seal inside - on D.B.

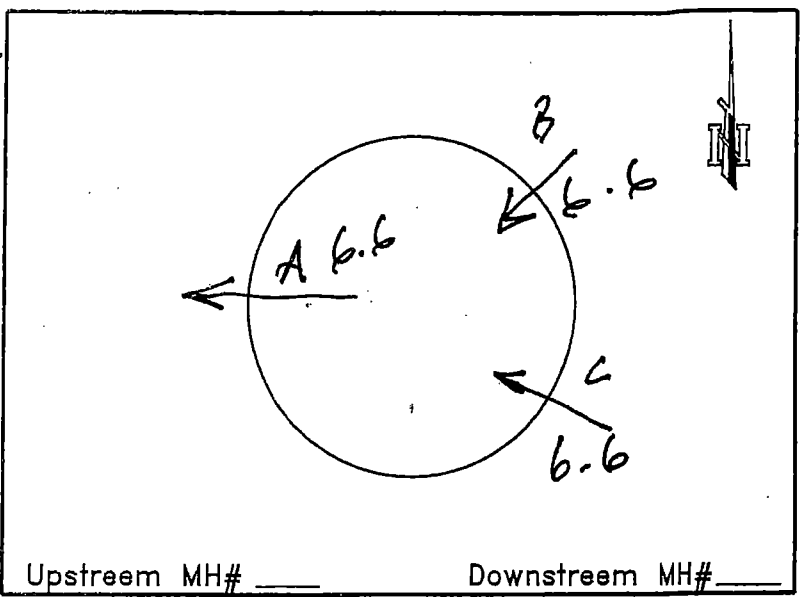
Project: Mena Utilities SSES
 Location: FOREST ST. GILNAN
 Basin: 12
 MH No. 689
 Date: 7.1.10 Time: _____
 Inspector: (BA)

Previous SSES listed this manhole for complete replacement - now suggests - seal inside

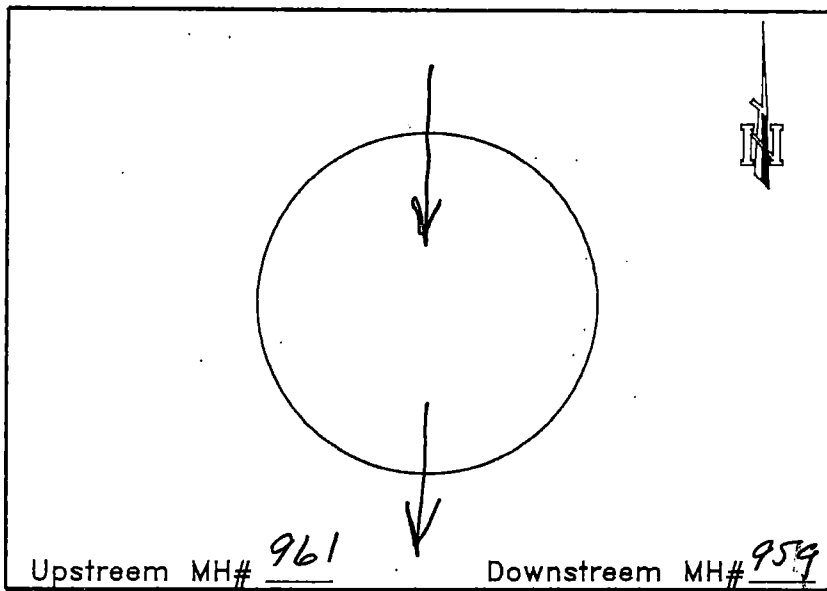
- Main Line Pipe Penetrations
 Service Penetrations
 Manhole Joints
 Cone Broken
 Lid Broken
 Lid Missing
 Hole in Lid
 Other LEAKING @ BASE

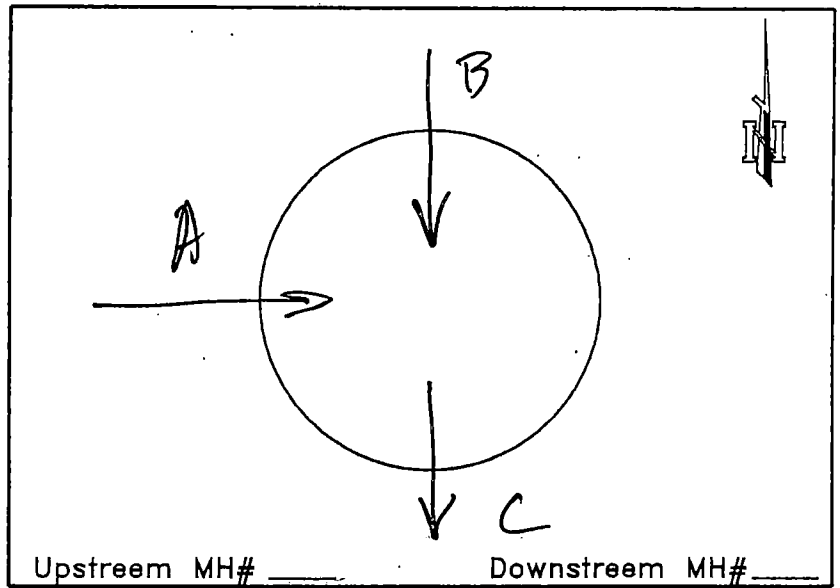
ADDITIONAL COMMENTS THIS M/H HAS BEEN REHABED
BUT STILL LEAKING FROM WALL
AND AROUND PIPE

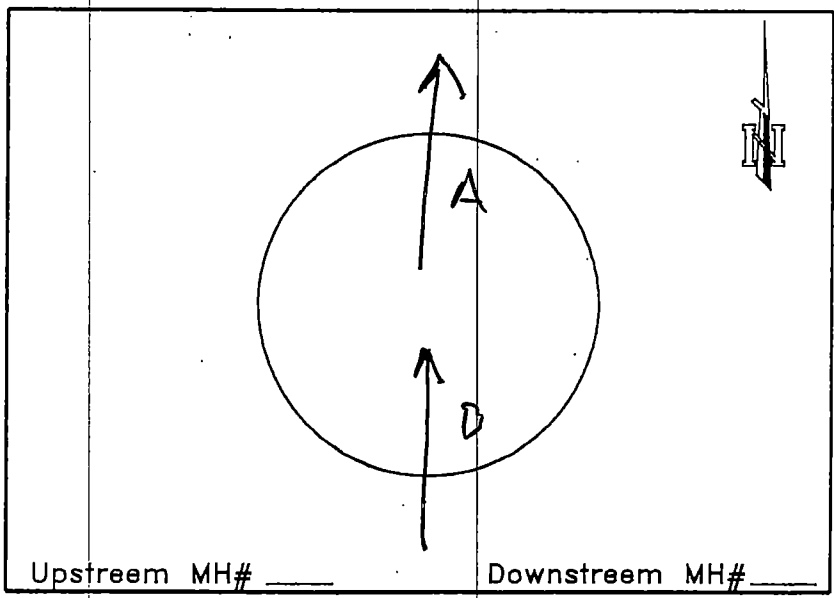
Project: Mena Utilities SSES
 Location: 1202 BRANDON DRIVE
 Basin: 10
 MH No. 1048 B
 Date: 2-28 Time: _____
 Inspector: (RM)

ADDITIONAL COMMENTS BASE OF M/H LEAK.

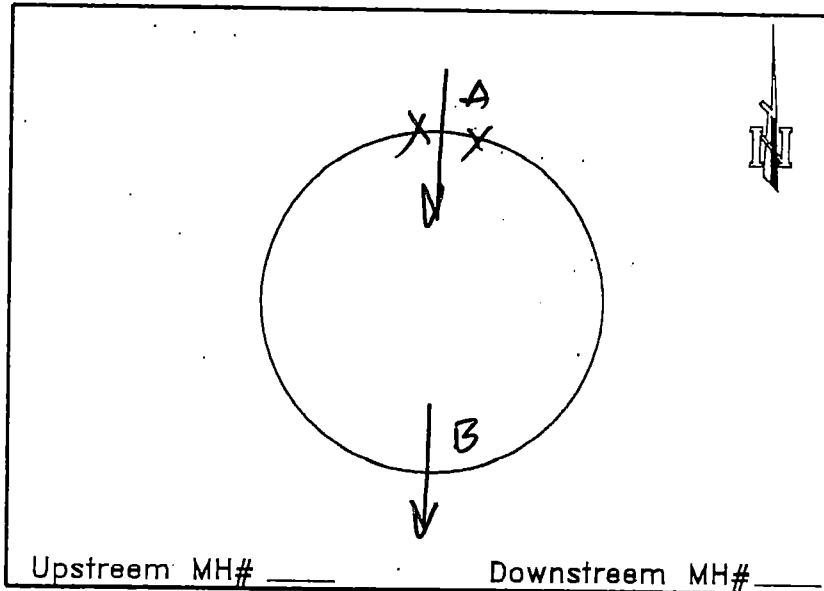
Project: Mena Utilities SSES
 Location: MT. CALVARY Cem. ON EVE
 Basin: 10
 MH No. 898
 Date: 3-2 Time: _____
 Inspector: BS

MANHOLE CONDITION	
<input type="checkbox"/> Good	
<input type="checkbox"/> Fair	
<input checked="" type="checkbox"/> Poor	
<input type="checkbox"/> Debris in Flowline	
<input type="checkbox"/> Debris on Bench	
<input type="checkbox"/> Evidence of Surcharge	
<input type="checkbox"/> Evidence of Infiltration	
<input type="checkbox"/> Other _____

SOURCE OF LEAK	
<input checked="" type="checkbox"/> Main Line Pipe Penetrations	
<input type="checkbox"/> Service Penetrations	
<input type="checkbox"/> Manhole Joints	
<input type="checkbox"/> Cone Broken	
<input type="checkbox"/> Lid Broken	
<input type="checkbox"/> Lid Missing	
<input type="checkbox"/> Hole in Lid	
<input type="checkbox"/> Other _____

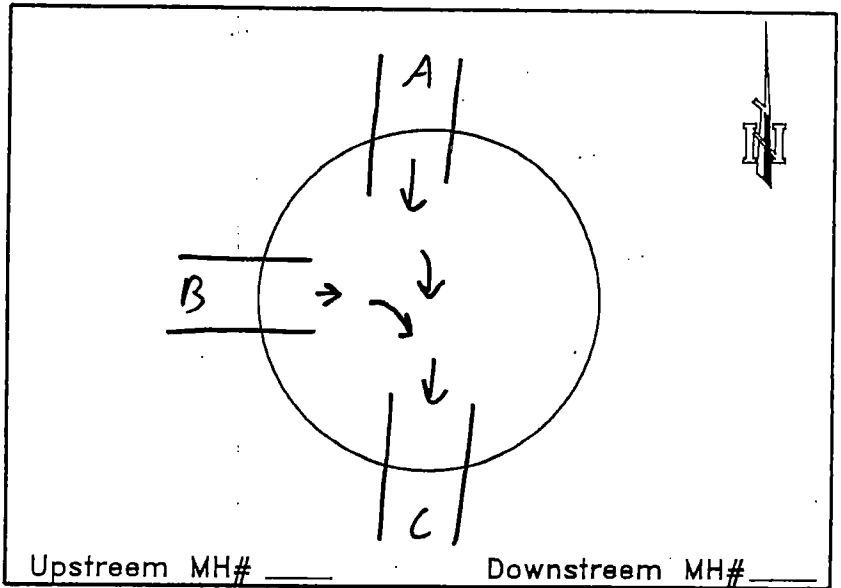
Project: Mena Utilities SSES
 Location: Hensley & Vermillion
 Basin: 10
 MH No. 1039
 Date: 2/23/11 Time: _____
 Inspector: Rodey

Concrete 4 ft. Diameter

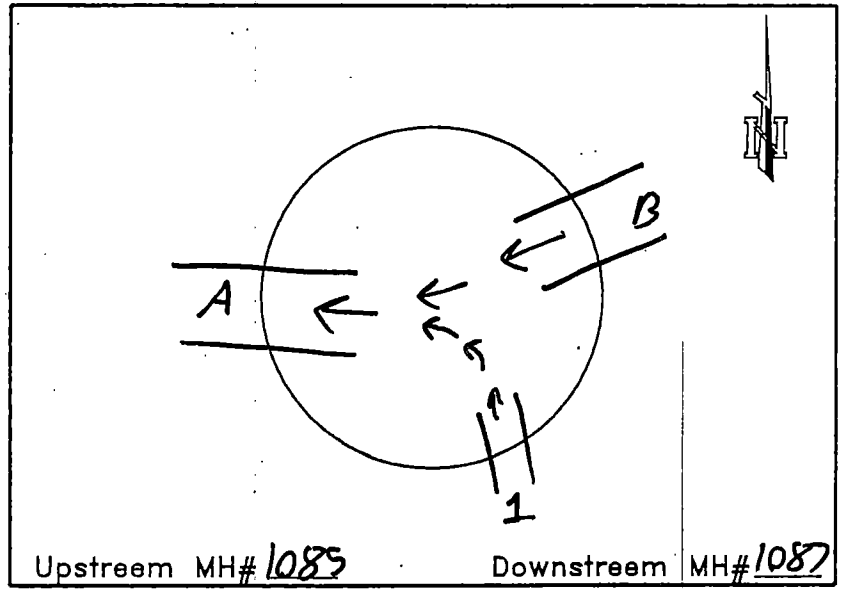
Project: Mena Utilities SSES
 Location: Behind new House
on 375 West
 Basin: 15
 MH No. 1086
 Date: 2/24/11 Time: _____
 Inspector: Boley

Concrete 6 ft. Diameter
