SEWER SYSTEM EVALUATION

FOR CONSENT ADMINISTRATIVE ORDER (CAO) LIS 11-066

WILMOT SEWER COLLECTION SYSTEM & WASTEWATER TREATMENT FACILITY
CITY OF WILMOT, ARKANSAS

DATE: August 31, 2016

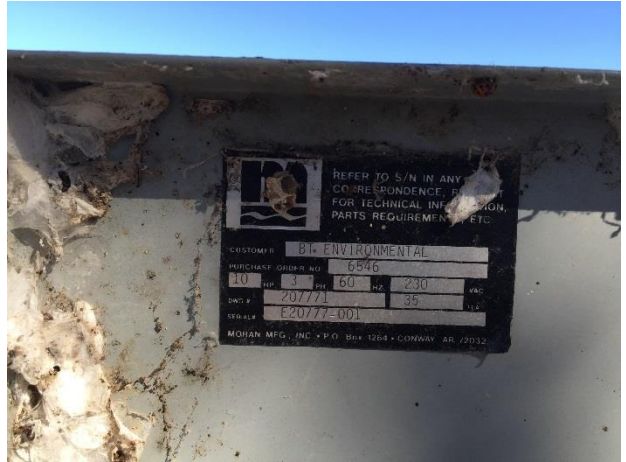
Figure 6 -Existing pump station info tag

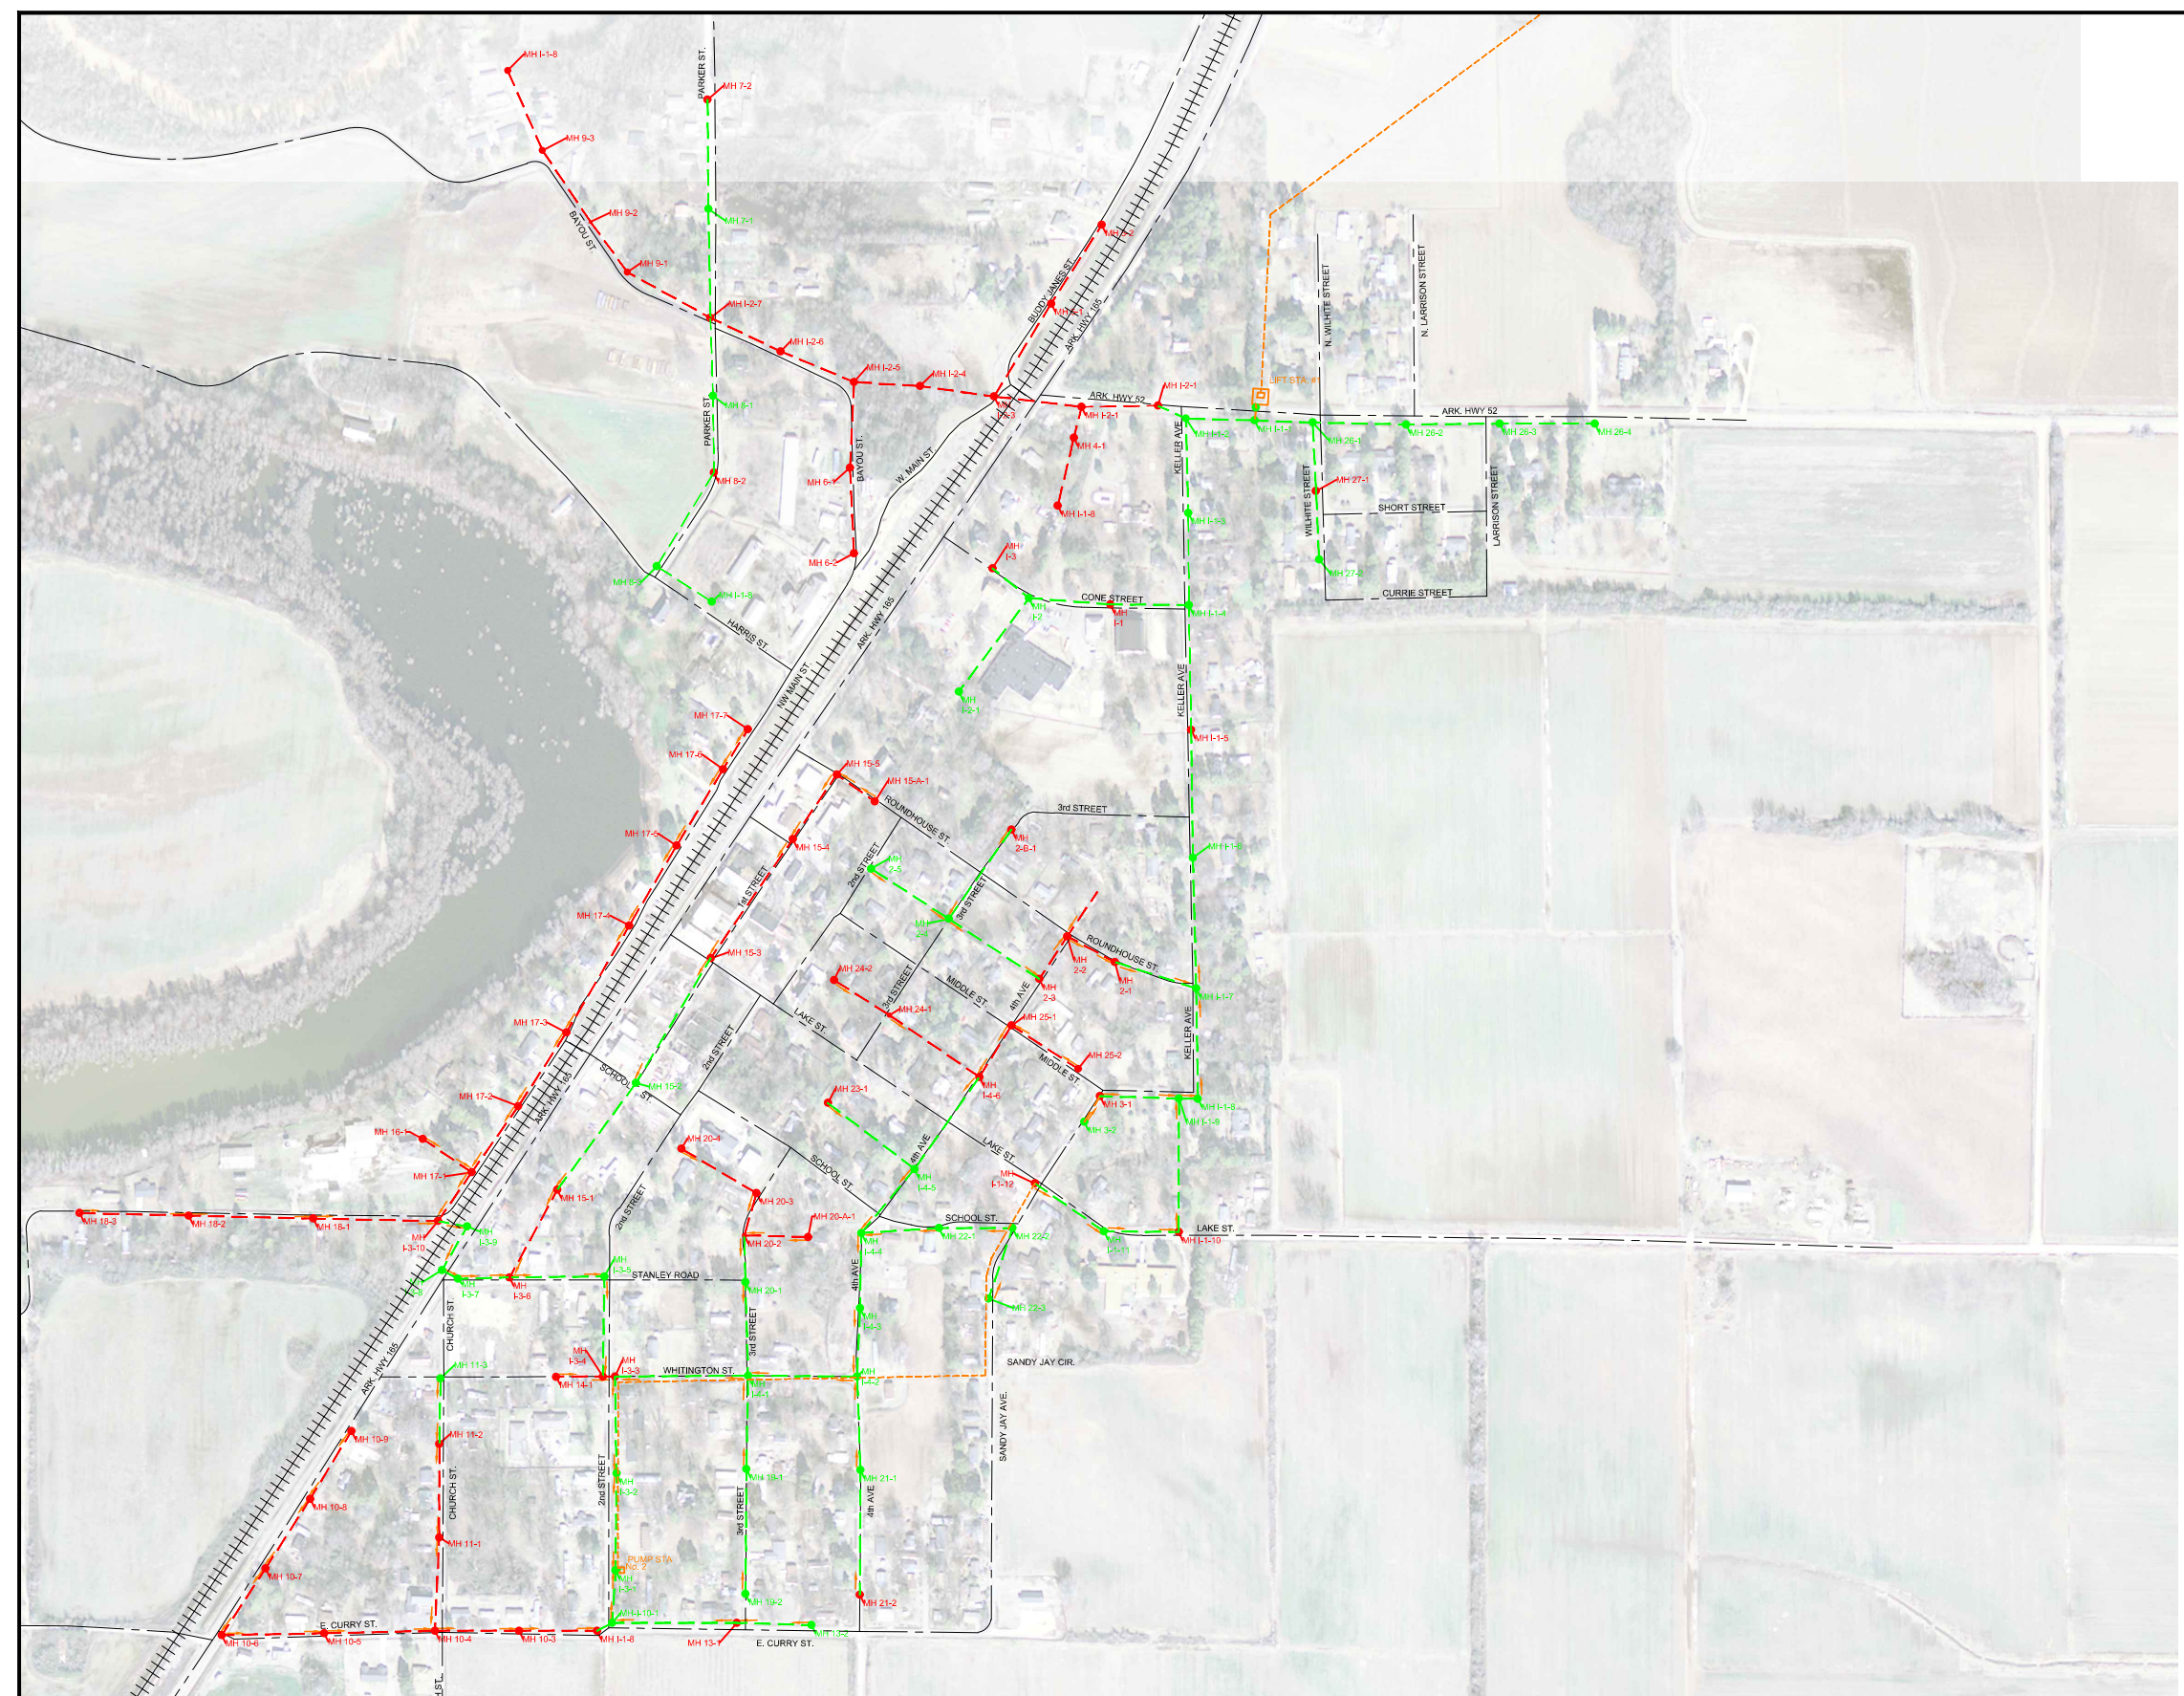
MANHOLE INVENTORY MAP
SMOKE TEST FINDINGS
CITY OF WILMOT, ARKANSAS

⊙ **BURIED / NOT FOUND MANHOLE (73)**
⊙ **FOUND MANHOLE (45)**

MANHOLE LID CRACKED

As previously stated, there are 73 manholes that have either been paved over or inaccessible. The lids of these manholes need to be uncovered and the ring and lid raised to grade. The 6 existing manholes that have lids below grade in wet areas also need to be raised to prevent intrusion of storm water into the system. Once the inaccessible manholes are raised to grade, another round of smoke testing should be conducted to locate problems in the untested areas. Approximately one leak was found for every 1500 linear feet of main in the portion of the system that was tested. This suggests that an equal number of problems will be found in the remaining 50 percent of the system that was not tested. A list of the problems found in the smoke testing was provided to the City and they were to begin correcting the issues immediately.

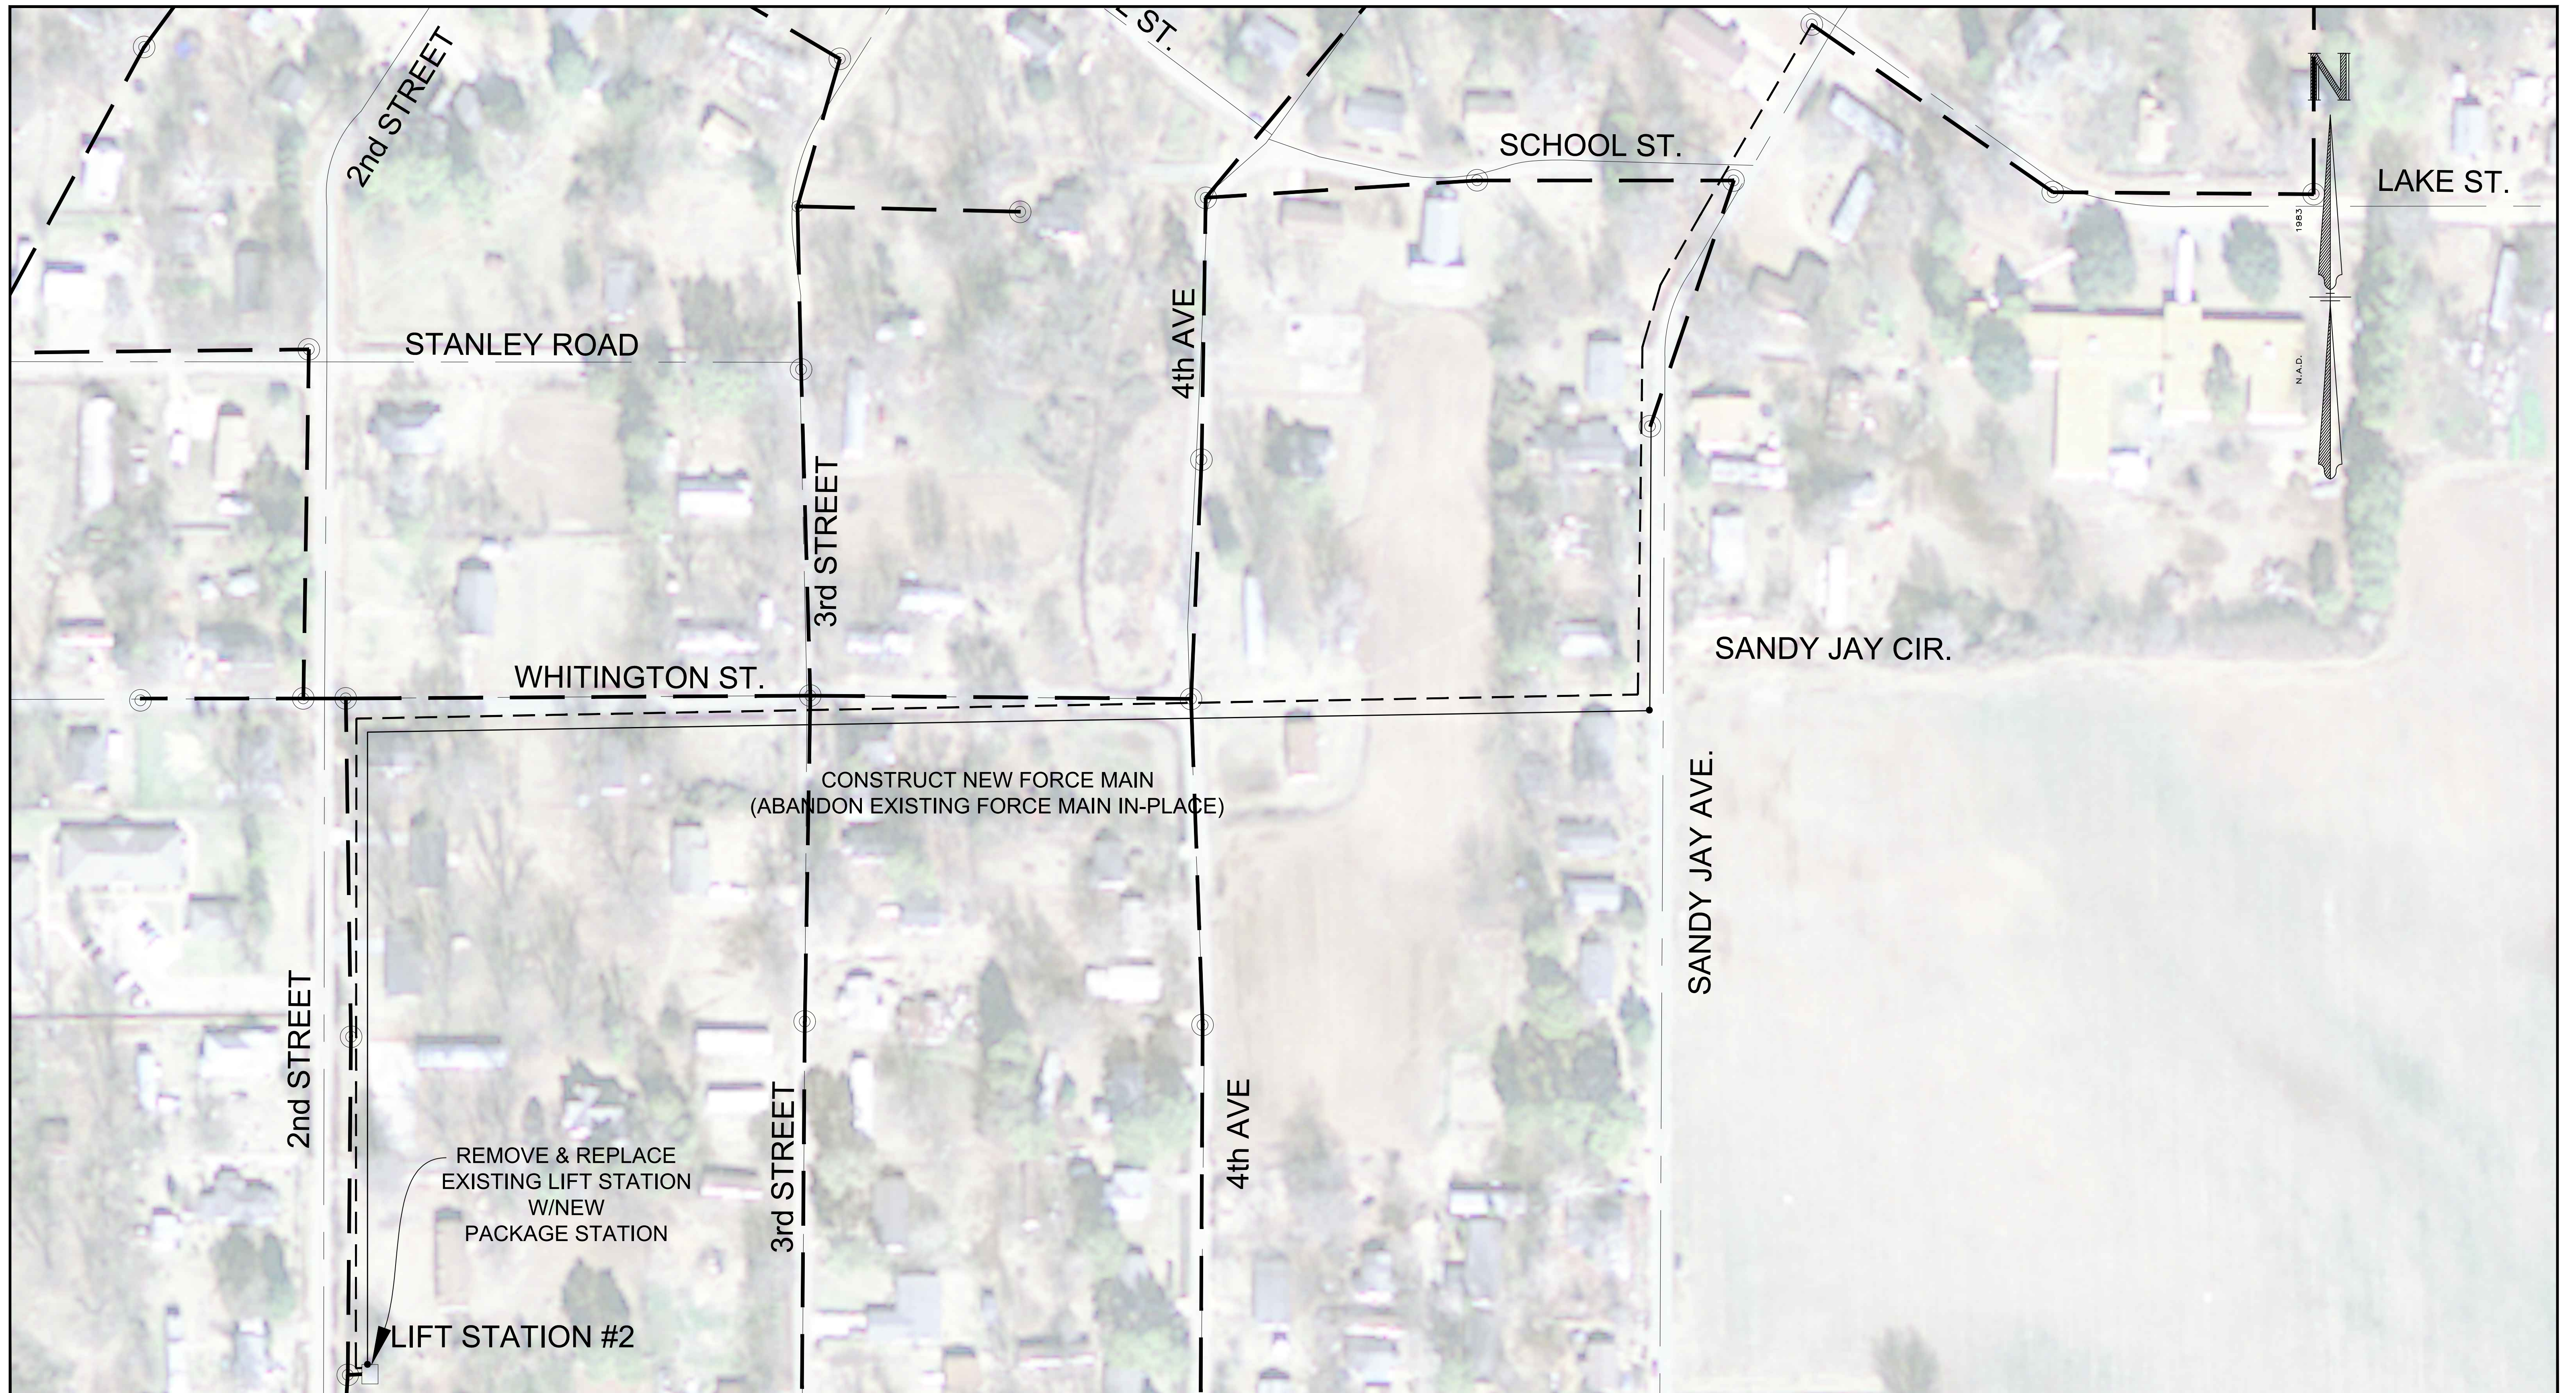
LIFT STATION #2

Both of the collection lift stations are dated and in disrepair. The structures are old and while the controls are still functioning, they contain several safety issues for workers performing maintenance or repairs to the stations. We therefore recommend the installation of two new duplex submersible lift stations and wet wells. The existing station can stay in operation until the new units are installed and operational. At that point the influent can be rerouted into the new stations and the old pumps, building and wet well be demolished. A drawing of the proposed pump station rehabilitations is included in Attachment 7.
