PRELIMINARY ENGINEERING REPORT

***WASTEWATER SYSTEM
IMPROVEMENTS***

***MARBLE FALLS SEWER IMPROVEMENT
DISTRICT NUMBER ONE***

***MAY 2010
(REVISED JUNE 2010)***

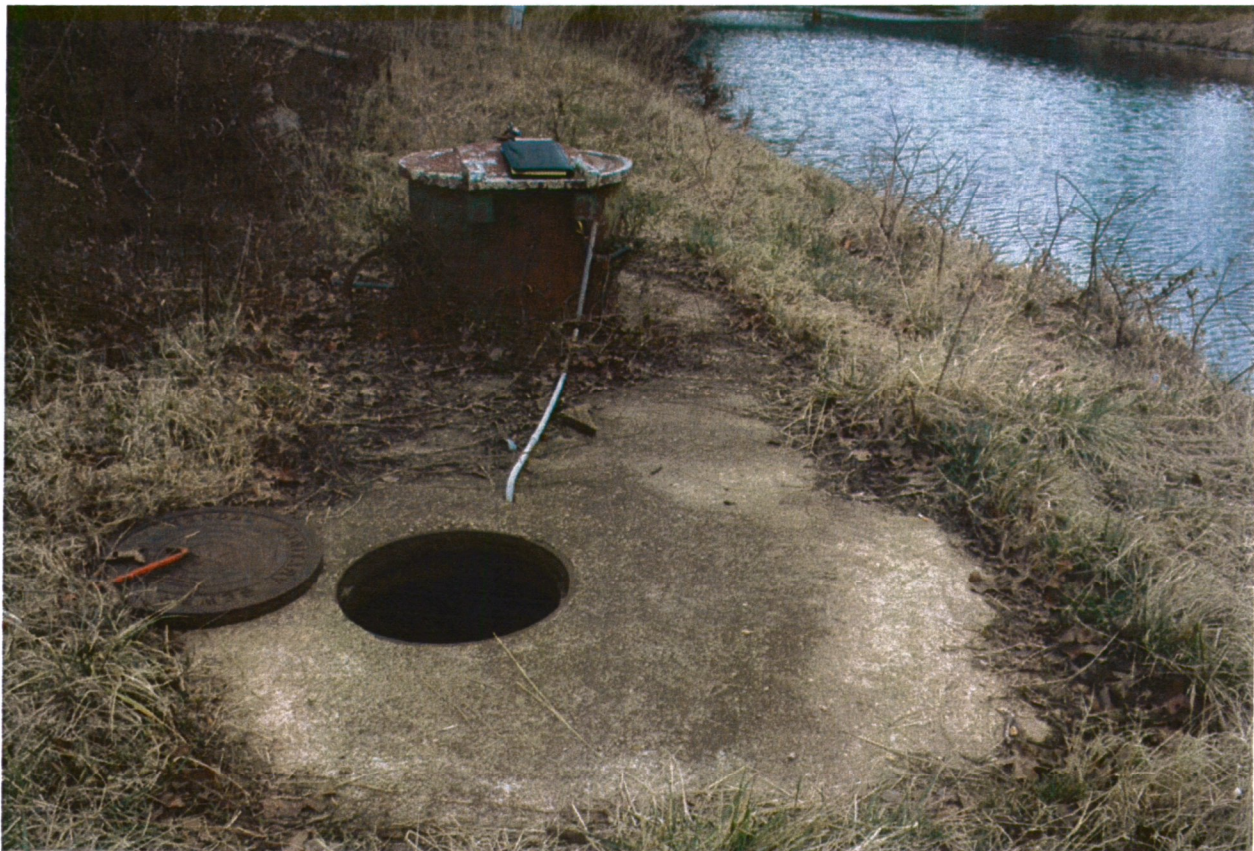
Figure 3.19 Lift Station 2

Lift Station 2 is shown in Figures 3.19 - 3.21.

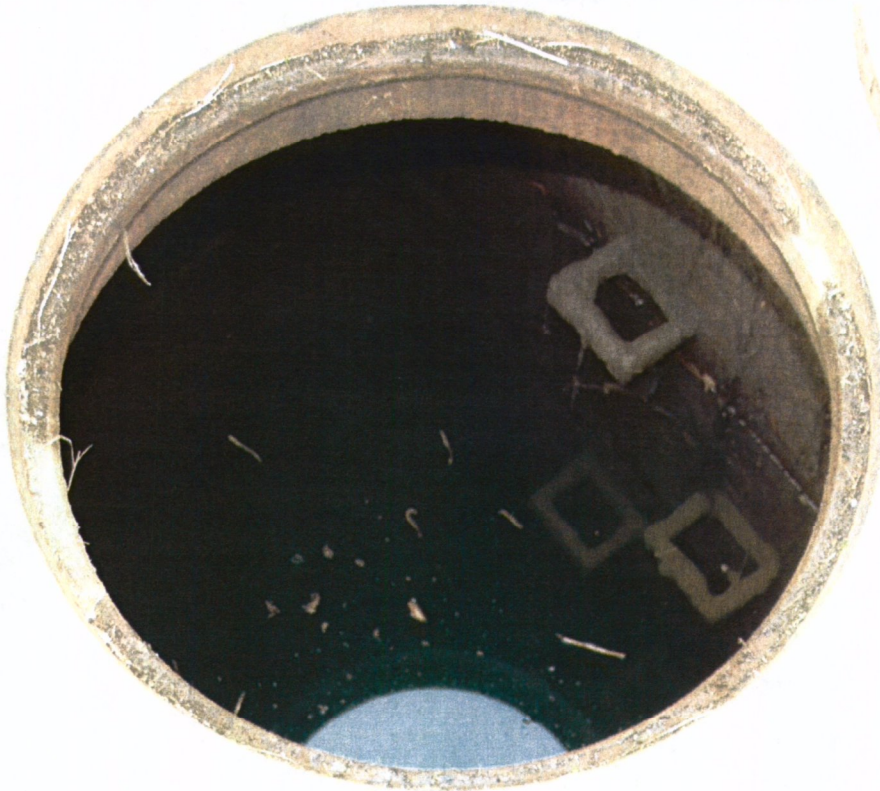
Figure 3.20 Lift Station 2 Wetwell Prior to Pumping

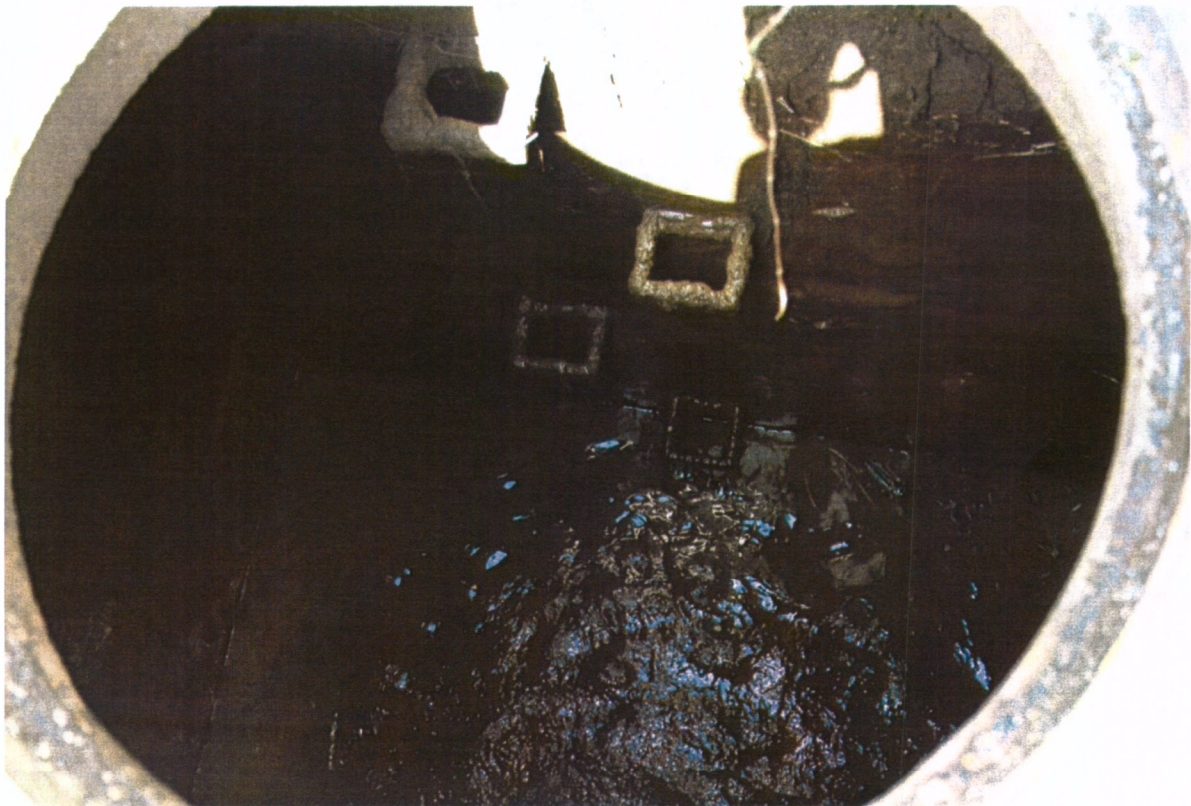
Figure 3.21 Lift Station 2 Wetwell During Pumping

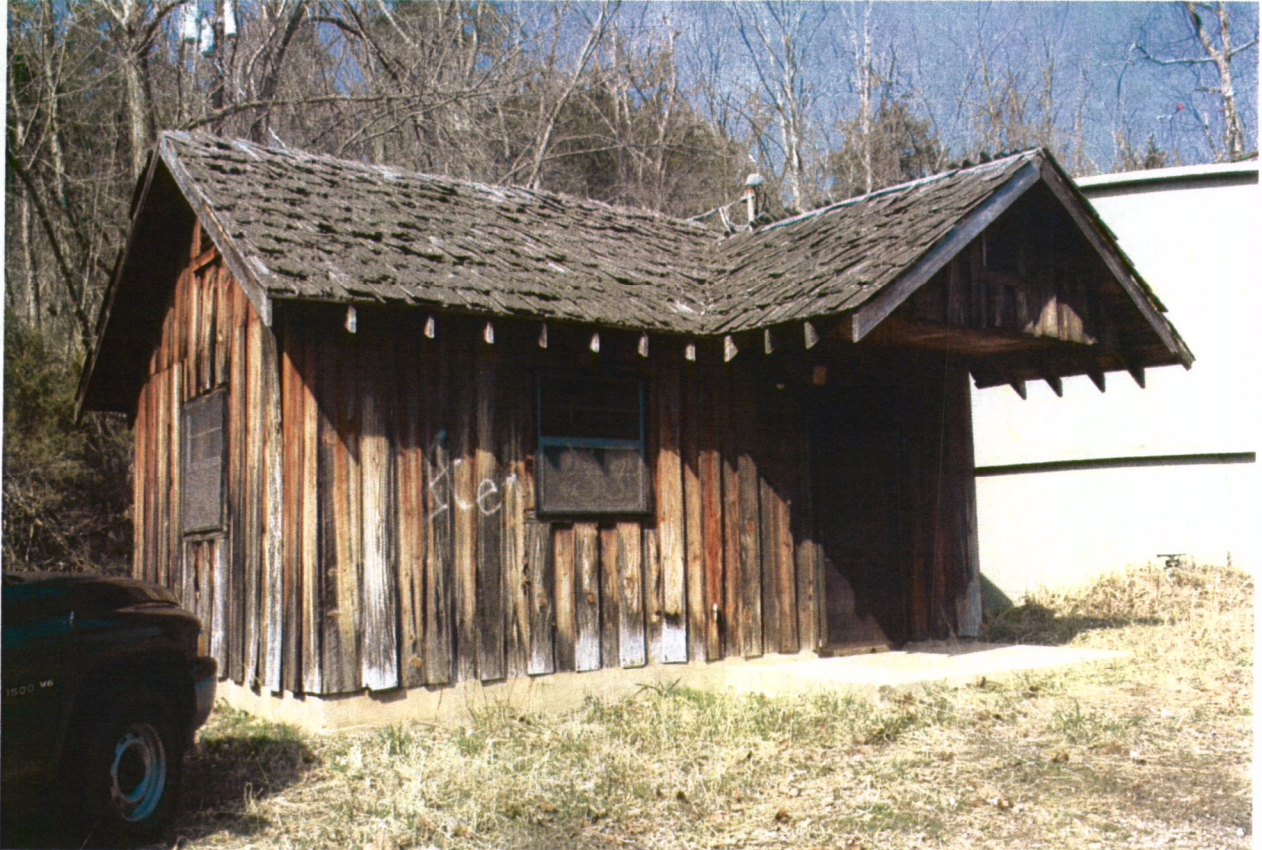
Figure 3.23 Equipment Building Photo

The existing service building is approximately 40 years old and is in poor condition overall. Shown below are items that we considered deficient.

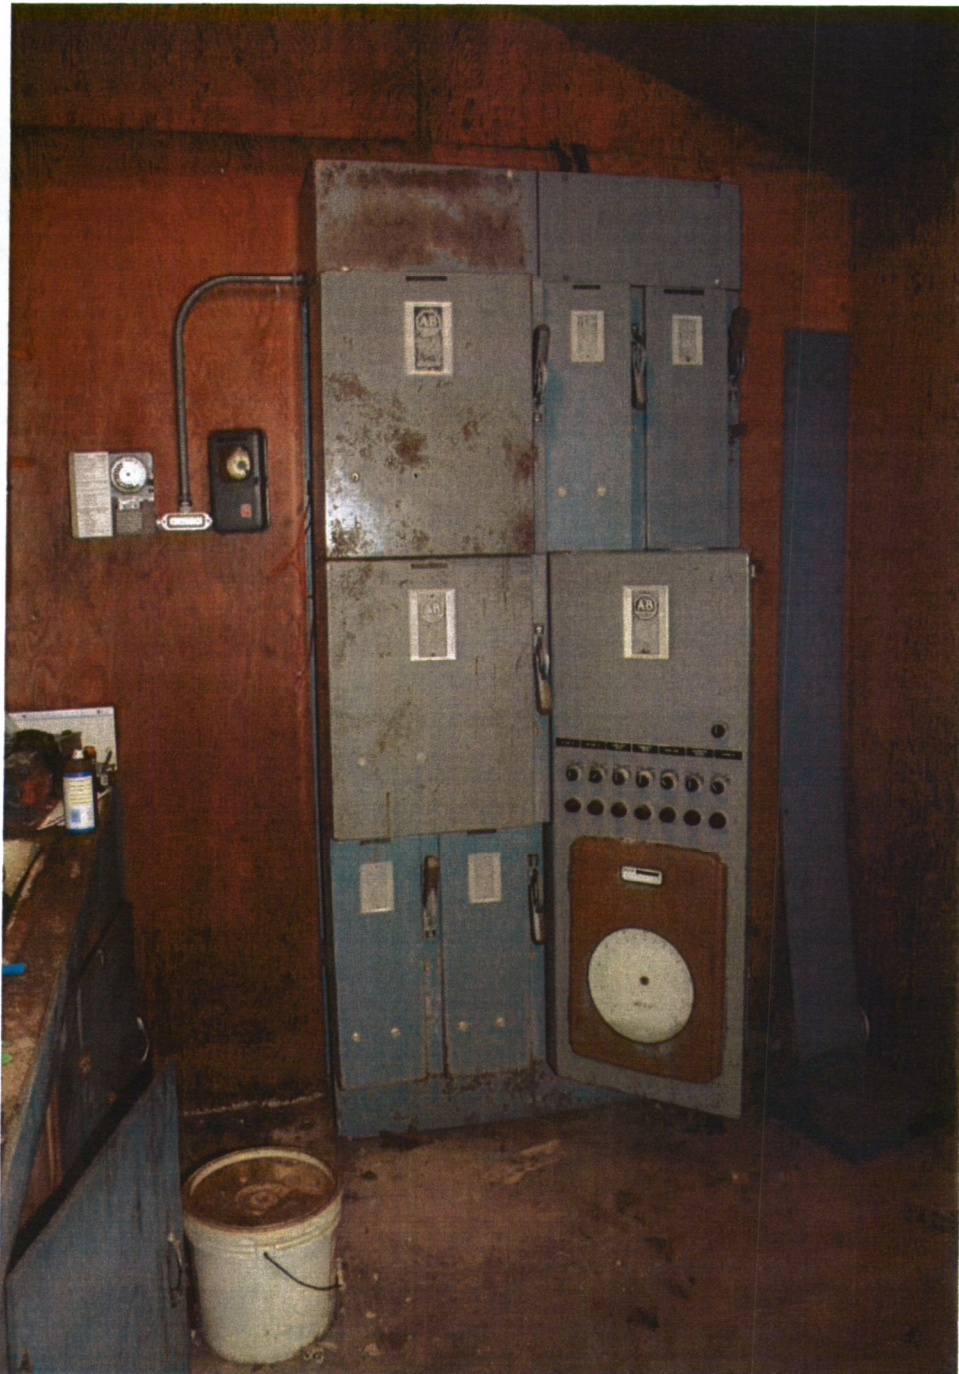
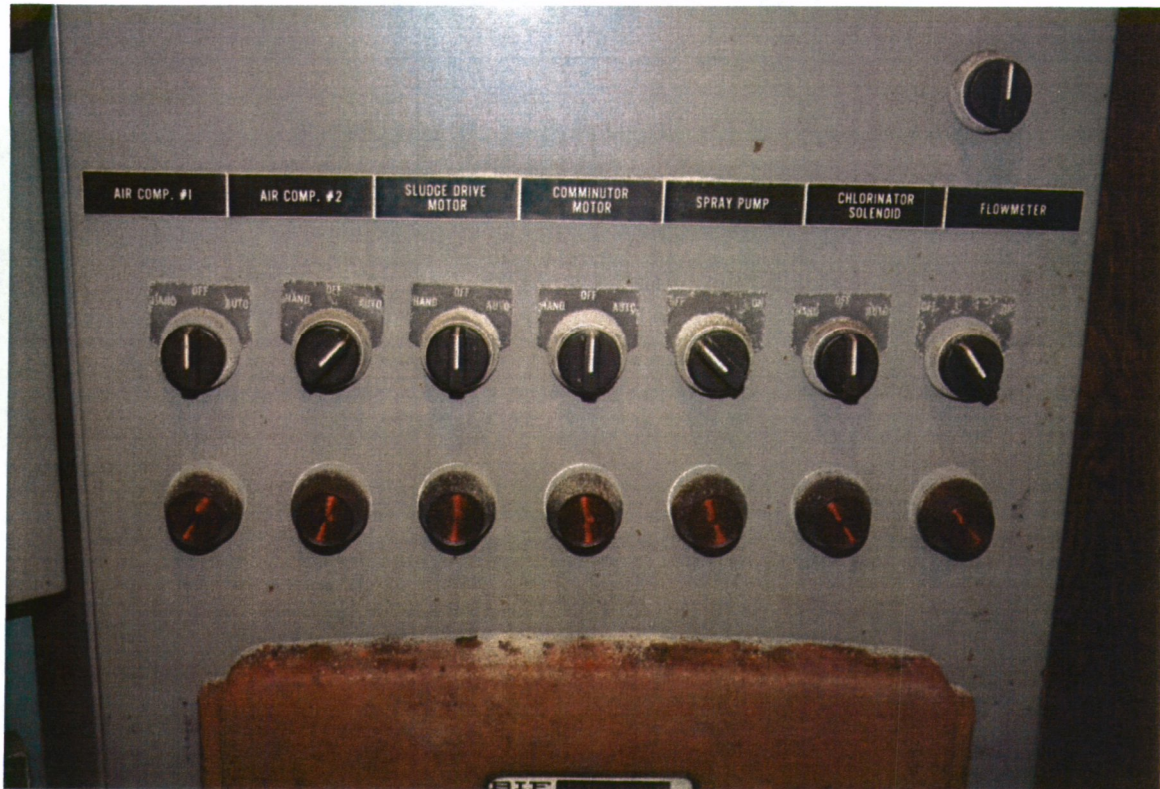
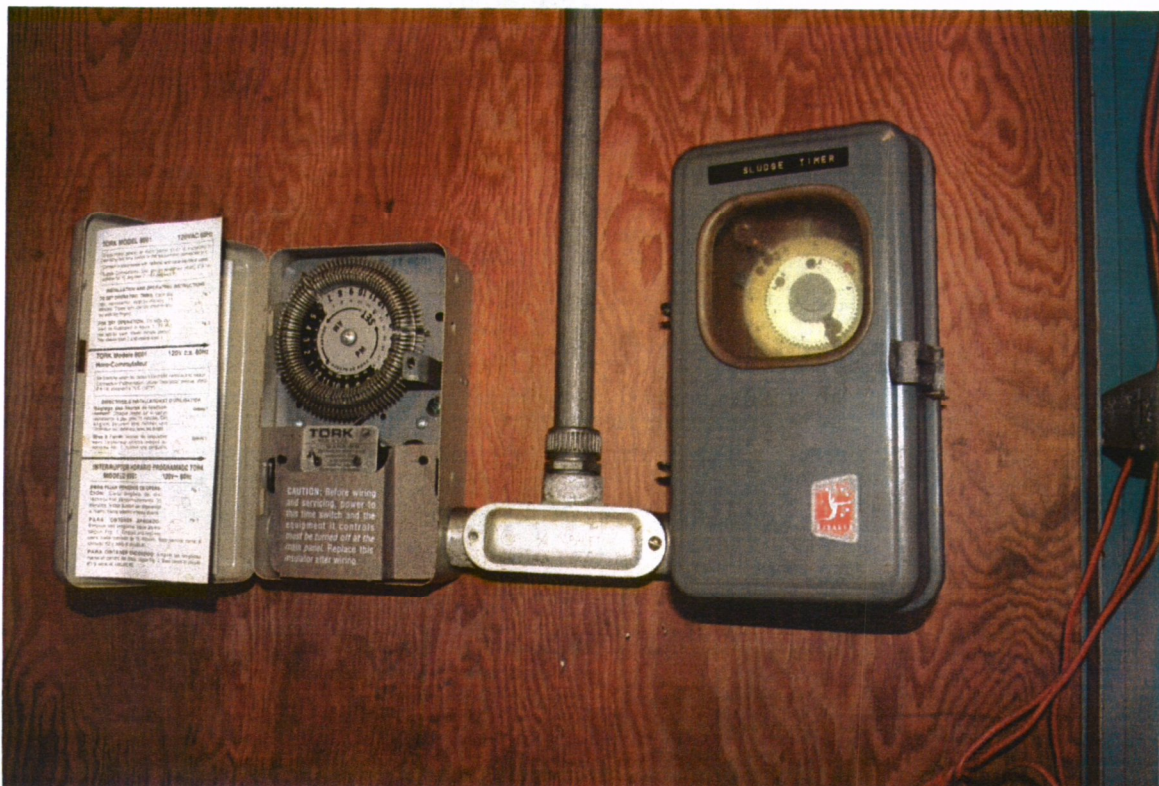
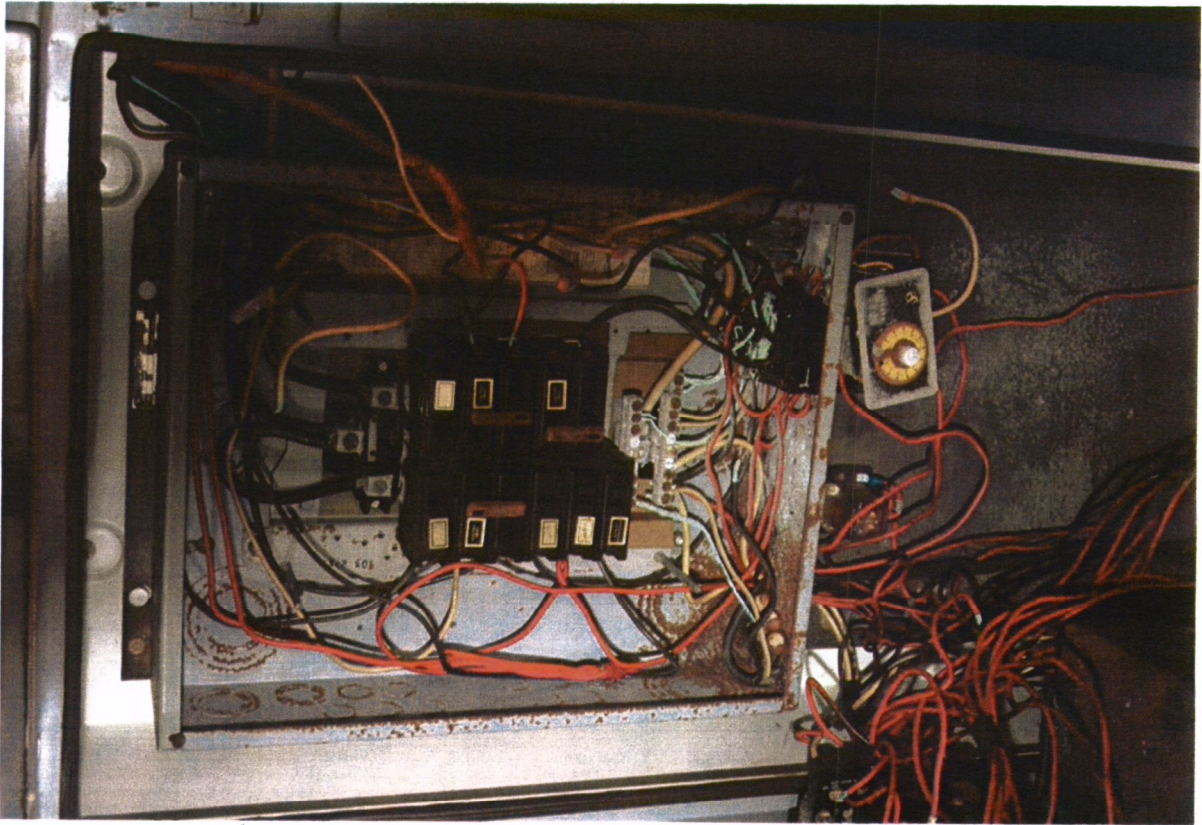
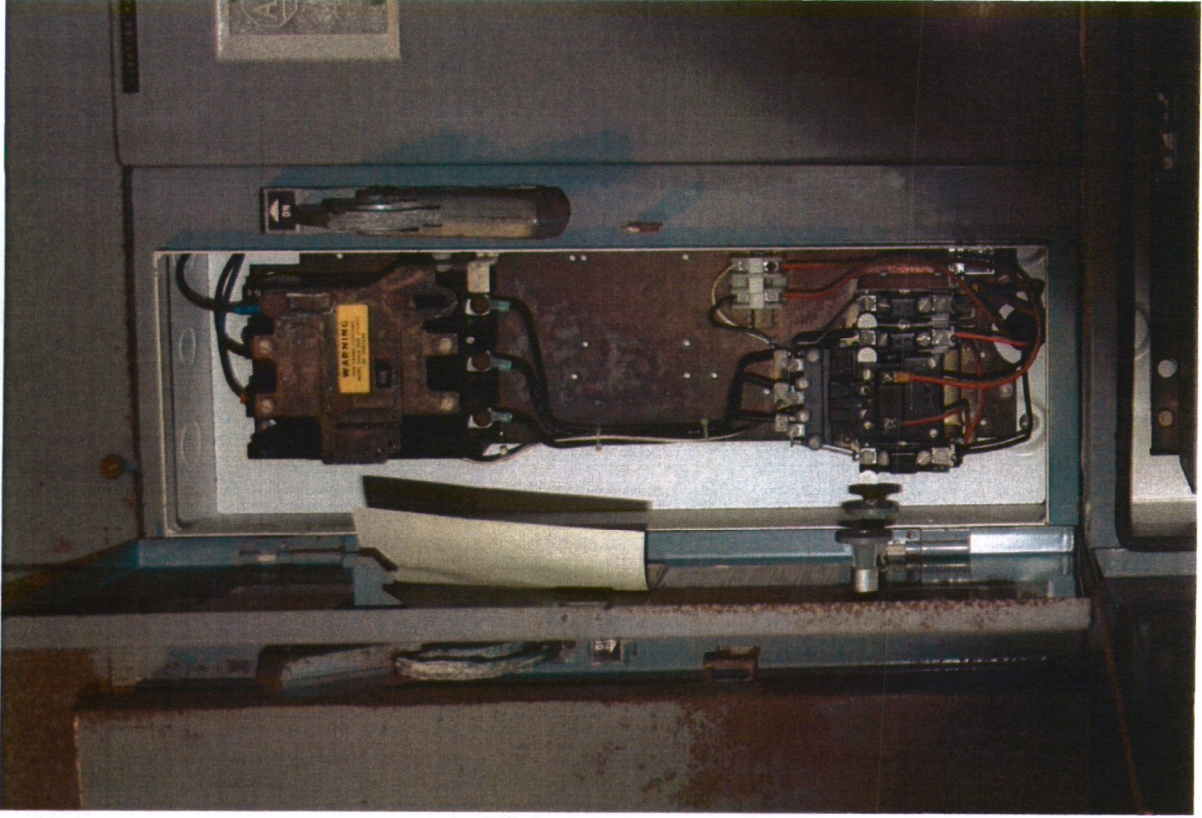
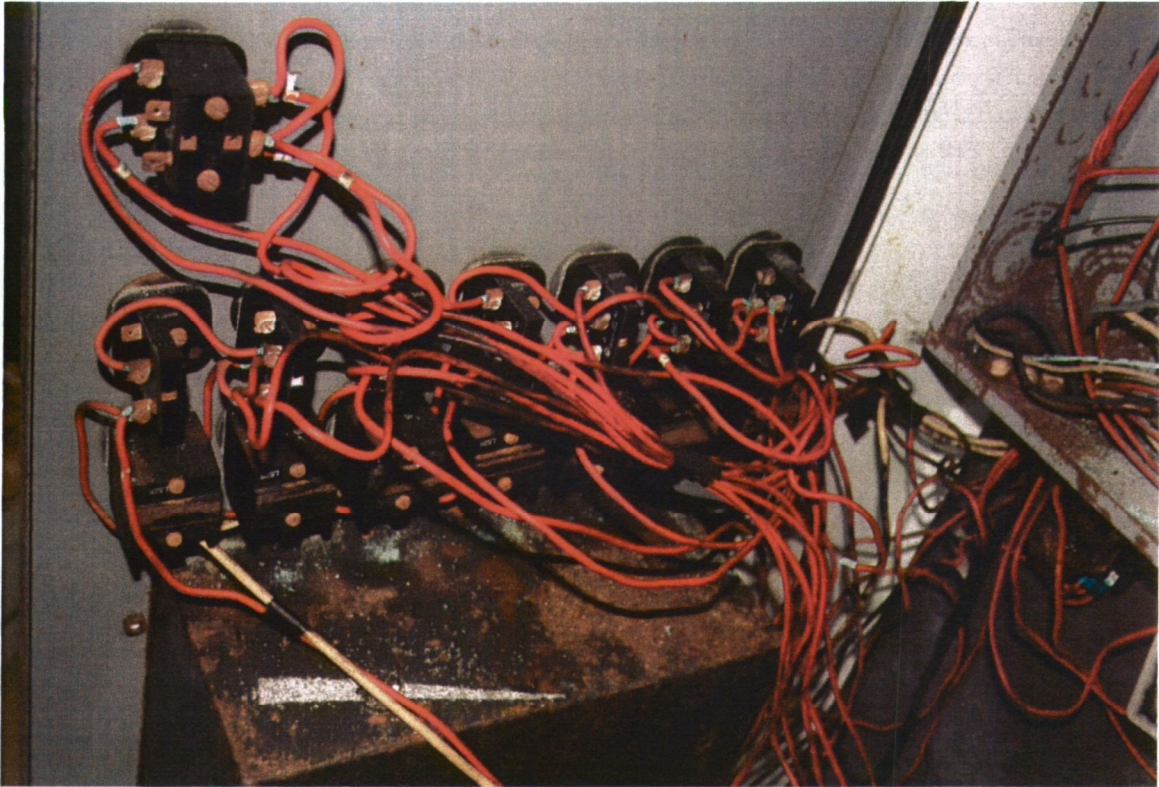
The equipment building also houses the control panels and timers for the treatment system. The control panels are located on the interior of the northern wall. This places them in close proximity to the electric meter and electric shut off valve, which are located on the exterior of the northern wall. Photos of the control panels are included as Figures 3.26-3.32.

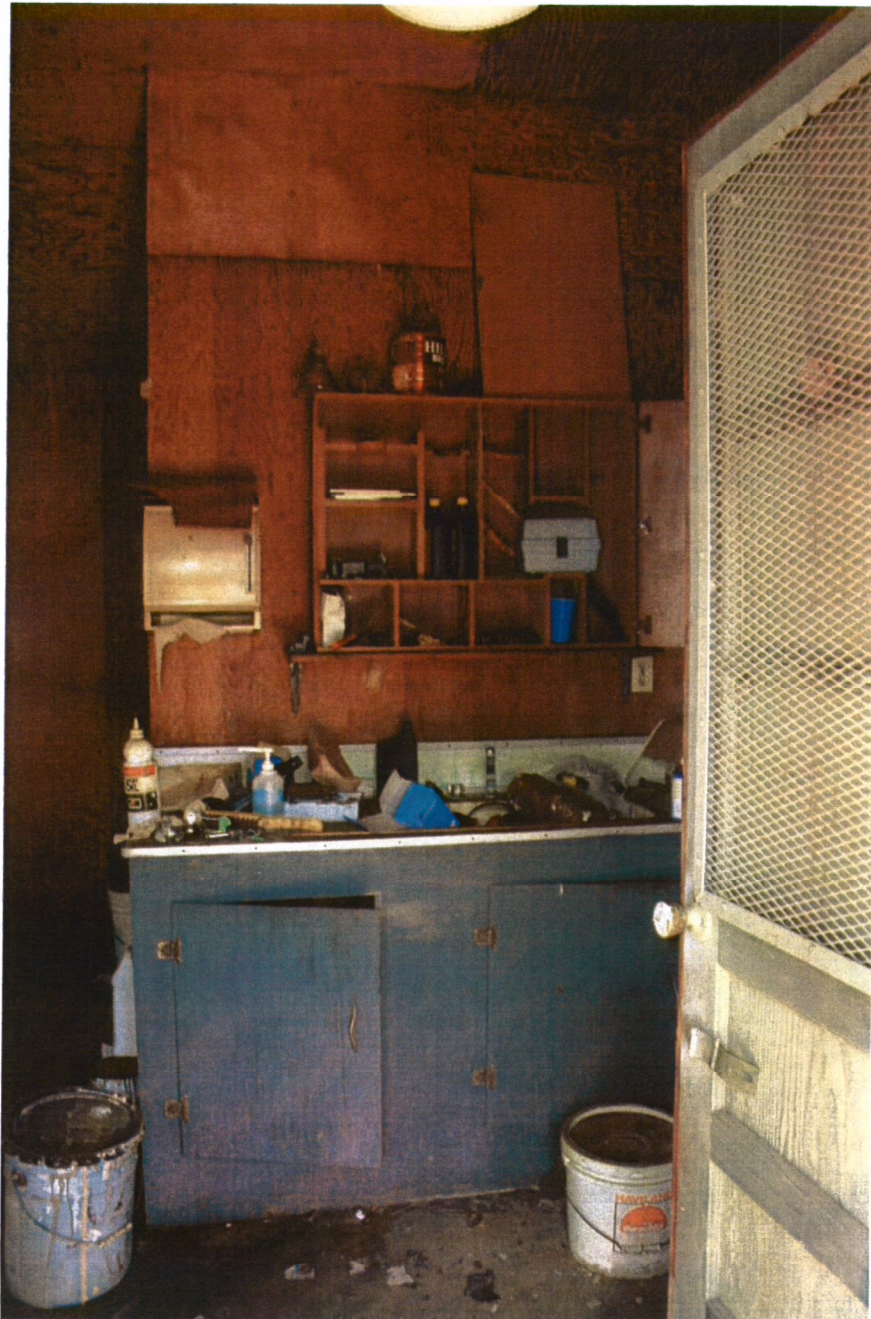
Figure 3.33 Utility Sink and Cabinet Photo

In addition to the blower units and electrical / control panels, there are several other items located in the equipment building which should be noted. There is a small heater mounted to the western wall of the building, near the blower units. A small ventilation fan is mounted in the corner of the window in the southern wall of the building. There is a utility sink with cabinets and counterspace mounted to the main room side of the east supply closet wall. There are two drains in the concrete floor located near the blower units which, along with the drainage from the sink, flow directly to the polishing pond.

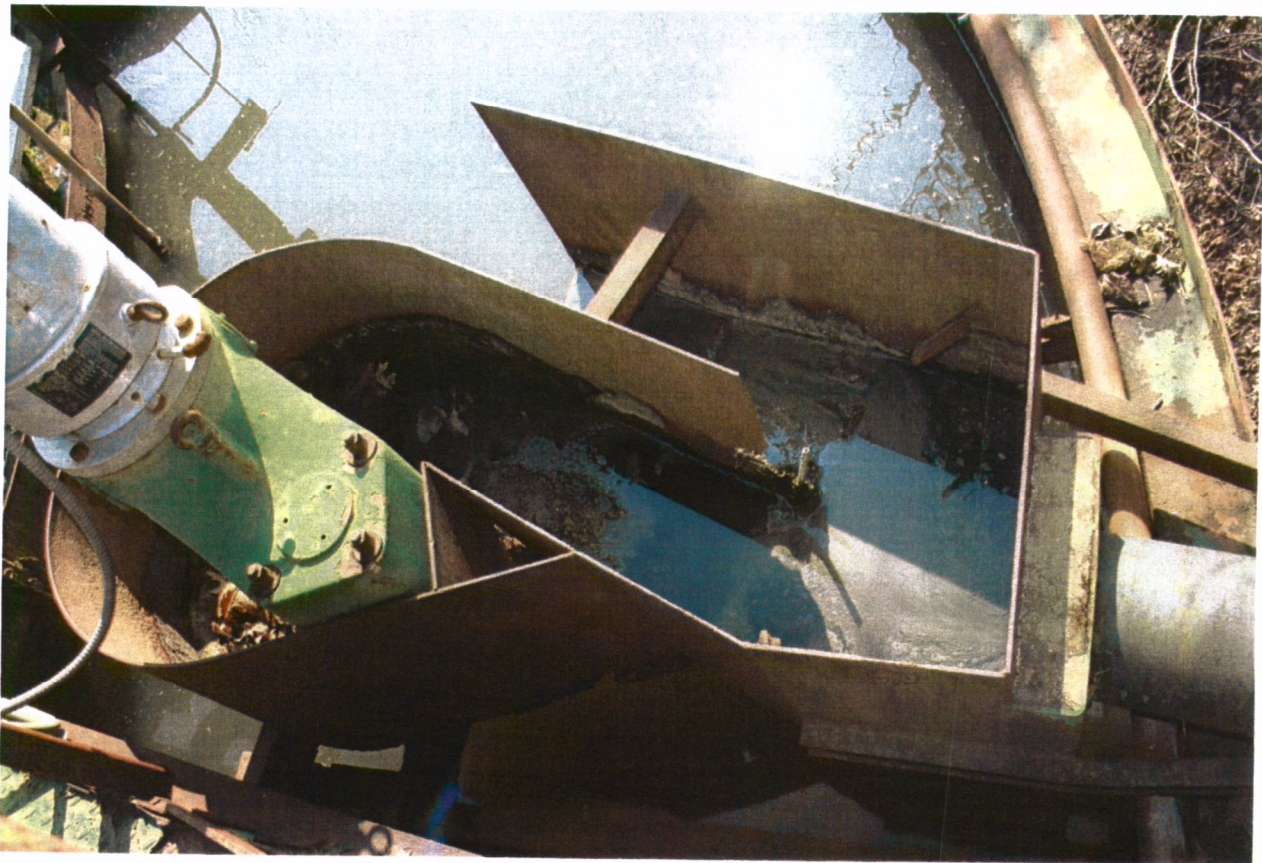
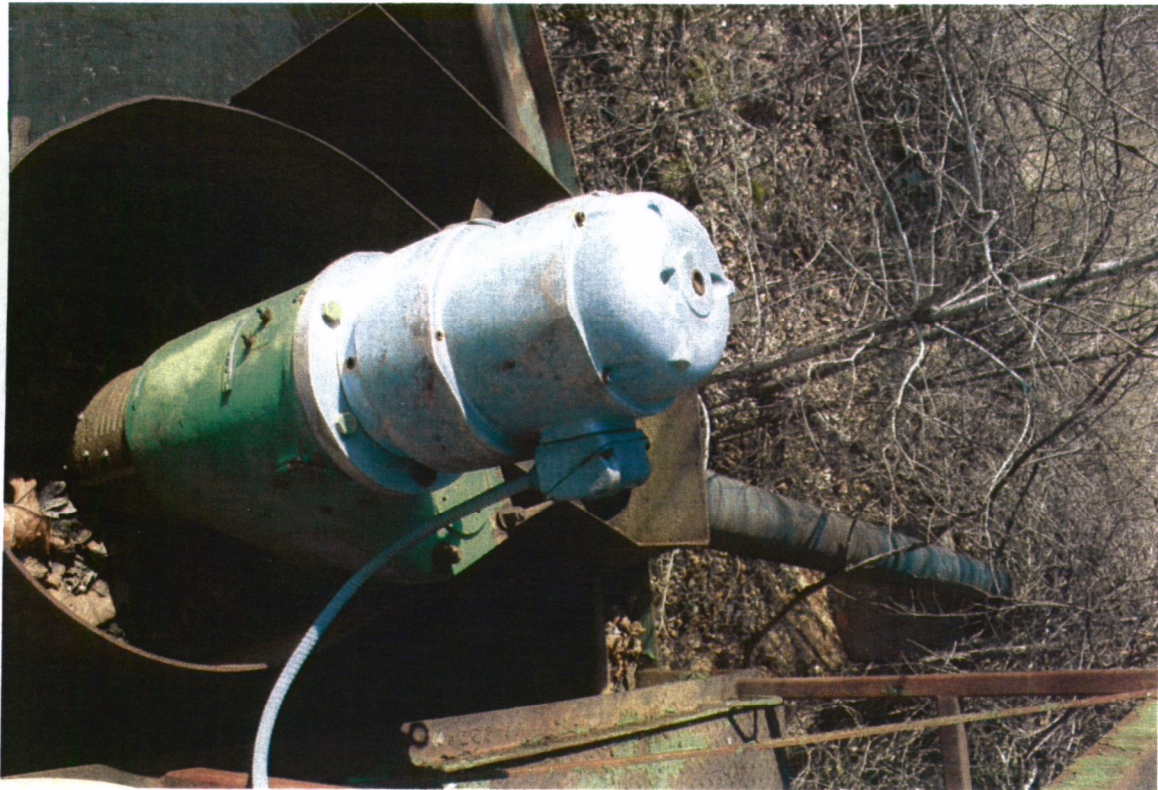
Figure 3.35 Comminutor

Two separate sewage mains from the collection system merge at the concrete inlet box, located on a shelf at approximately the same height as the top of the treatment plant. One line is the force main from Lift Station Number Two, which is located within the old "Dogpatch" amusement park. The other line is a gravity main which enters the inlet box from the north. From the inlet box, the raw sewage travels through an aerial gravity line to a comminutor mounted at the top edge of the tank wall near the end of the catwalk. The comminutor is designed to reduce the size of any solids, using a screen and a grinding unit. The comminutor was manufactured in England by James & Attwood, Ltd. for Smith and Loveless, and is Model No. 10RCC3687, Serial No. 41-0229 02-0477. The comminutor is powered by a 3 phase, 60 Hertz, 230/460 volt, 2.0/1.0 amp, 1800/45 revolutions per minute, 0.5 horsepower electric motor mounted to the top of the comminutor. The motor was manufactured by Smith and Loveless, type SOPD-38, Product No. 0005C-1BAC-0010, Serial No. 224857A-1. The screen for the comminutor is ripped, and most of it is missing. Debris visible in the comminutor channel leading to the grinder unit indicated that no significant flow had entered the grinder unit in some time. The electrical box for the comminutor is mounted to the catwalk railing. Photos of the comminutor are included as Figures 3.35 and 3.36, and a photo of the comminutor electrical box is included as Figure 3.37.

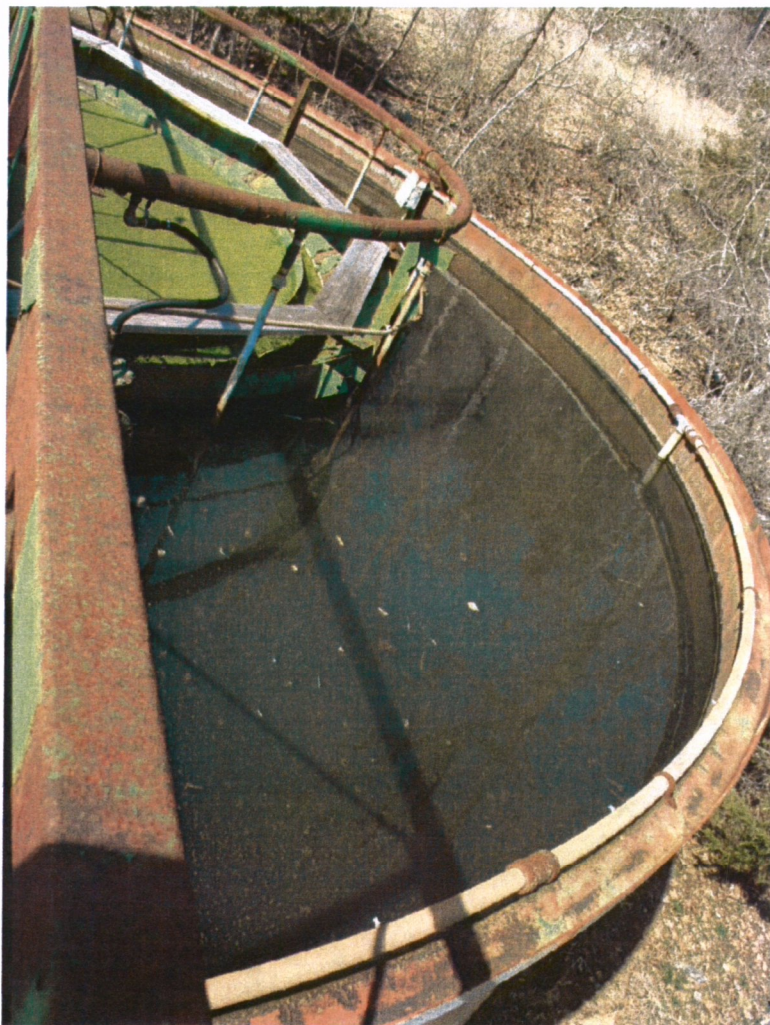
Figure 3.38 Aeration Piping and Spray Nozzles

From the Comminutor, the sewage flows into the outer chamber of the treatment unit, the aeration chamber. As shown in Figure 3.38, the aeration chamber is supplied air via steel tubing around its inner edge, which carries the air from the blowers in the equipment shed. Smaller aeration piping extends vertically down into the tank at regular intervals from the main air line, providing a method of diffused aeration from the bottom of the chamber. The Nelson Engineering report indicates that, at the time the report was prepared, the aeration system was operated by timer, and ran five times per day. A water pipe mounted around the outer rim of the aeration chamber has spray nozzles at regular intervals used for spraying the surface of the fluid within in order to reduce foaming. The photo included as Figure 3.38 shows the spray nozzles, the piping supplying effluent to the spray nozzles, the main aeration line, as well as the vertical air lines extending below the surface of the wastewater. The electrical box for the spray pump is also visible near the main aeration line in this photo.

There was a large volume of wastewater in both the aeration chamber and the clarifier chamber during the evaluation of the plant. The presence of wastewater in the tank prevented direct observation of components below the surface. In addition, a thick layer of bright green algae is present at the surface of the clarifier chamber. All exposed metal surfaces exhibited evidence of extreme corrosion. The existing paint is chipped, cracked, and peeling, and there are large areas where no paint remains at all.

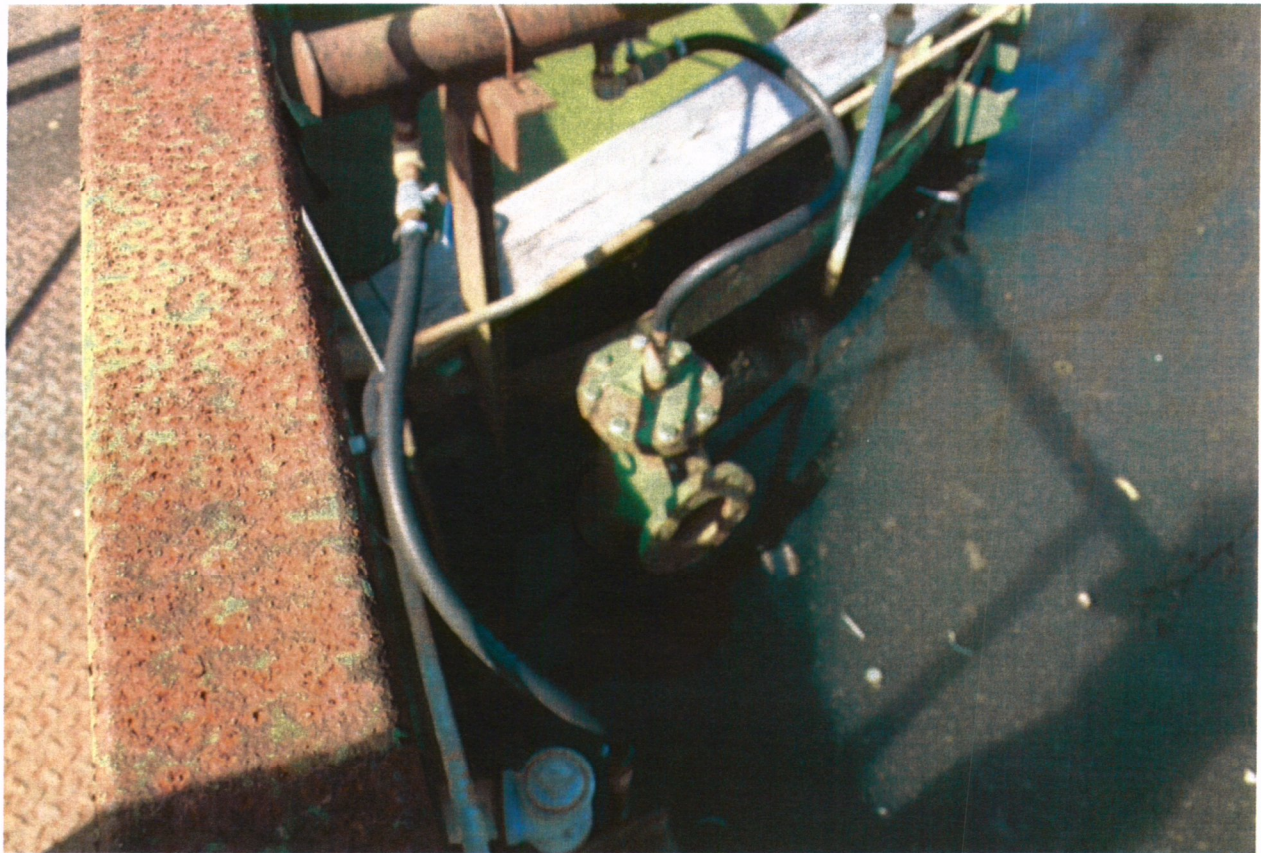
Figure 3.39 Sludge Airlift

The sludge airlift is located near the inner wall of the aeration chamber near the catwalk, and allows sludge to be recirculated from the bottom of the clarifier to the aeration chamber. A photo of the sludge airlift is included as Figure 3.39.

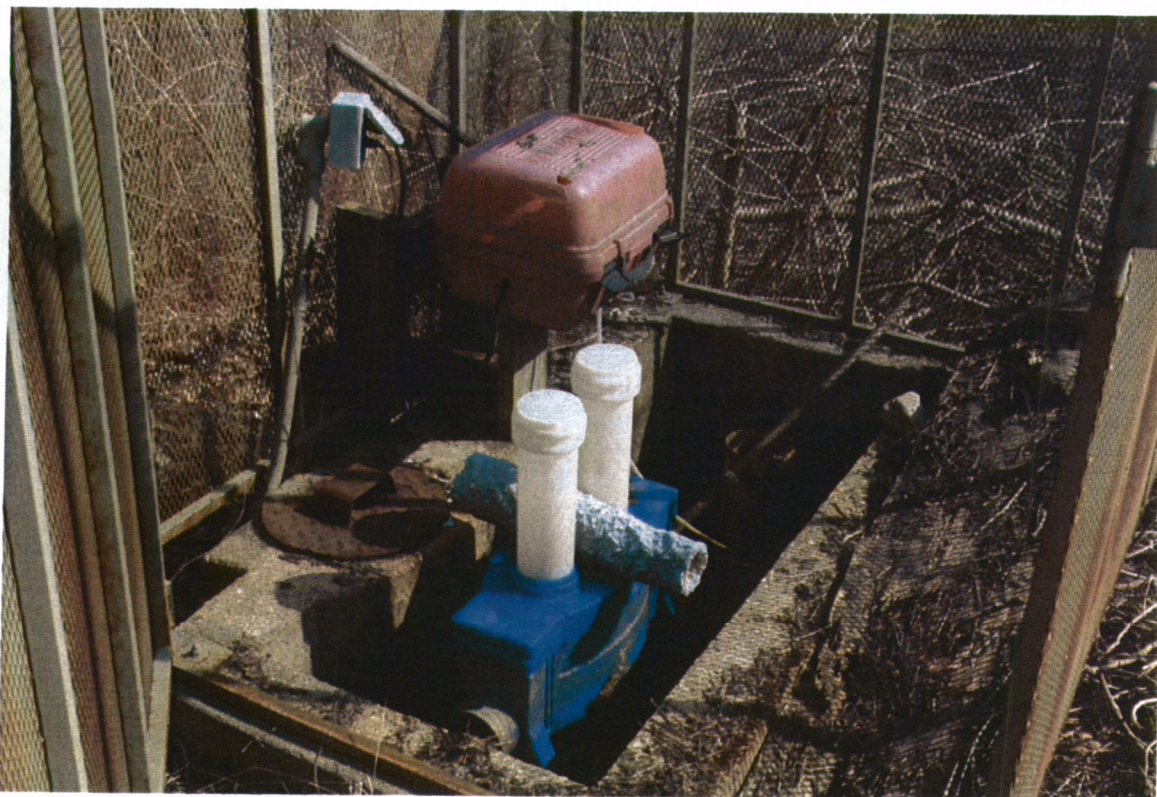
Figure 3.42 Tablet Chlorinator and Chlorine Contact Chamber

not appear to be functional in its current state.

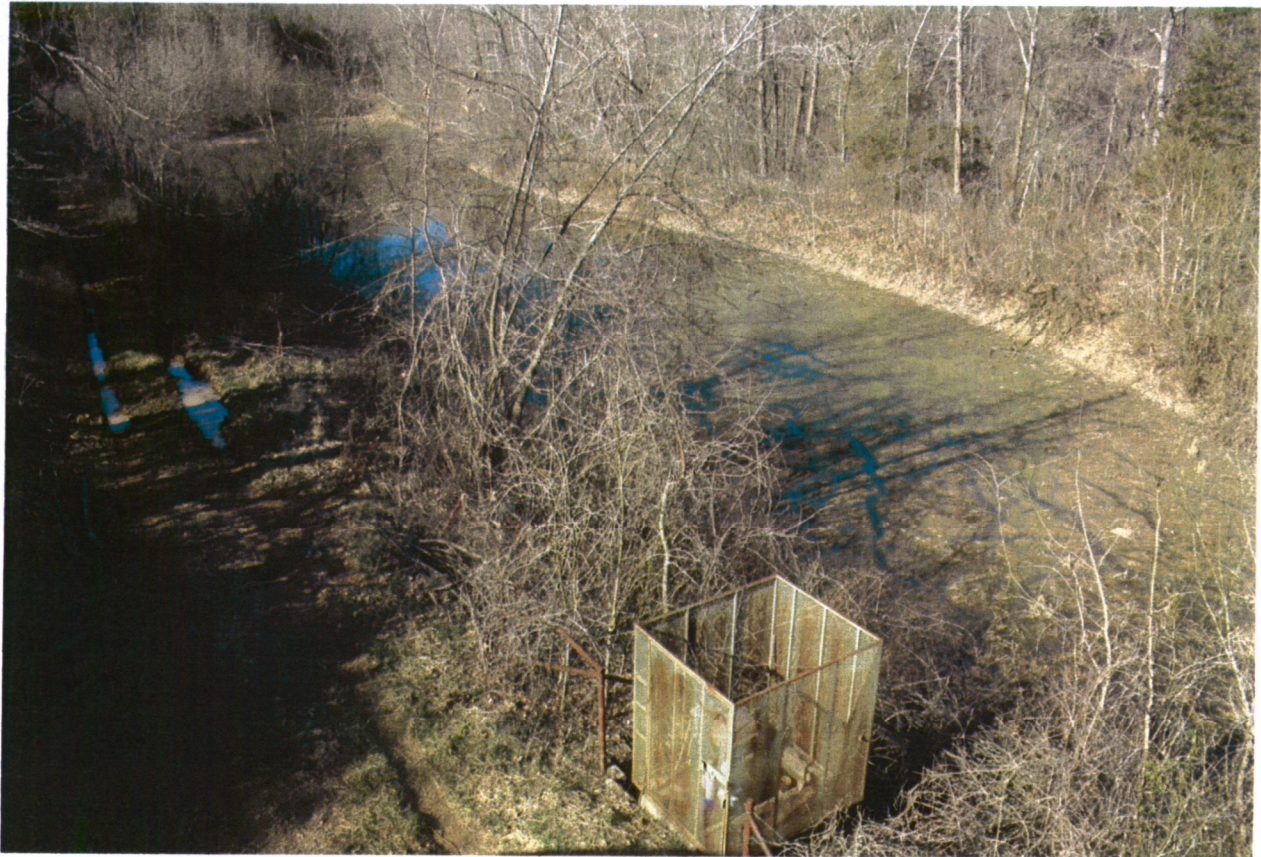
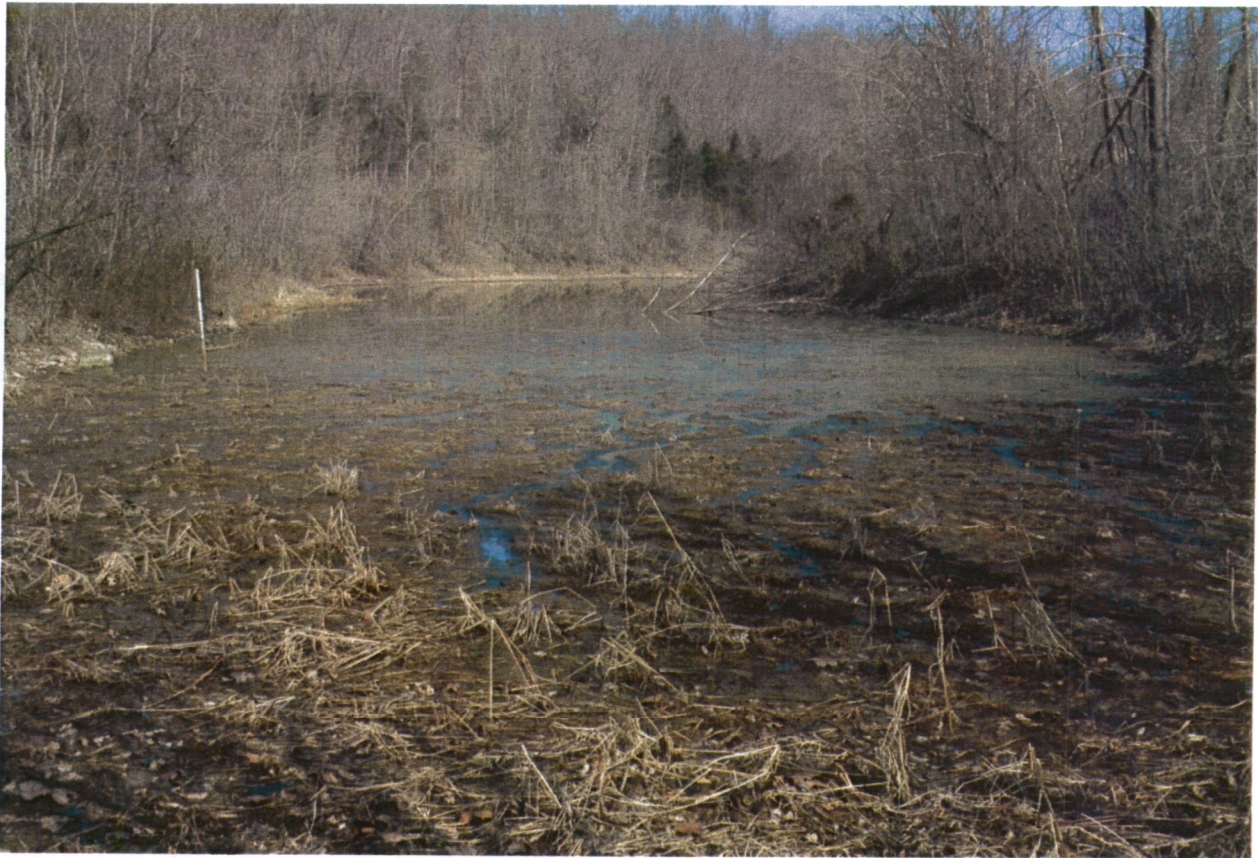
Figure 3.43 Polishing Pond

Currently, there is some water present in the bottom of the pond, but the water level is well below what would be required for it to flow through the outflow structure. The polishing pond is shown in Figures 3.43 and 3.44.
